BOULSTON MANOR, PEMBROKESHIRE: BUILDING RECORDING

Prepared by Dyfed Archaeological Trust
For CADW

RHIF YR ADRODDIAD / REPORT NO. 2012/27
RHIF Y PROSIECT / PROJECT RECORD NO. 102767

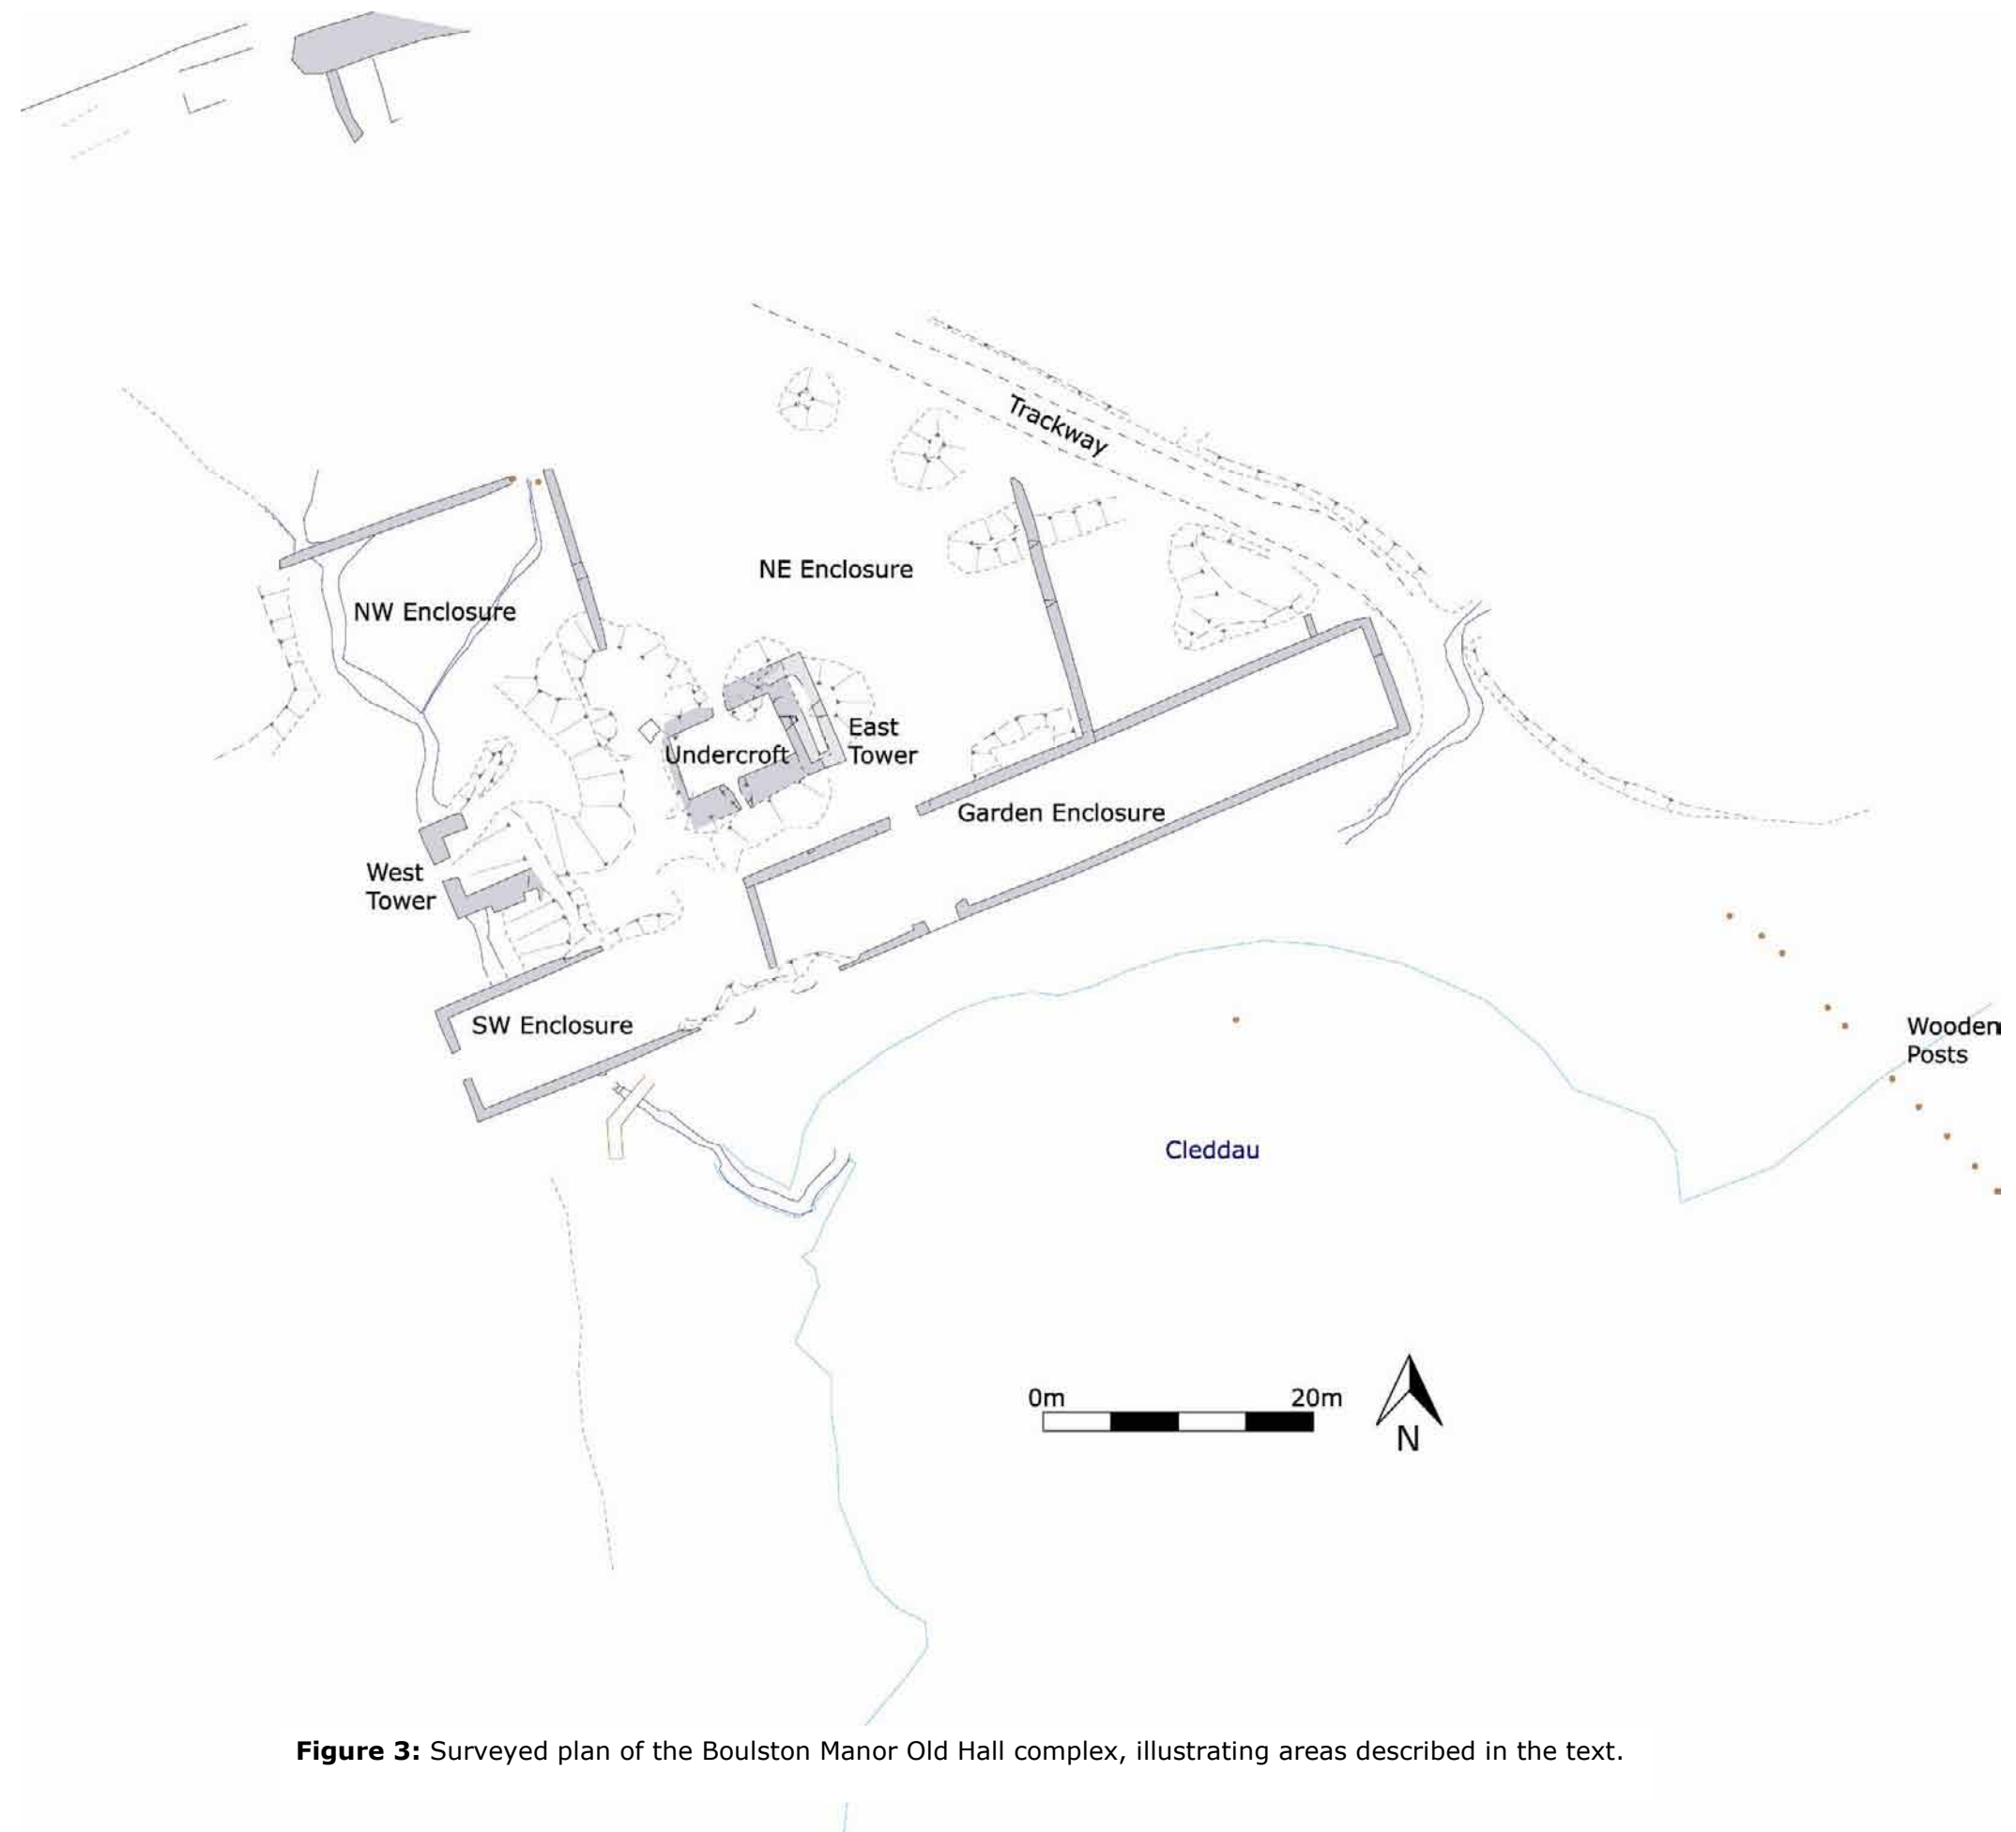
Figure 3: Surveyed plan of the Boulston Manor Old Hall complex, illustrating areas described in the text.

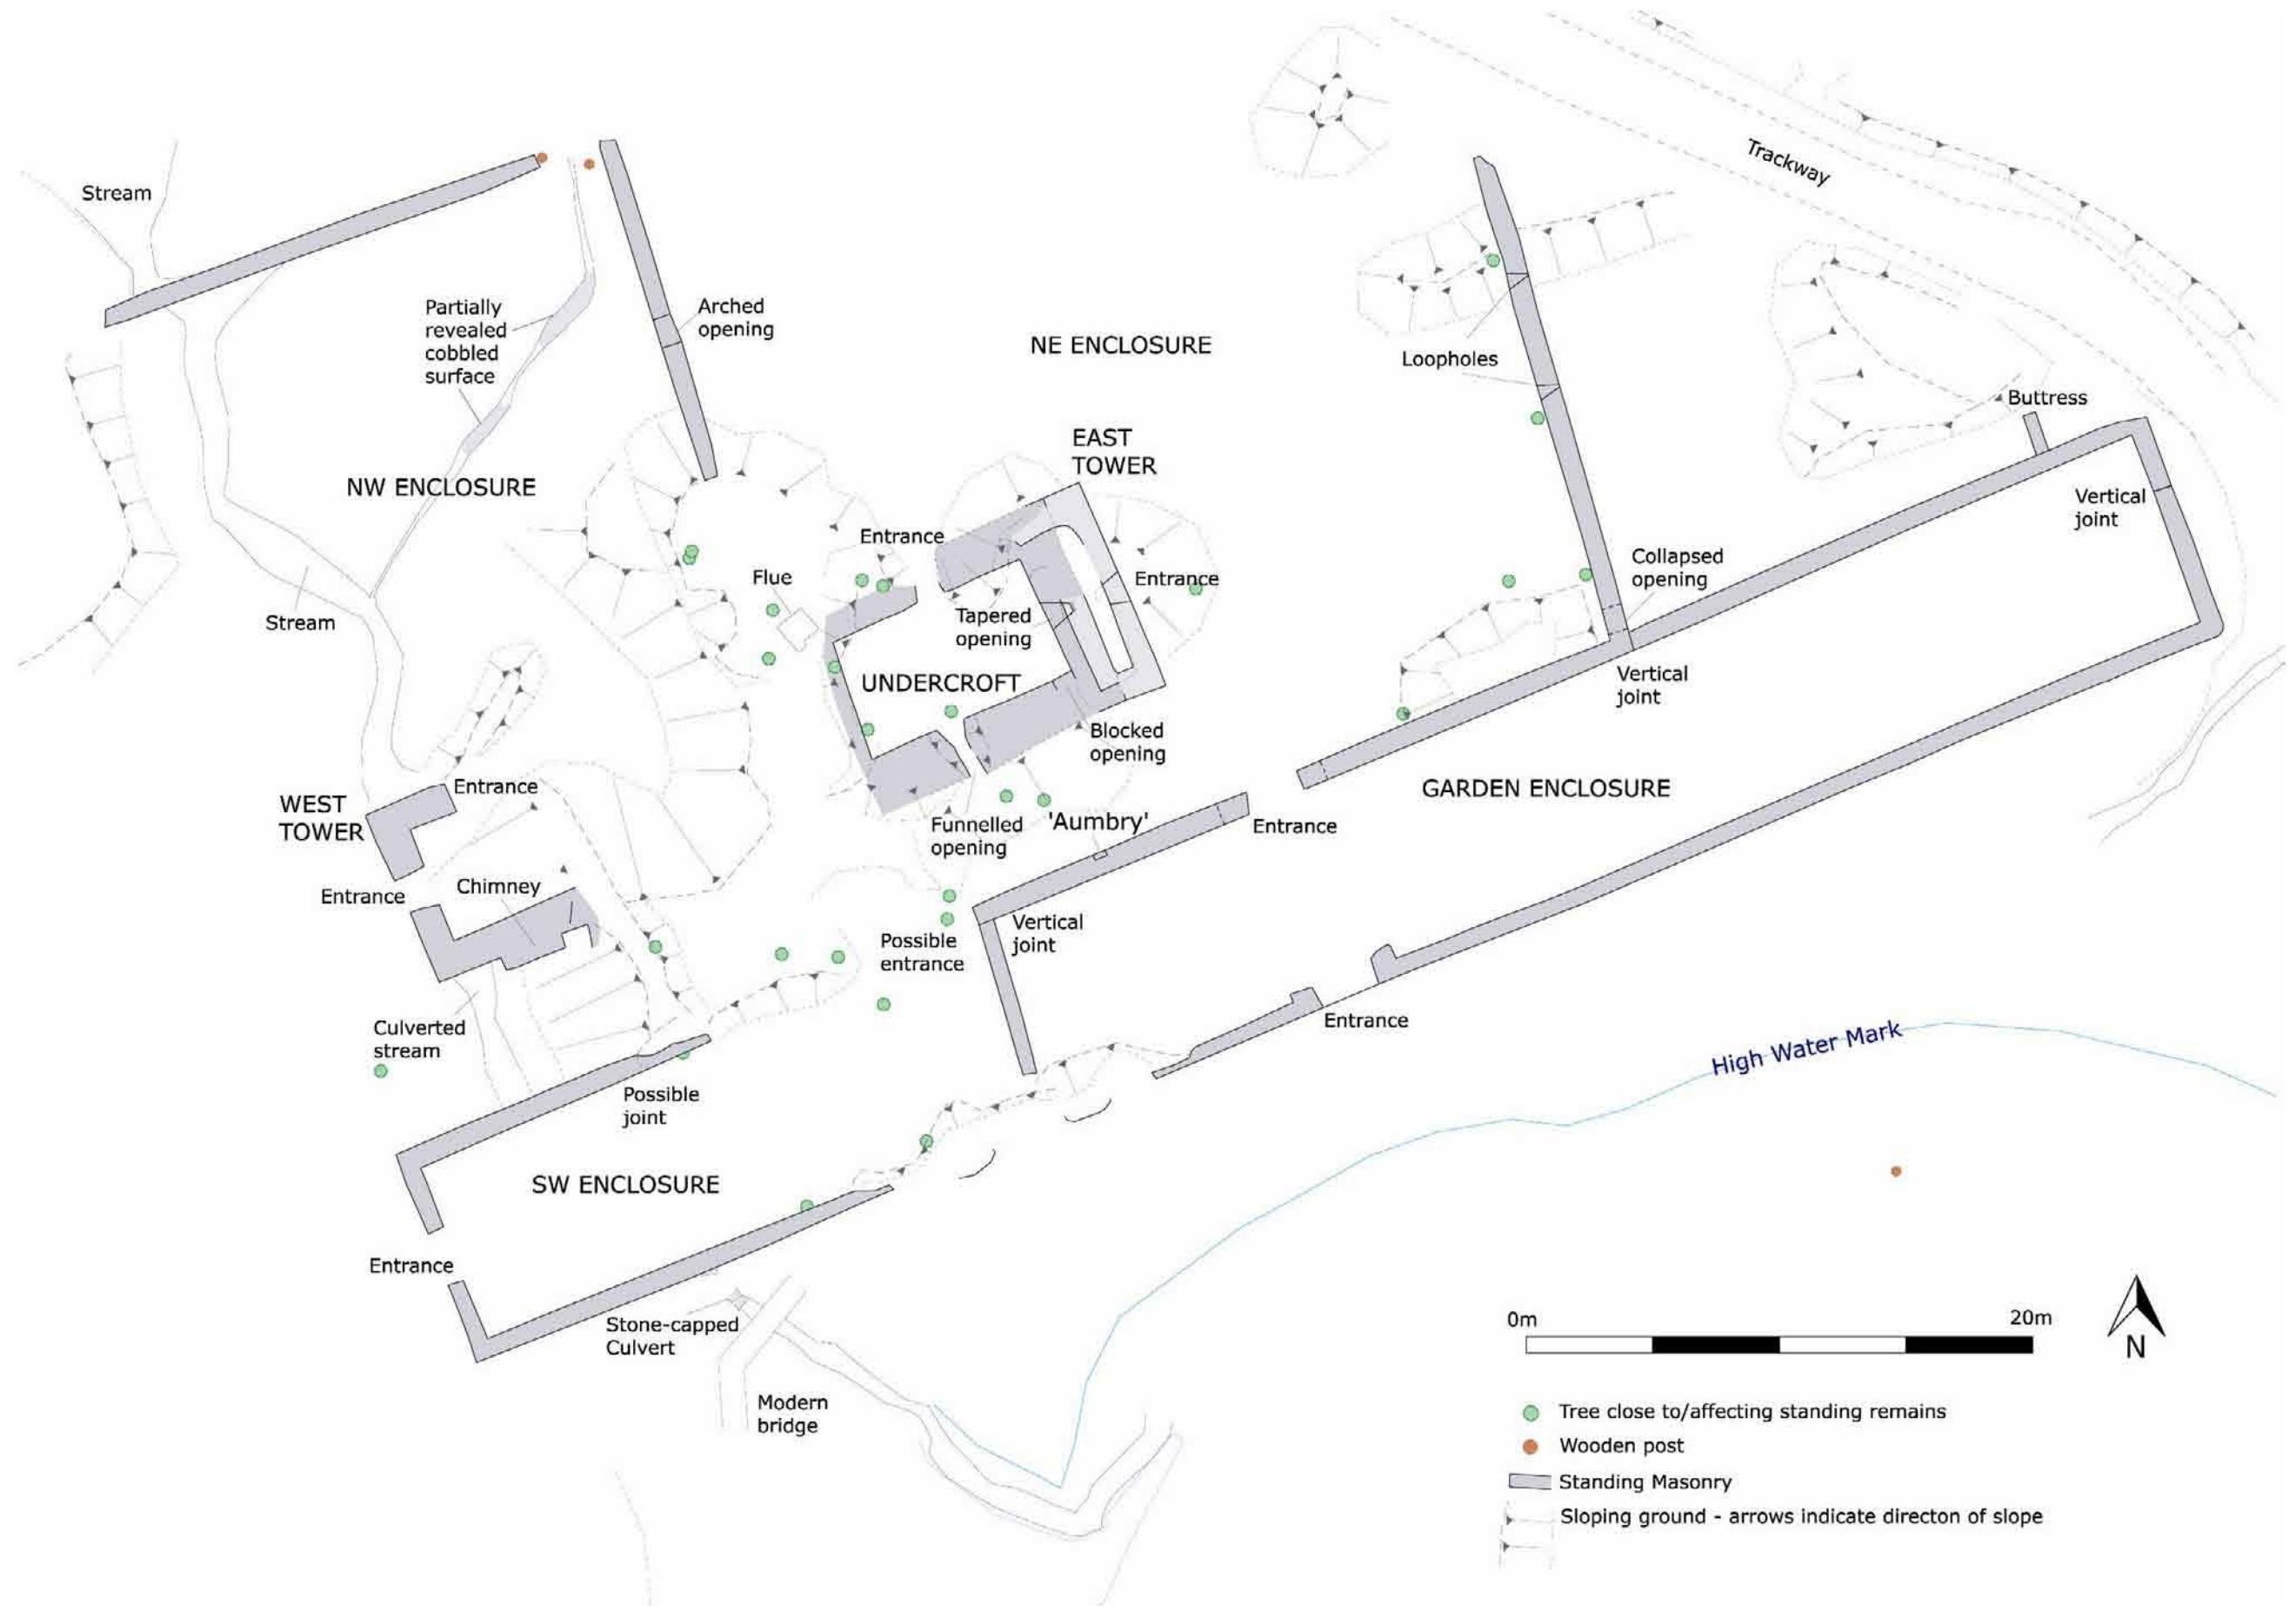
Figure 4: Detailed survey of the main structures and features described in the text. The locations of trees close to or affecting the standing remains are also marked.

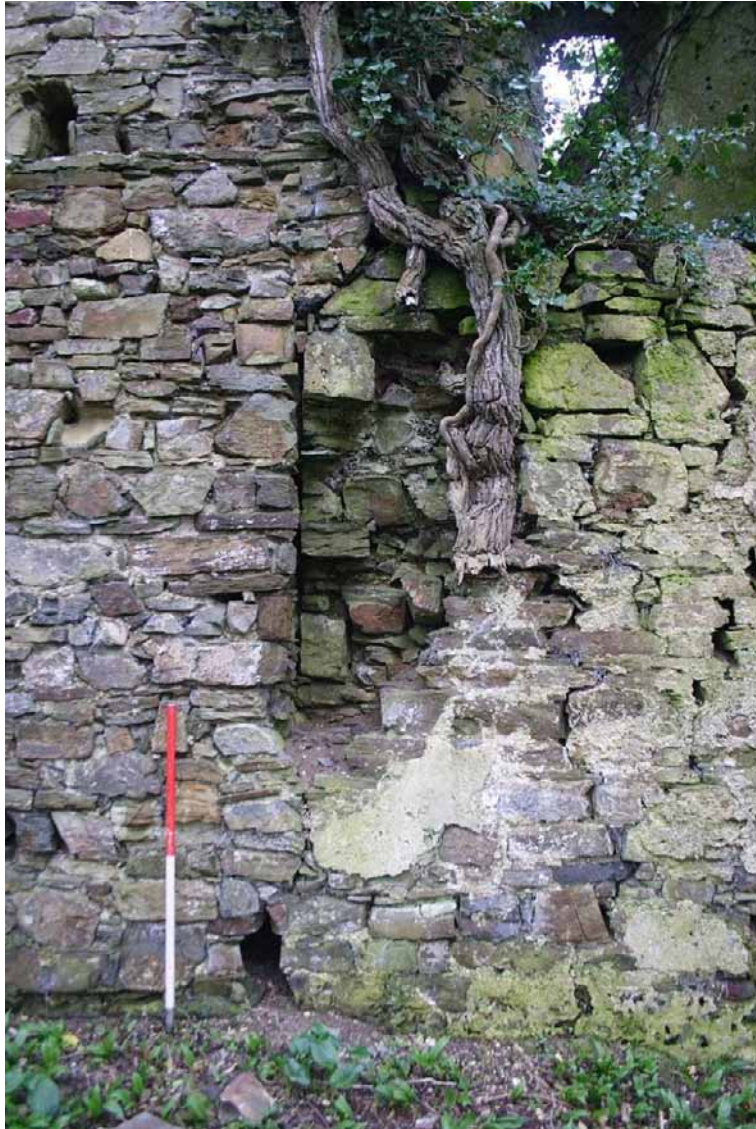
Photo 7: Close up of join in the western face. 1m scale.

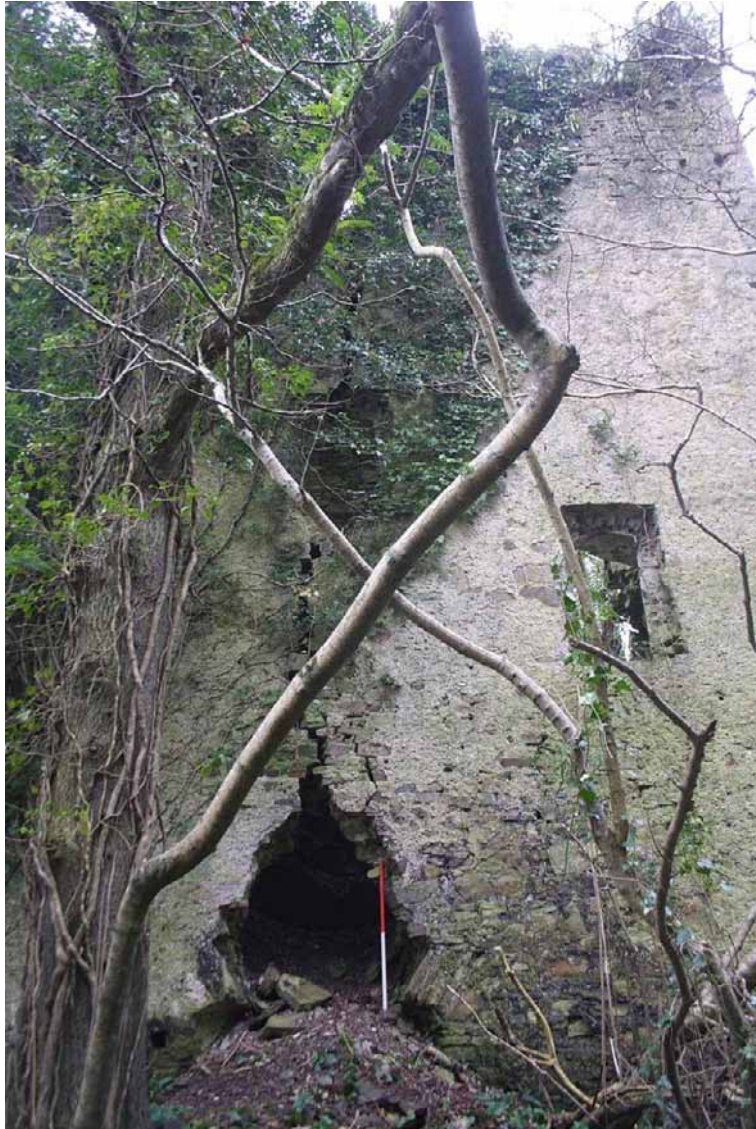
There is a ground floor arch, presumably for an entranceway, in the centre of the east gable tower wall, just visible above the build-up of rubble and soil (photo 9). The top of the arch has collapsed, which has caused stonework immediately above to fall in, and a large crack has opened the full height of the tower. This entrance opens into a narrow space 0.8m wide, and opposite a blocked narrow splayed opening in the undercroft wall.

Within the eastern tower of the main hall a large crack has formed running the full height of the eastern wall where the lower arched entranceway has collapsed. Within the undercroft the ceiling shows clear signs of subsidence on its western side, although there are no obvious signs of recent movement. However, should the undercroft be allowed to collapse it is possible that this will also weaken the remains of the eastern tower, as they are directly connected.

Photo 9: Closer view of the collapsed archway and vertical crack above. 1m scale.

All these structural issues should be monitored regularly to ascertain if they are causing further deterioration, and to establish the best way of repairing or preventing further structural deterioration.

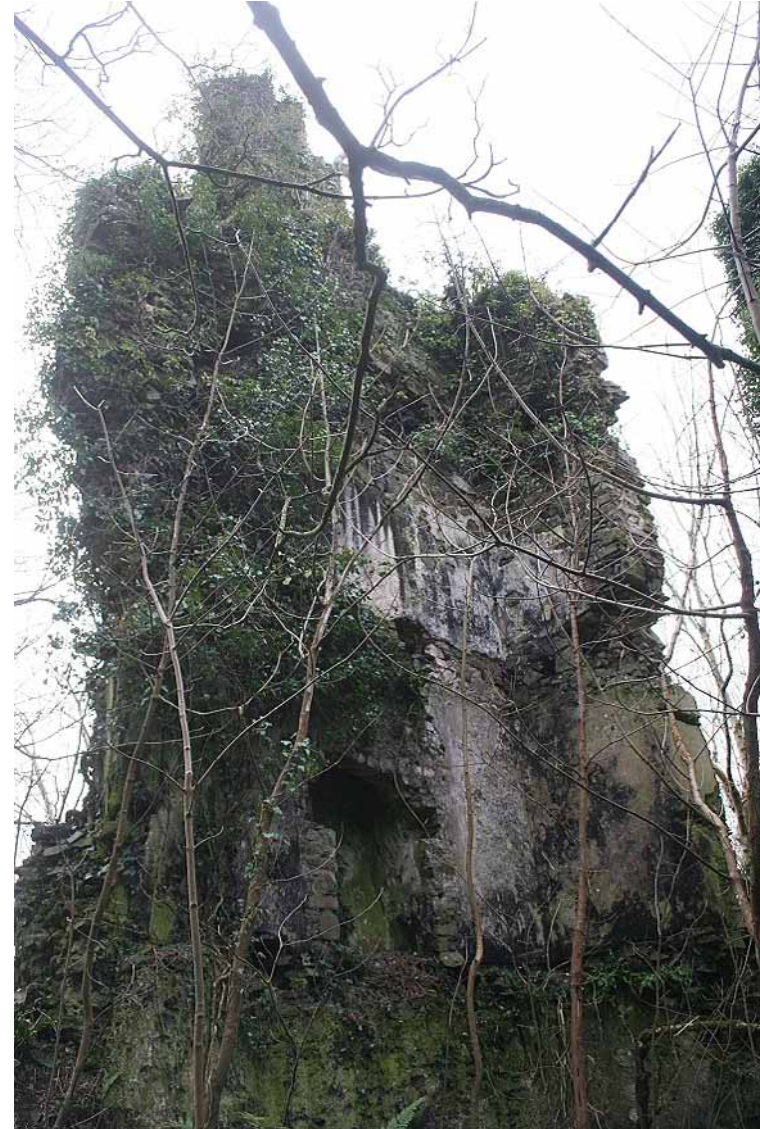
Photo 17: Looking north along the western wall of the Western Tower, showing the outward lean. 1m scale.

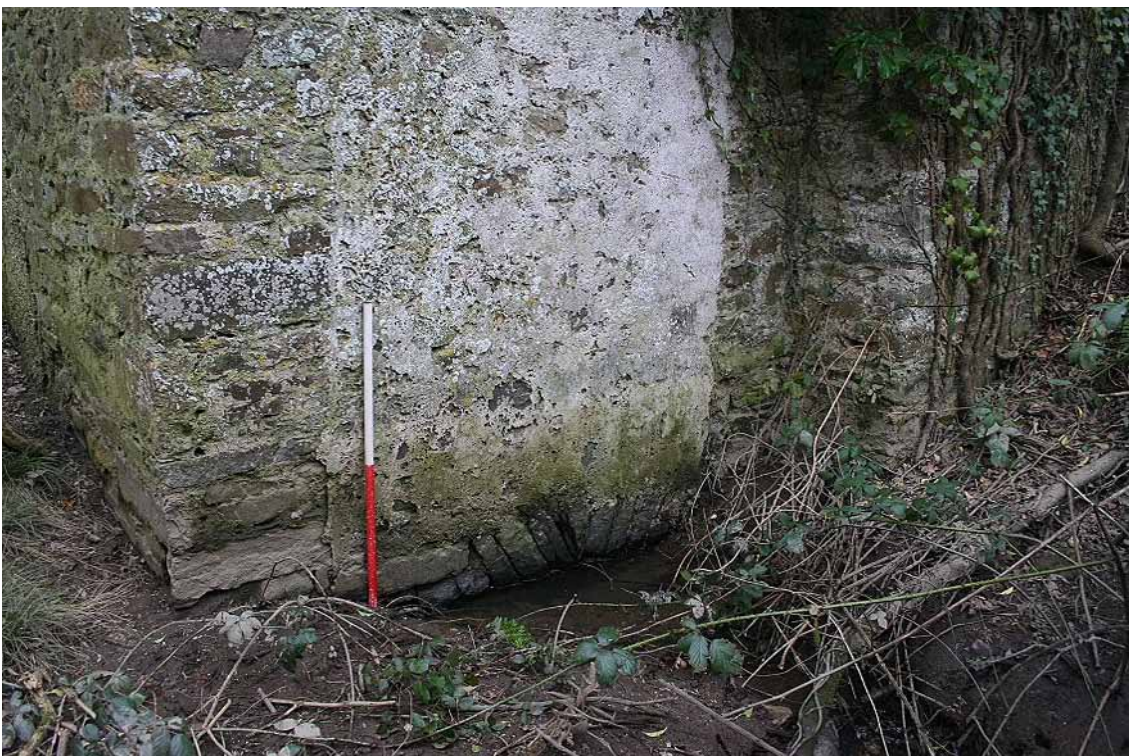
Similarly the culvert should be examined and cleared as it enters the northwest enclosure from the north. It has clearly become blocked at this point, pooling against the northern side of the wall and then forcing its way through the structure of the wall itself. This is likely to be removing mortar and creating a weak point within the wall which, if allowed to continue, could cause a substantial part of this wall to eventually collapse.

Photo 21: Stream pooling around the northern side of the Western Tower, also showing thick growth of ivy. 1m scale.

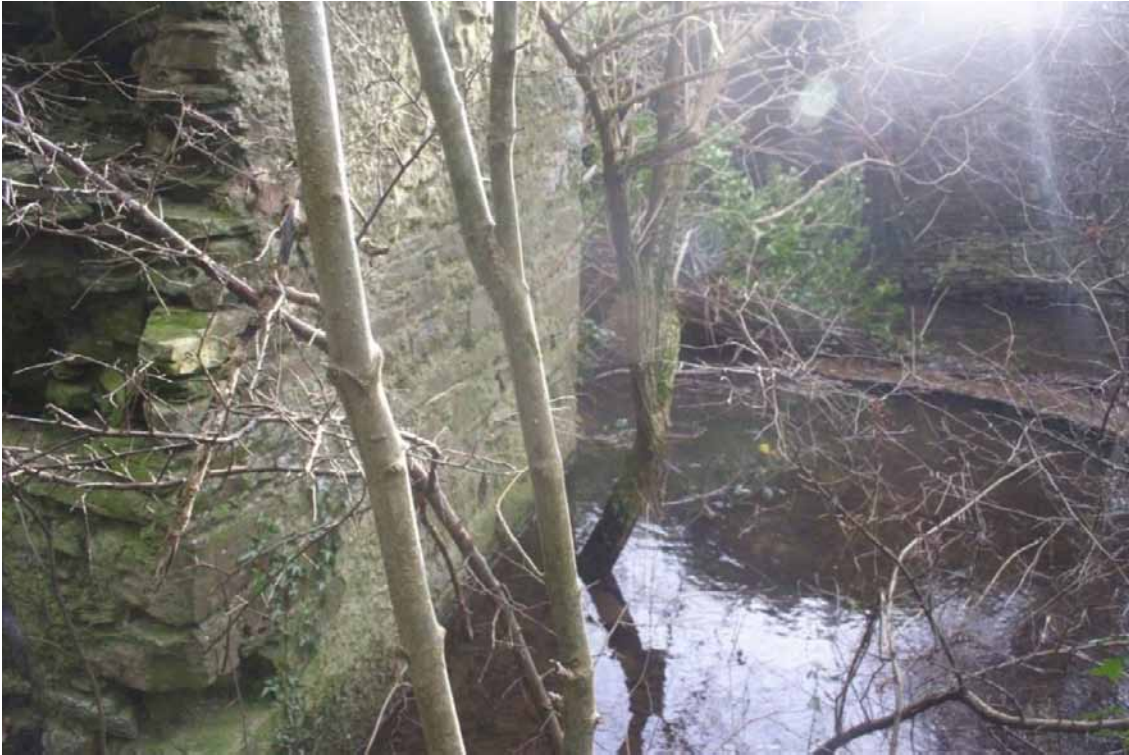
Photo 22: Stream emerging from the culvert on the south side of the Western Tower. 1m scale.

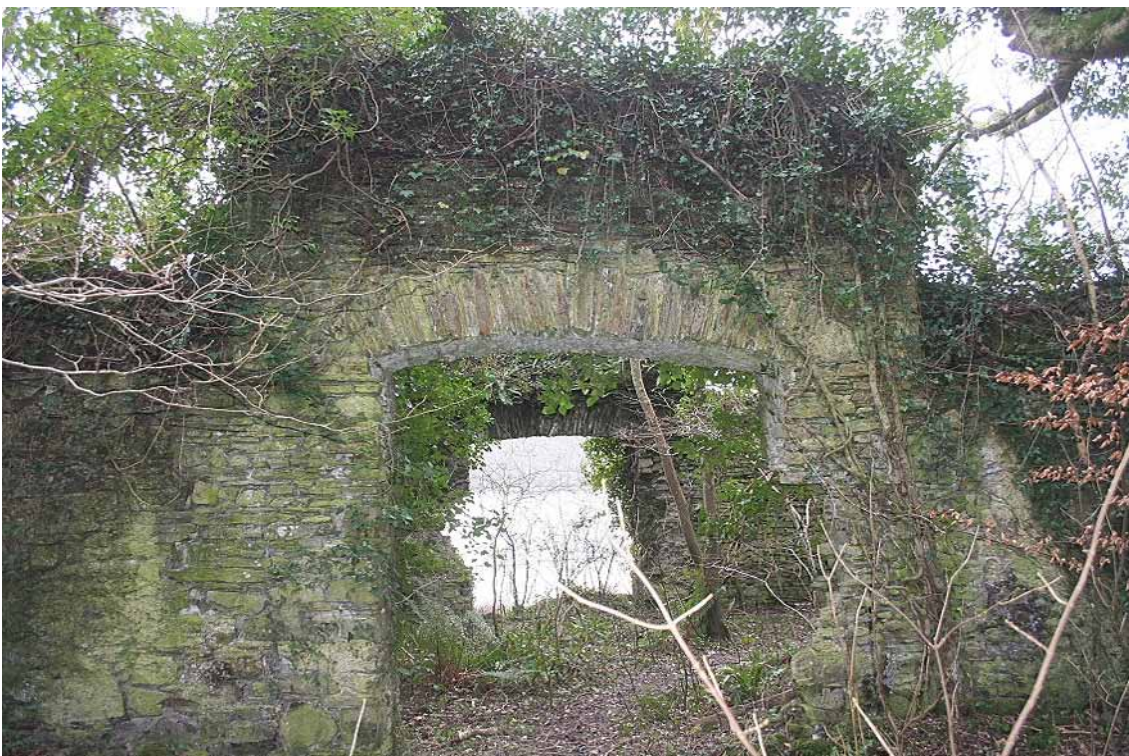
The remains all lie at the edge of the Western Cleddau, which is already undermining the long southern wall of the garden enclosure. The mortar has been washed out of much of the lower courses, and many of the facing stones have been removed exposing the rubble core behind. Erosion from tidal action will increase with rising sea levels. Climate change is recognised by the Welsh Assembly Government as one of the biggest threats facing the planet. Loss of landscape and heritage caused by it will have a negative impact on the quality of life in Wales and that 'without intervention our distinctive historic environment will degrade' (Environment Strategy for Wales, Welsh Assembly Government 2006). It is estimated that during this century temperatures will rise by 1 – 2 degrees centigrade, that there will be a 2% - 9% rise in precipitation and that sea level will rise by 180mm – 790mm (Wales: Changing Climate Challenging Choices, National Assembly for Wales 2007). Climate change and rising sea levels will: increase coastal erosion; inundate currently dry sites; create more extreme weather conditions promoting erosion of upstanding remains, particularly on areas such as sand dunes. Human responses to climate change will also impact on the historic environment, as new sea defences will be required whilst others will be abandoned under 'managed change'.

Photo 35: Closer view of the southern wall of the garden enclosure, viewed from the south. 1m scale.

Repair work to the face of the southern wall of the garden enclosure could help to protect any exposed core work, prevent undermining and slow down the rate of erosion. Regular monitoring would be required to assess the full effect of river erosion and sea level change.

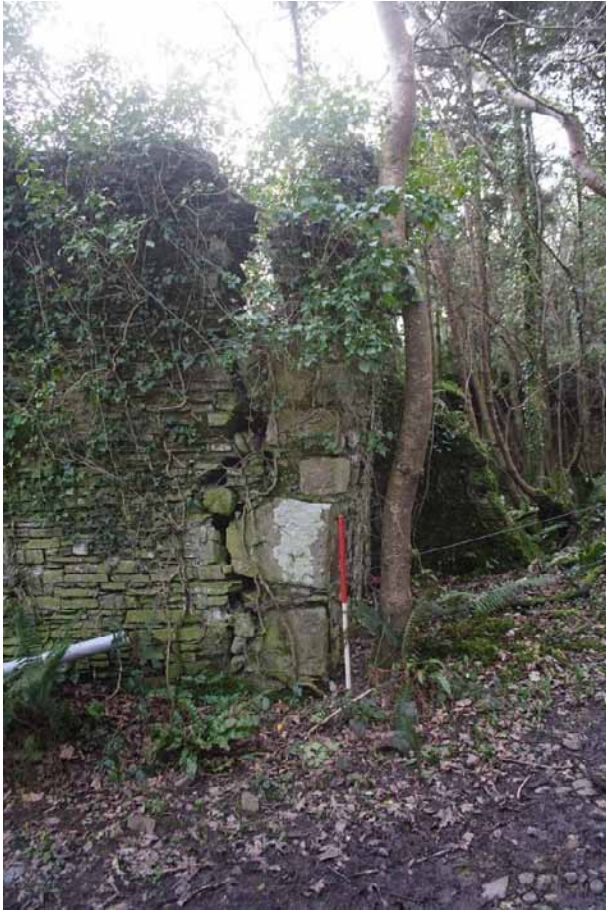
Photo 43: Damage at the north-eastern corner of the Garden Enclosure. 1m scale.
