# GGAT 112: Second World War Military Airfields of South Wales

Year 2-Airfield Hinterland

A report for Cadw  
by Paul W Huckfield BA

GGAT report no. 2013/024  
Project no. GGAT 112

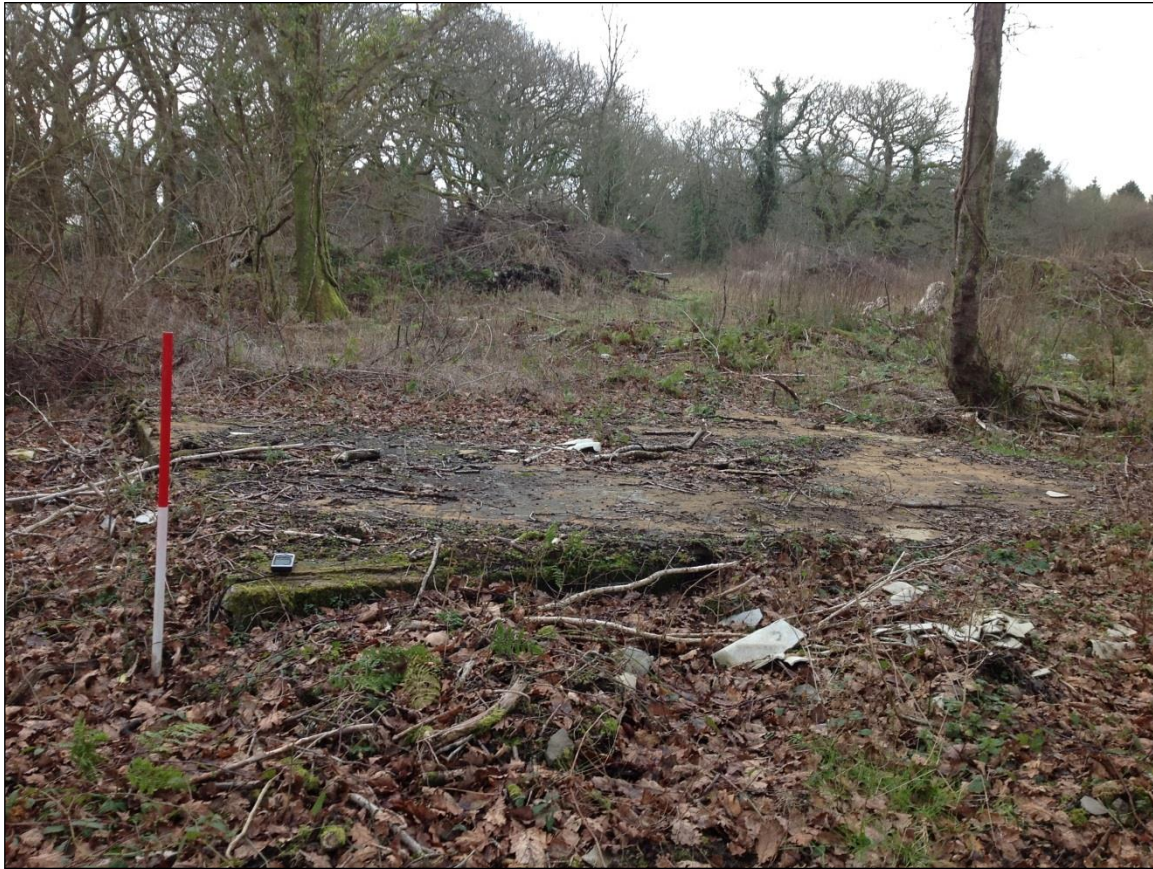
*Plate 5: All that remains of the sergeants latrine block. View to the southwest.*

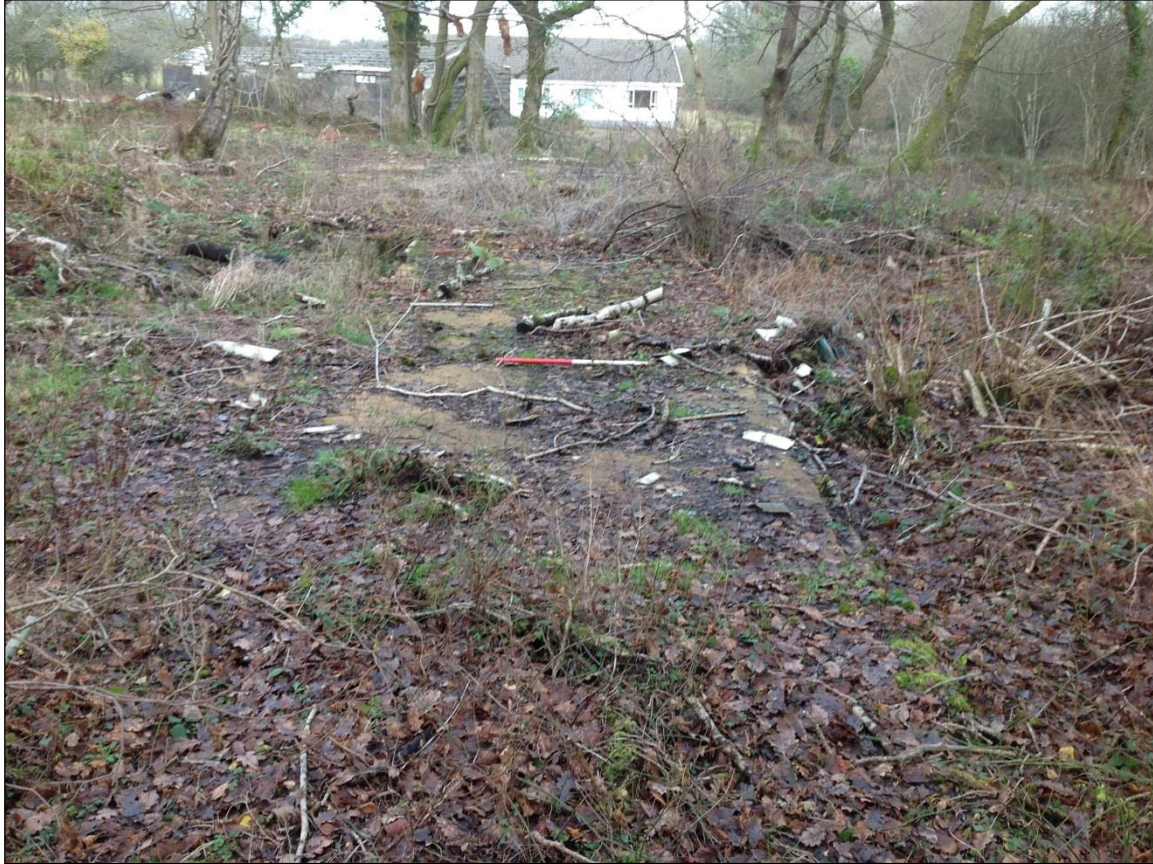
*Plate 6: Very little remains of PRN 07814w, the Airwomens Quarters.*

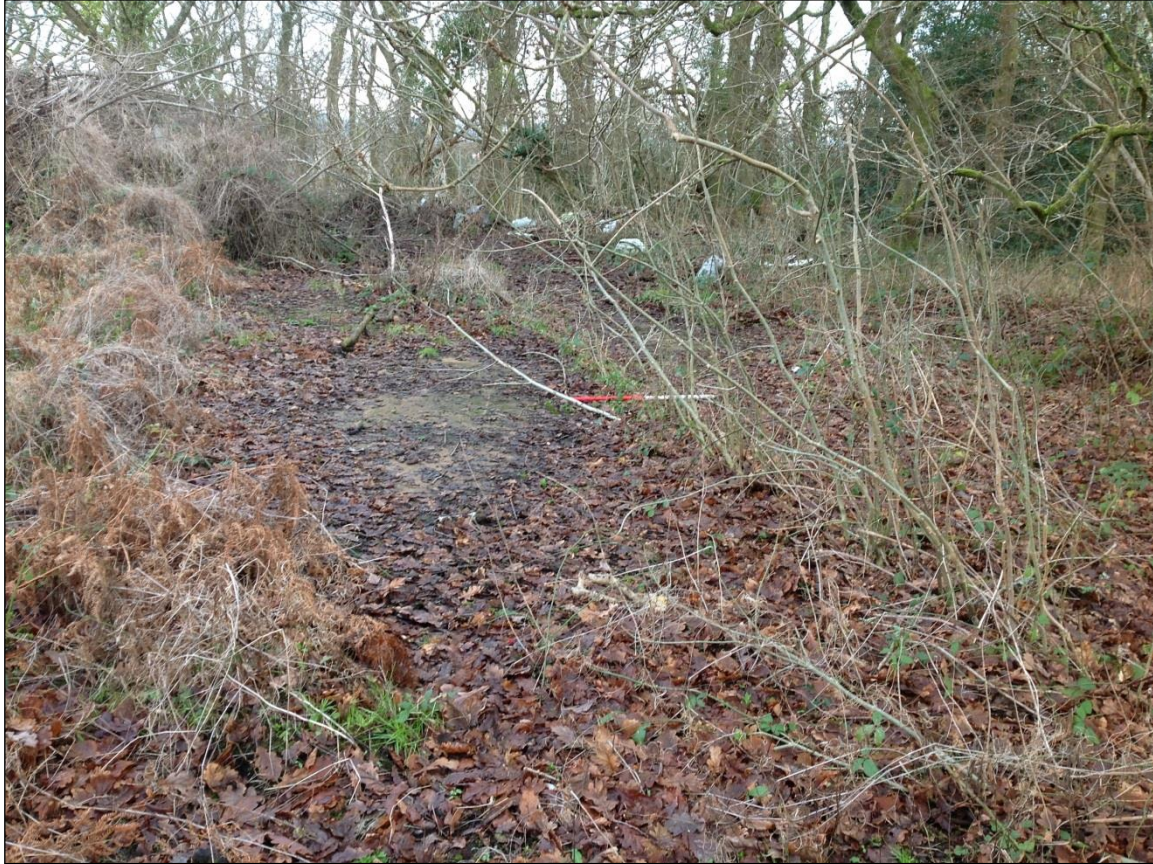
*Plate 7: Heavily overgrown airwomens quarters.*

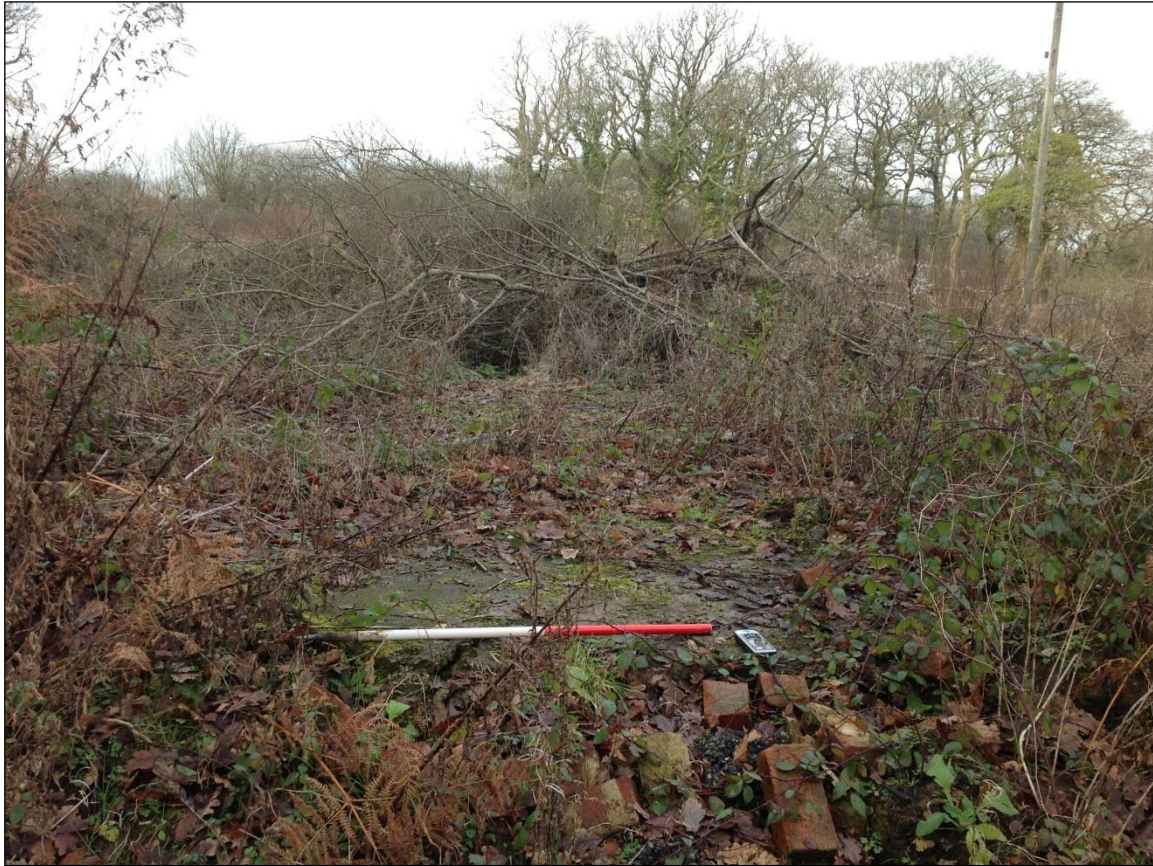
*Plate 8: The remains of the 36'x16' Nissen Rest Hut.*

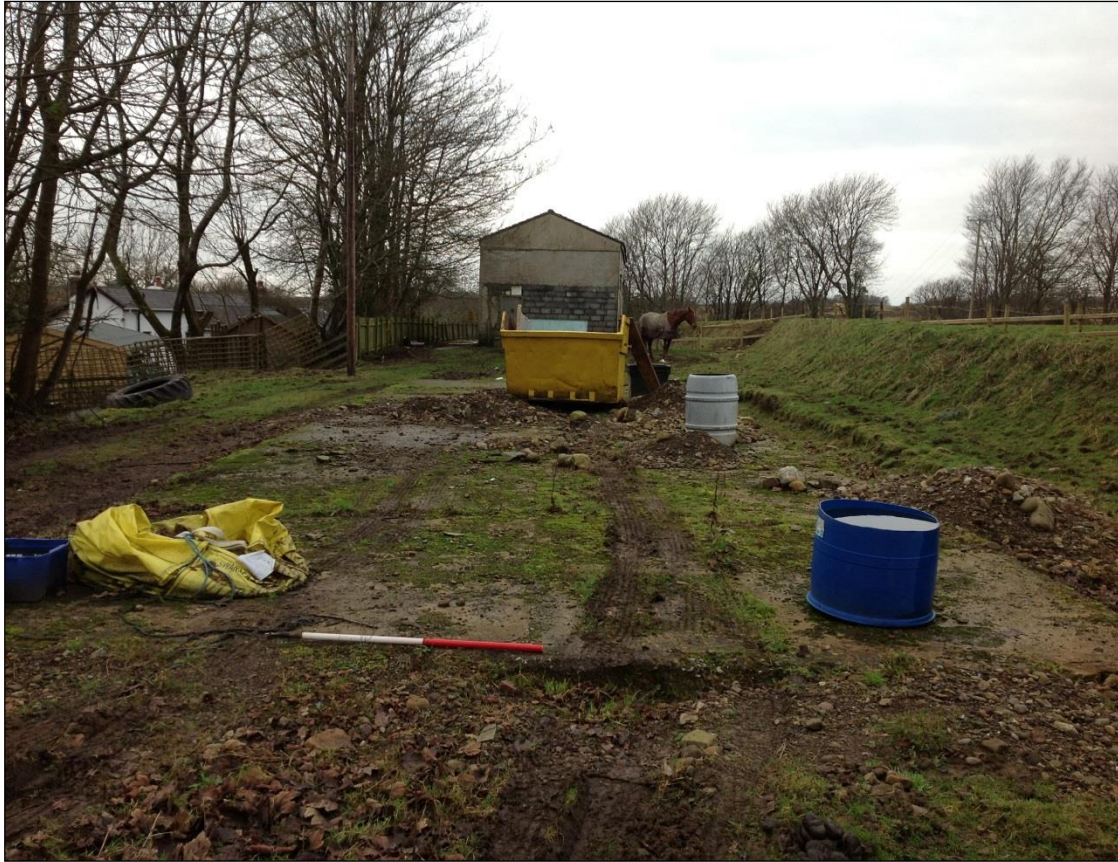
| <b>Description</b> | <p>A heavily damaged linear concrete apron is all that survives of the south easterly airmens quarters within Site No. 6.</p> <p>Airmen were accommodated in the standard 'Nissan type' huts. The structure would have been semi-circular in section and comprised of a prefabricated curved corrugated iron sheeting over an internal steel frame. The structure would have had beds, wooden lockers and a stove.</p> |
| <b>Condition</b> | Near Destroyed |
| <b>Condition rating</b> | Near Destroyed |

*Plate 36: A heavily damaged concrete apron is all that survives of PRN 07843w.*

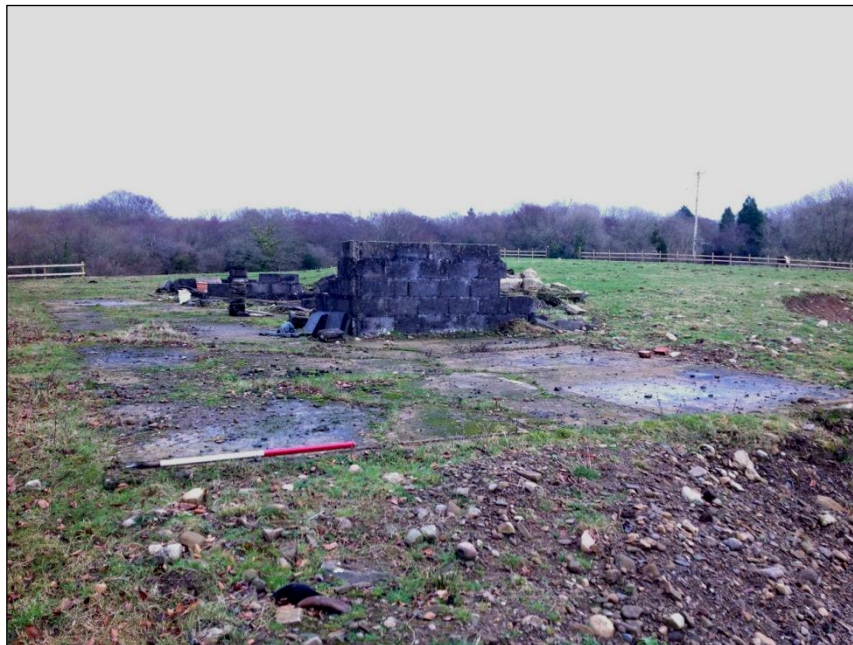
| <b>Description</b> | <p>A heavily damaged linear concrete apron is all that survives of the airmens quarters. A later addition, constructed of blockwork walls, has been added to the northern half of the apron. This is now also damaged.</p> <p>Airmen were accommodated in the standard 'Nissan type' huts. The structure would have been semi-circular in section and comprised of a prefabricated curved corrugated iron sheeting over an internal steel frame. The structure would have had beds, wooden lockers and a stove.</p> |
| <b>Condition</b> | Near Destroyed |
| <b>Condition rating</b> | Destroyed |

*Plate 38: Heavily damaged airmens quarters. View to the north.*

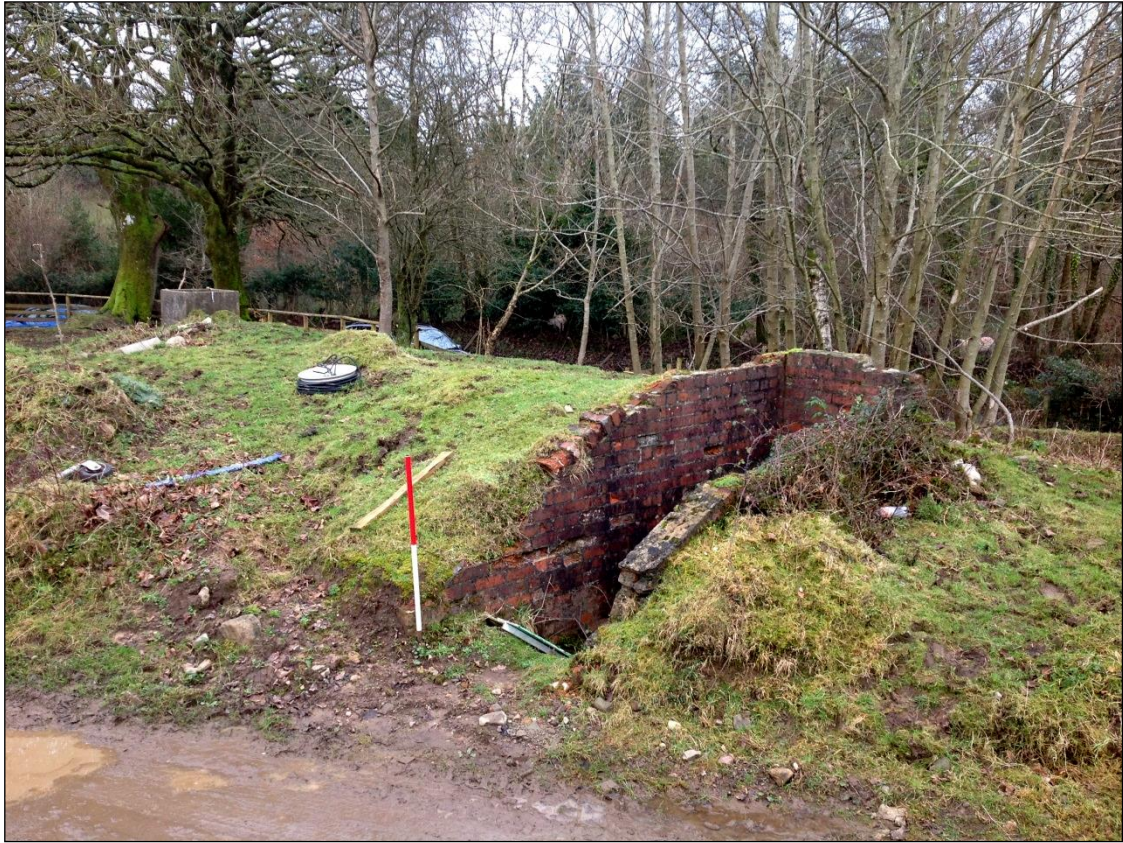
| <b>Description</b> | <p>Semi-sunken air-raid shelter manufactured by the Stanton Ironworks Co Ltd in Derbyshire (better known for sewage pipes &amp; manhole covers). This type of shelter could be built in any length, but usually consisted of 18 sections of pre-cast concrete arched-shaped sides, bolted together to form a standard Air Ministry shelter for 50 men.</p> <p>The brick-lined entrance is considerably damaged, as well as the earthen bung around the structure, which provided bomb splinter protection. Access to the interior of this site was not possible and therefore the condition is unknown</p> |
| <b>Condition</b> | Near Destroyed (exterior only) |
| <b>Condition rating</b> | Very Bad (exterior only) |

*Plate 43: Heavily damaged exterior of the southern Stanton shelter*

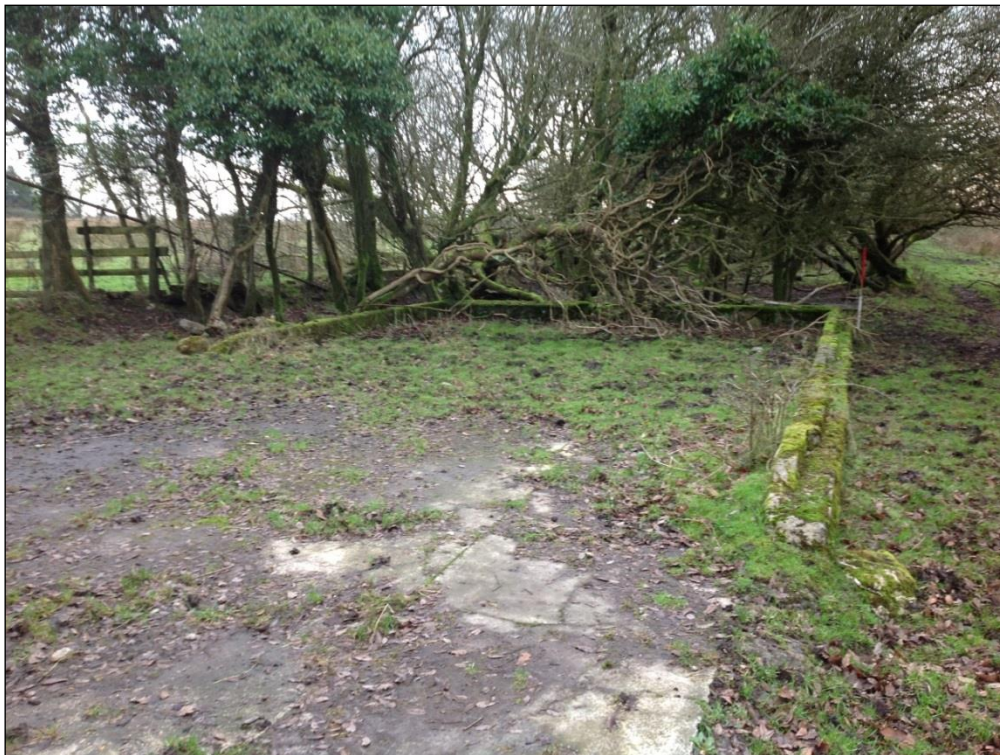
| <b>Description</b> | A heavily damaged linear concrete base with a low section of external walling, clothing the southern end, are all that survives of the building. This site belongs to a group of four structures used by the Army Guard Unit, who were tasked with the protection of the Airfield from German attack. |
| <b>Condition</b> | Near Destroyed |
| <b>Condition rating</b> | Destroyed |

*Plate 45: The heavily damaged remains of PRN 07852w.*

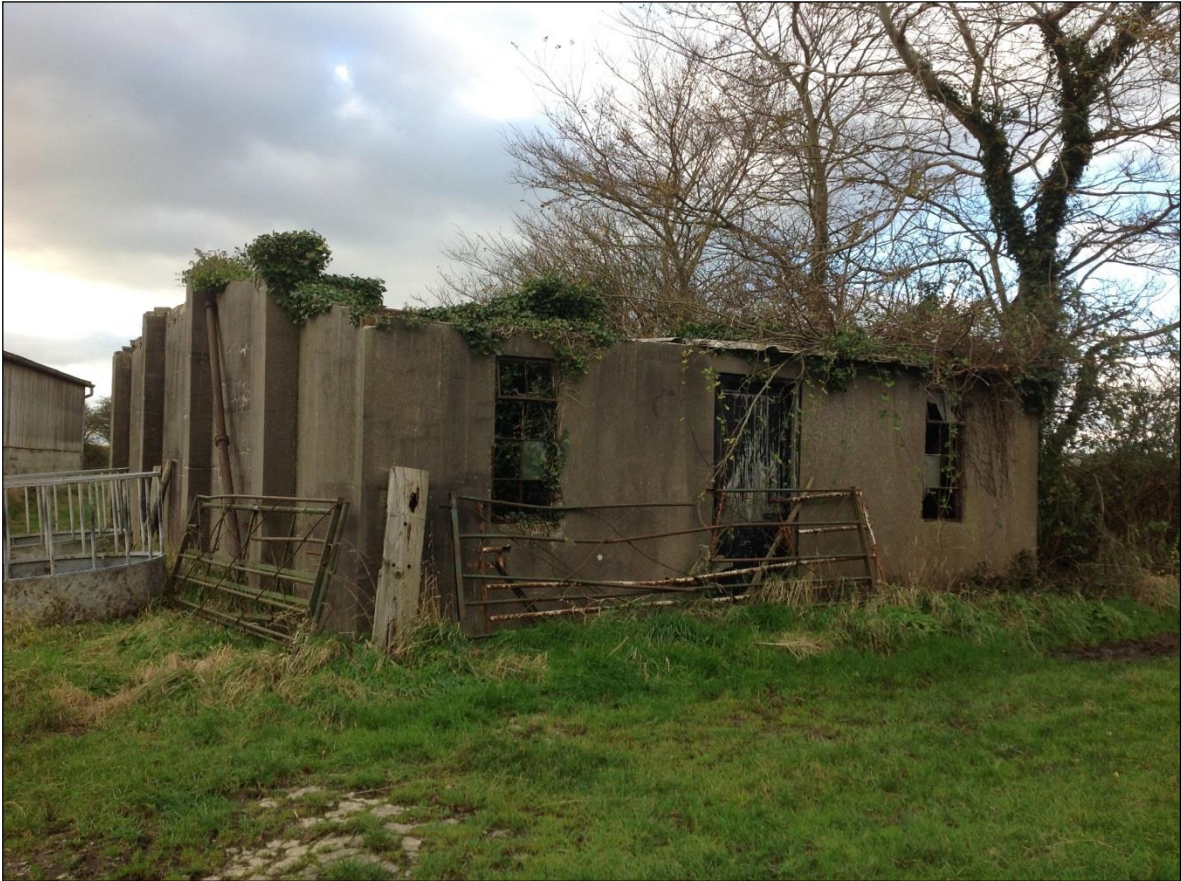
*Plate 92: The heavily damaged remains of the Sites Squash Court. The main building should actually be double in height.*

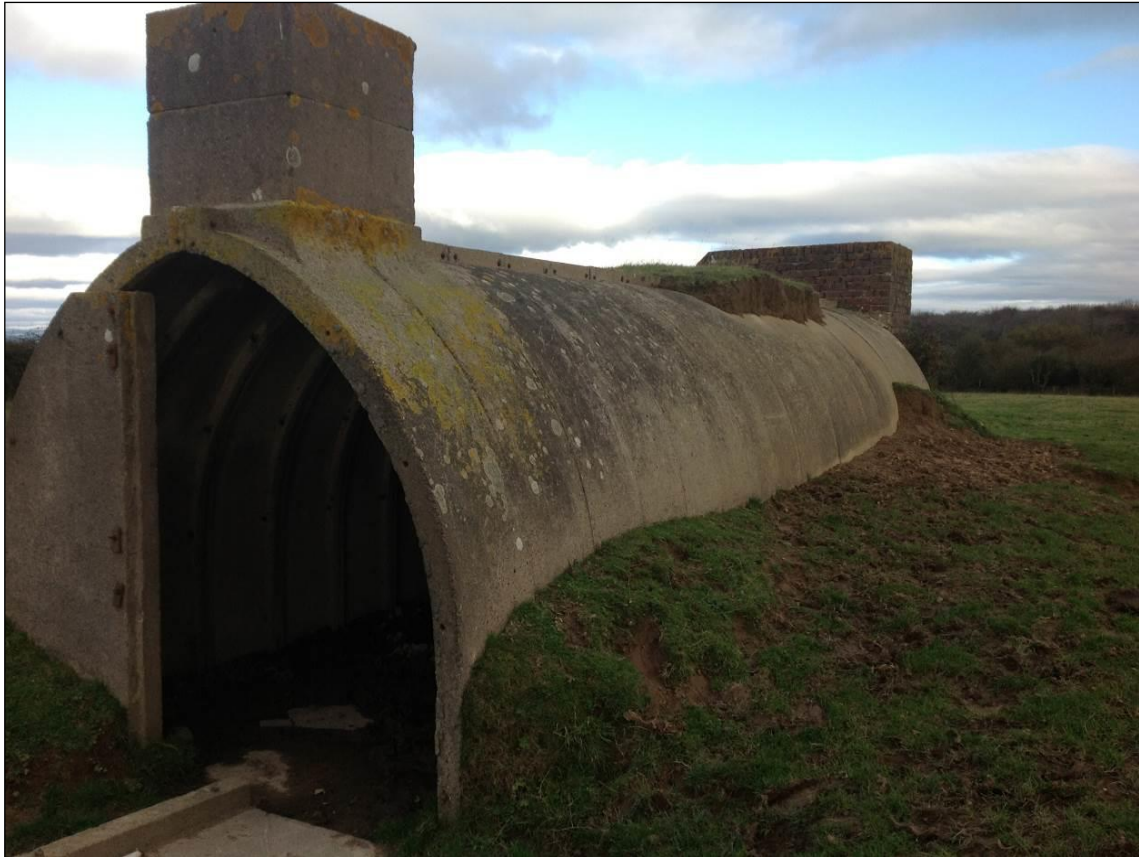
*Plate 104: The protective earthen mound surrounding PRN 04444s has been eroded to reveal the construction beneath.*

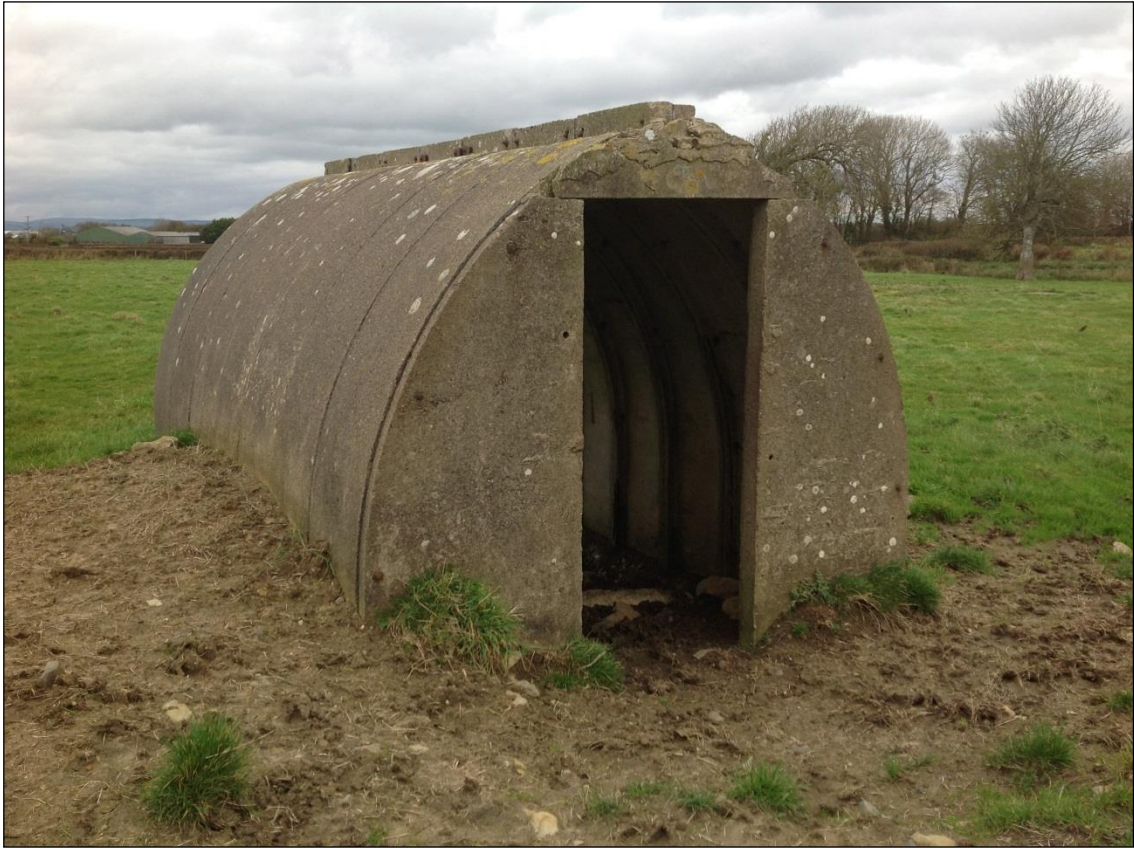
*Plate 115: The main entrance to the air raid shelter PRN 04455s.*

*Note the missing mound and emergency exit hatch to the rear.*

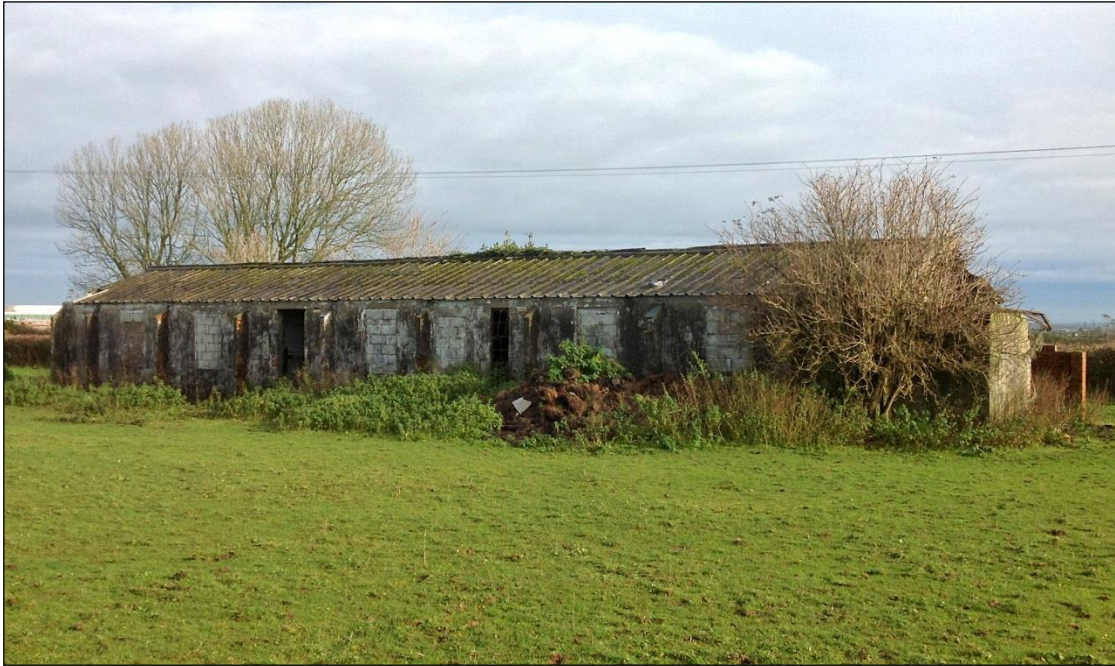
**Condition** Damaged/Converted  
**Condition rating** Poor/Converted  
**Period** Modern  
**Group Value** No  
**Form** Building  
**Associated PRN sites** 04459s, 04460s  
**Linked to airfield function?** No  
**Of technical/Structural interest?** Yes  
**Historical association?** No

*Plate 122: The remains of the Officers Mess and Quarters. View to the east*

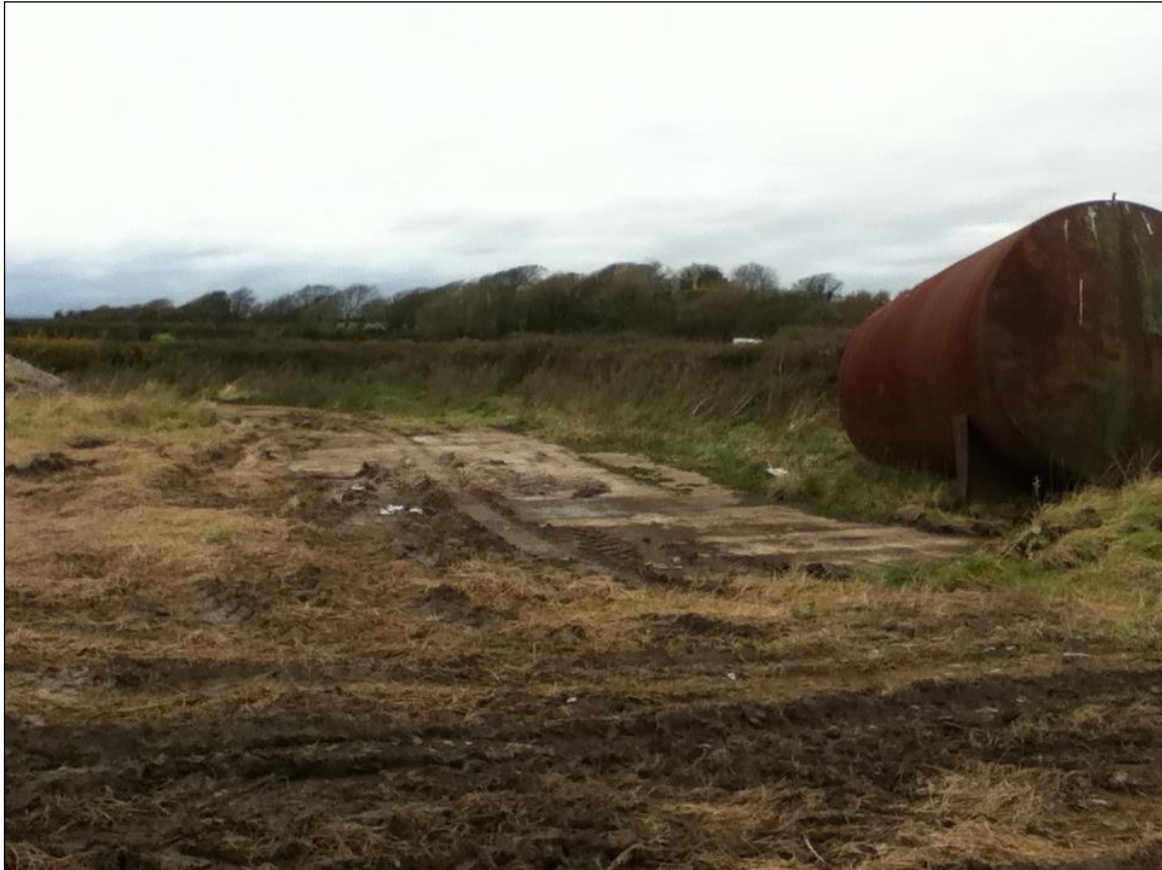
*Plate 124: The concrete apron is all that survives of building 176. View to the north.*
