# **YNYSLAS HULKS, YNYSLAS, CEREDIGION: ARCHAEOLOGICAL INVESTIGATIONS 2014 INTERIM REPORT**

Prepared by Dyfed Archaeological Trust  
For Cadw

RHIF YR ADRODDIAD / REPORT NO. 2014/39  
RHIF Y DIGWYLLIAD / PROJECT RECORD NO. 107509  
Cadw Project No. DAT 135

**James Meek MCIfA**

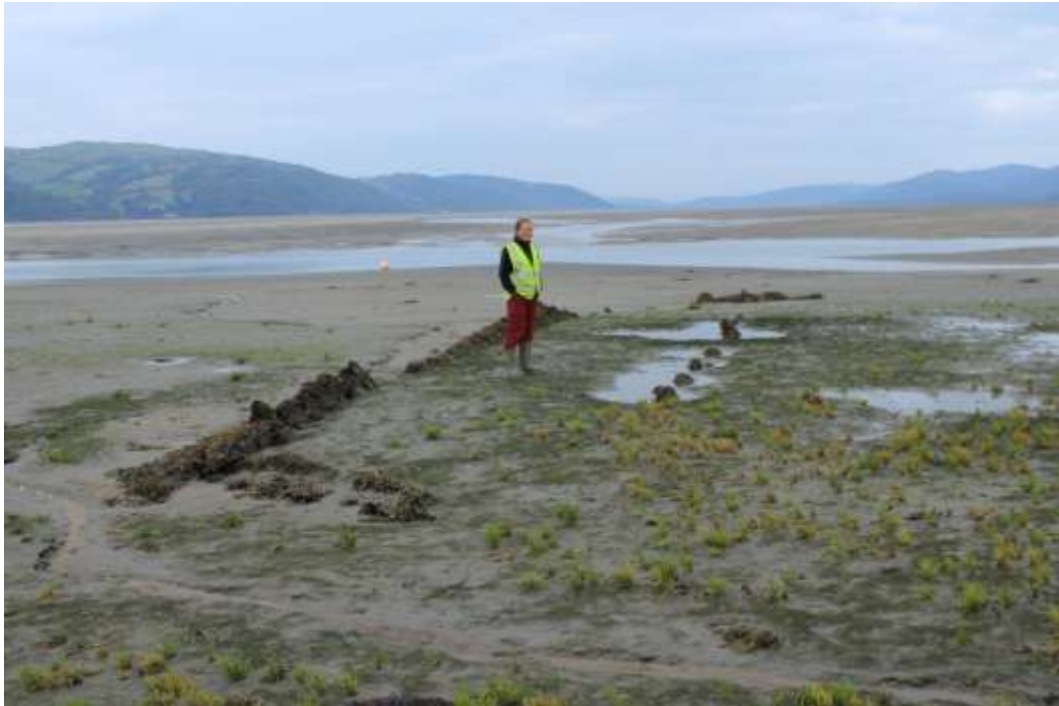
Photo 1: Wreck 1, viewing northwest

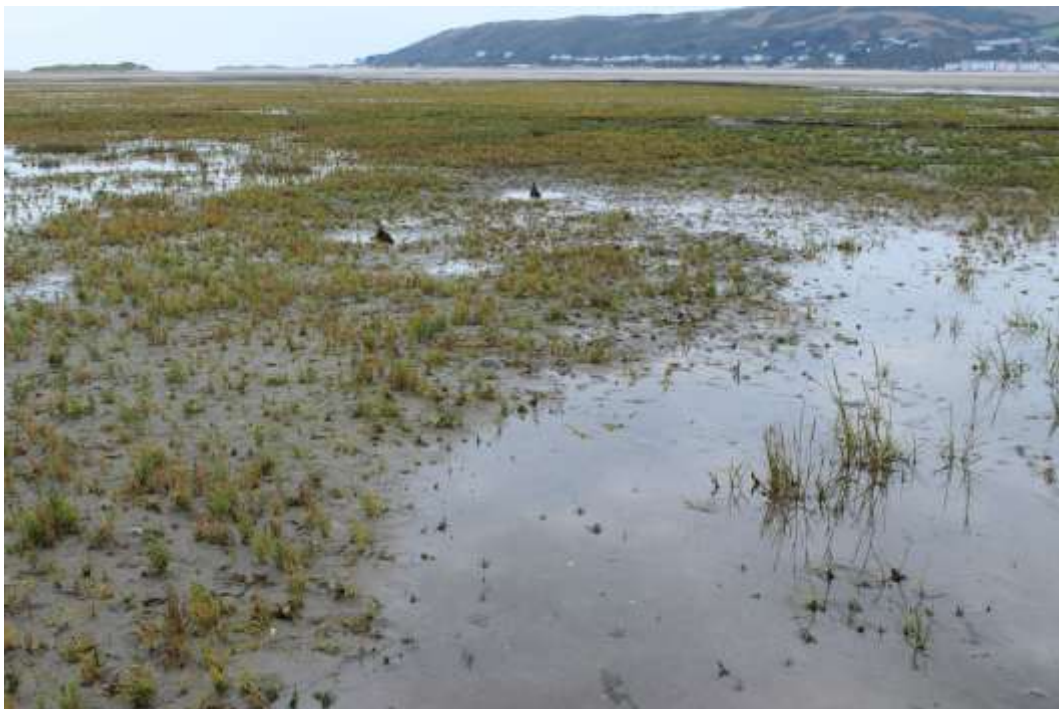
Photo 2: Wreck 2, viewing northwest along centre line of submerged wreck  
(towards upright timber in centre of photo).

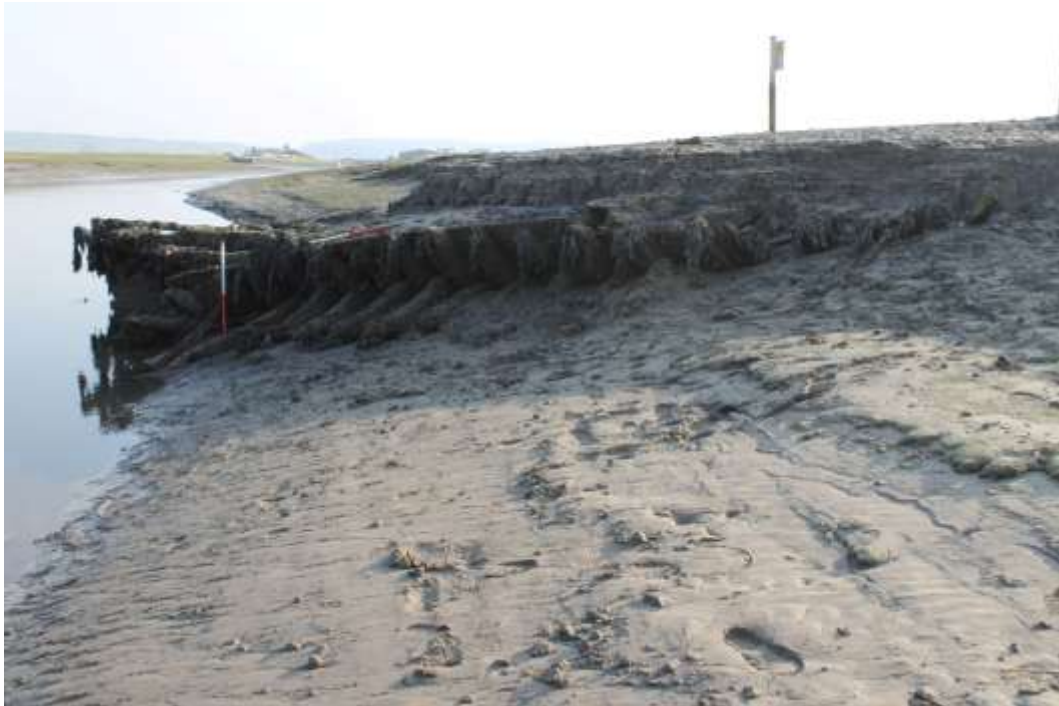
Photo 3: Wreck 3, viewing south on bank of Afon Leri

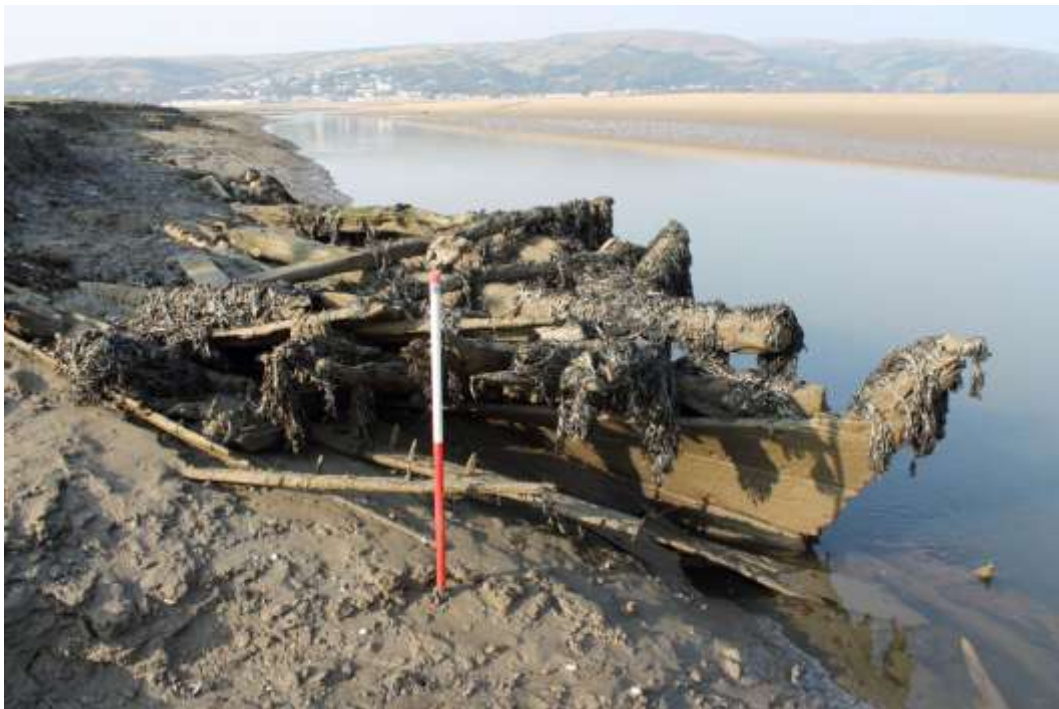
Photo 4: Wreck 3, viewing north on bank of Afon Leri

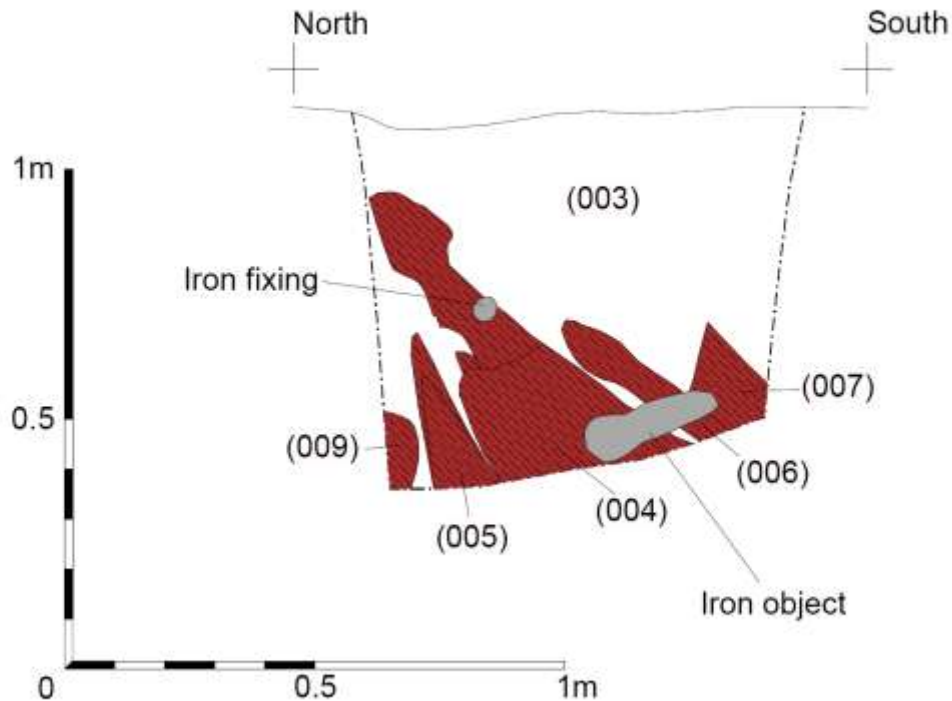
**Figure 5:** Southwest facing section of Trench 2 showing surviving elements of the timbers and possible identification below. (003) – estuarine silts (004) – stempost; (005) – cutwater; (006) – apron; (007) – stemson; (008) not shown and (009) – unknown loose timbers?

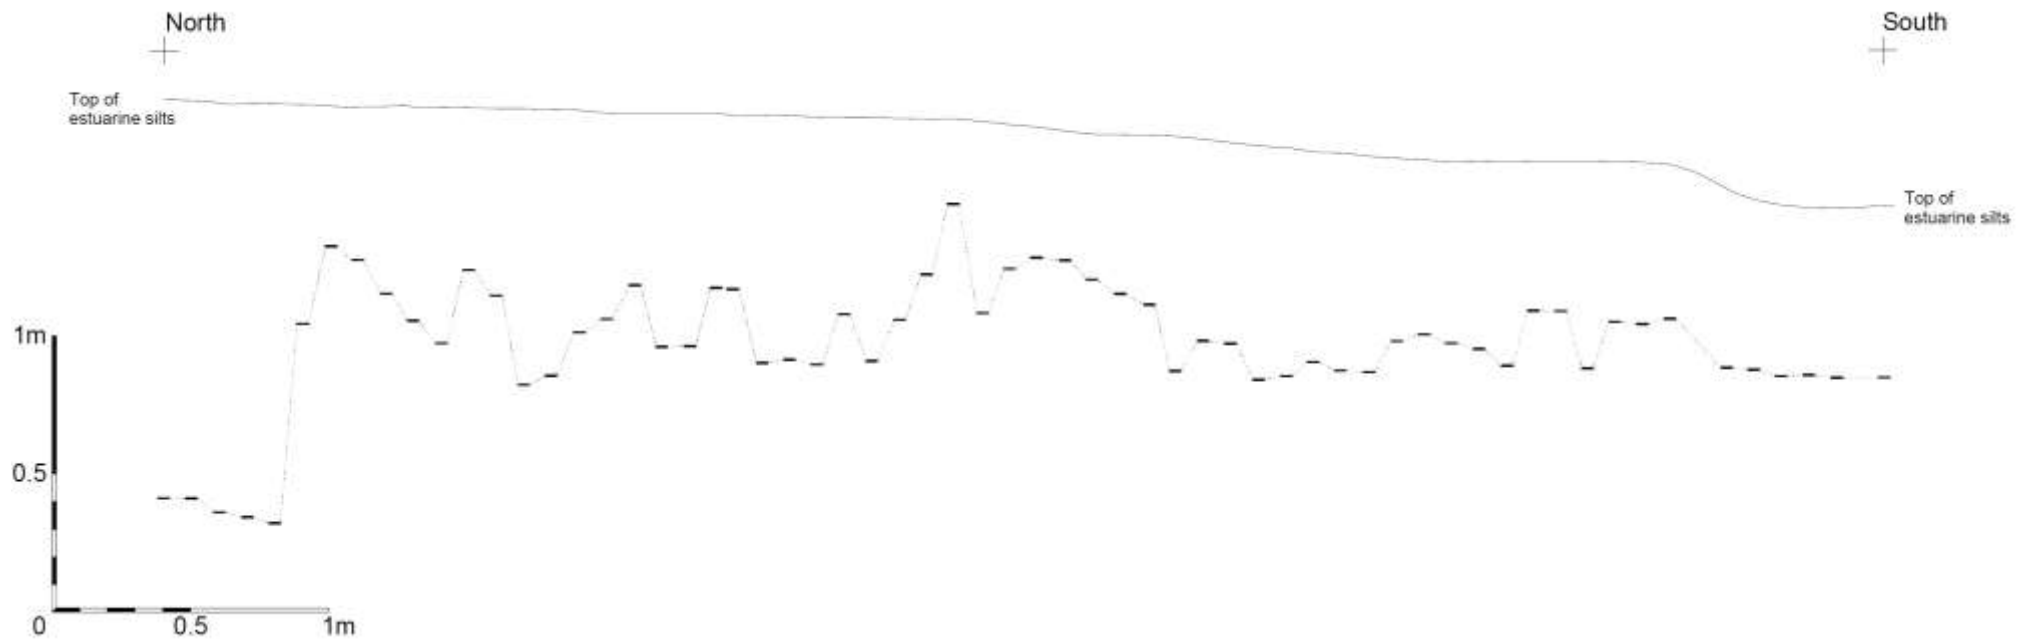
Profile 1 (Figure 6) indicates that timber elements to survive to the northwest of the stempost, possibly associated with the collapsed bow itself, at depths of around 1.40m. The top of the stempost was not exactly crossed by the profile, but adjacent timbers were noted surviving at around 0.5m below the top of the silts. The profile indicates that timber elements survive as high as 0.3m below the top of the silts, but mostly average out at around 0.8m to the northwest to

0.6m to the southeast, as the silts drop down toward the bank of the river. Presumably the profile identifies the hold and objects or collapsed timbers on top of it.

**Figure 6:** Profile 1 along the centre line of Wreck 3, with readings taken every 10cm.  
depths shown are to the top of solid timbers

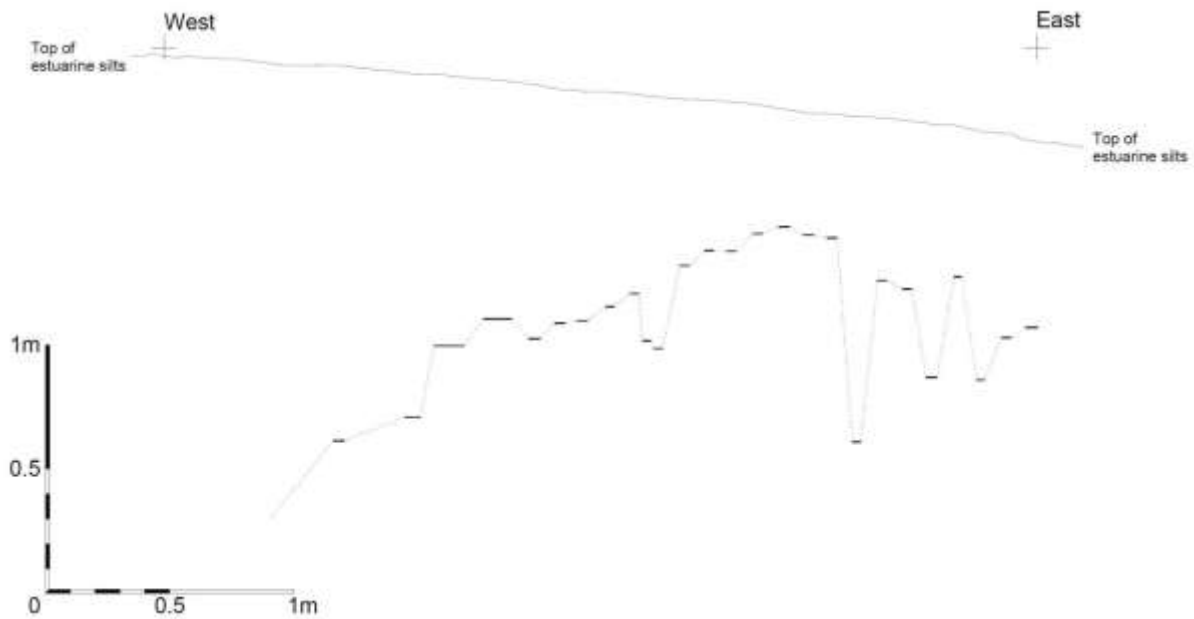
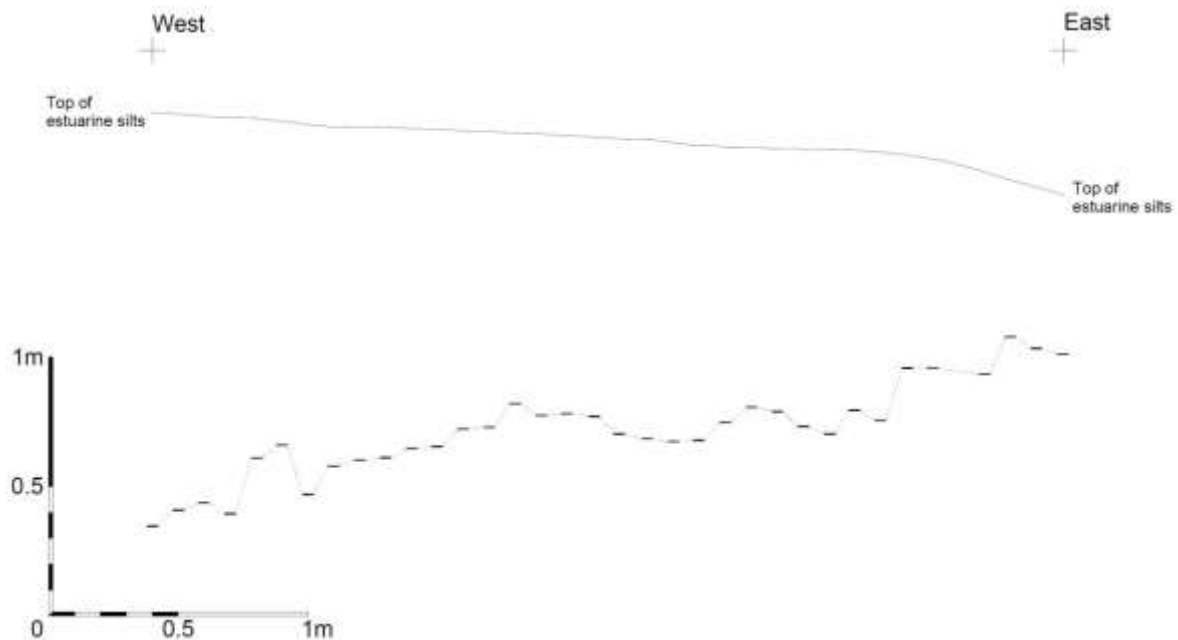
**Figure 7:** Profile 2 along the width of Wreck 3 (northern profile), with readings taken every 10cm. Depths shown are to the top of solid timbers (no timbers recorded to southwest)

**Figure 8:** Profile 3 along the width of Wreck 3 (southern profile), with readings taken every 10cm. Depths shown are to the top of solid timbers

The results of Profiles 2 & 3 (Figures 7 & 8) both indicate a similar trend across the width of the vessel. Obviously the silt level drops towards the Afon Dyfi, but it would still appear that the depth of surviving timbers rises towards the southwest. At the northwestern end of Profile 2, no timbers were recorded within the 1.50m depth for which measurement was possible. At the southwestern end of both sections timbers were present at c.0.60m below the top of the silts. This may indicate that the vessel is either tilting towards the southwest, or that the port side of the boat had dropped perhaps as the keel had split.

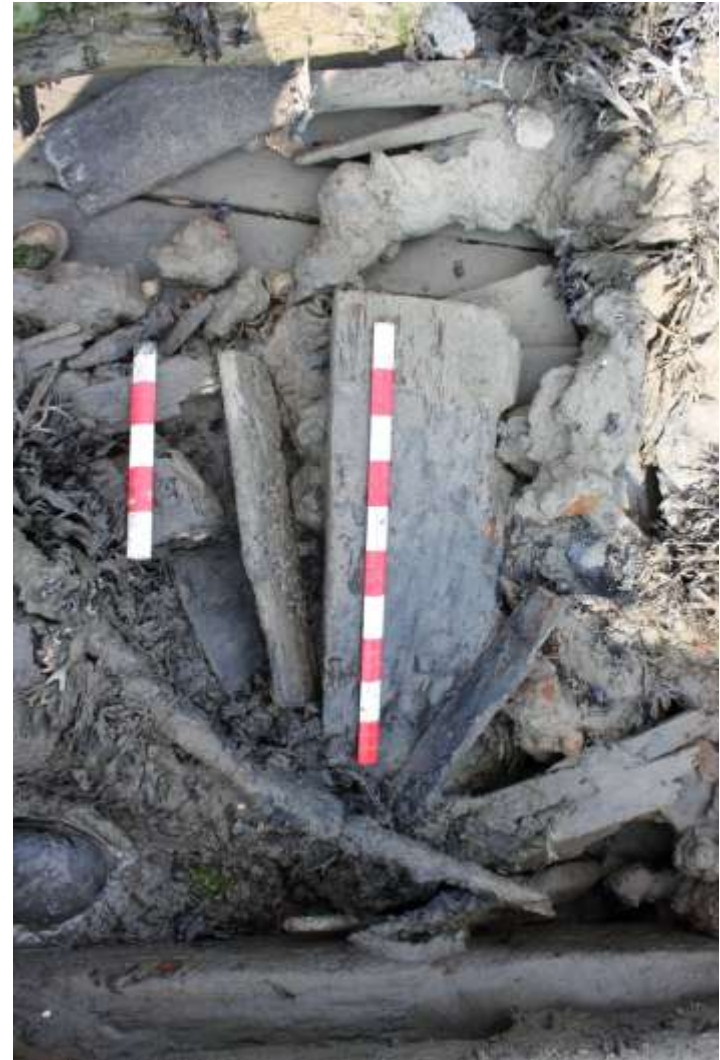
Photo 12: Small wooden boards which may have formed a small box located in the hold, with iron objects (parts of chains) around and beneath it.

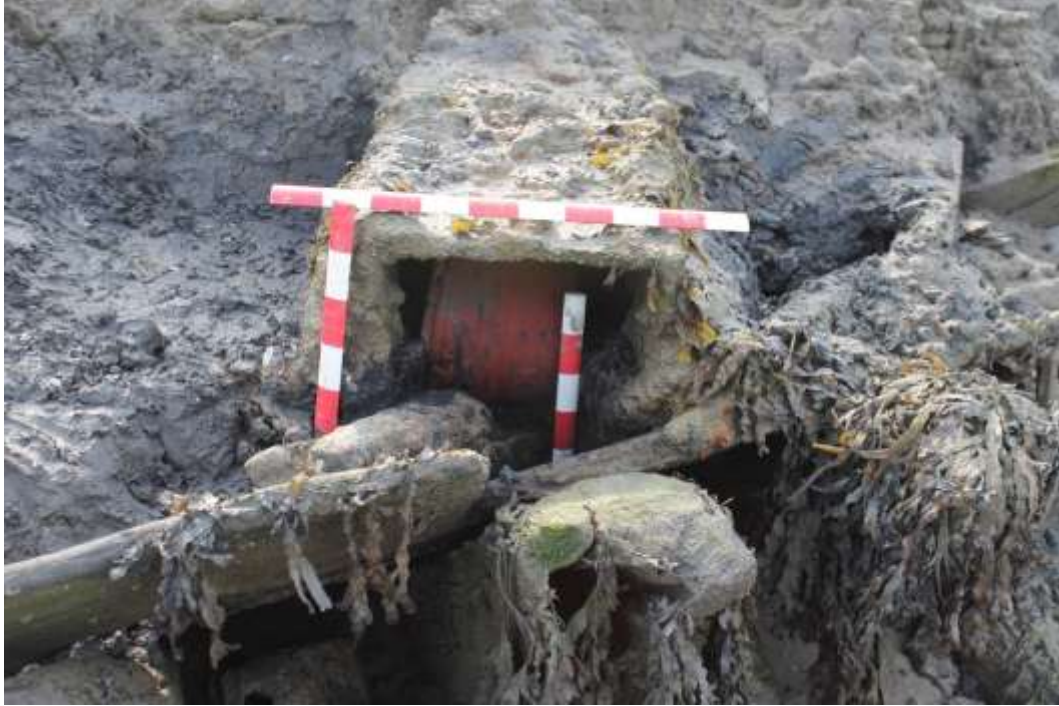
Fragments of slate were also recovered from this area. Larger iron objects were also visible within the exposed part of the hold of the boat, including coils of iron chain (Photo 12), various unidentified fragments and a large rectangular box which could possibly have been the ships stove (Photo 13). An internally glazed mixing bowl or cooking pot was lodged within this box which could not be removed (Photo 13).

Photo 13: Possible ships stove with ceramic mixing bowl wedged within

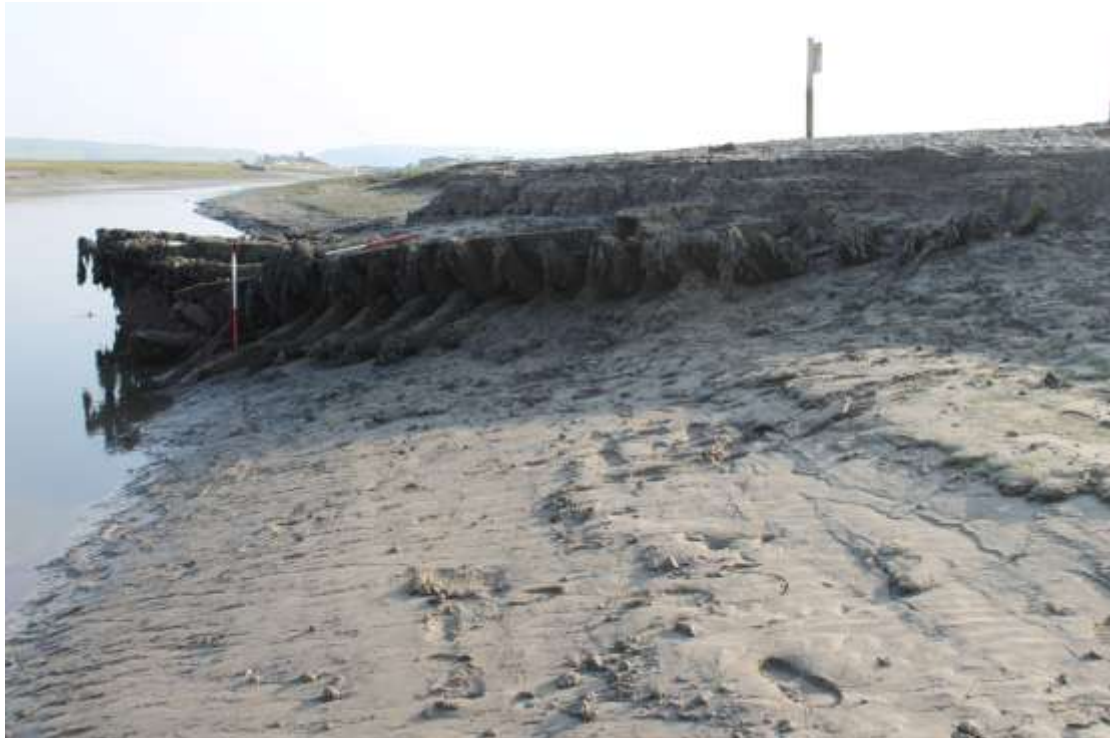
1.1 This written scheme of investigation presents a proposed detailed methodology for further archaeological recording and partial excavation of the eroding hulk on the bank of the Afon Leri, at Ynyslas, Ceredigion (Photo 1). The hulk is one of three located at the junction of the Afon Leri and the Afon Dovey. The hulk to be investigated is eroding from the western bank of the Leri located at NGR SN 61594 93942. The wreck is suffering from significant and constant erosion, exacerbated by the winter storms of 2013-2014.

Photo 1: Showing the hulk eroding into the Afon Leri, viewing south
