# **MEDIEVAL AND EARLY POST-MEDIEVAL CHURCHES AND CHAPELS**

**A THREAT-RELATED ASSESSMENT 2010-11**

Prepared by Dyfed Archaeological Trust  
For Cadw

RHIF YR ADRODDIAD / REPORT NO. 100039  
RHIF Y PROSIECT / PROJECT RECORD NO. 2010/47

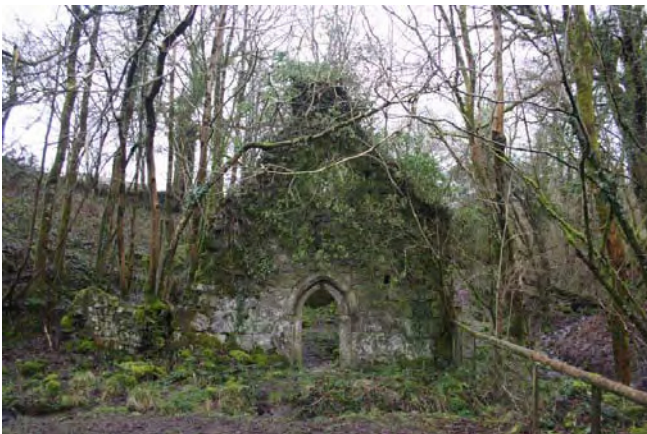
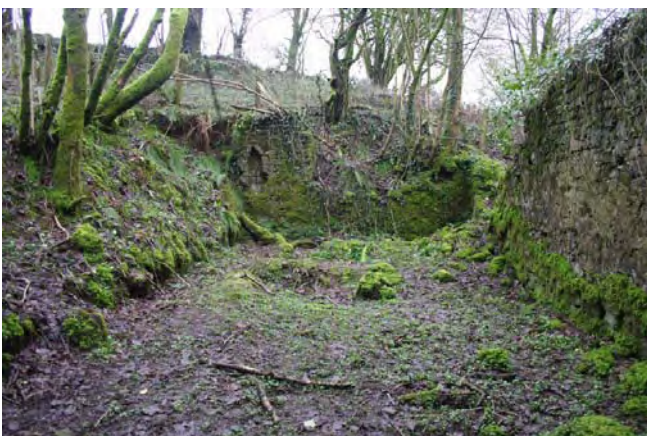
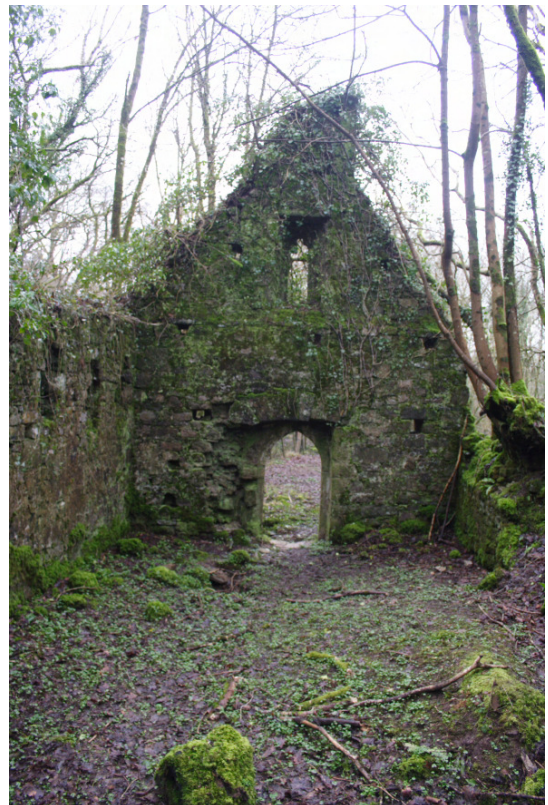
A medieval well chapel which has a spring within its walls. It was a roofless shell by the twentieth century. The site was excavated and renovated by the Carmarthenshire Antiquarian Society in 1970. It was described as a simple building, probably late thirteenth century. Part of the altar and some medieval pottery sherds were found during the excavation but no evidence for burials. Tradition has it that the waters of the well here were good for curing spasms.

The features of the floor were obscured by a thick layer of fallen leaves, although it was evident that the eastern end is raised. The chapel is recorded as a "well-chapel" and, although no well was evident, an exposed section of a fast-flowing, stone-lined water channel, below floor level, was located just within the entranceway, presumably emanating from a natural spring.

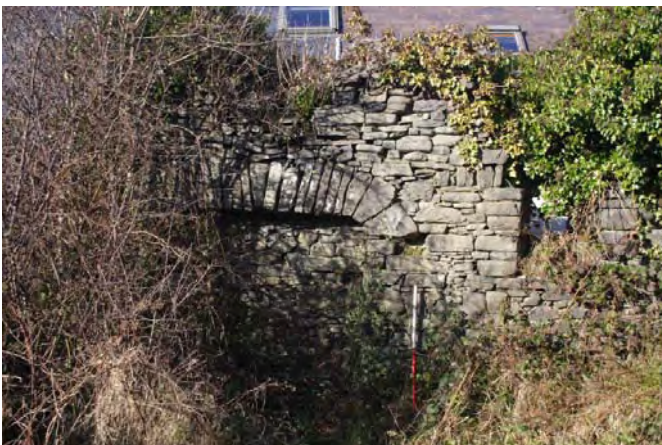
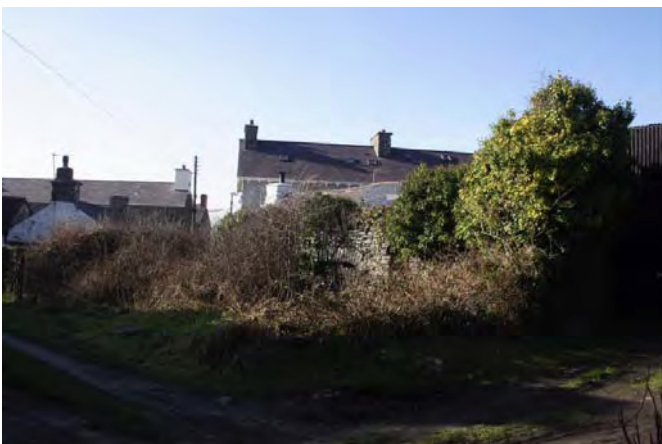
The site, known as Neuadd, was visited during the Churches and Chapels project in 2011. Set within a residential area of old cottages, the site comprises some substantial surviving masonry that forms an east-west rear wall and north-south western end wall of a building. The southern, front wall has almost completely gone - large masonry fragments and the remnant of a possible foundation trench mark its line - and much of the eastern end wall has collapsed. There is a wide fireplace in the rear wall with a pitched stone canopy and evidence of at least two window apertures, one now blocked up. The walls are heavily overgrown with shrubs and trees and the interior of the structure is totally obscured by vegetation.

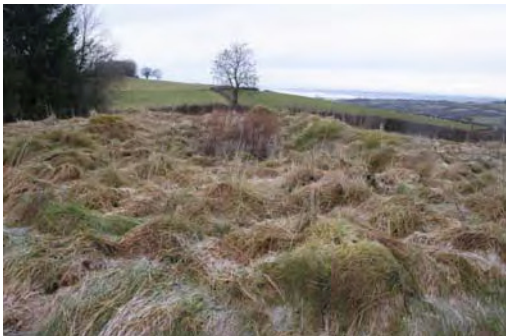
Remains of late medieval chapelry to Llandeilo Fawr parish, which was vestigial in the early 20th century (RCAHM 1917, 89 No.266). It was dedicated to the 'Celtic' St David. Site visit in 2011 showed that the chapel is now represented by a roughly rectangular earthwork, orientated east to west, and consisting of at least two chambers. The remains are located on a slight mound within a large enclosure, which is not necessarily contemporary.

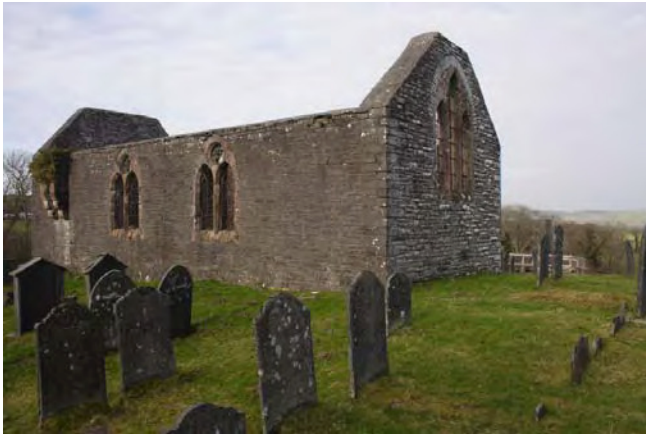
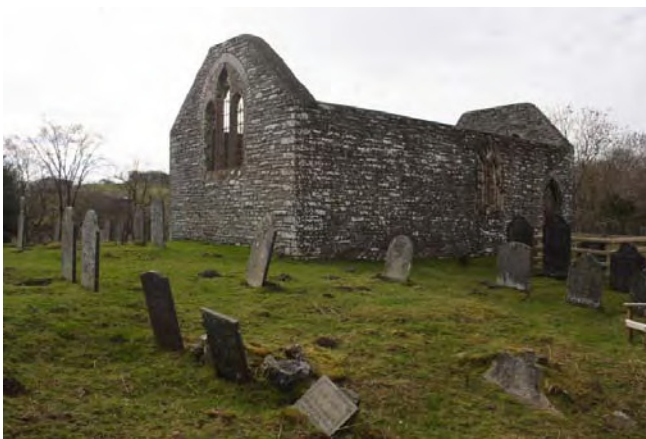
Site of the redundant medieval church of St Michael, parish church of the ecclesiastical parish of Rhostie. Tradition has it that the church was a possession of the Knights Templars of St John in the 13th century. The medieval church was ruined by 1811 and a new church was built in 1816. This was replaced by a new building c.1880. Within a century the church had been abandoned and it is now derelict and unused.

The church is aligned east-west and sits within a sub-rectangular / ovoid churchyard that contains numerous graves. The churchyard is on a built-up platform above a farm track and a stream that runs to the west and south of the church. The church, of slate rubble with dressed quoins, is now roofless but the walls stand to full height, the tops capped with concrete. The gable tops have been removed. The church comprises three rooms; an entrance porchway at the western end that leads to a small vestry, containing a fireplace, and an arched entrance through to the main space of the church. Fragments of red and black floor tiles survive just within the church doorway. Much of the internal plasterwork has deteriorated and fallen from the walls and grass is growing on the window sills. The floor is also covered by a thick layer of grass, obscuring any possible features. Some remnant of stained glass survives in several of the metal-framed windows.

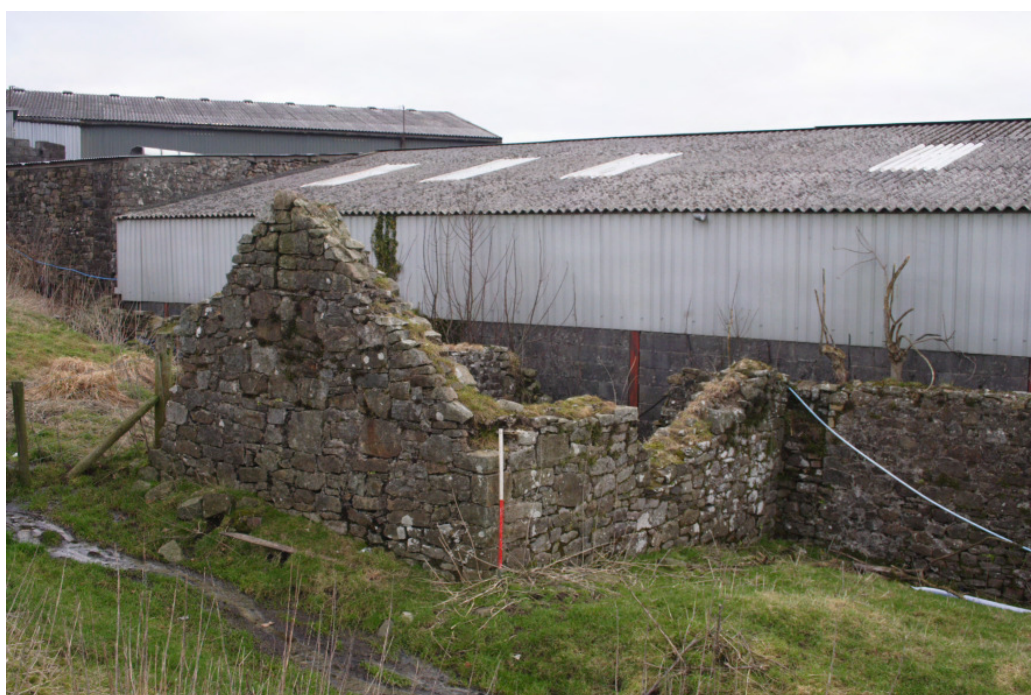
A site visit in 2011 showed that this chapel is a single chambered structure with east, west and south walls still standing. The chapel is orientated SW to NE and is approximately 5m long and 6m wide. The NE gable end has been destroyed, probably by a farm building which itself has been replaced by a modern barn. The entrance was presumably in the NE end as no other entrance is visible. There is a lot of rubble within the interior, and a possible grave.

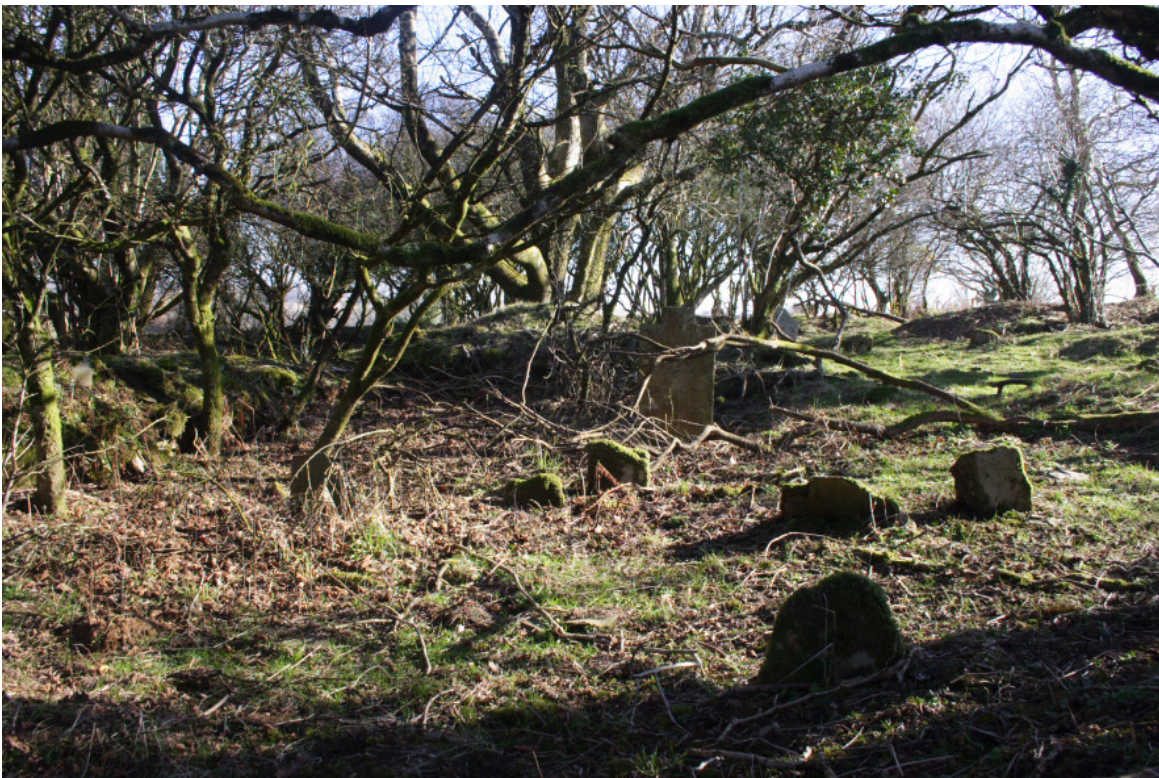
Chapel known as Hendy cwrdd, 'the Old Meeting-house', founded in 1714. The chapel ruins are in a fenced-off area of woodland alongside a trackway that runs along the field boundaries. Depicted on the 19th century Ordnance Survey map as a ruin, the site stands within a graveyard containing 18th-19<sup>th</sup> century graves.

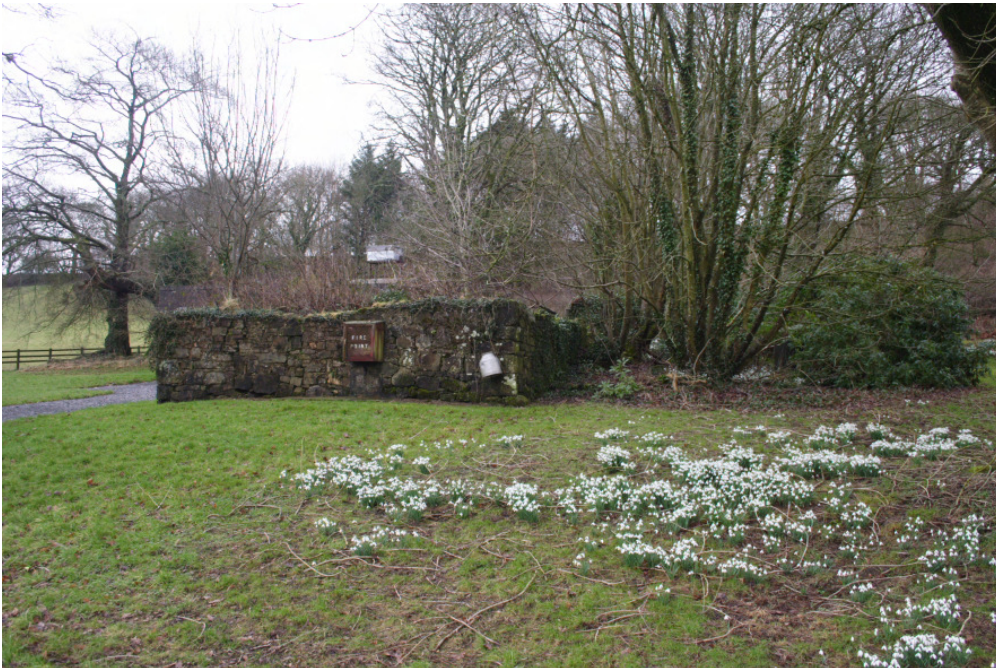
The church is now a roofless shell aligned WNW - ESE. Much of the fabric of the church has been removed since the record made in 1984 and the walls stand just over a metre high. Field observations made by R.E.Kay in 1954 show the entrance doorway and two windows in the western wall and a further two windows in the north wall. His illustrations also depict gravestones standing beyond the northwestern corner of the church, which have now gone. The church is now an overgrown, roofless ruin, and the churchyard is a caravan park. M. Ings 2011

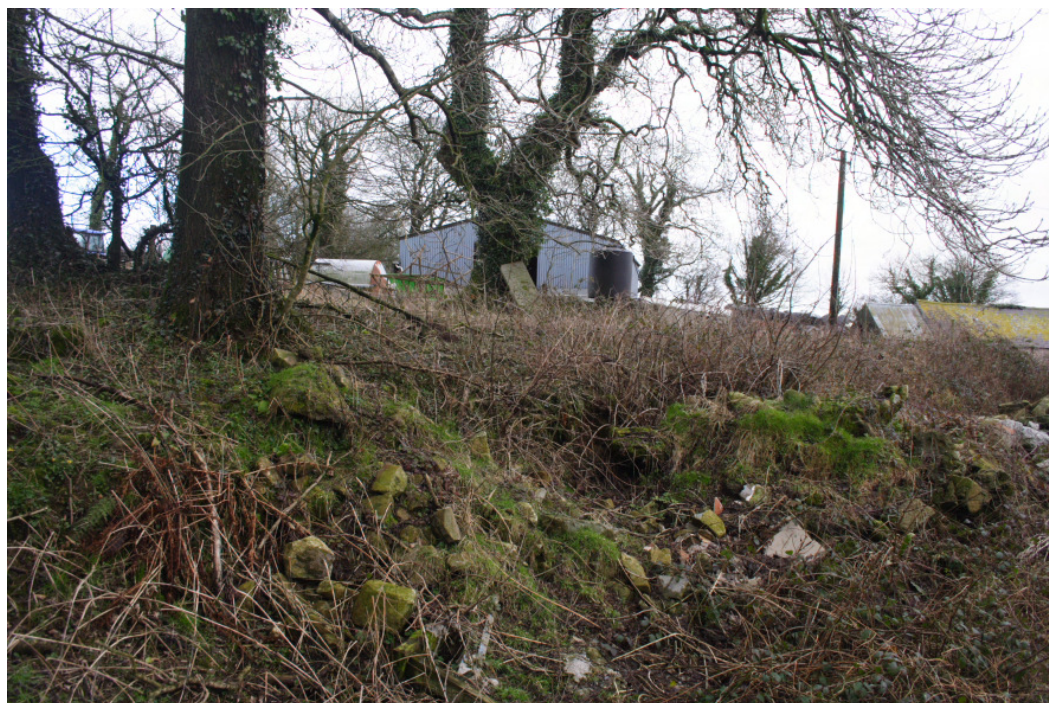
The site comprises a substantial platform within Rinaston Farmstead, built to the side of a farm track. It is marked by steep, stone revetted banks to the west and south and ephemeral earthbanks to the north and west. No standing remains of the former church survive. A gravestone, once recorded to be located within the chancel, now leans against a tree on the platform. This marks the burial of David Morse in 1785 and his wife Martha in 1789  
M. Ings 2011

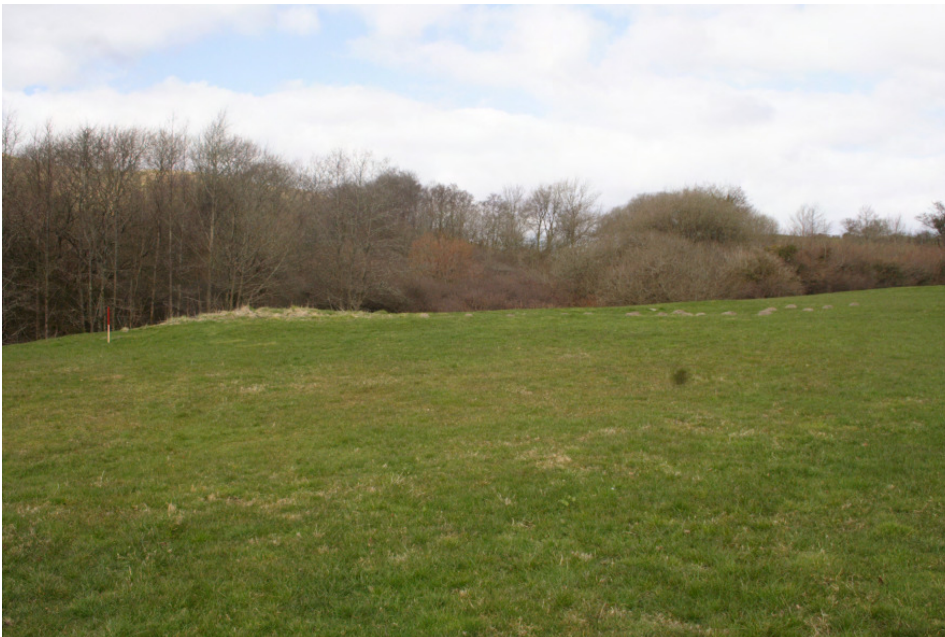
In 2011, the site was still visible as an earthwork occupying a gentle west-facing slope in improved pasture. The chapel was marked by an earthwork 28m E/W and 10m N/S. The earthwork at the west end stood up to 0.3m high internally and 1m externally. Elsewhere the earthwork was less well marked. A large stone was exposed on the north side. Approximately 30m to the south and the east of the chapel were linear undulations, 0.3m high, and numerous depressions, which may mark the limit of the chapel enclosure/cemetery. The farmer had no knowledge of a holy well, but a farm well had been in use up to 15 years ago in the field to the north on the other side woodland. R Ramsey and K Murphy 2011, compiled from several sources.

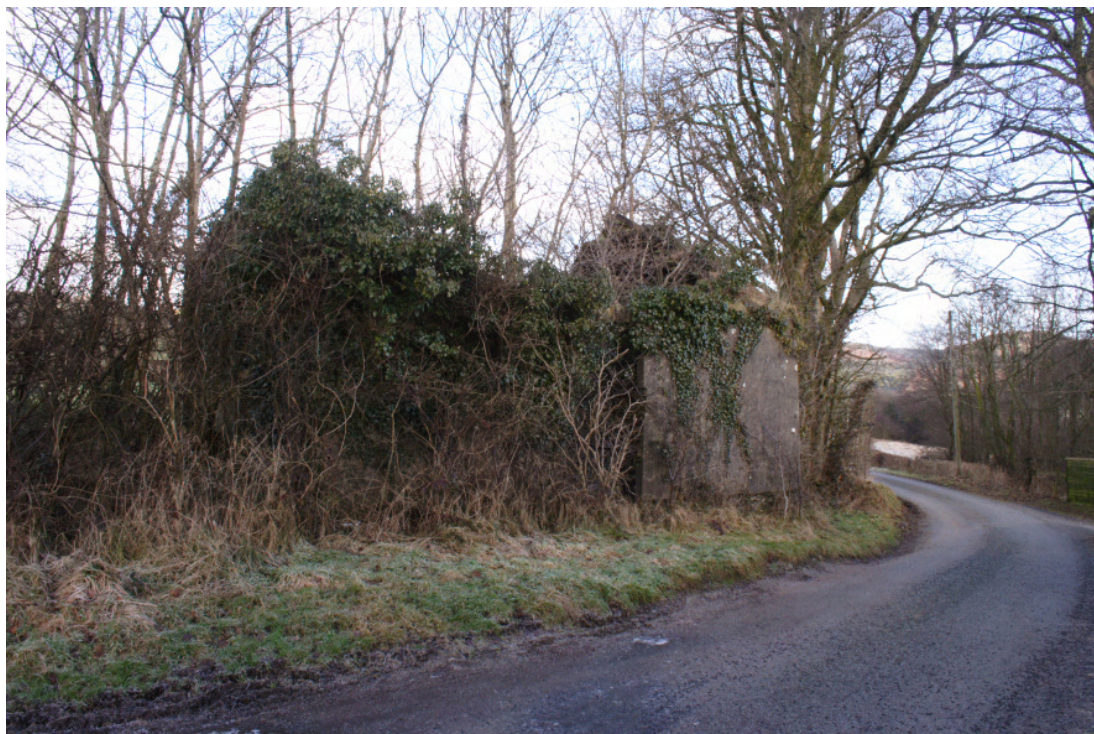
Methodist chapel shown on OS 1st and 2nd ed maps. It is a single chambered structure orientated E to W. It is around 5x7m in size with a small rectangular structure added on at its E gable end. It is constructed of mortared stone and rendered in concrete. The owner remembers it having a slate roof, although it is now roofless, and a pulpit. There are two large windows at either end. The doorway is in the centre of the south wall. The walls are partially collapsed on the north side and there is considerable scrub growth around and within the structure. OD 2011
