# HIGH STATUS MEDIEVAL SITES

## CASTELL CARNDOCHAN

Conservation and Assessment Excavation

Report No. 1213

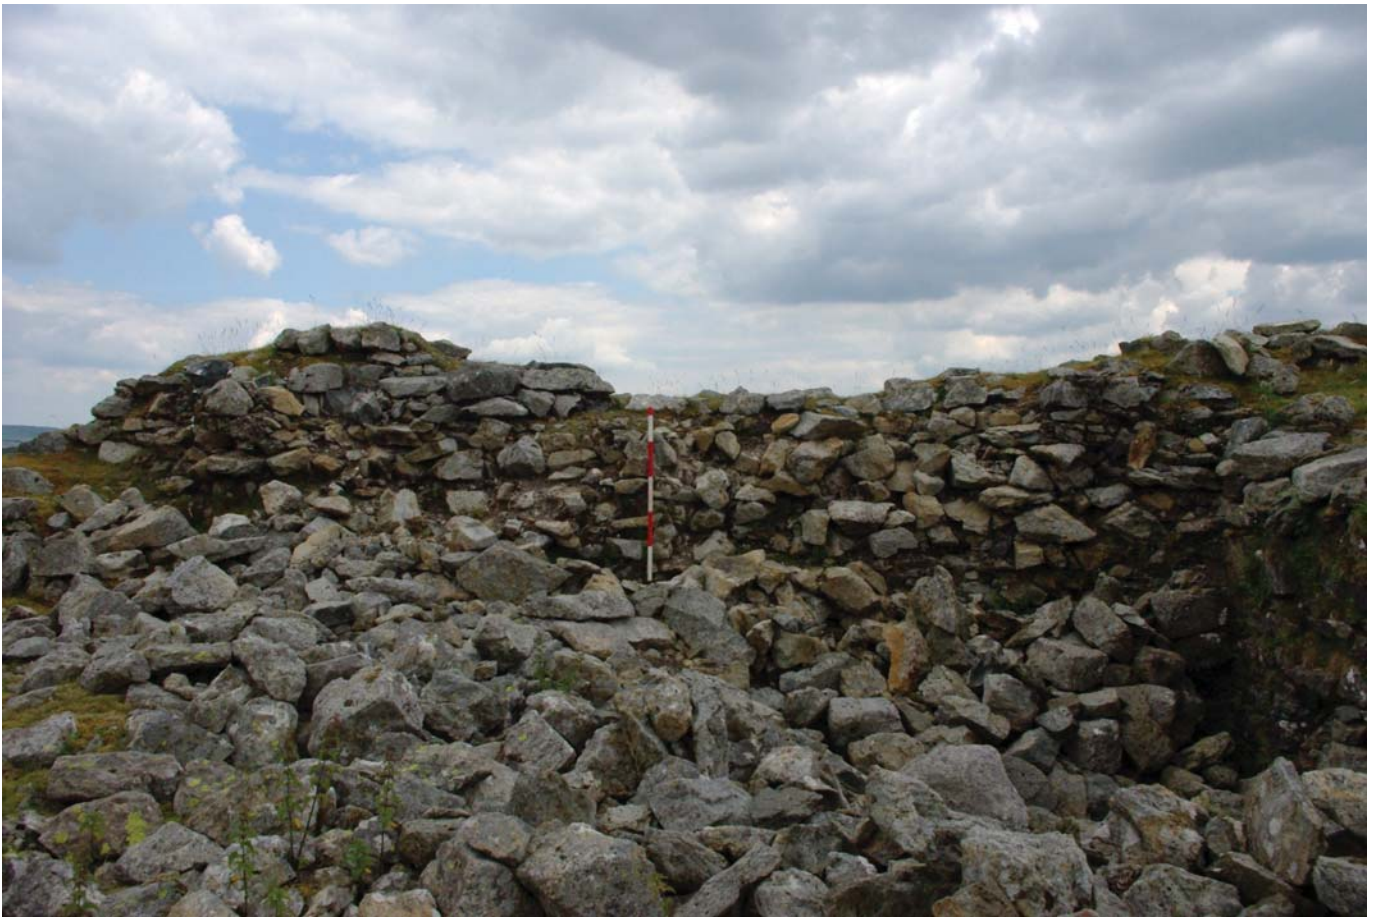
Plate 5 Trench 1, (collapse A) before clearance

There was a spread of un-weathered loose rubble in front of the collapse and there was some loose stone lying on the steep exposed surface of the core (Plate 5). The loose stone was first removed from the stable core to prevent it from falling into the trench during subsequent work. The core was stabilised with a temporary covering of wire mesh. The loose stone was then cleared from in front of the collapse while carefully monitoring the standing masonry for any signs of instability. The rubble was between 0.5m and 0.6m deep.

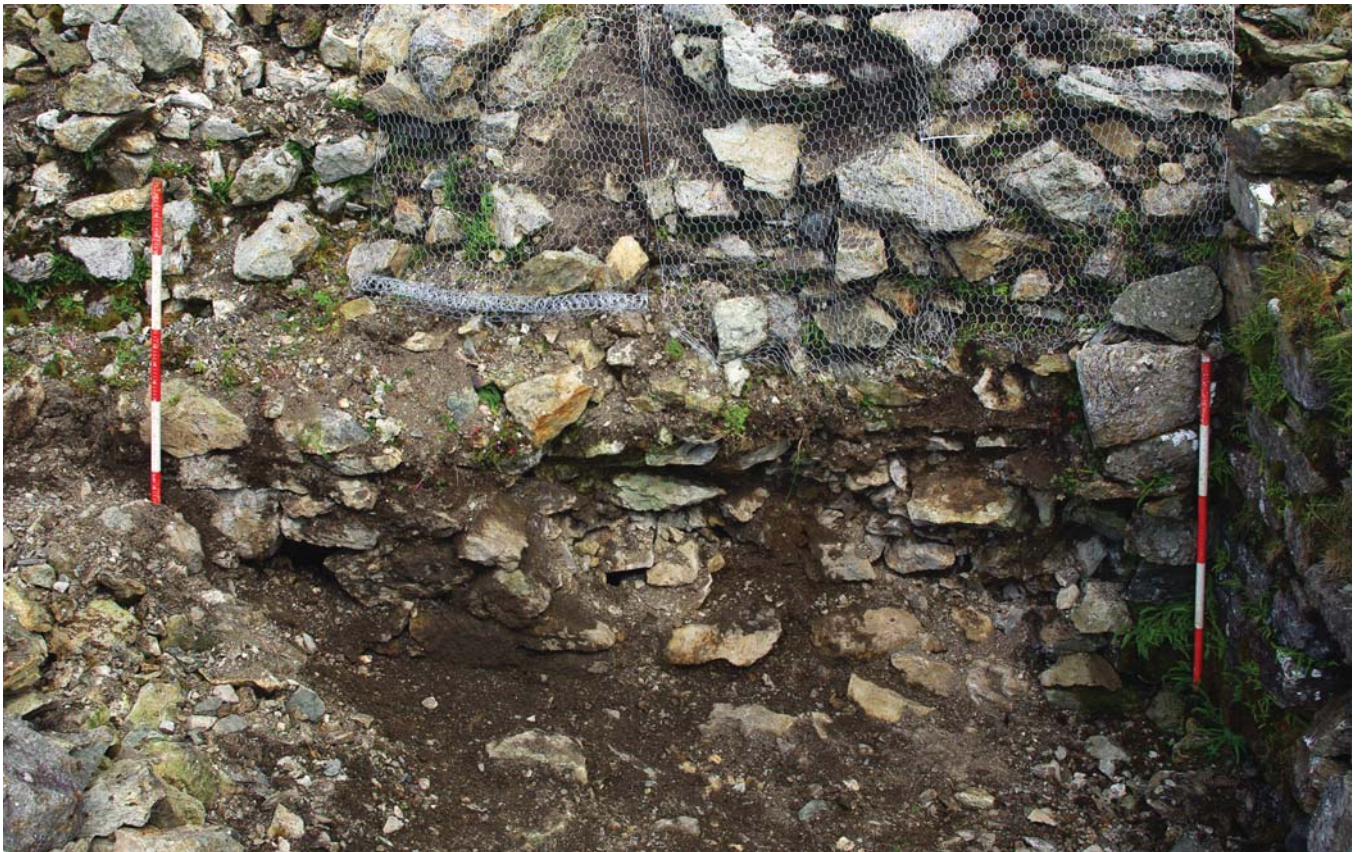
Plate 6 Trench 1 (collapse A) after clearance

The clearance revealed extant facing on the north-west side of the collapse (Plate 6). This contained some voids but appeared to be fairly stable. The central 1.3 m of facing had collapsed from the base. The masonry was not hand-drawn on site for health and safety reasons but a drawing was produced from rectified photographs and an orthographic projection from a 3D model (Fig. 3). The clearance of the loose rubble revealed a surface of compacted gravel and small stones which appeared to coincide with the base of the wall and could be the remains of a floor level. There were, however, small voids beneath all of the extant facing stones suggesting that the wall had been undermined by the early excavations and the floor levels disturbed. This was presumably a contributory factor in the loss of the facing. The exposed core at the base of the wall appeared to be mostly *in situ* but contained frequent voids and in its present state threatens the stability of the wall above (Plate 7).

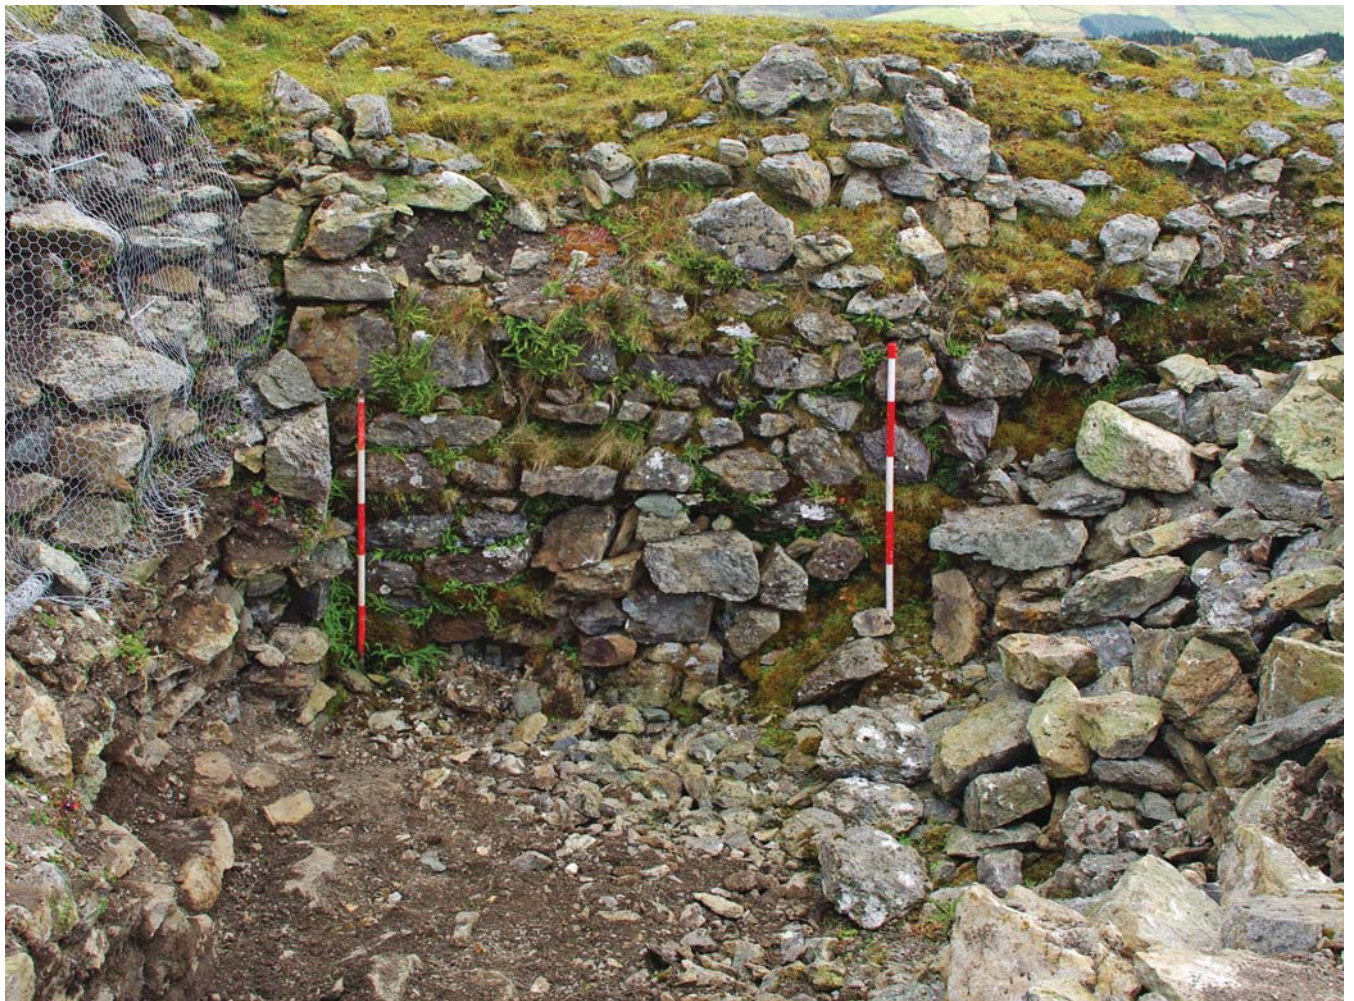
Plate 8 Trench 1, Collapse B after clearance

The south-eastern wall of the tower, adjacent to the collapse, survives to a height of c. 1.8m and appears to be reasonably stable (collapse B, see plate 8). There is, however, a large void close to the base, again probably a result of the wall being undermined. This has, at some time in recent years, been packed with dry-stone masonry. This was not disturbed during the clearance. This facing was partially obscured by vegetation and a drawn elevation was not produced.

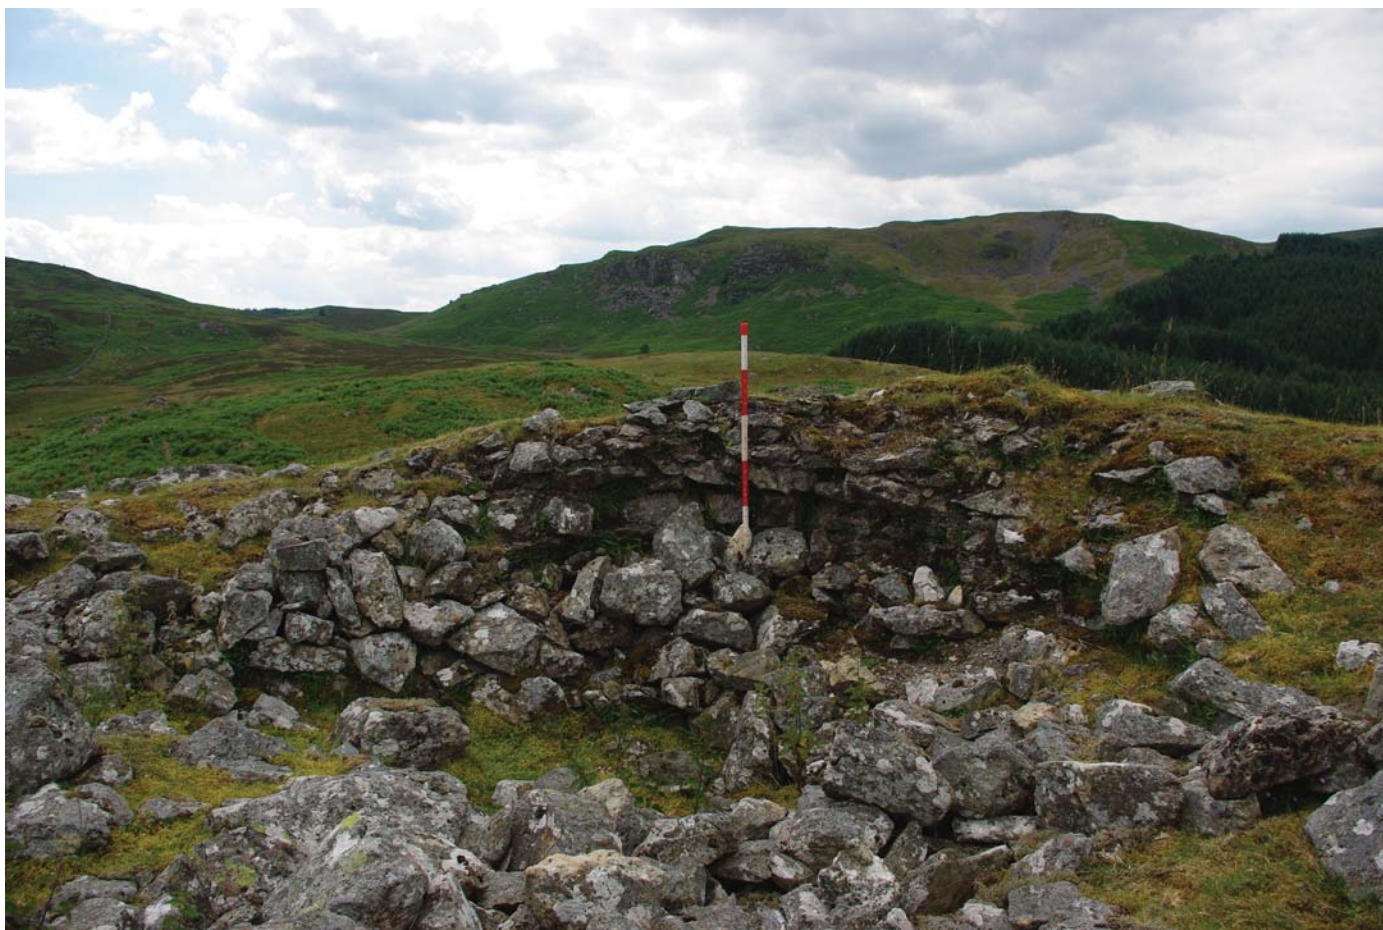
Plate 11 Trench 2, collapse C before clearance

This trench encompassed collapse C, in the middle of the apsidal end of the D-shaped tower, and investigated the masonry to either side. Before clearance there was a 2.2m wide collapse with

extant mortar-bonded wall-core standing to a height of 1.2m. This had eroded to a state of moderate short-term stability (Plate 11).

Reinstatement should be carried out as described by Mike Garner in Appendix 2. The eroding area should be built up with mortared core-work thus supporting the surviving masonry.

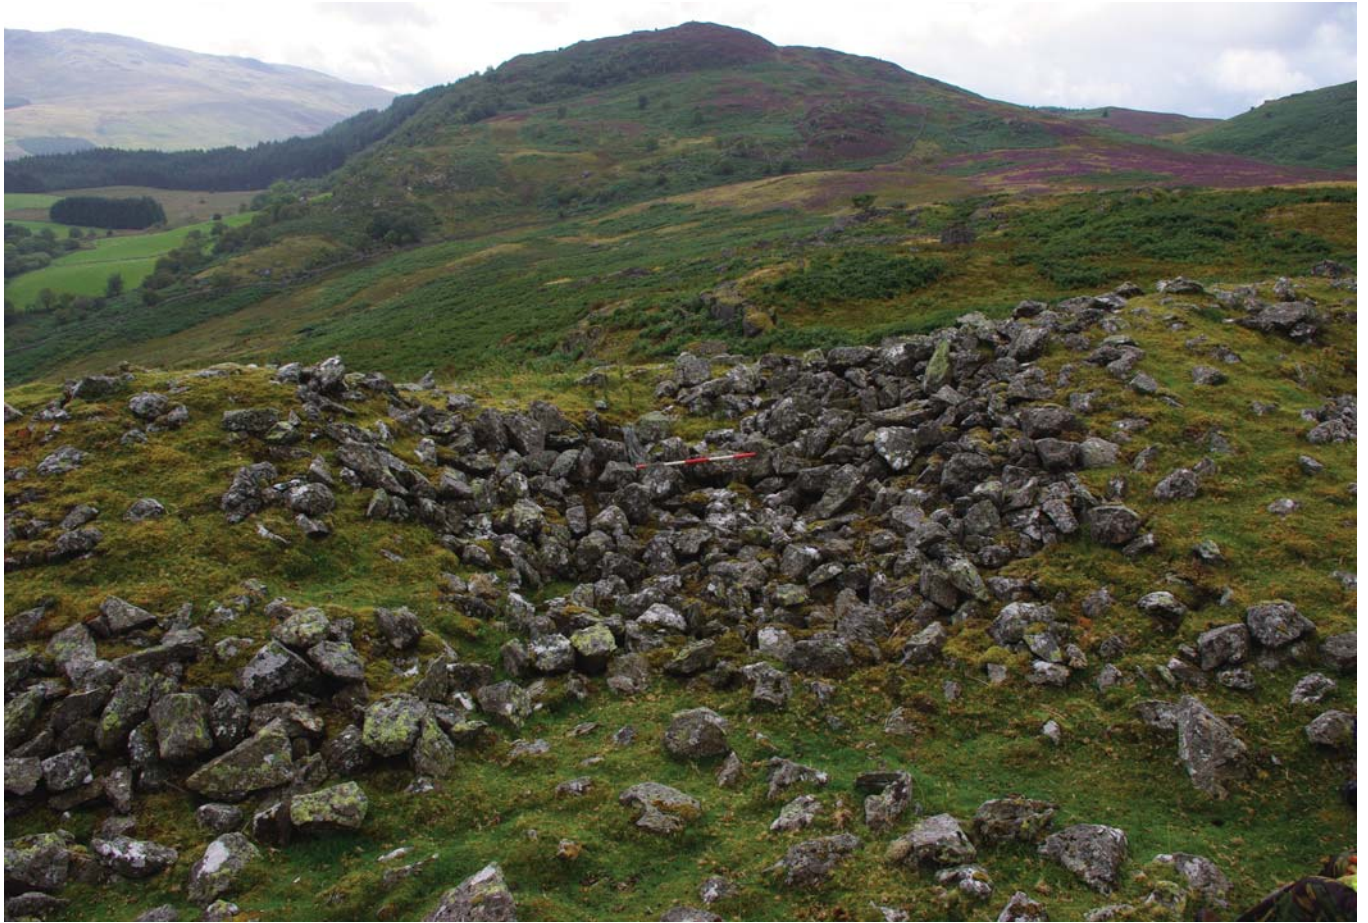
Plate 13 Trench 3 before excavation

This trench was excavated in order to investigate a fairly featureless area of rubble (Plate 13). This comprised a roughly circular bank of stone with a further amorphous bank to the west. This had been variously interpreted as a gate between turrets and a half-round tower (Hogg 1953-6). Cathcart King and Kenyon (2001, 407) suggest that Hogg's interpretation of a round tower may be correct and also suggest that the gate into the castle is likely to be between this and the D-shaped tower, concluding that "the determination of its position, and the exact plan of the half-round tower, are the principal questions which excavation would help to solve at Carndochan"

Some of this area comprised grassed over rubble and was stable and well-consolidated, the rest consisted of loose rubble and there were signs of some disturbance in the western side. It was decided to clear the rubble from an irregular area comprising half of the "half round" tower along with a small area to the west and only to clear unconsolidated rubble. This resulted in an approximately H-shaped trench with overall dimensions of 5.5m x 7.2m.

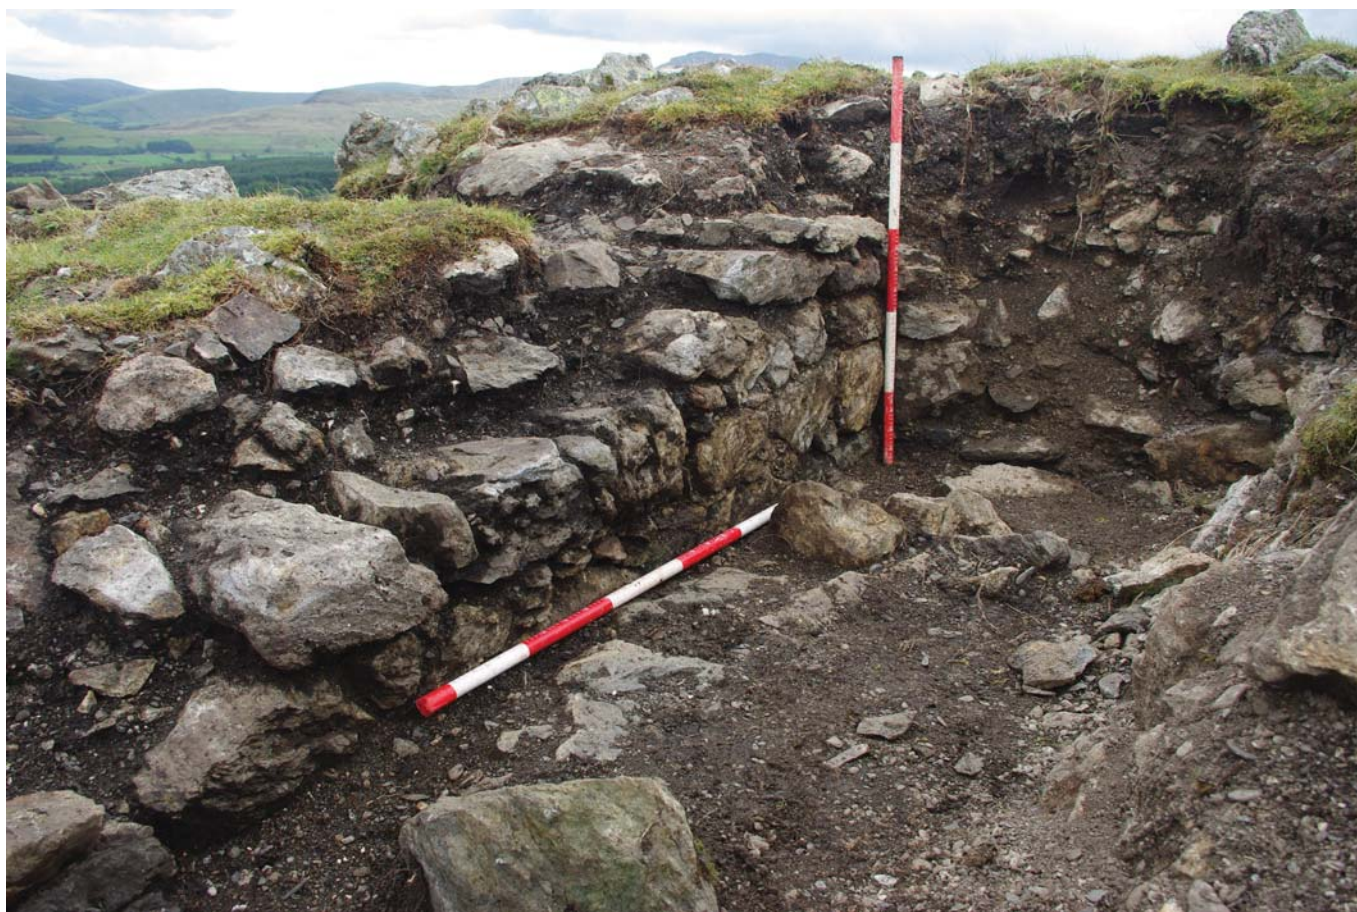
Plate 18 Trench 3, rectangular building after excavation

On the western side of the trench, a facing of similar masonry was identified, comprising what appears to be two sides of a rectangular structure (Plate 18). The eastern wall could be traced for 3.4m and the southern for 0.9m. The eastern face formed the outer face of the D-shaped tower 007. The eastern wall appeared to abut the southern although further clearance would be needed to confirm this and it is possible that the two walls could be bonded together. The full extent of this structure was not uncovered but the topography of the collapsed stone suggests dimensions of approximately 4m x 4m. The tumble was again not excavated to its full depth and only the top of the masonry was uncovered.

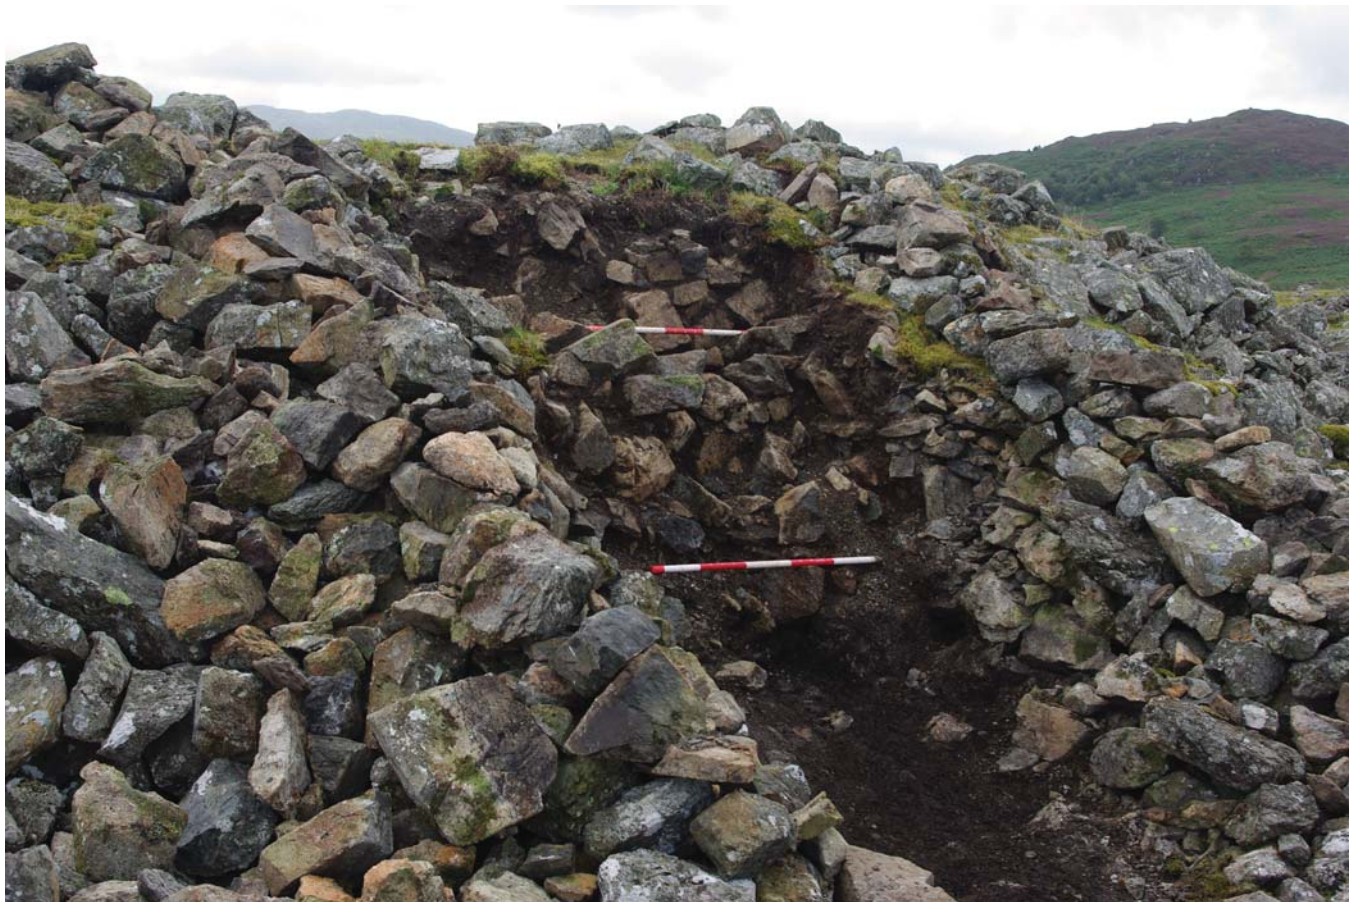
Plate 20 Trench 4, battered masonry and collapse at the base of the square keep

The rubble was cleared from a 1.7m x 5.0m area of the outer slope. Only loose stone and the gravel matrix were cleared. This revealed a more stable layer of stone and a line of semi collapsed facing. Plate 20 shows the trench after clearance. The stable masonry was stepped, with a line of possible facing at the top of the slope. There was little at this level that could be confirmed as original undisturbed masonry and therefore any interpretation should be seen as being provisional.

The stepped slope could be interpreted as either semi-collapsed core or alternatively as tumble with the face still surviving beneath the rubble. Unfortunately there was no opportunity to excavate further. If the former, it is possible that the tower had a battered base in a similar fashion to the round tower at Castell y Bere and that the facing stones have been lost. The possible facing at the top of the slope appears to be relatively slight and did not continue down into the rubble. It would indicate a wall width of about 1.7m. The base of the stepped rubble slope was sitting on bedrock.

The bedrock in front of the masonry was sealed by a context of dark charcoal-rich soil perhaps indicating destruction by fire. This was not excavated but a small sample was taken. A preliminary examination indicates that the charcoal is very finely comminuted and may not be suitable for radio-carbon dating. Clearly more extensive excavation would be required to provide any definitive structural evidence but there is clearly potential for the recovery of further information in this area.
