# GGAT 112: Second World War Military Airfields of South Wales

RAF Llandow

A report for Cadw  
by Paul W Huckfield BA

GGAT report no. 2012/032  
Project no. GGAT 112  
National Grid Reference:  
SS95950 71770

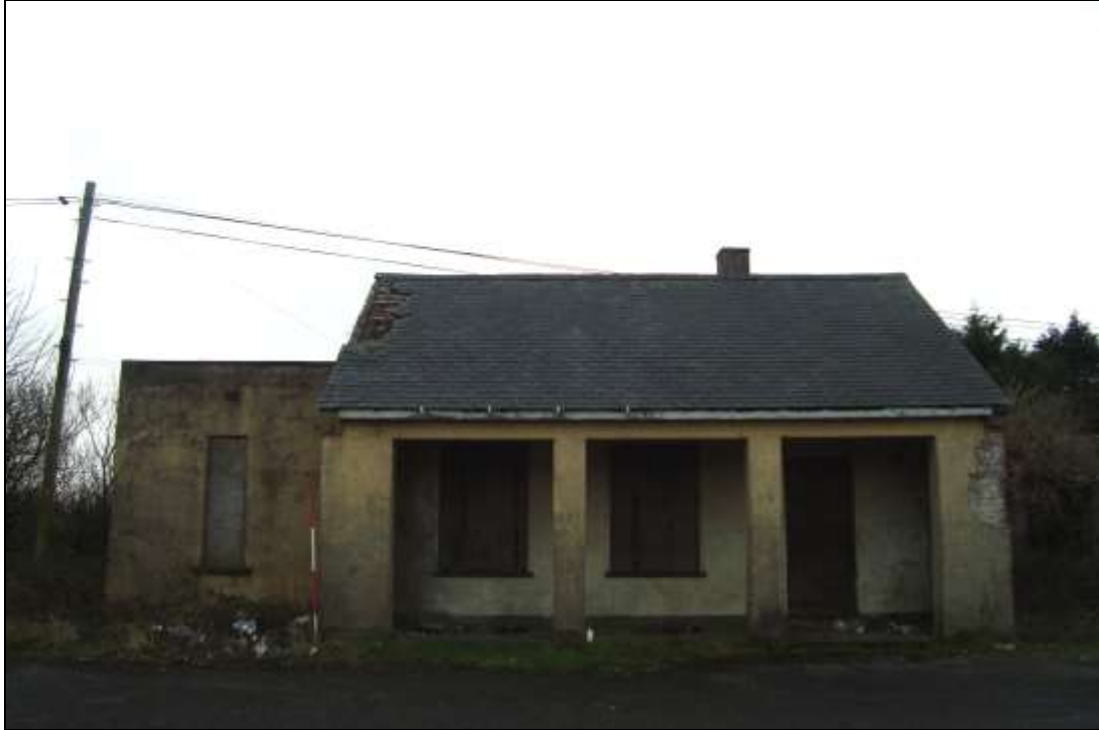
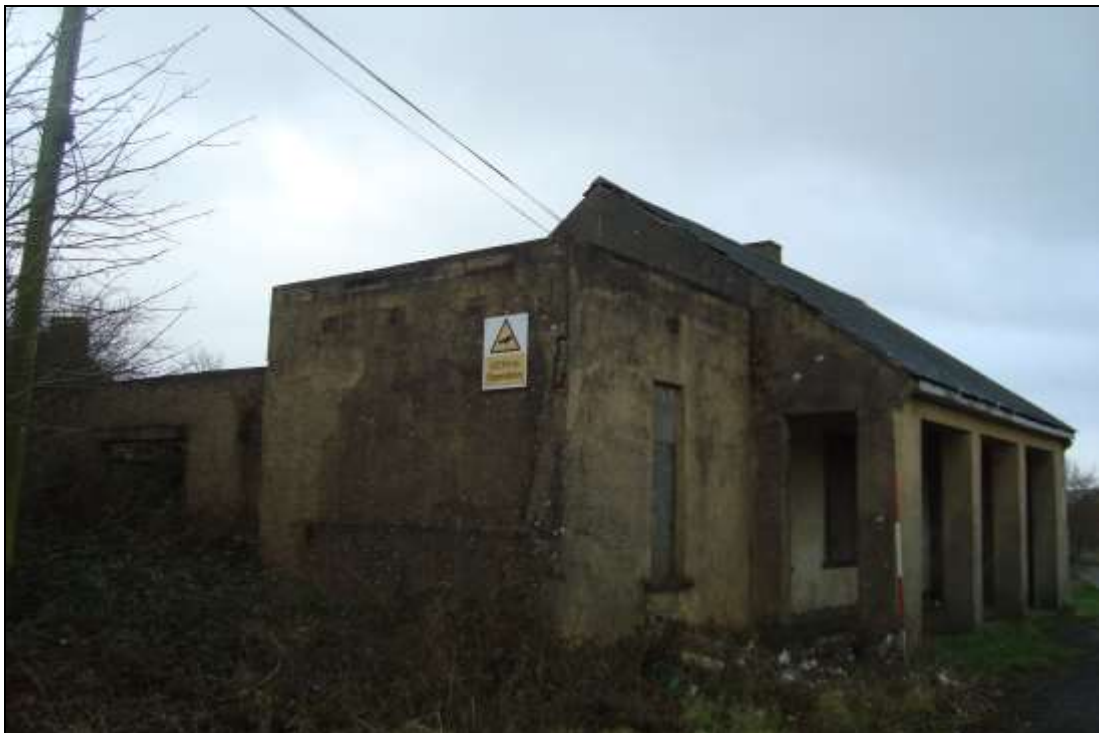
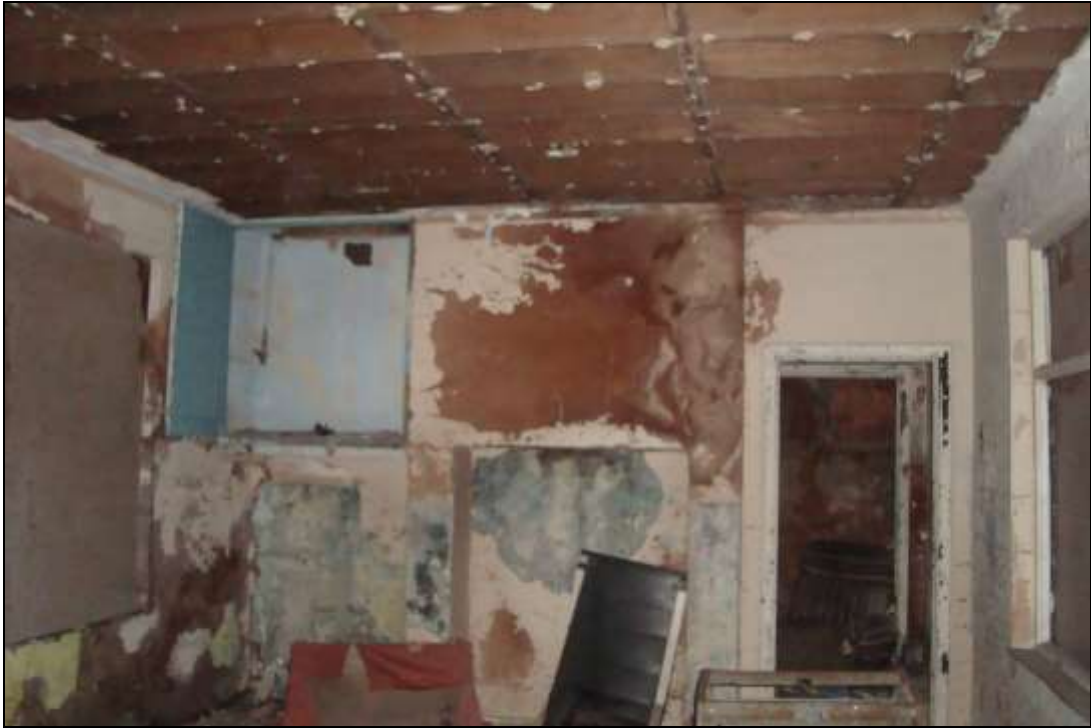
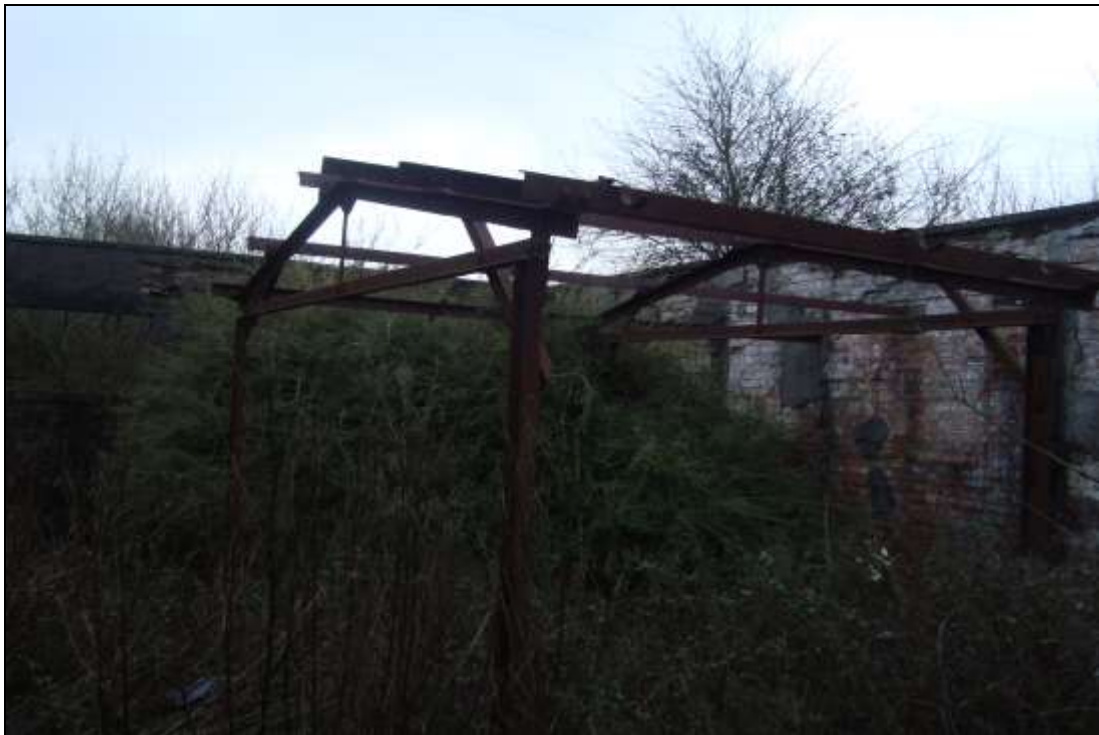
| <b>Description</b> | <p>Wardens Office Sub-Unit type 2881/37. This structure is the standard type found on most Aircraft Storage Units (ASU) sub-sites such as Llandow Site 'A'. The rectangular building has a colonnade of four square-faced columns, without capitals, at the front and an extension with a single lancet window to the southeast of the structure. The being has been clad in cement render. At the rear of the building is an enclosed area encircled by a high wall. Within this enclosure is a steel framed structure of unknown use.</p> <p>The building exterior is still in a fair state of preservation, though some of the concrete render to the final northwest column has fallen away exposing the brickwork beneath. In addition, a number of tiles are also missing from the front of the roof. The interior has faired less well.</p> |
| <b>Condition</b> | Damaged |
| <b>Condition rating</b> | Fair |

*Plate 1: Wardens Office (northeast facing elevation)*

*Plate 2: Side elevation of the Wardens Office (southeast facing)*

*Plate 3: Interior of the building*

*Plate 4: Enclosed area at the rear of the office with the unknown steel framed structure*

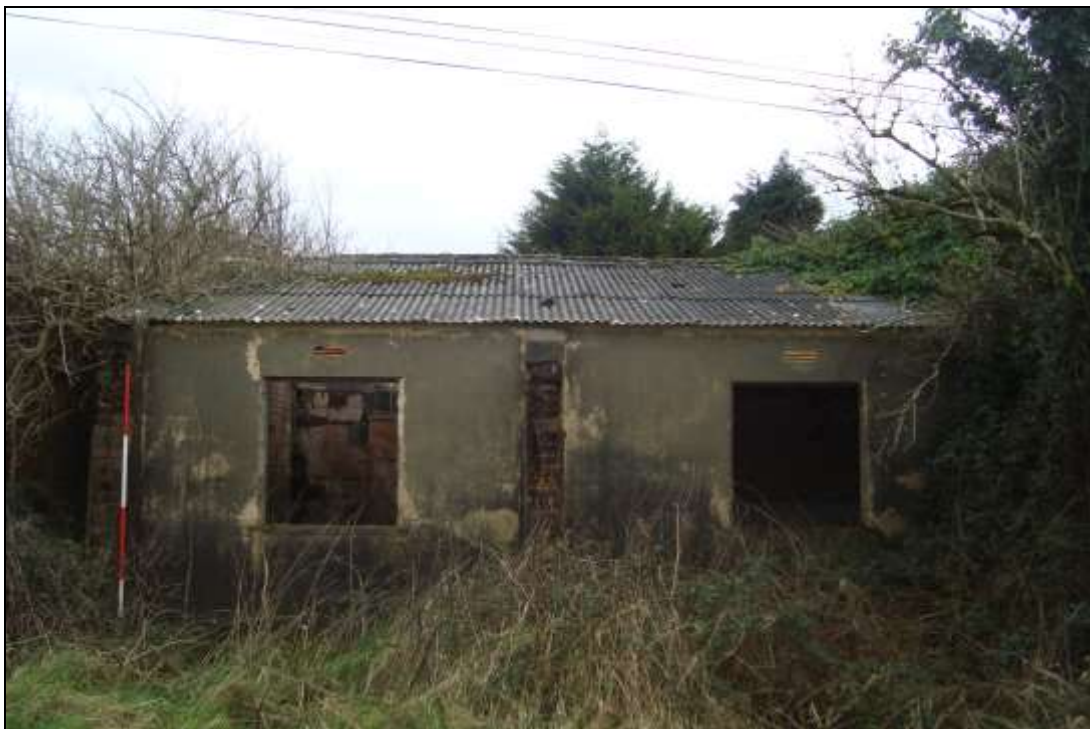
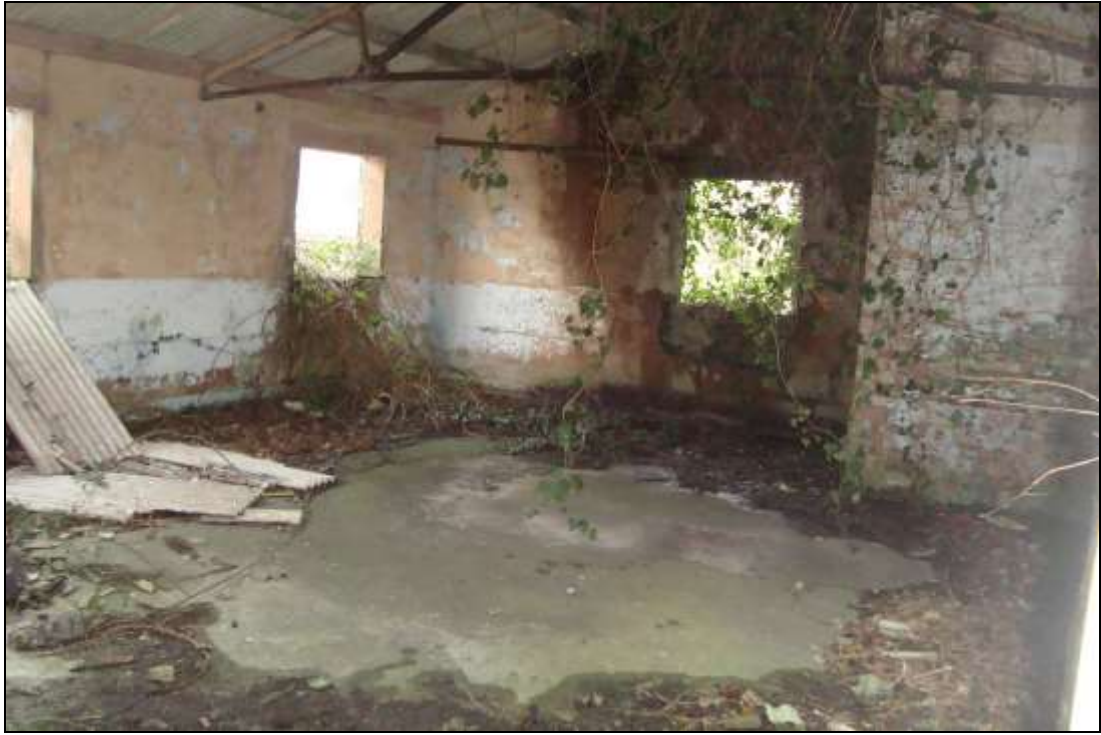
| <b>Description</b> | A rectangular brick building rendered in concrete with internal steel 'A' frame supporting a corrugated asbestos roof. This buildings fabric is in a poor state of repair and all the windows and doors have been removed, as too have all the internal fixtures. |
| <b>Condition</b> | Damaged |
| <b>Condition rating</b> | Very Bad |

*Plate 5: Front elevation of the canteen block (northeast facing)*

*Plate 6: Interior of the canteen. Note the steel 'A' frame roof supports*

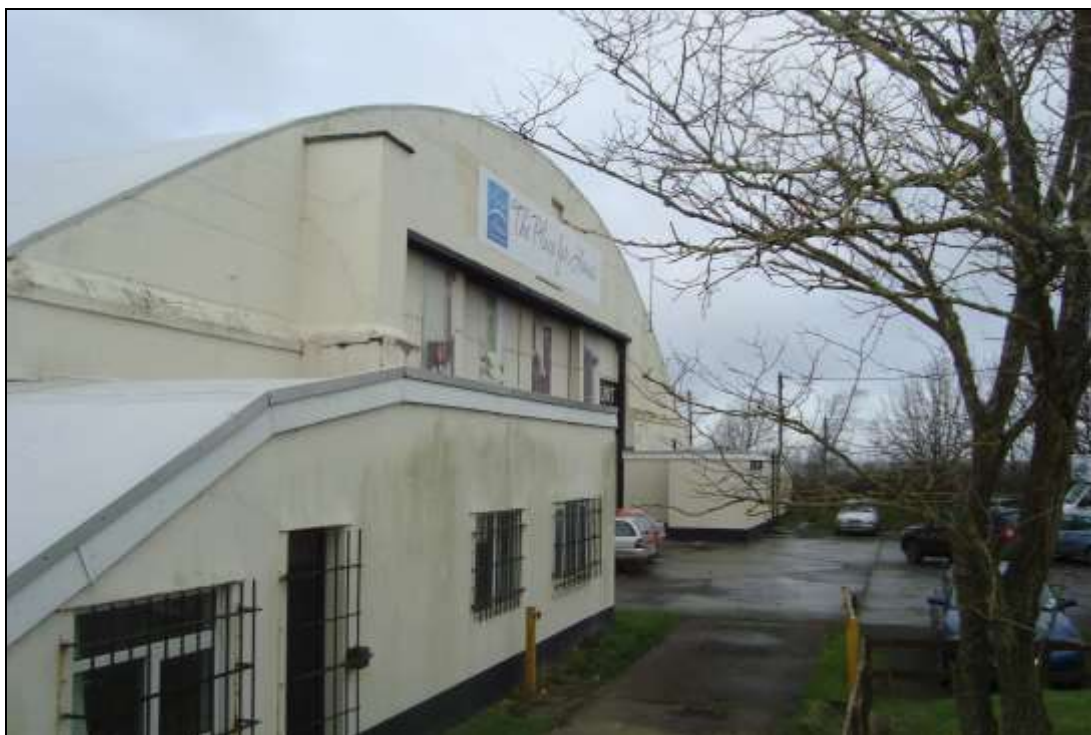
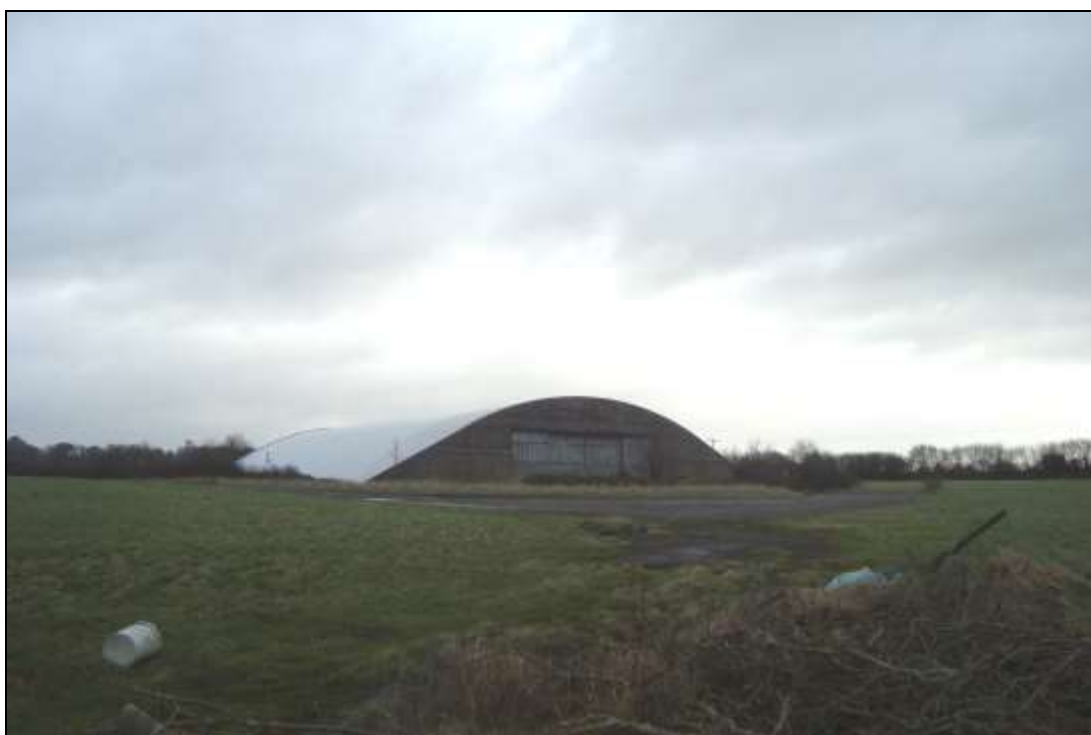
| <b>Description</b> | <p>This curved military aircraft hangar produced in 1939 is to be found mainly at Storage and Maintenance units. The 'L' shed (Drawing No. 5163/39 &amp; 10755/39) is a steel frame structure, which is then clad with steel sheeting and reinforced concrete and typically covered with a thin layer of concrete, earth and turf.</p> <p>This hangar has had a degree of conversion, mainly to the front elevation. The flanking offices have been re-clad and re-roofed, however, the remains of heating chimney stack is still in place. The rear of the hangar maintains more of its original look. Internal rooms have been constructed within the interior and the hangar is currently in use by a furniture store.</p> |
| <b>Condition</b> | Converted |
| <b>Condition rating</b> | Fair |

*Plate 7: Front elevation of the 'L' type hangar. View to the northwest*

*Plate 8: Rear elevation. View to the east*

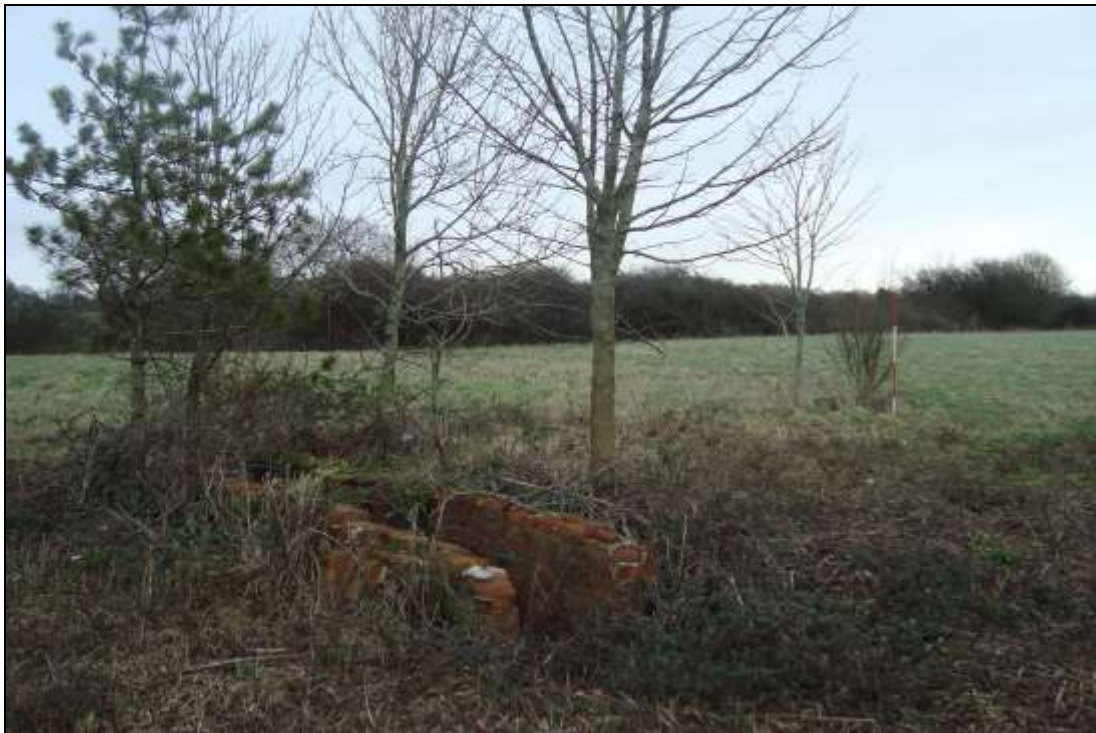
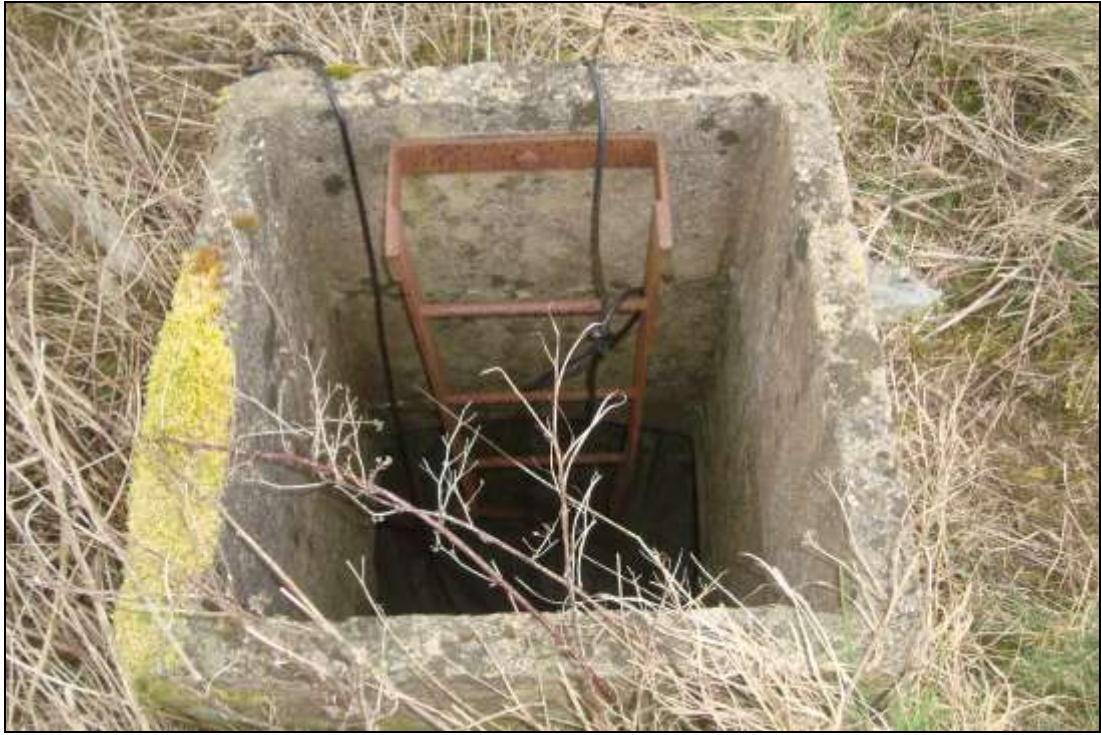
| <b>Description</b> | Underground air raid shelter. The entrance is constructed from brick, while the emergency exit is made from pre-cast concrete. Access to the interior of this site was not possible and therefore the condition is unknown. |
| <b>Condition</b> | Not known |

*Plate 11: Entrance to the shelter. View to the north*

*Plate 12: Emergency exit constructed from pre-cast concrete*

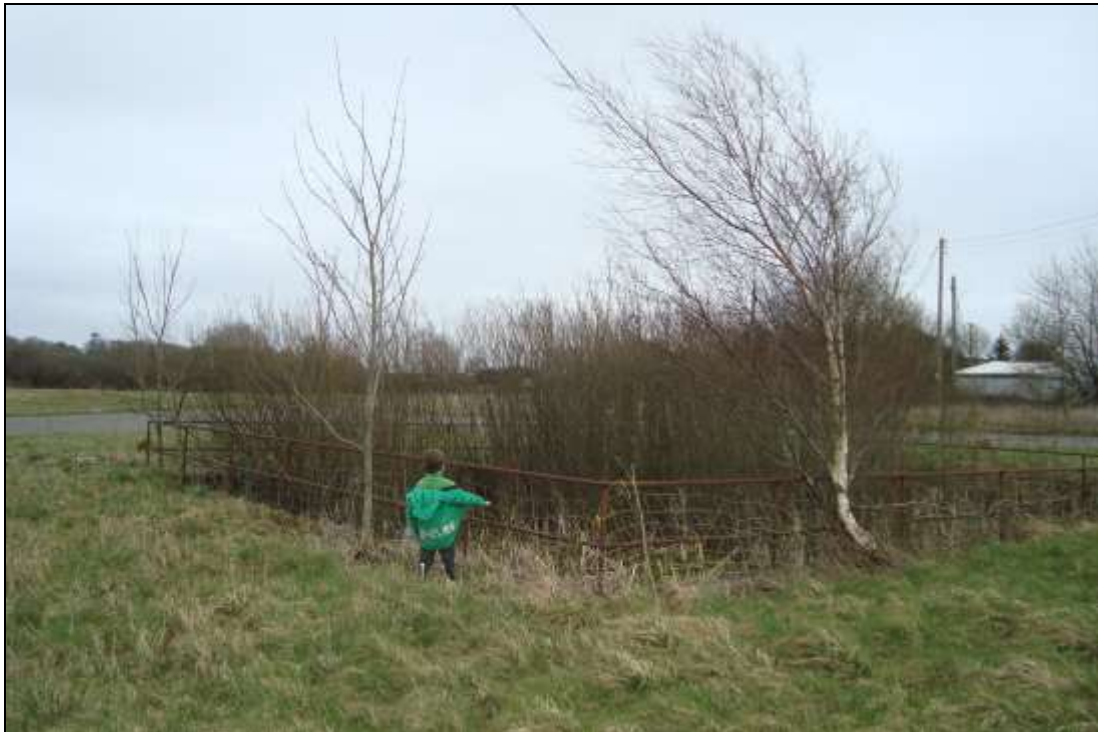
| <b>Condition</b> | Damaged |
| <b>Condition rating</b> | Fair |

*Plate 15: Static water tank, still surrounded by the original railings*

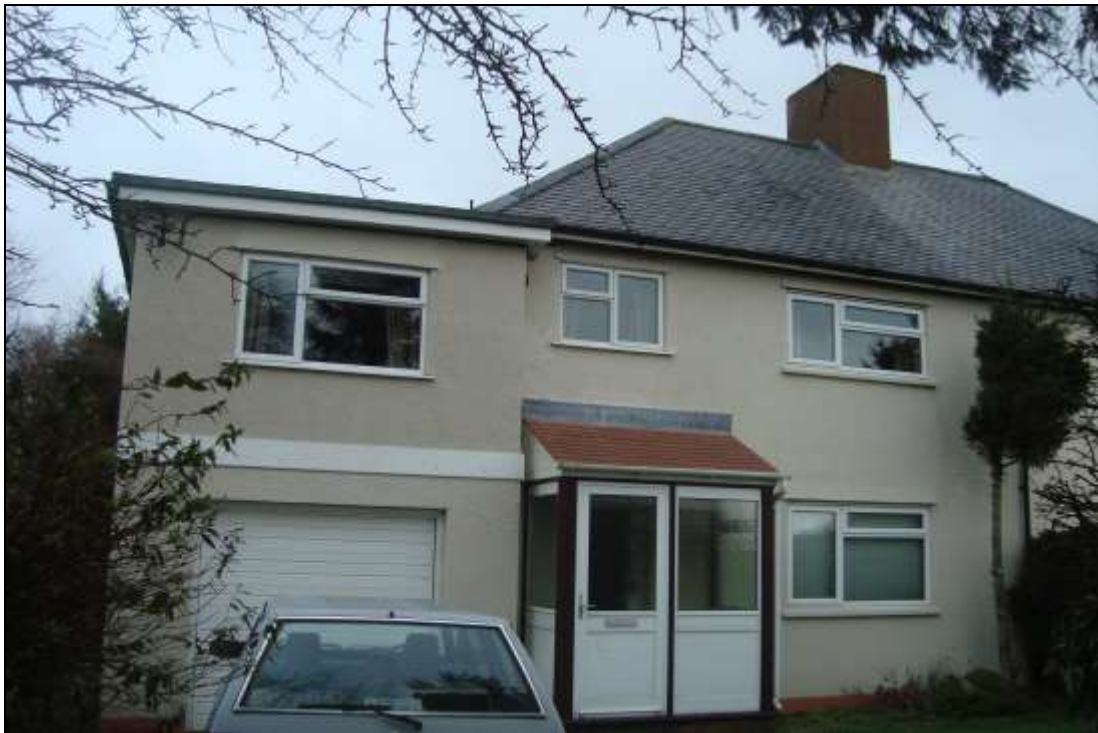
| <b>Condition</b> | Converted |

*Plate 16: Western of the two Married Wardens Quarters (south facing elevation)*

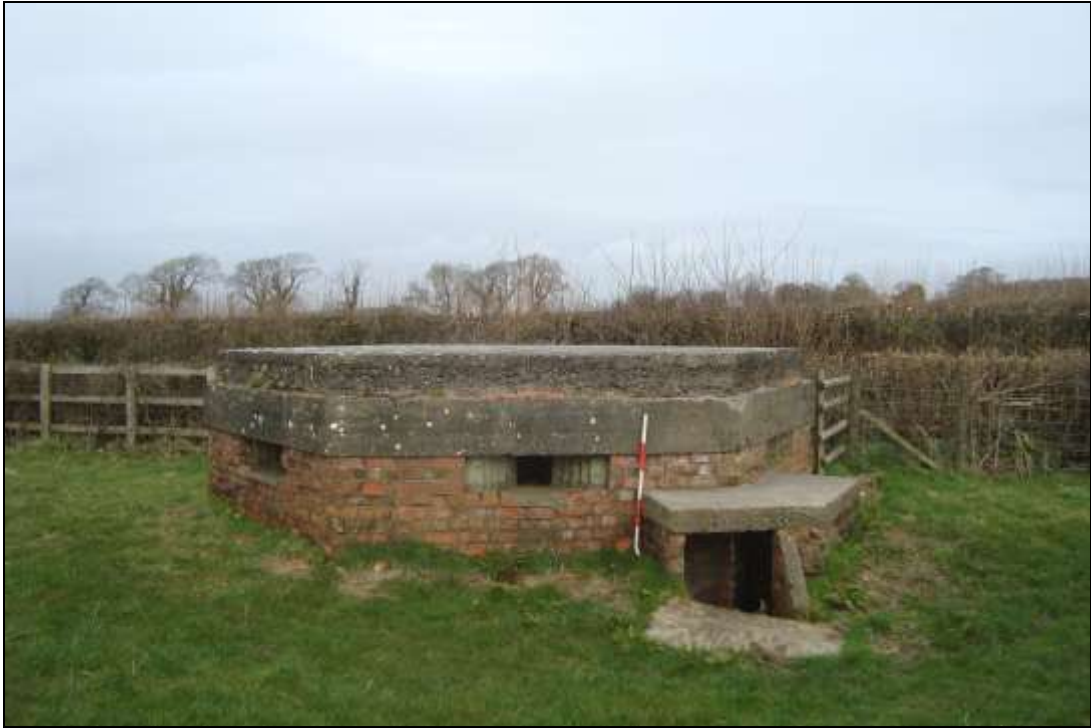
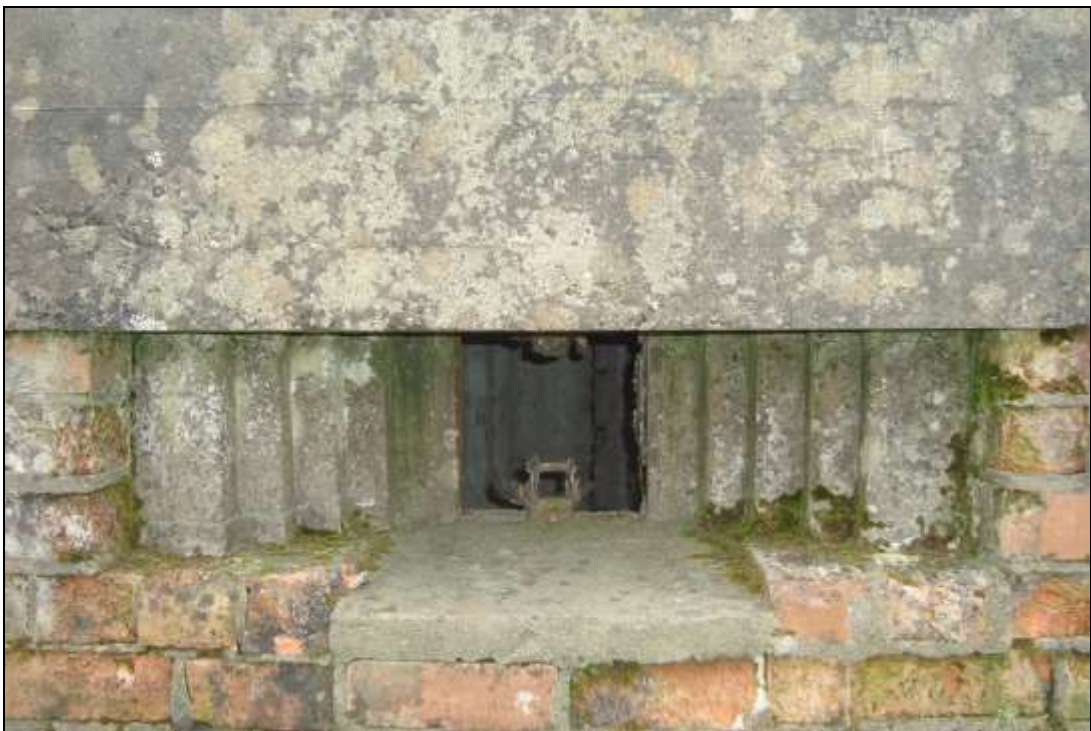
| <b>Condition</b> | Damaged |
| <b>Condition rating</b> | Fair |

*Plate 18: Type 22 pillbox. View to the east*

*Plate 19: View of the Turnbull mount frame within the northern most loophole*

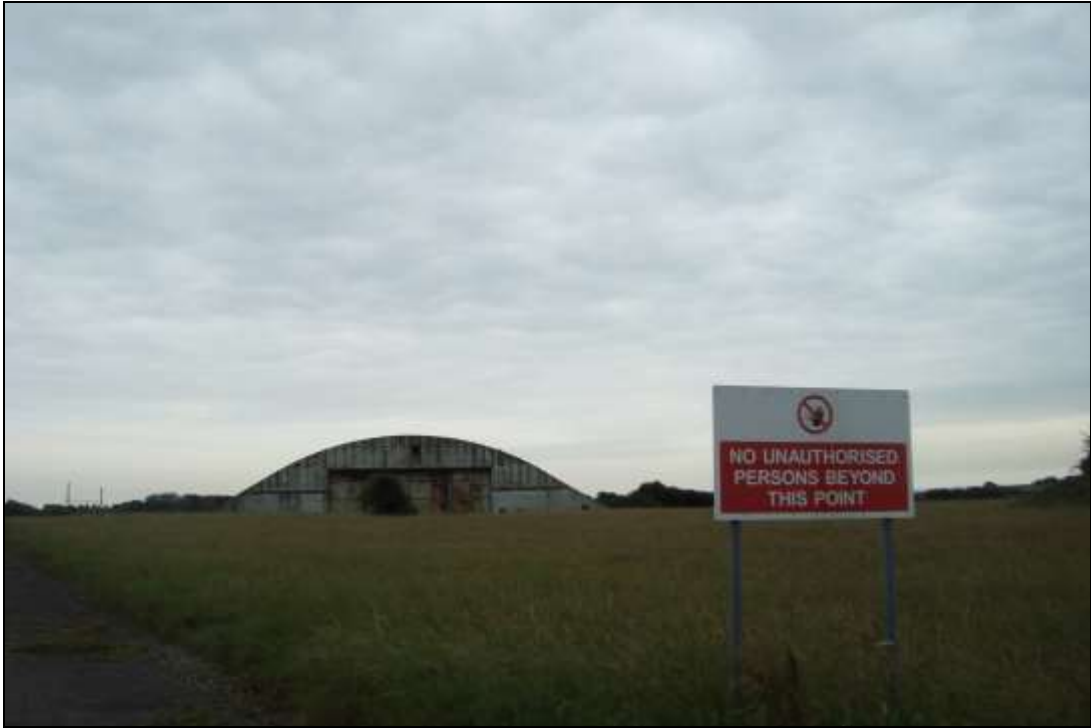
| <b>Description</b> | This curved military aircraft hangar produced in 1939 is to be found mainly at Storage and Maintenance units. The 'L' shed (Drawing No. 5163/39 & 10755/39) is a steel frame structure, which is then clad with steel sheeting and reinforced concrete and typically covered with a thin layer of concrete, earth and turf. Access to this site was not possible and therefore the condition is unknown. |

*Plate 20: 'L' type hangar 40. View to the south*

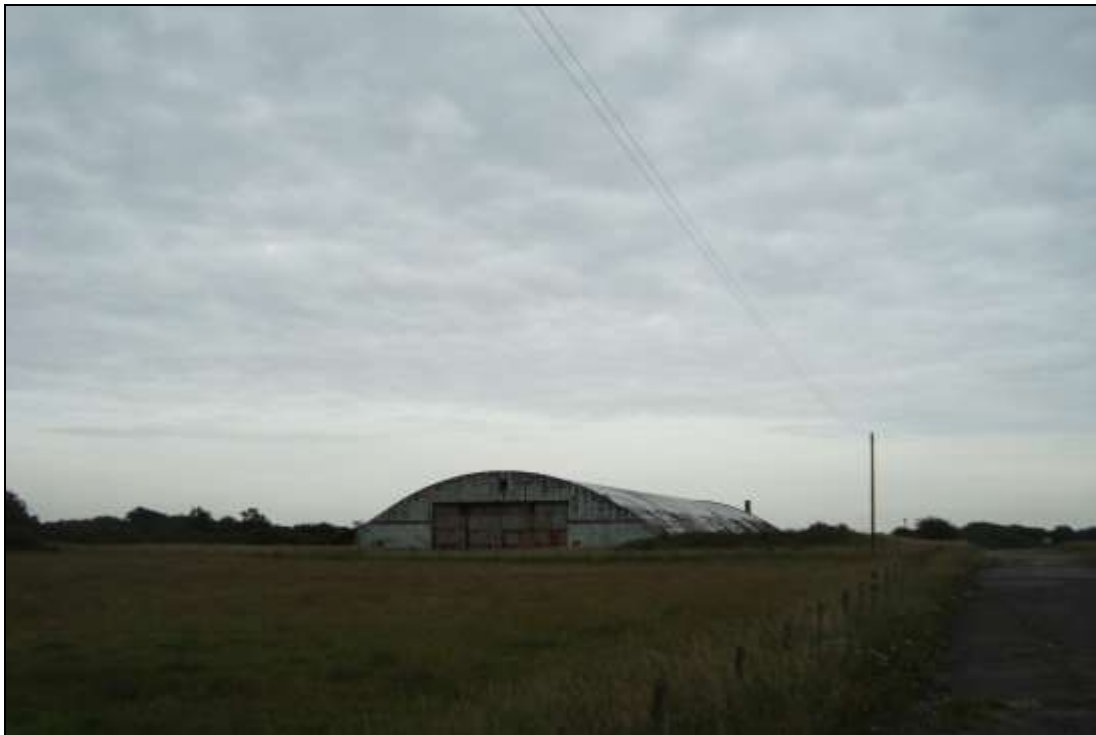
| <b>Description</b> | This curved military aircraft hangar produced in 1939 is to be found mainly at Storage and Maintenance units. The 'L' shed (Drawing No. 5163/39 & 10755/39) is a steel frame structure, which is then clad with steel sheeting and reinforced concrete and typically covered with a thin layer of concrete, earth and turf. Access to this site was not possible and therefore the condition is unknown. |

*Plate 21: 'L' type hangar 31. View to the south*

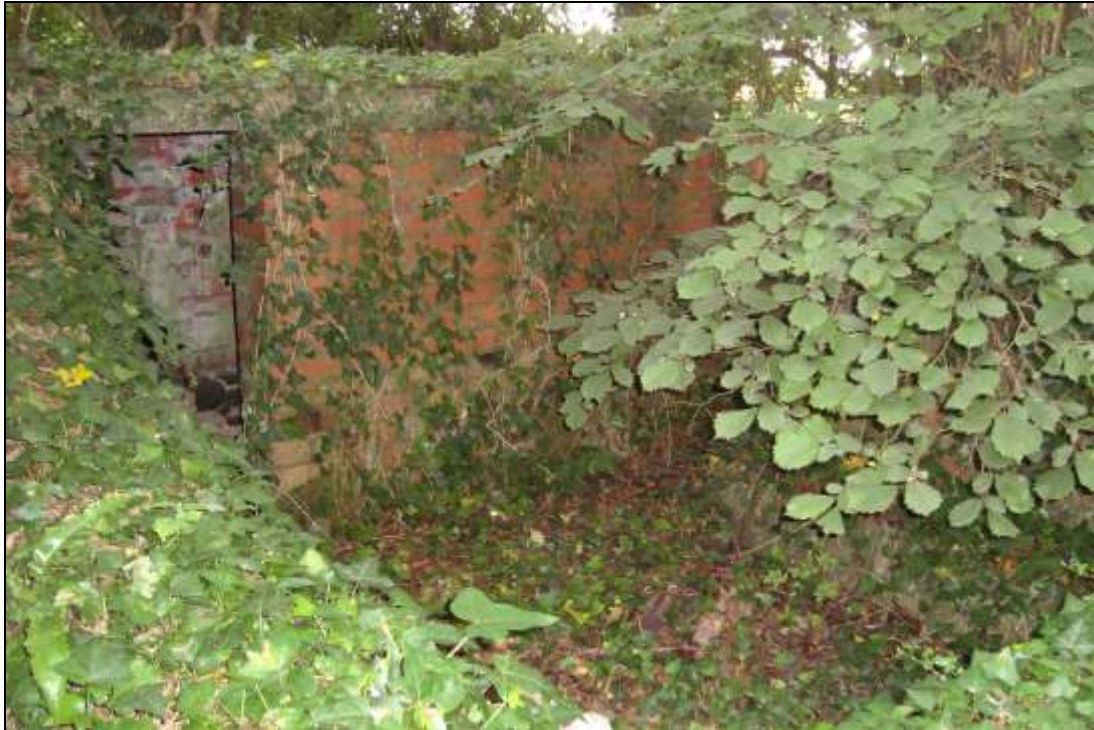
| <b>Description</b> | The brick remains of a Firewatchers hut with flat cast concrete roof. This building housed personnel whose job it was to keep a look out for small fires, such as burning enemy incendiaries, from various locations around the sub-site. |
| <b>Condition</b> | Damaged |
| <b>Condition rating</b> | Poor |

*Plate 23: Remains of a Firewatchers hut*

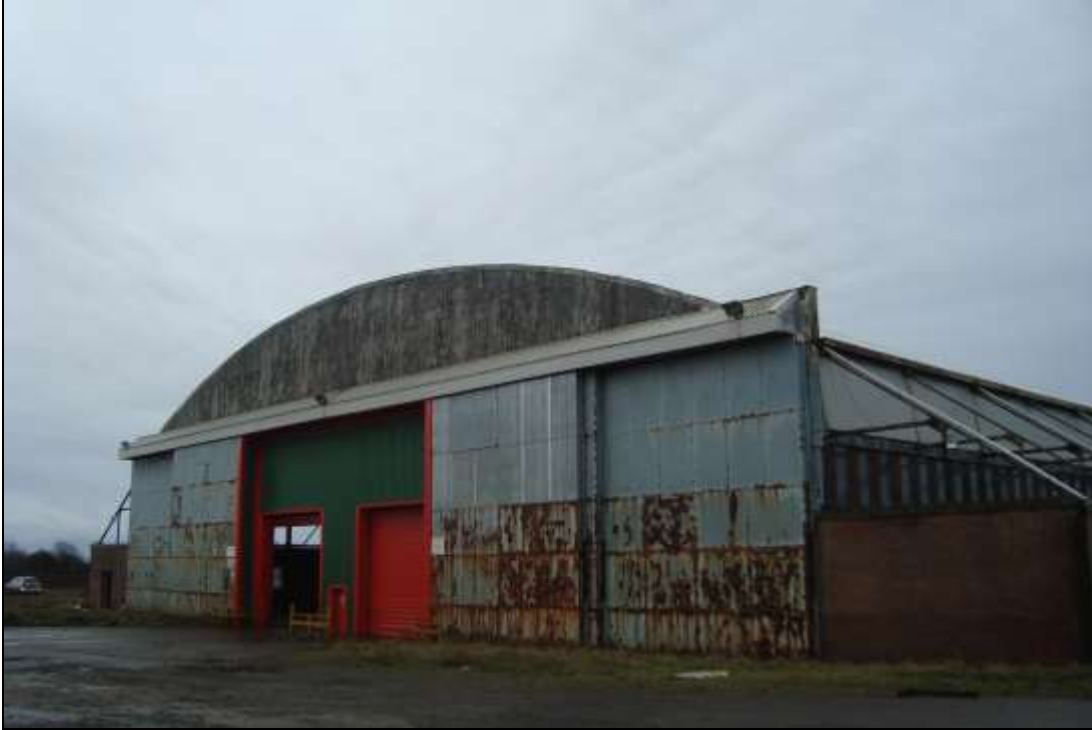
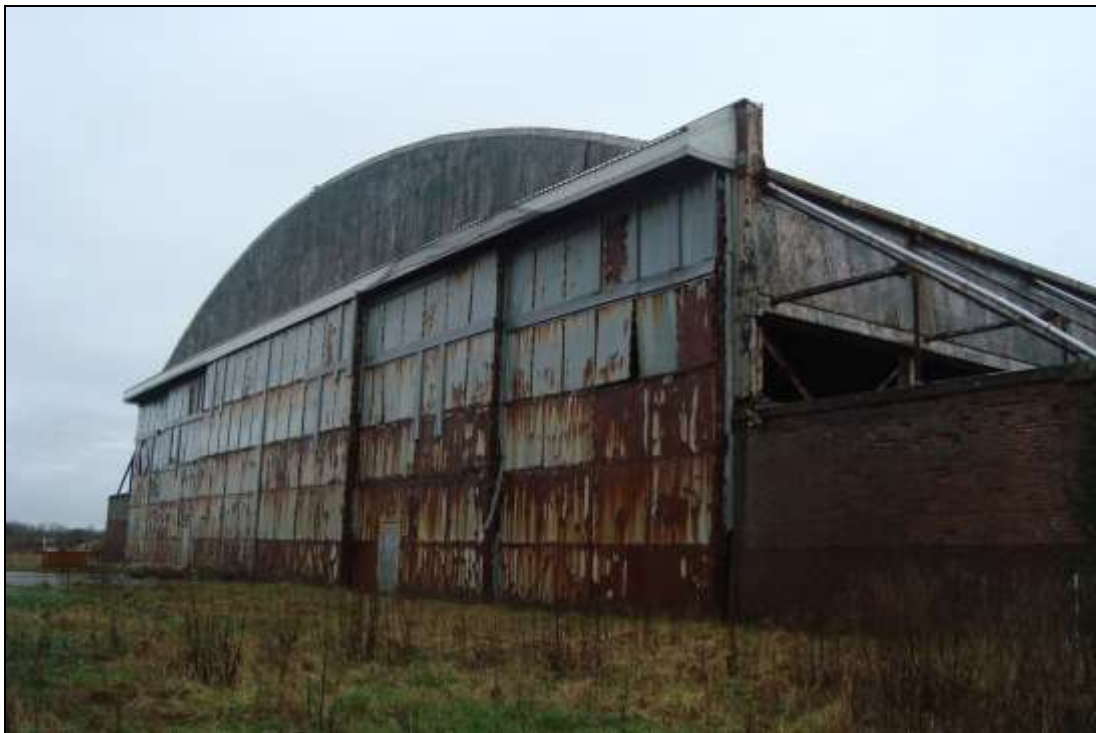
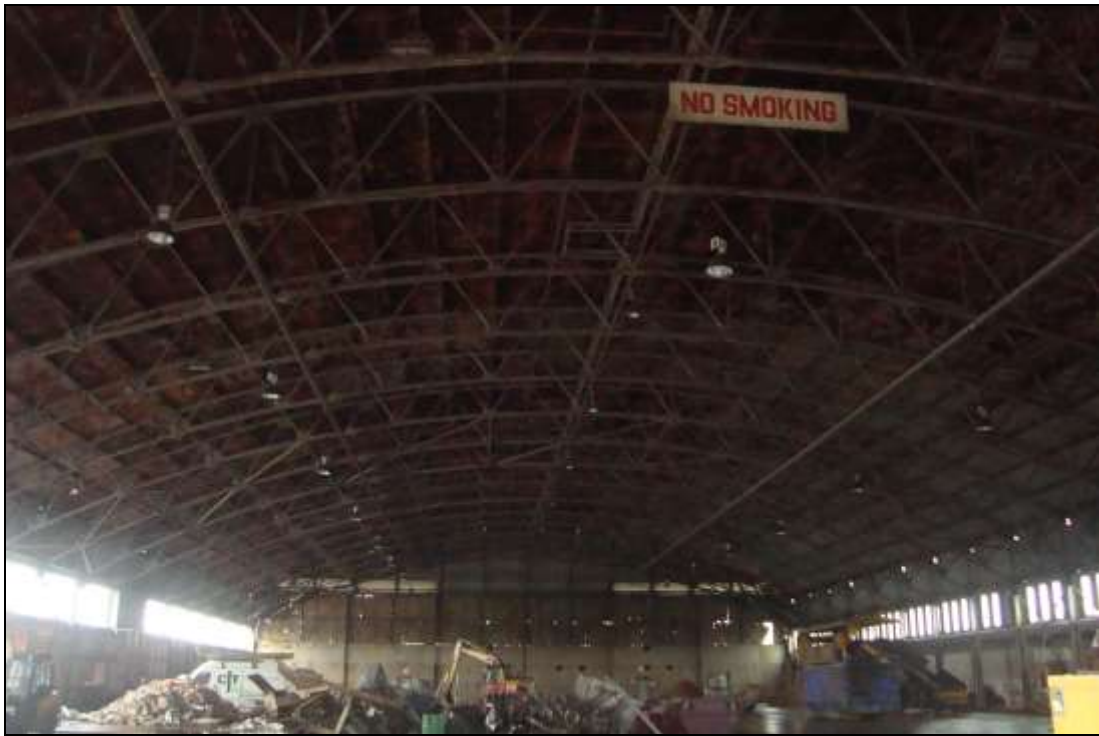
| <b>Condition</b> | Damaged |
| <b>Condition rating</b> | Poor |

*Plate 24: Front elevation of hangar 50. Note the addition of the new door portals*

*Plate 25: Rear elevation of the hangar*

*Plate 26: The internal curved steel framed superstructure is still intact*

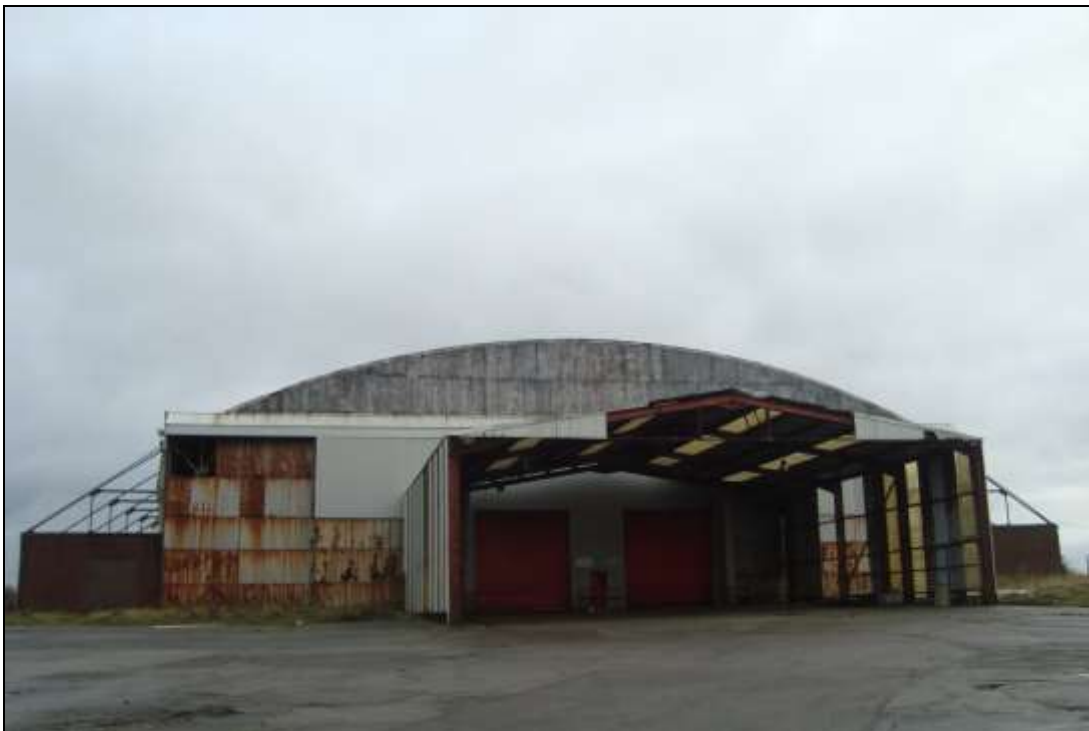
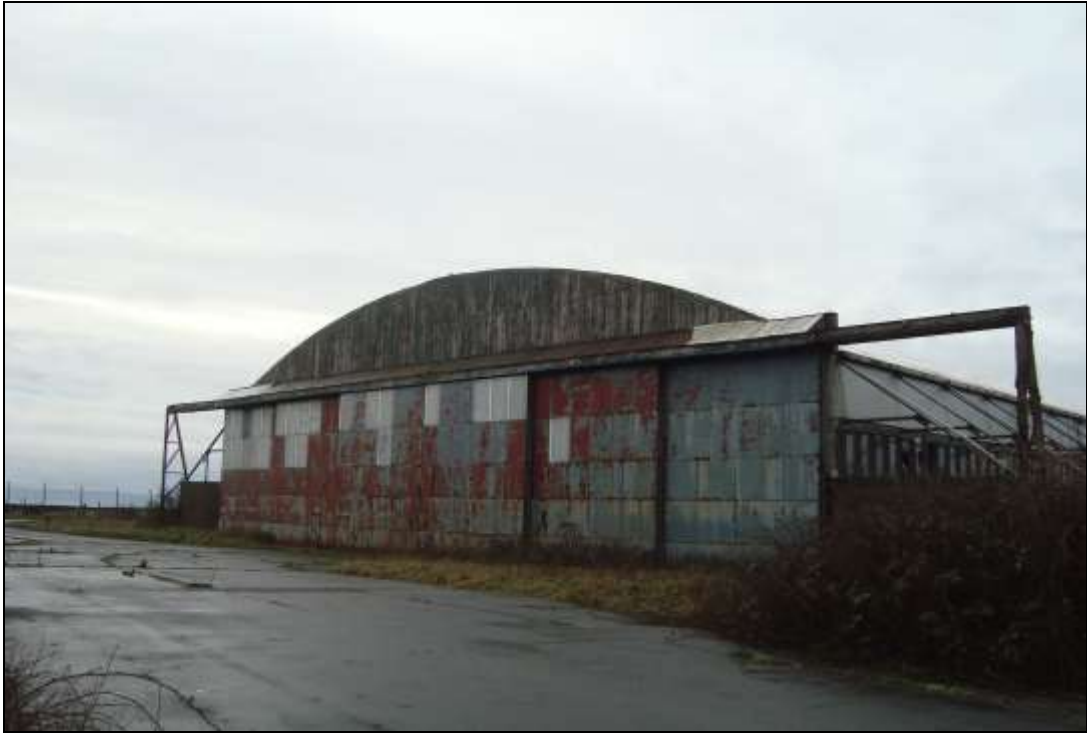
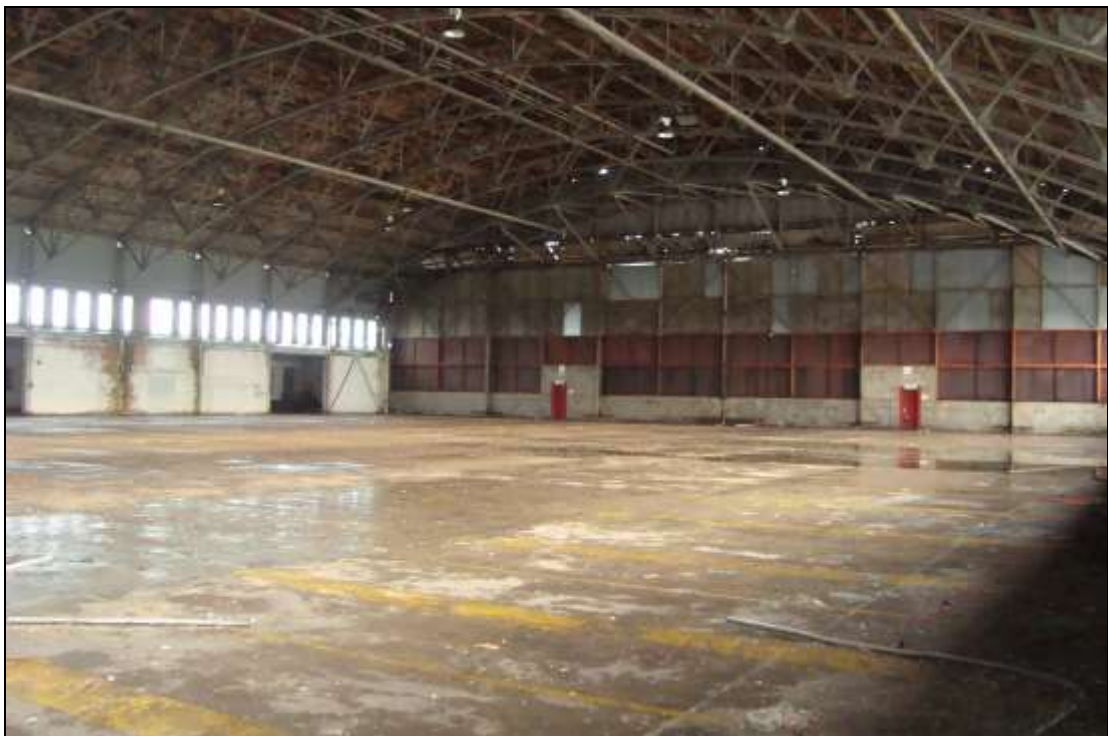
| <b>Condition</b> | Damaged |
| <b>Condition rating</b> | Fair |

*Plate 28: Prefabricated extension to the west facing elevation of hangar 51*

*Plate 29: East facing elevation of the hangar with the external outriggers in place*

*Plate 30: Interior of the hangar. View to the east*

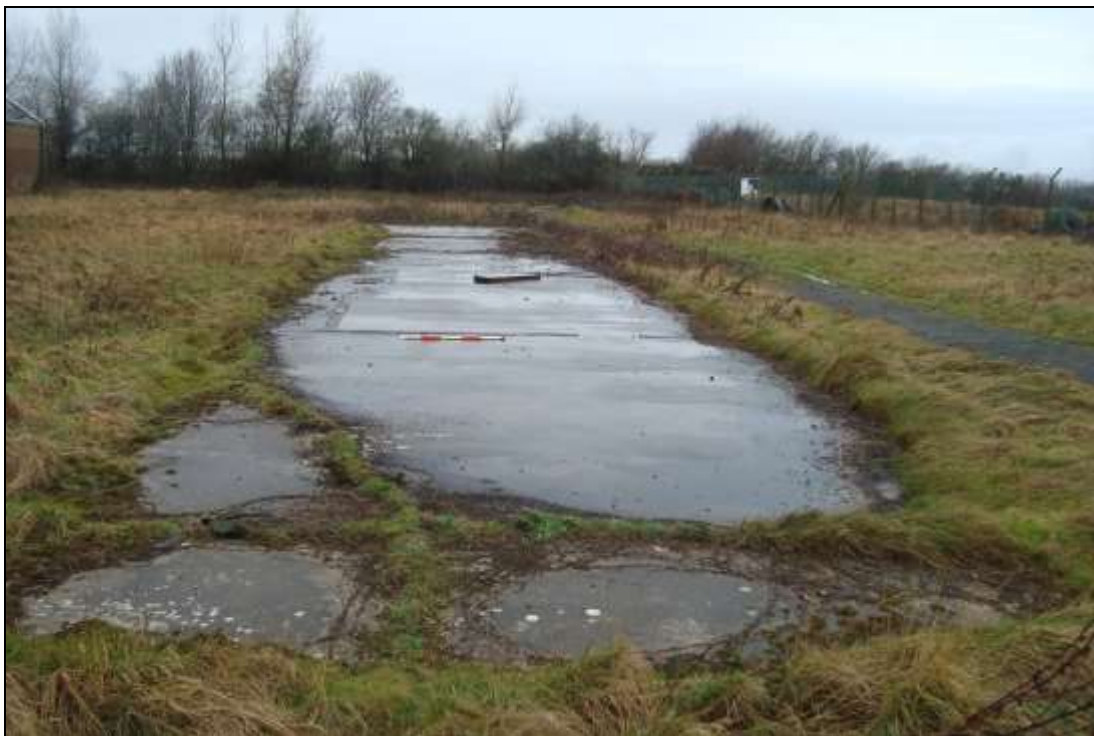
| <b>Condition</b> | Near-destroyed |
| <b>Condition rating</b> | Destroyed |

*Plate 31: Linear concrete platform is all that remains of the Flight Office*

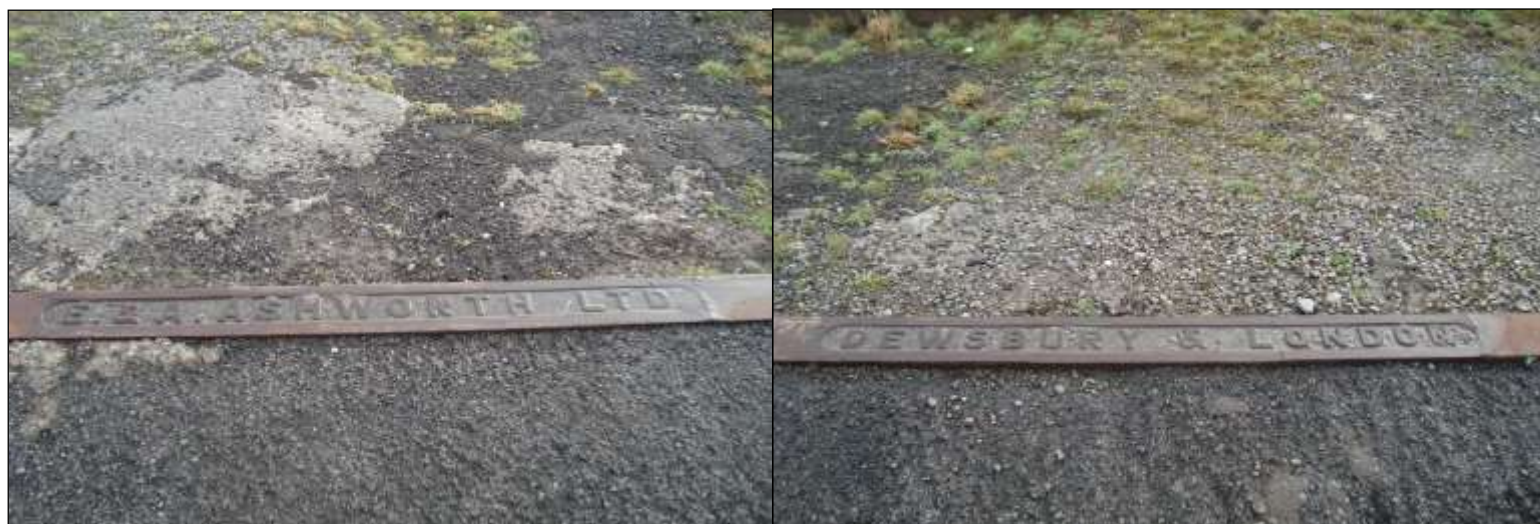
*Plate 34: Etched makers name around the cast iron weighing plate frame*
