# GGAT 112: Second World War Military Airfields of South Wales

RAF Llandow

A report for Cadw  
by Paul W Huckfield BA

GGAT report no. 2012/032  
Project no. GGAT 112  
National Grid Reference:  
SS95950 71770

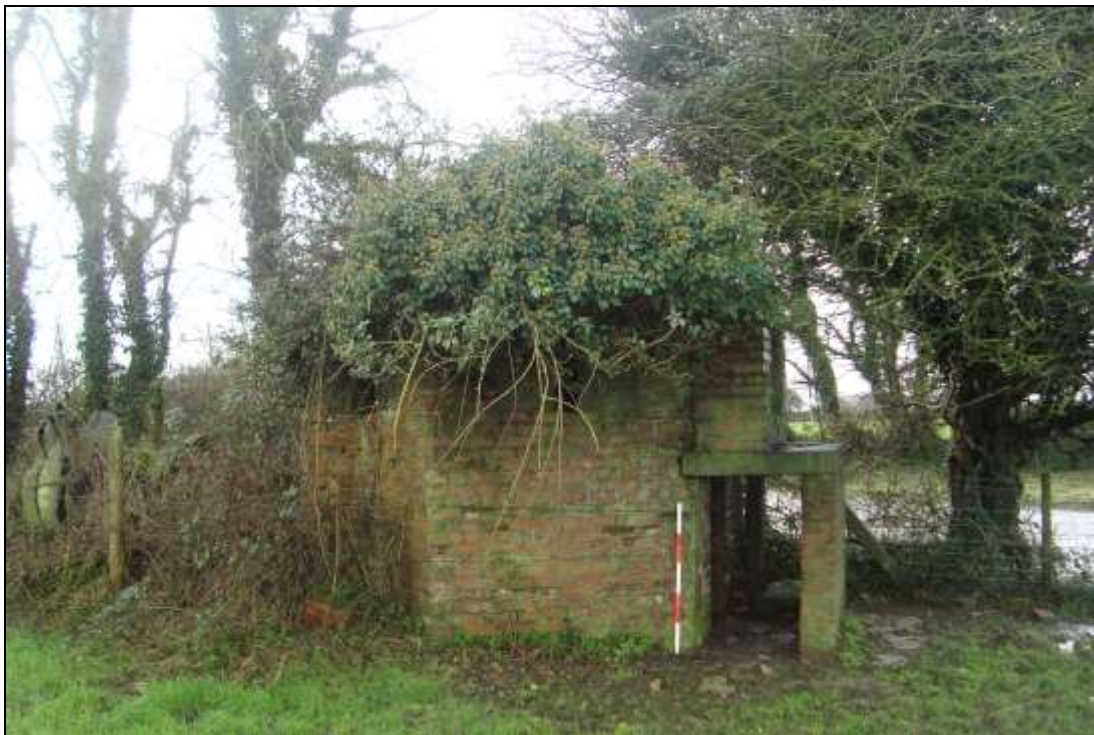
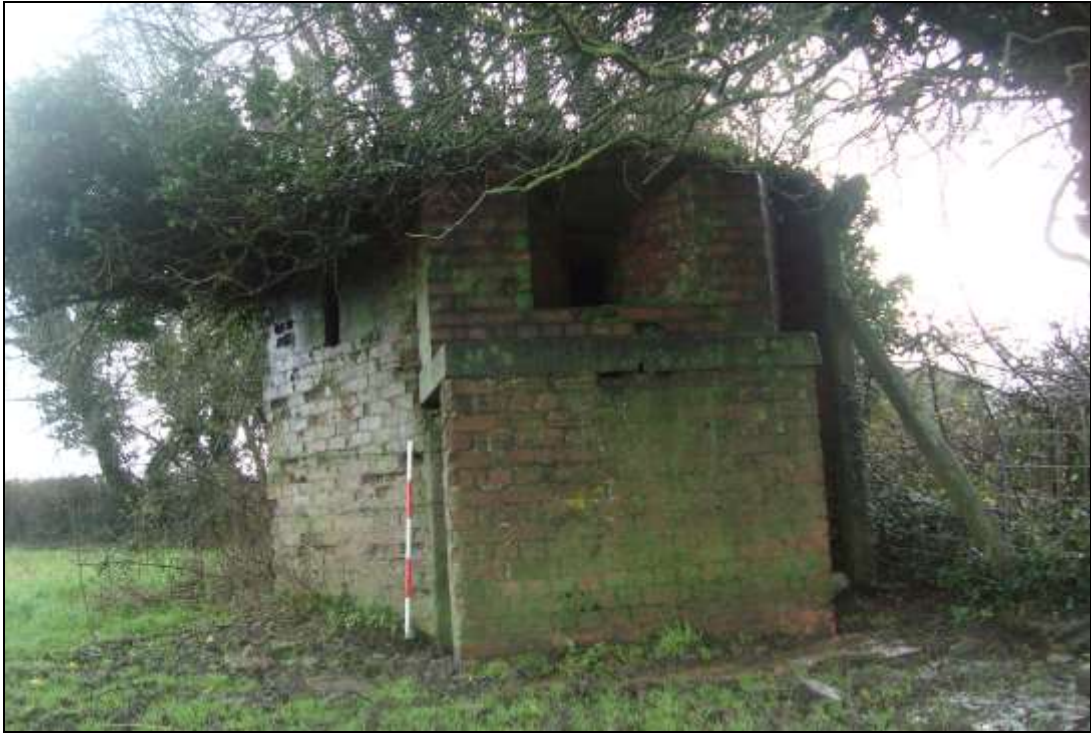
| <b>Condition</b> | Damaged |
| <b>Condition rating</b> | Poor |

*Plate 35: Type 22 (Variant) Pillbox (north facing elevation)*

*Plate 36: View of the extension, with loophole, above the blast wall (west facing elevation)*

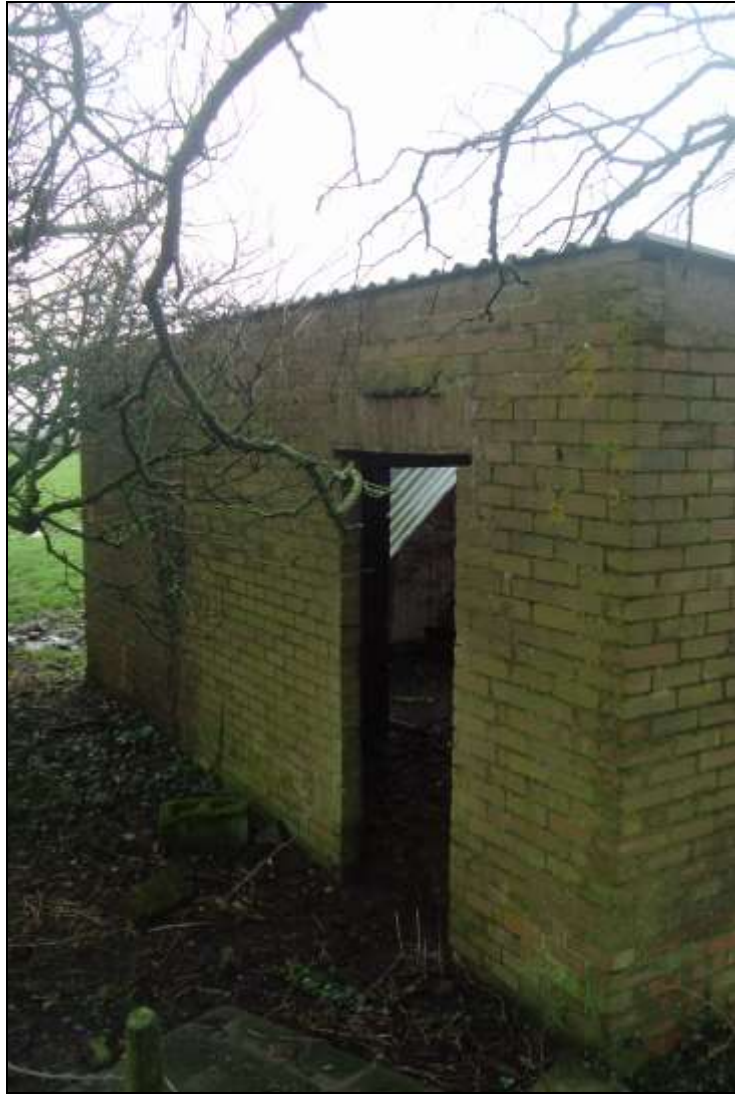
| <b>Description</b> | <p>Rectangular brick built structure with sloped roof divided into two rooms. The windows have been in-filled, though one of the original frames has been stored within one of the rooms.</p> <p>This structure is all that remains of a series of buildings that housed personnel whose job it was to keep a look out for small fires, such as burning enemy incendiaries, from various locations around the sub-site.</p> |
| <b>Condition</b> | Near Destroyed |
| <b>Condition rating</b> | Poor |

*Plate 39: Fire Watchers Hut. View to the southwest*

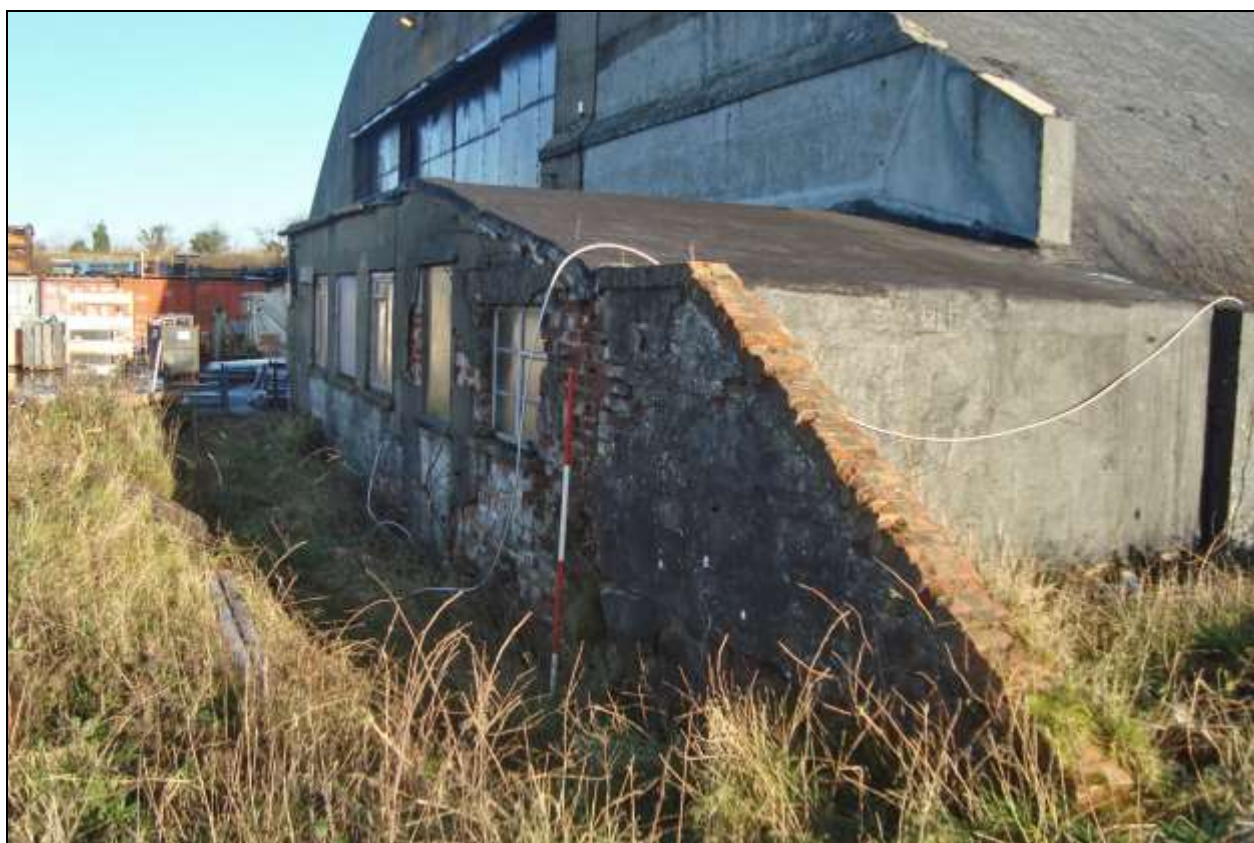
| <b>Description</b> | <p>Curved military aircraft hangar produced in 1939 is to be found mainly at Storage and Maintenance units. The 'L' shed (Drawing No. 5163/39 &amp; 10755/39) is a steel frame structure, which is then clad with steel sheeting and reinforced concrete and typically covered with a thin layer of concrete, earth and turf.</p> <p>The external and internal structure of the hangar has seen very little change. The eastern frontal annex building (this housed the boiler and was topped with a chimney stack) has been removed, however, the western, though losing some of the concrete render exposing the brickwork beneath, still survives in a good condition, retaining its original windows, doors, air bricks, external light switch casings and end brick revetment. The internal space all survives in equally good condition.</p> |
| <b>Condition</b> | Near Intact |

*Plate 44: Western office annexe with brick revetment*

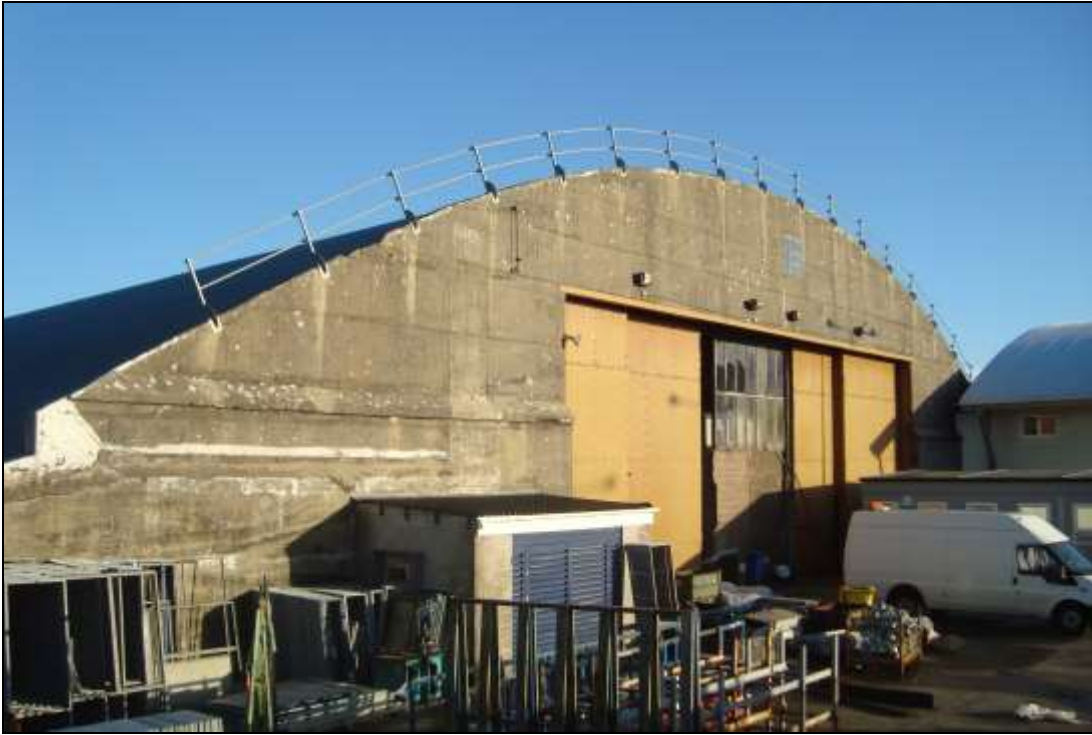
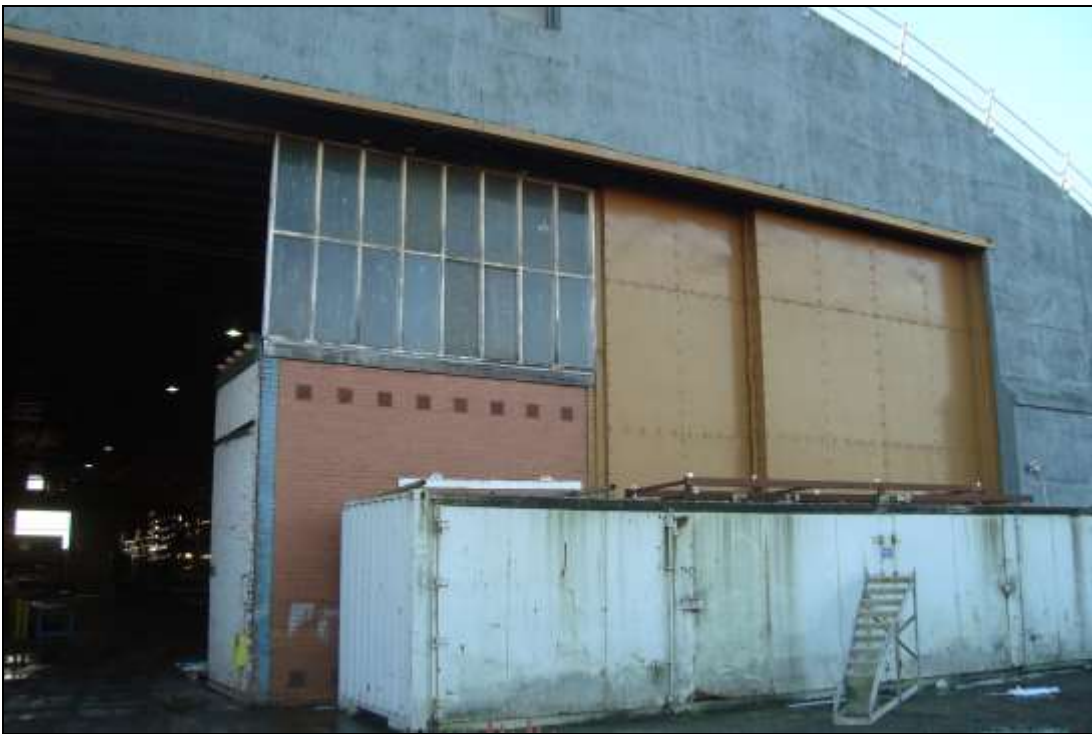
| <b>Description</b> | <p>This curved military aircraft hangar produced in 1939 is to be found mainly at Storage and Maintenance units. The 'L' shed (Drawing No. 5163/39 &amp; 10755/39) is a steel frame structure, which is then clad with steel sheeting and reinforced concrete and typically covered with a thin layer of concrete, earth and turf.</p> <p>The hangar has undergone some alteration; a central brick structure with internal staircase and upper set of windows has been included between the two front and rear hangar doors. At the front of the building both the two frontal annex buildings have been demolished, the chimney stack that stood on top of the northern can still be seen as a silhouette against the side of the hangar, while a portacabin type office and additional new build, that tastefully replicates the curved outline of the hangar, have replaced the southern.</p> |
| <b>Condition</b> | Near Intact |

*Plate 45: Front elevation of hangar 60. View to the southeast*

*Plate 46: Rear elevation; note the addition of the central brick feature and upper set of windows to the hangar*

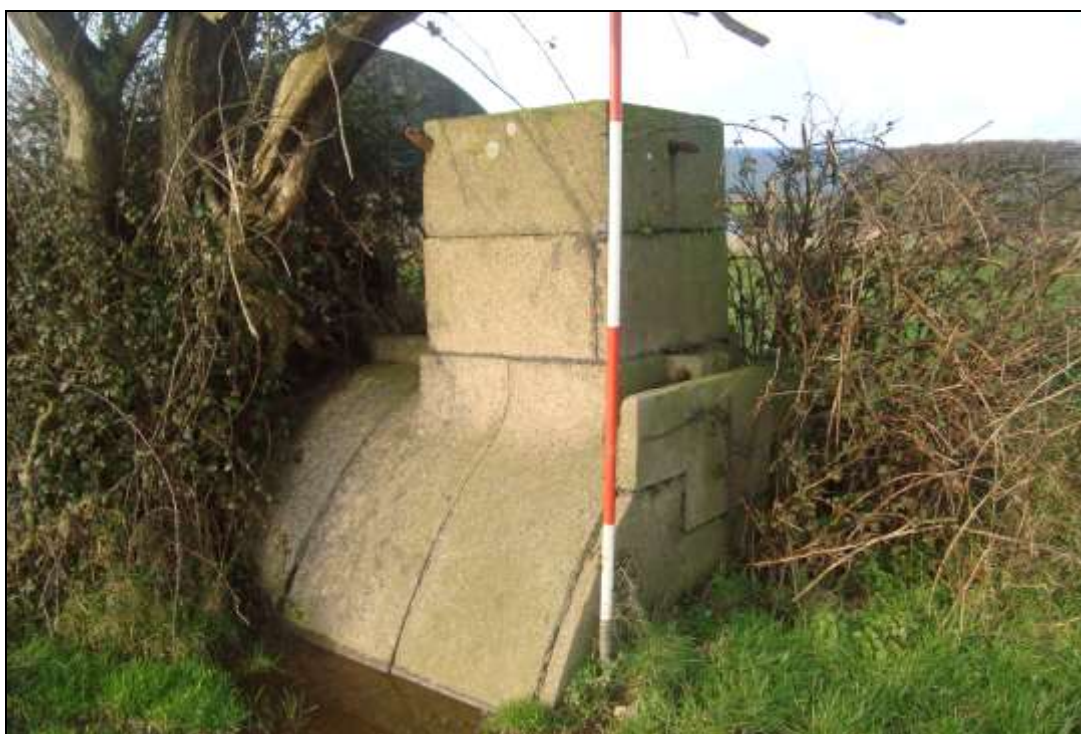
| <b>Condition</b> | Near Intact |
| <b>Condition rating</b> | Fair |

*Plate 48: The exposed emergency exit at the eastern end of the shelter*

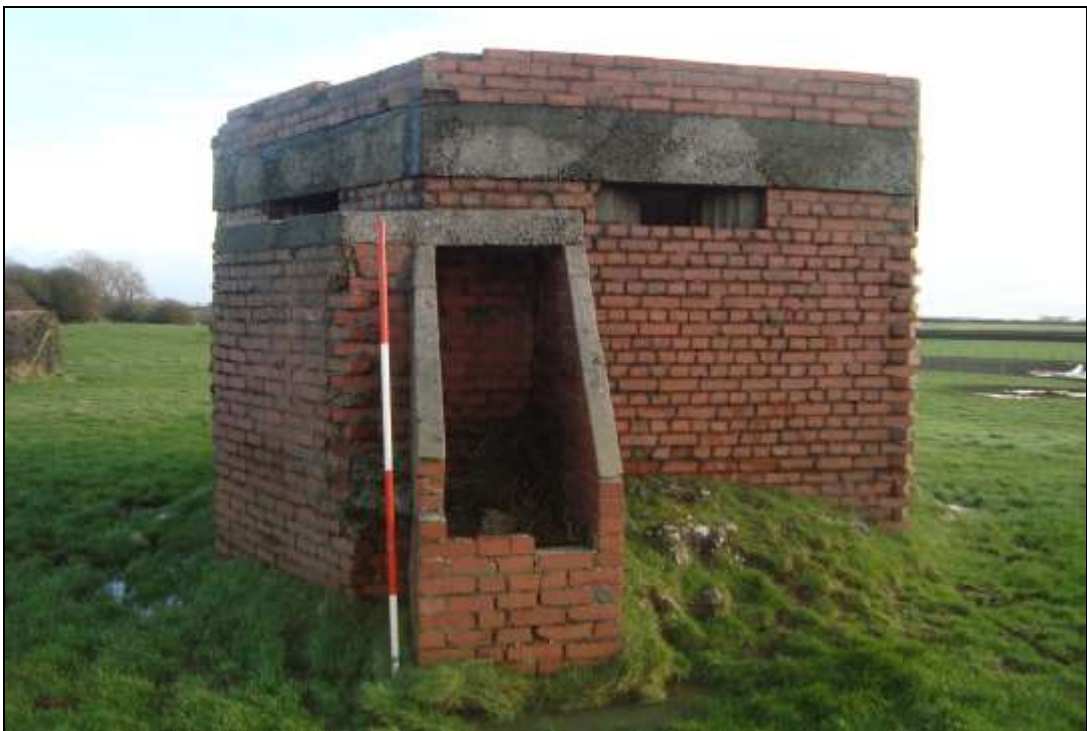
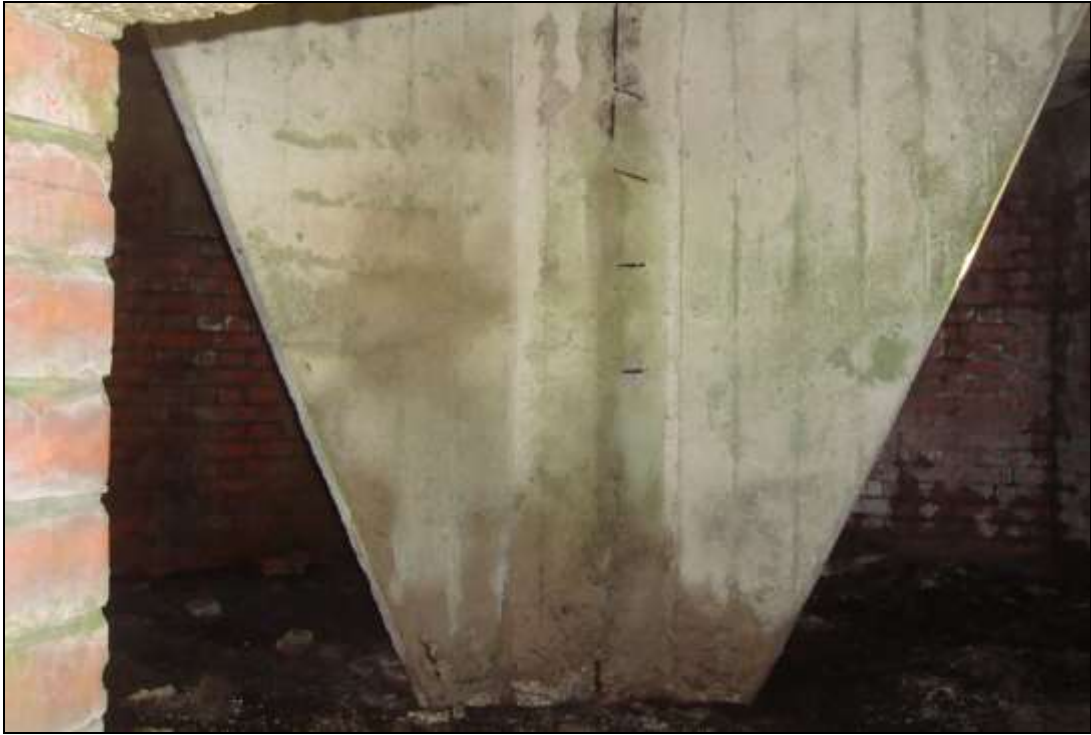
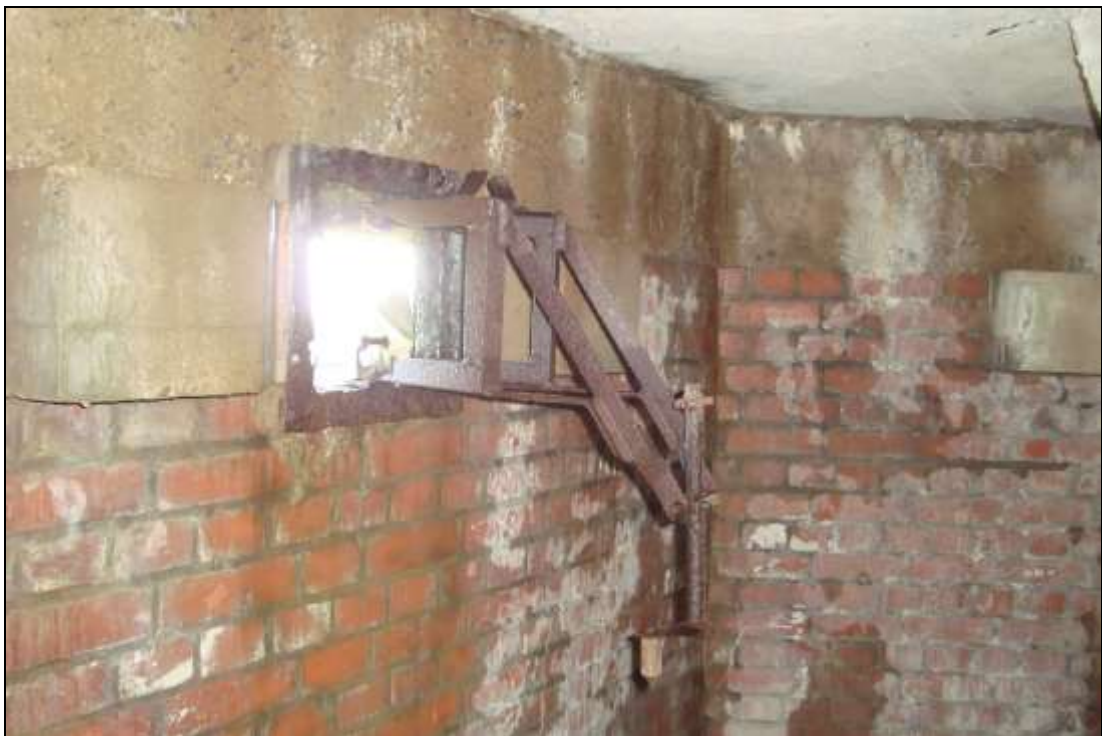
| <b>Condition</b> | Damaged |
| <b>Condition rating</b> | Fair |

*Plate 51: West facing elevation. Note the height of the reinforced entrance.*

*Plate 52: The internal 'Y' shaped anti-ricochet wall*

*Plate 53: Turnbull mount. Note the wooden handle on the elevation screw still in place.*

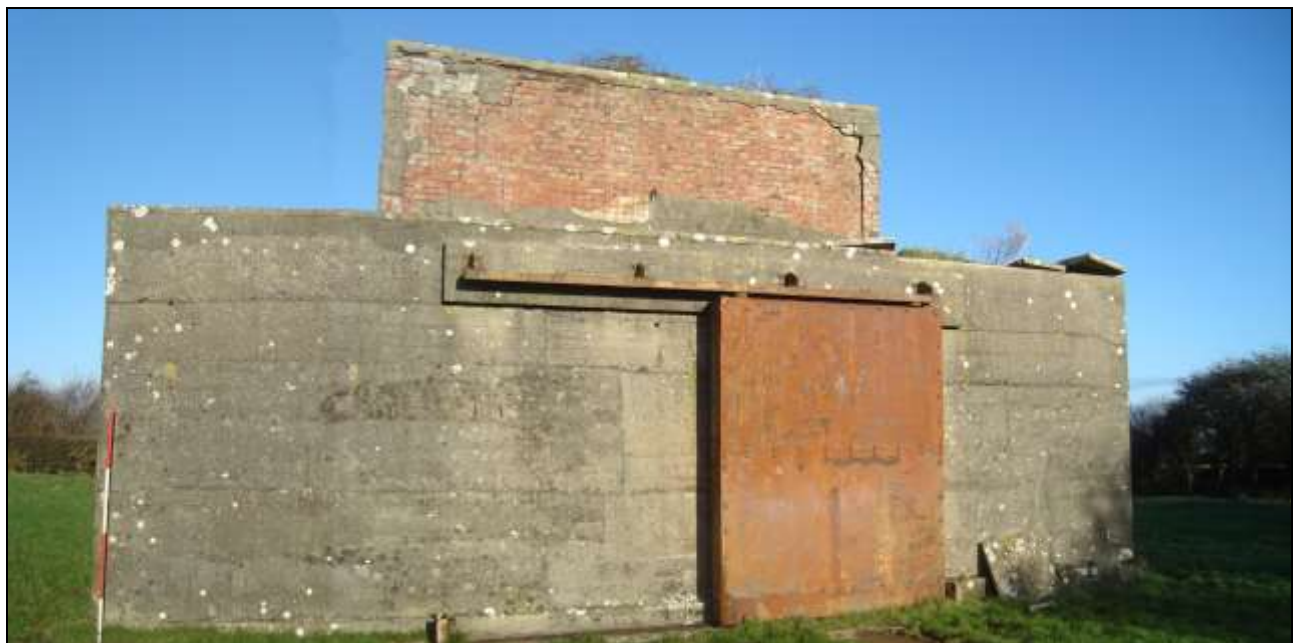
| <b>Description</b> | <p>Substantial rectangular Standby generator house (drawing No. 10599/38) is enclosed in a thick precast concrete blast wall. The building access is via a large cast-iron sliding door. The exterior of the building is in a good condition, with a small amount of damage to the roof and top of the blast wall caused by vegetation. Access to the interior could not be obtained.</p> <p>These specially designed buildings housed large diesel generators that drove large dynamos; these together were the 'set'. They were on standby to supply essential electrical services if the mains feed to the station were interrupted or broken.</p> |
| <b>Condition</b> | Near Intact |
| <b>Condition rating</b> | Good |

*Plate 56: West facing elevation of the Stand-by Set House*

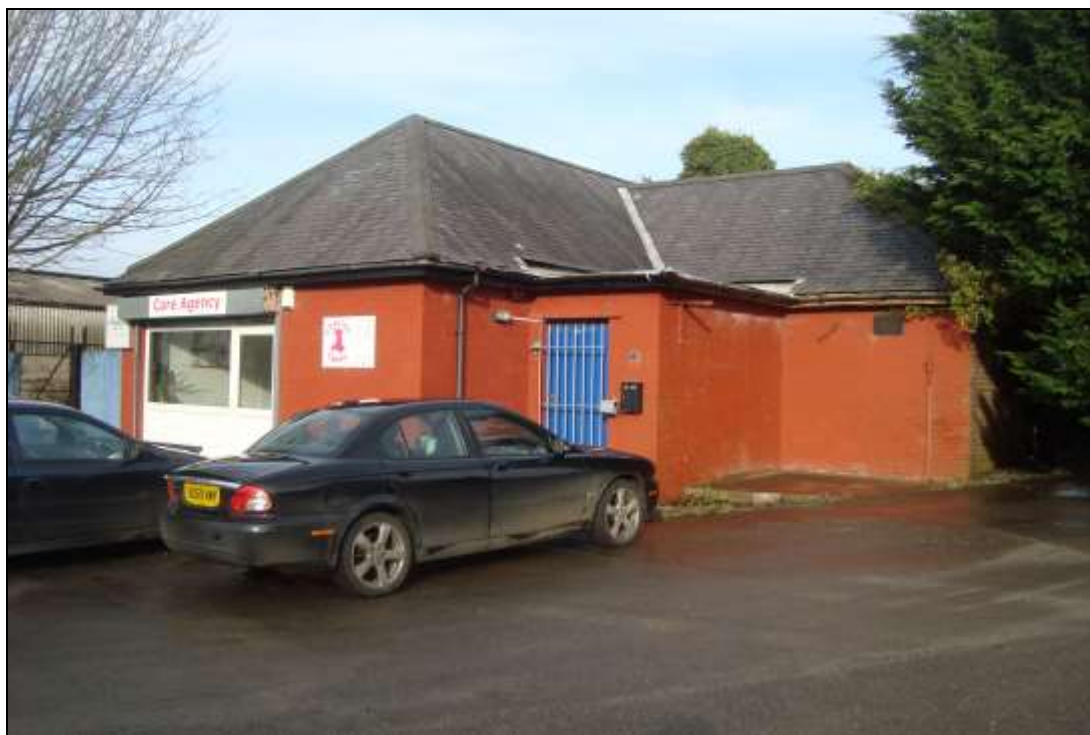
| <b>Condition</b> | Converted |
| <b>Condition rating</b> | Good |

*Plate 64: Front elevation of the Gas Decontamination Centre. View to the north*

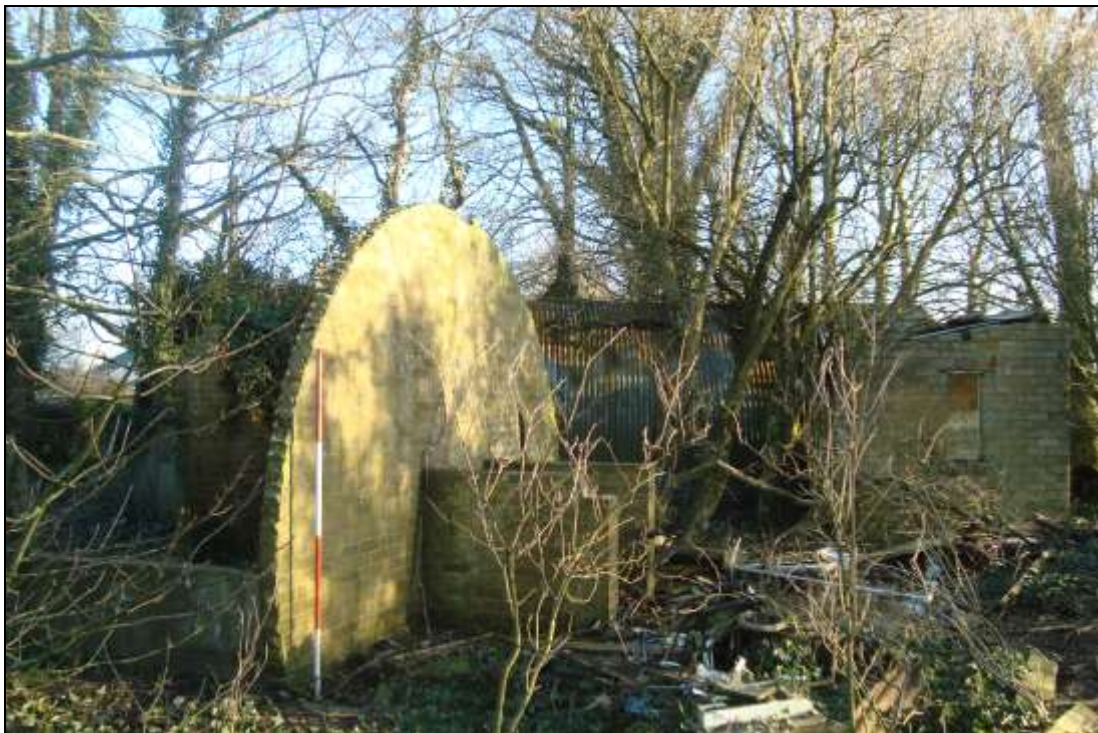
*Plate 84: Remains of one of the Turner curved asbestos hutting*

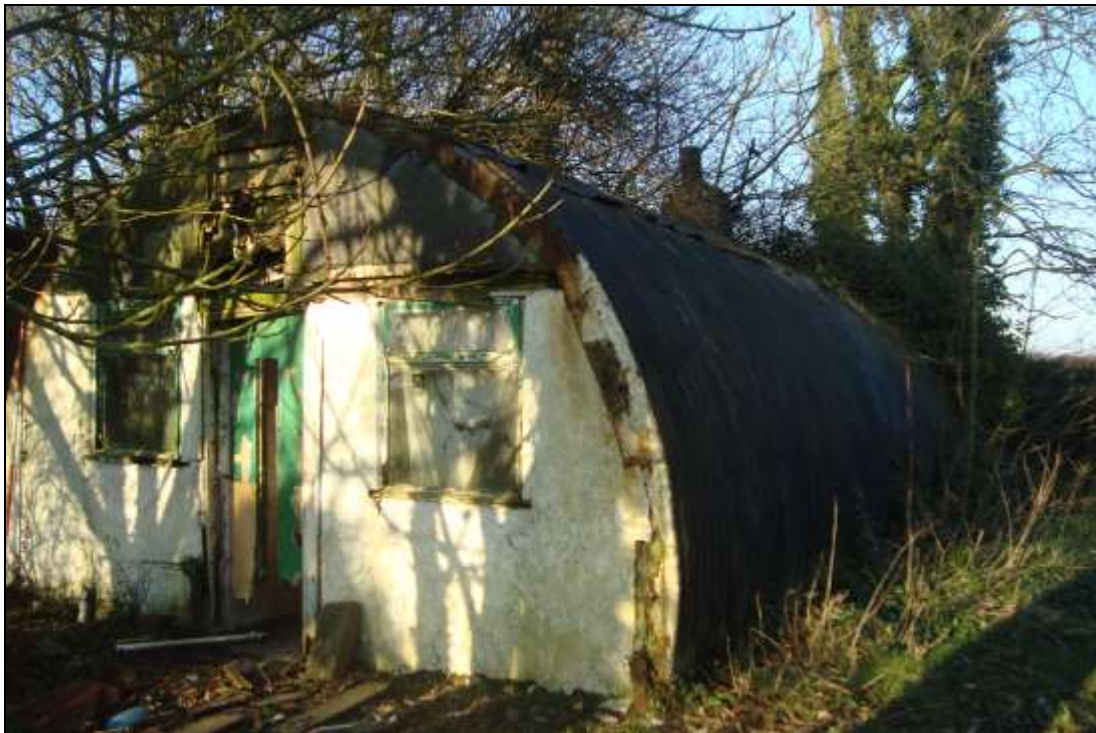
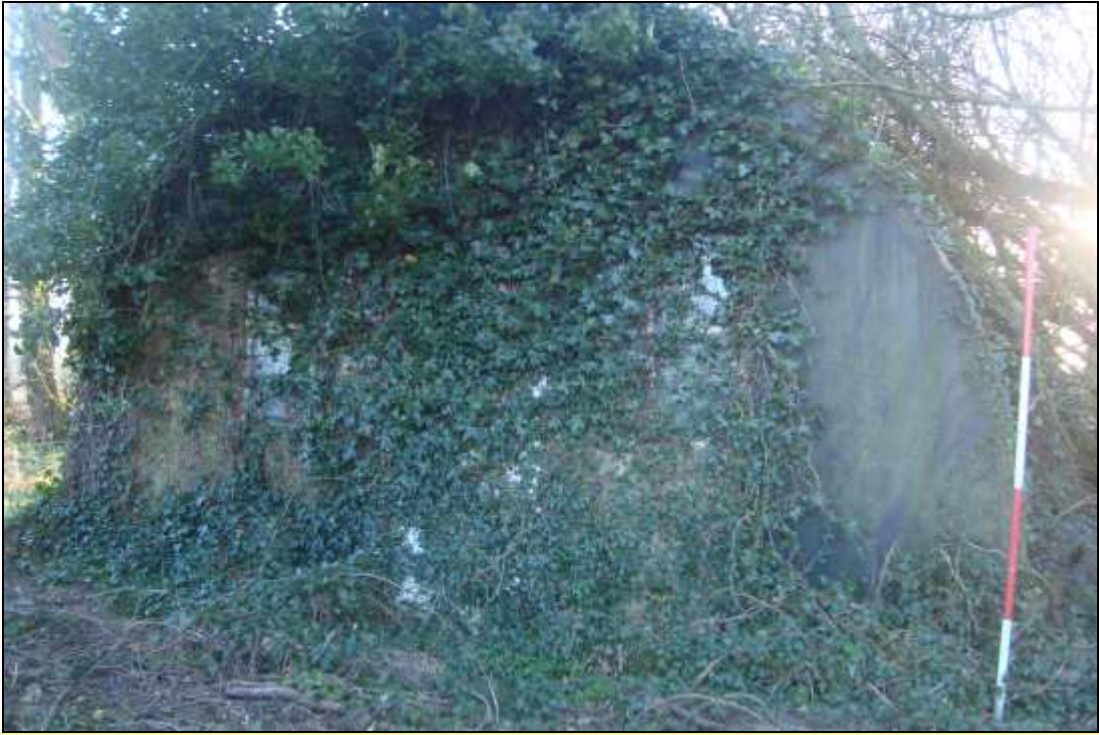
*Plate 86: Front elevation of the Turner type hut LD48*

*Plate 87: Rear of LD48*

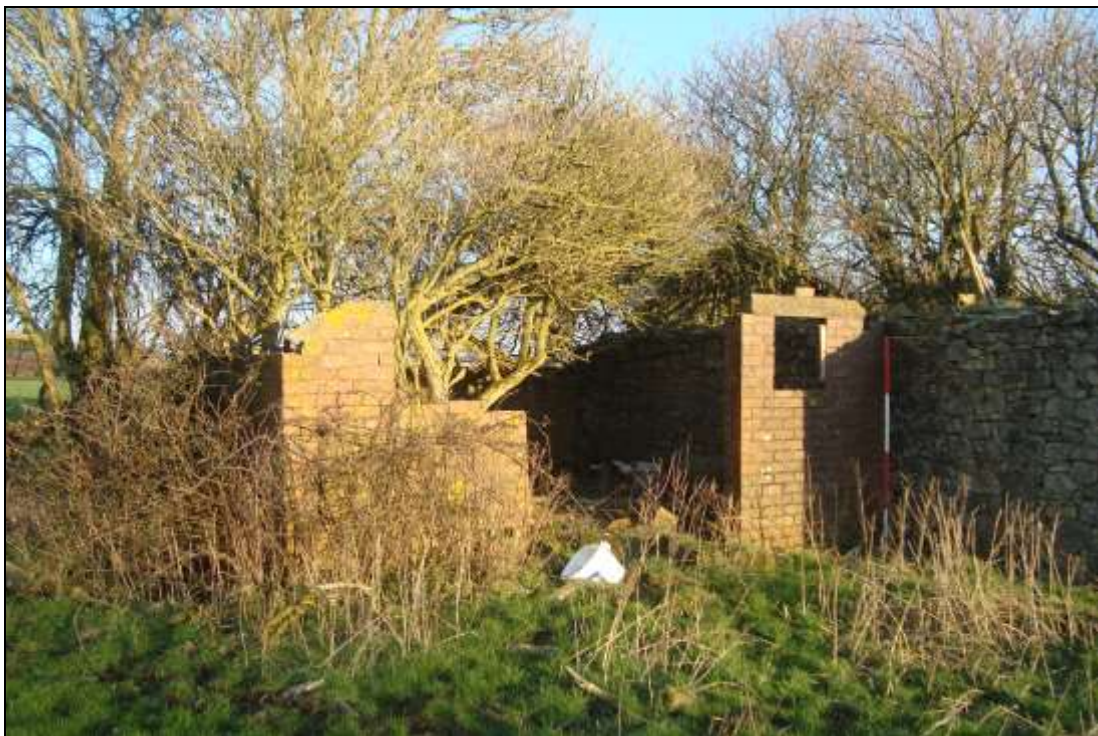
*Plate 88: Two upstanding brick walls are all that remains of this unknown structure.*

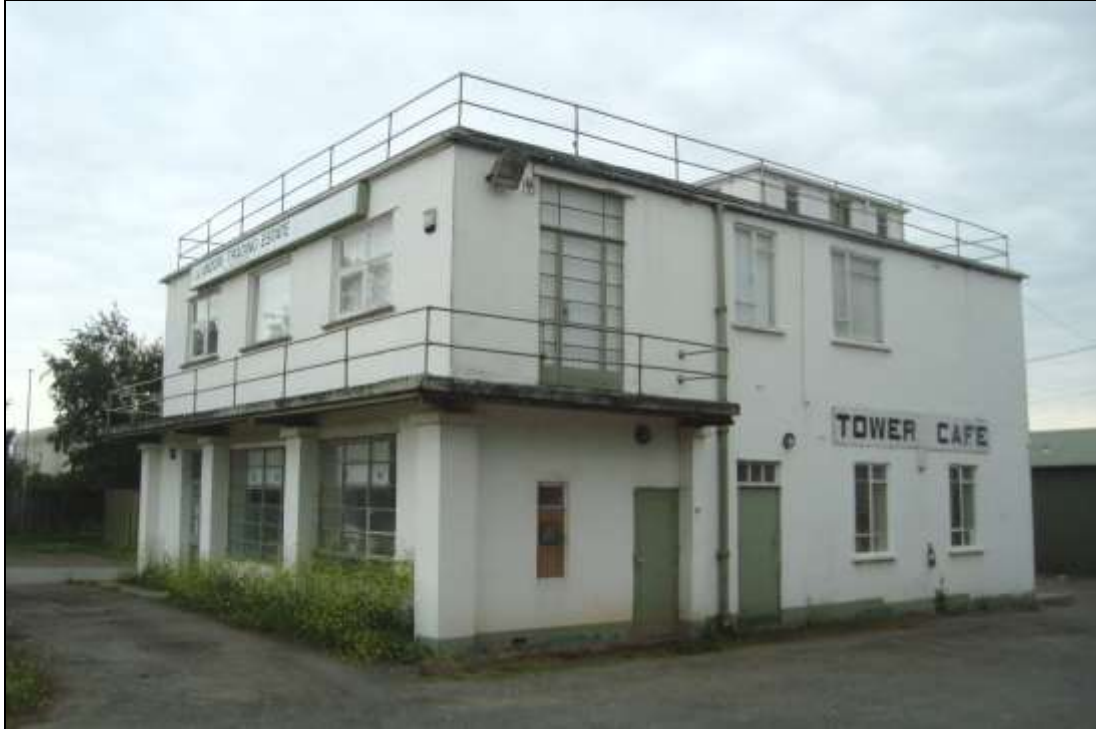
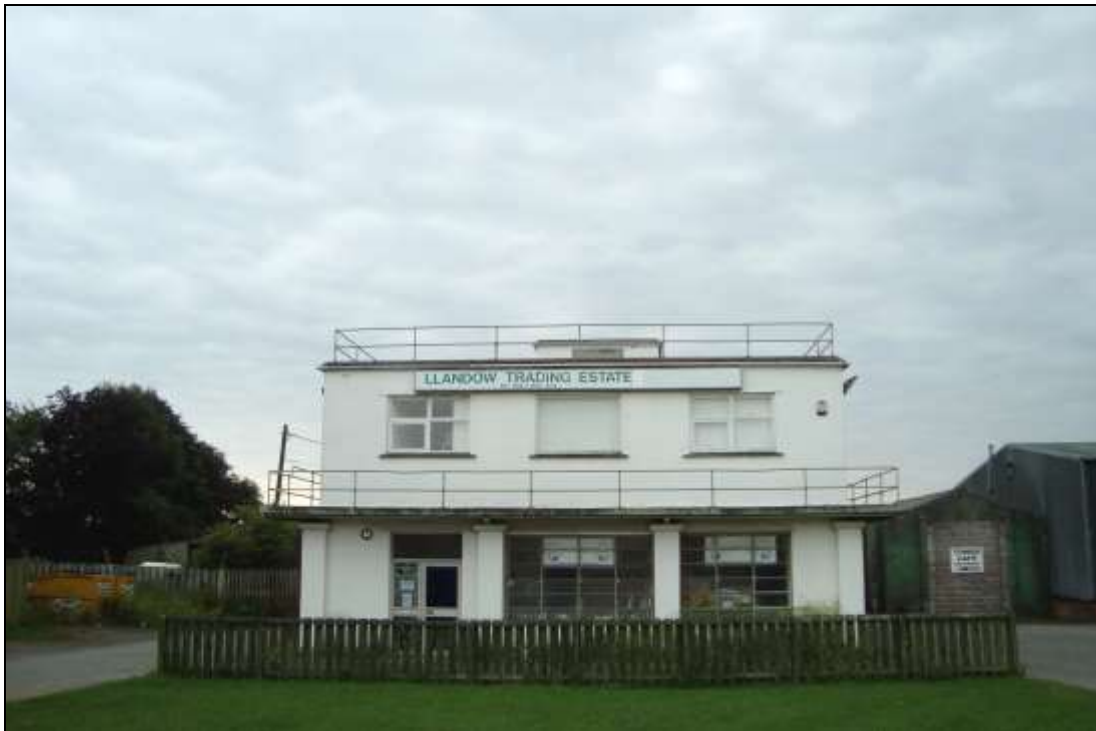
*Plate 90: Watch Office at RAF Llandow. View to the southwest*

*Plate 91; South elevation of the building*

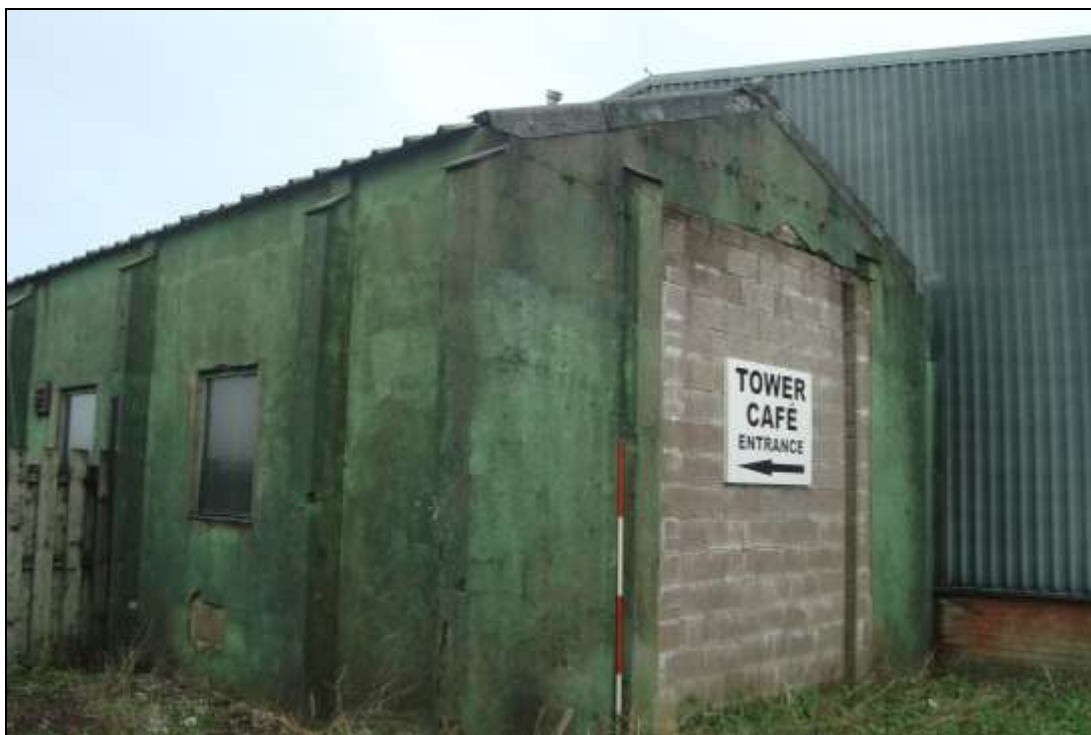
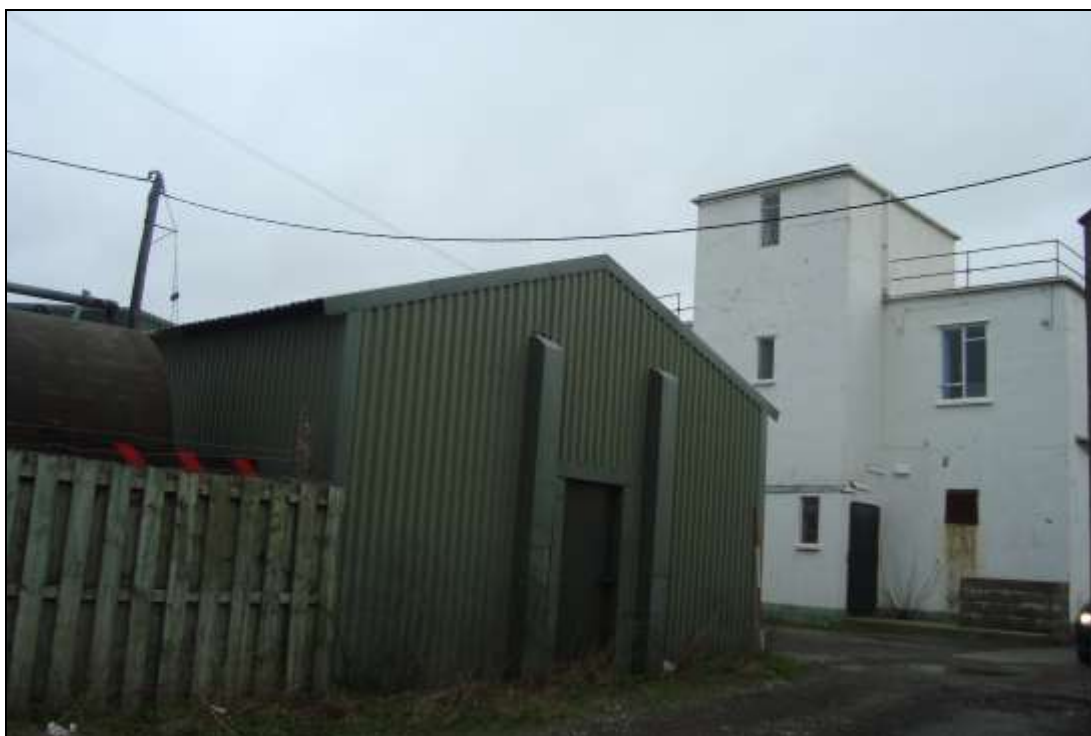
*Plate 92: The main entrance bay for the floodlight trailer shed. View to the west*

*Plate 93: The rear elevation of the building. View to the east.*

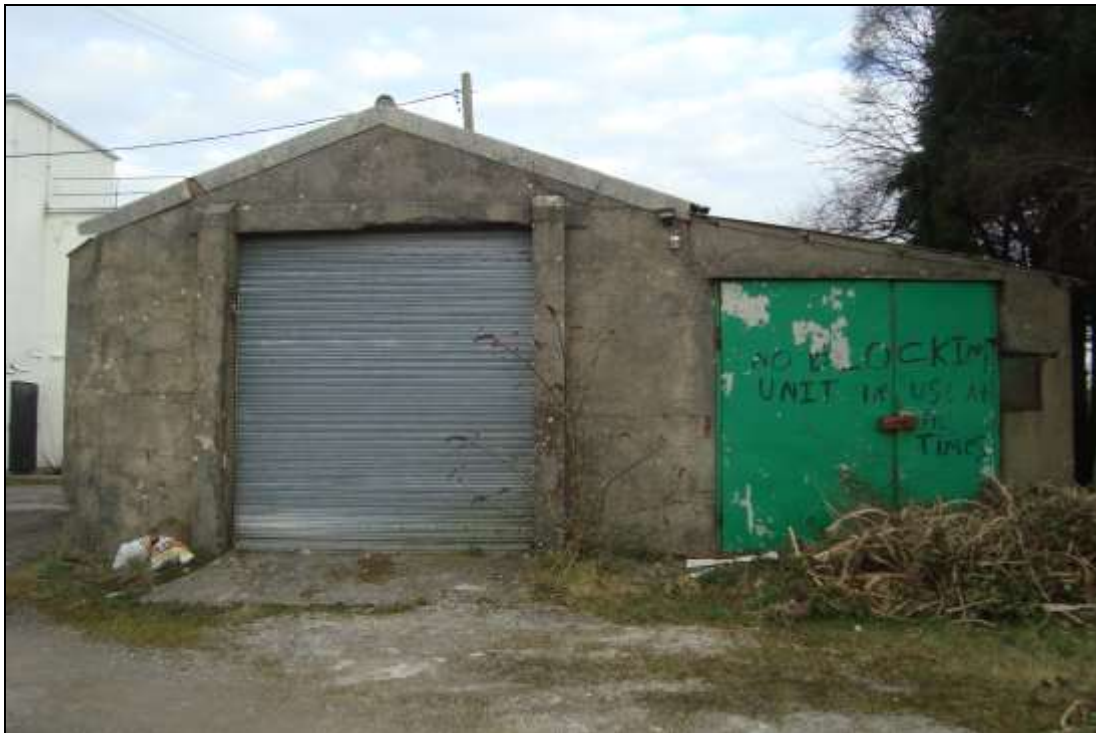
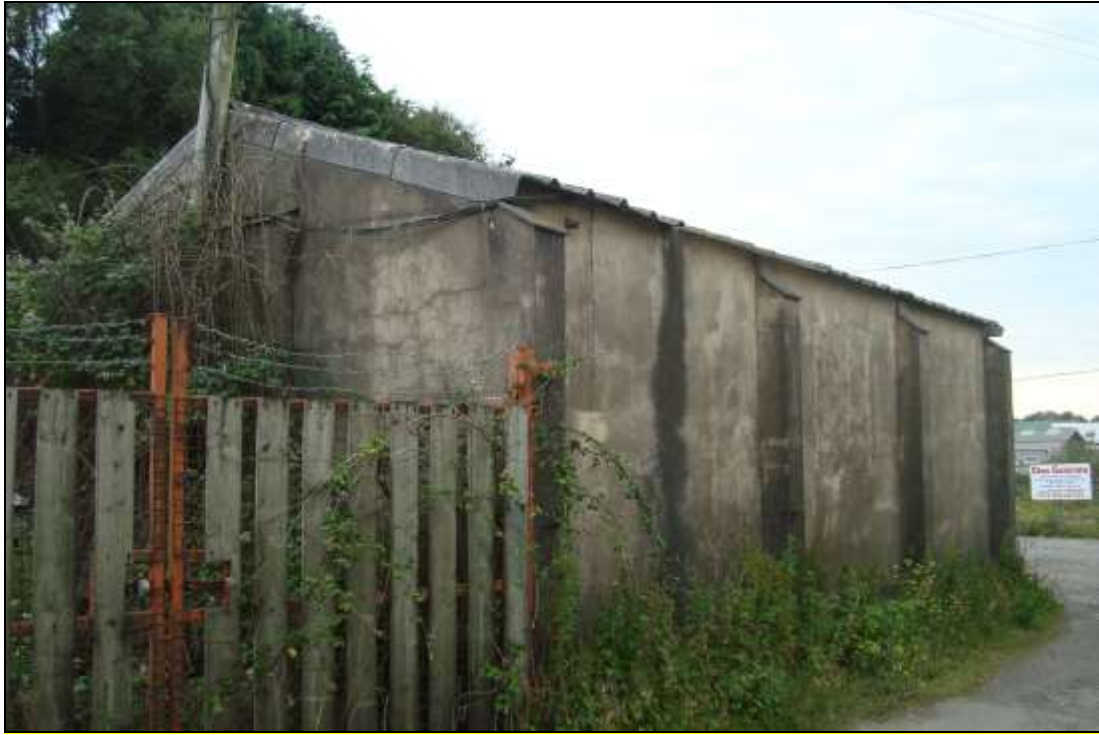
*Plate 94: The airfield Fire Tender shelter (west facing elevation)*

*Plate 95: The airfield Fire Tender shed. View to the west*

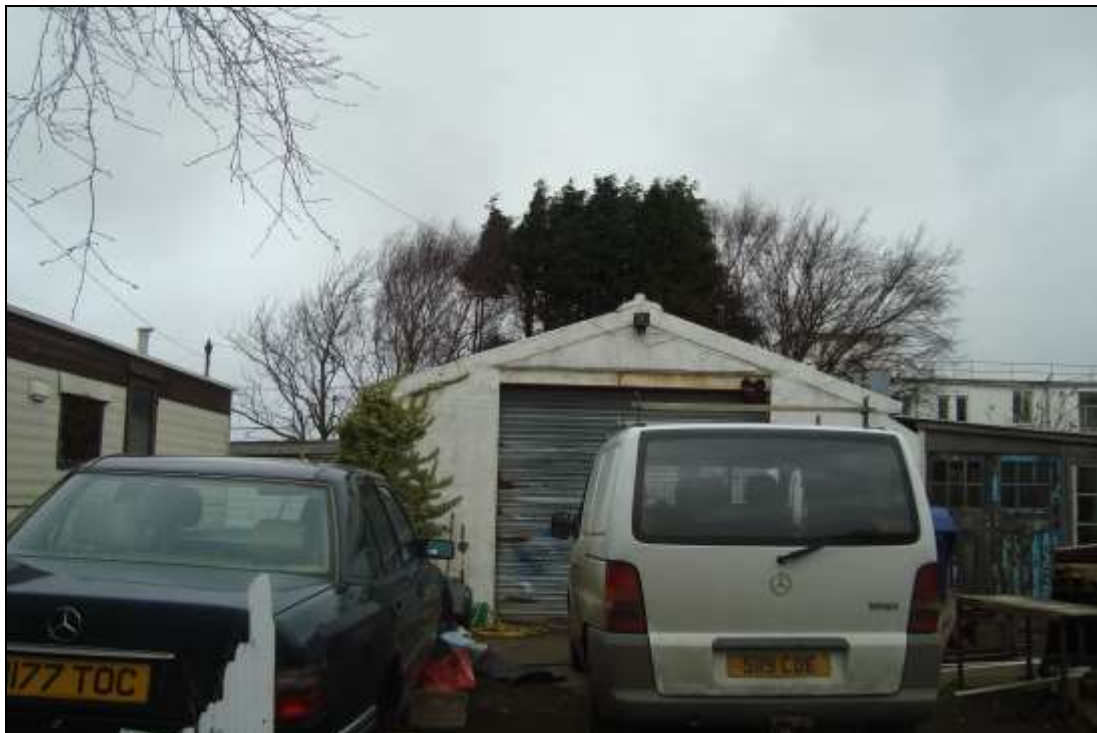
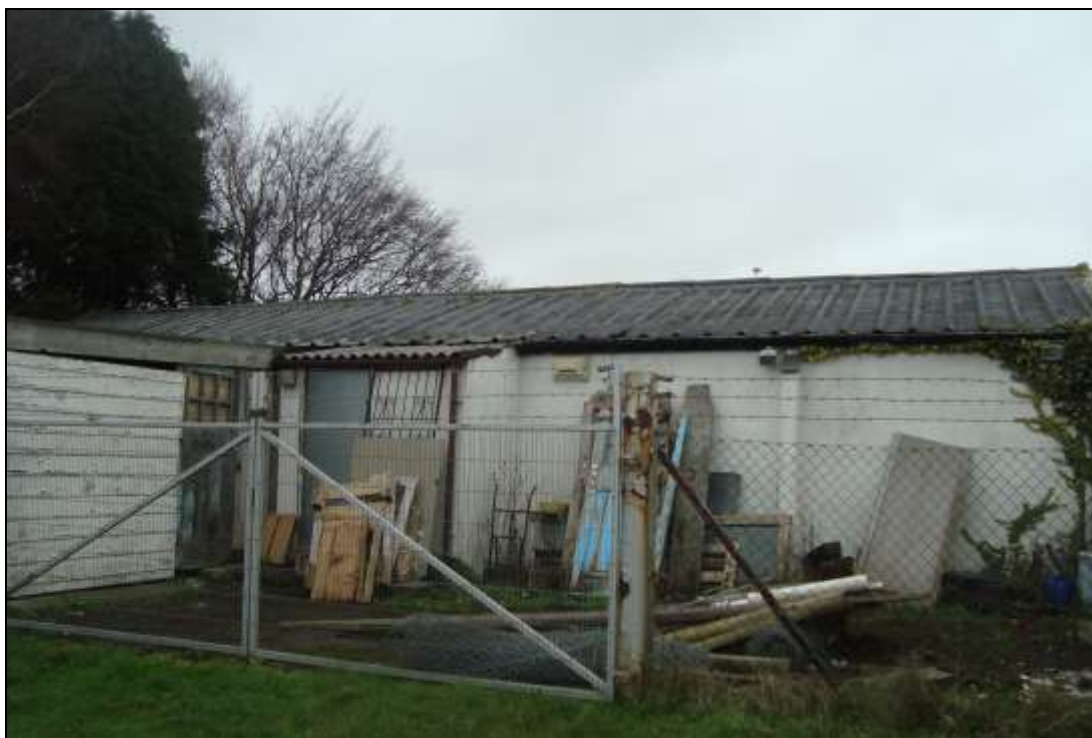
*Plate 96: Front elevation of the Squadron Office. View to the north*

Plate 97: Side elevation of building PRN 04229s

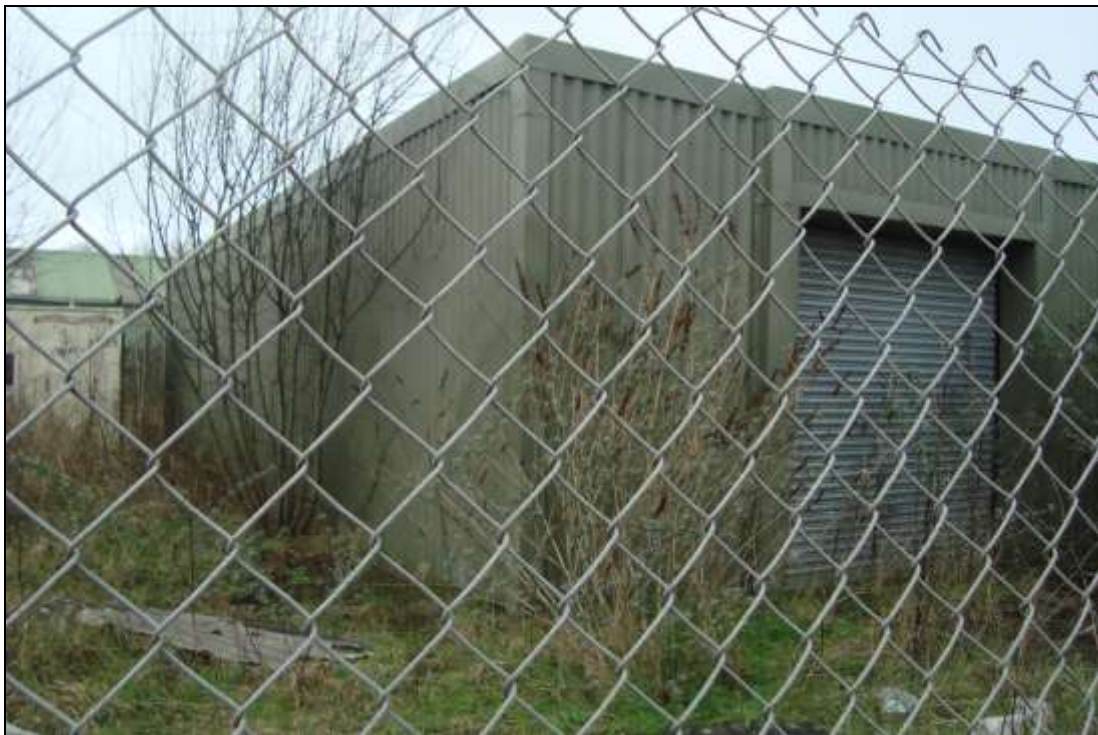
*Plate 100: Unrecognisable Lecture Block*

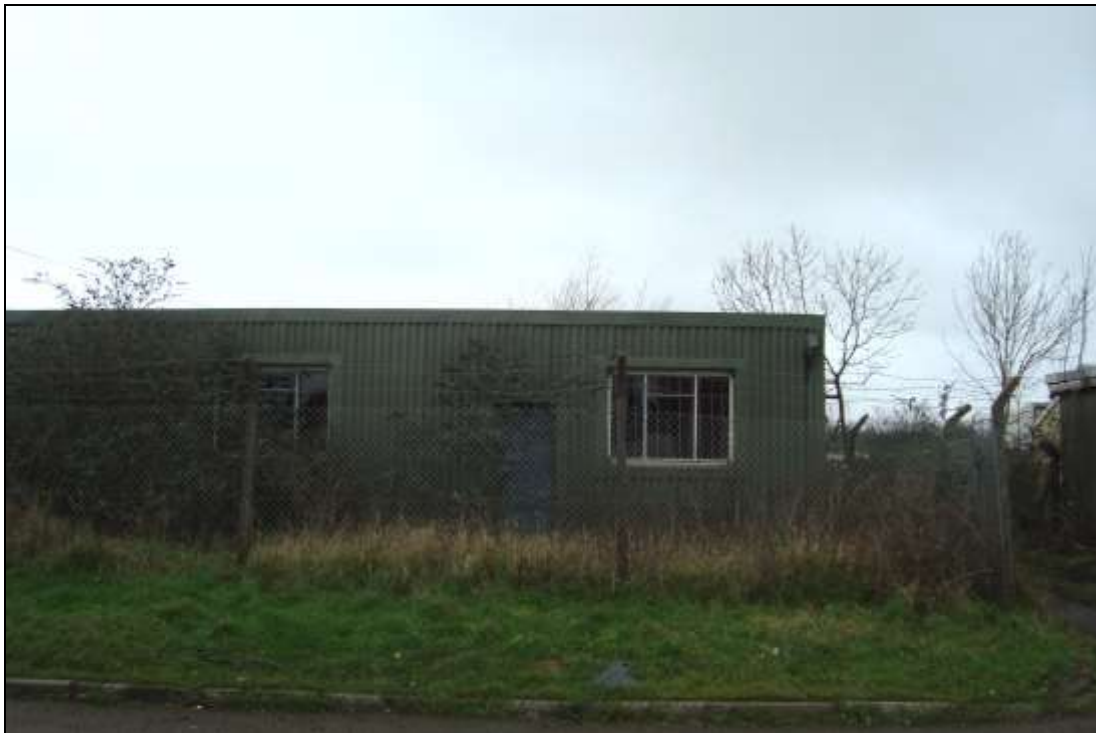
*Plate 101: The heavily re-clad Intelligence Block*
