# GGAT 112: Second World War Military Airfields of South Wales

RAF Llandow

A report for Cadw  
by Paul W Huckfield BA

GGAT report no. 2012/032  
Project no. GGAT 112  
National Grid Reference:  
SS95950 71770

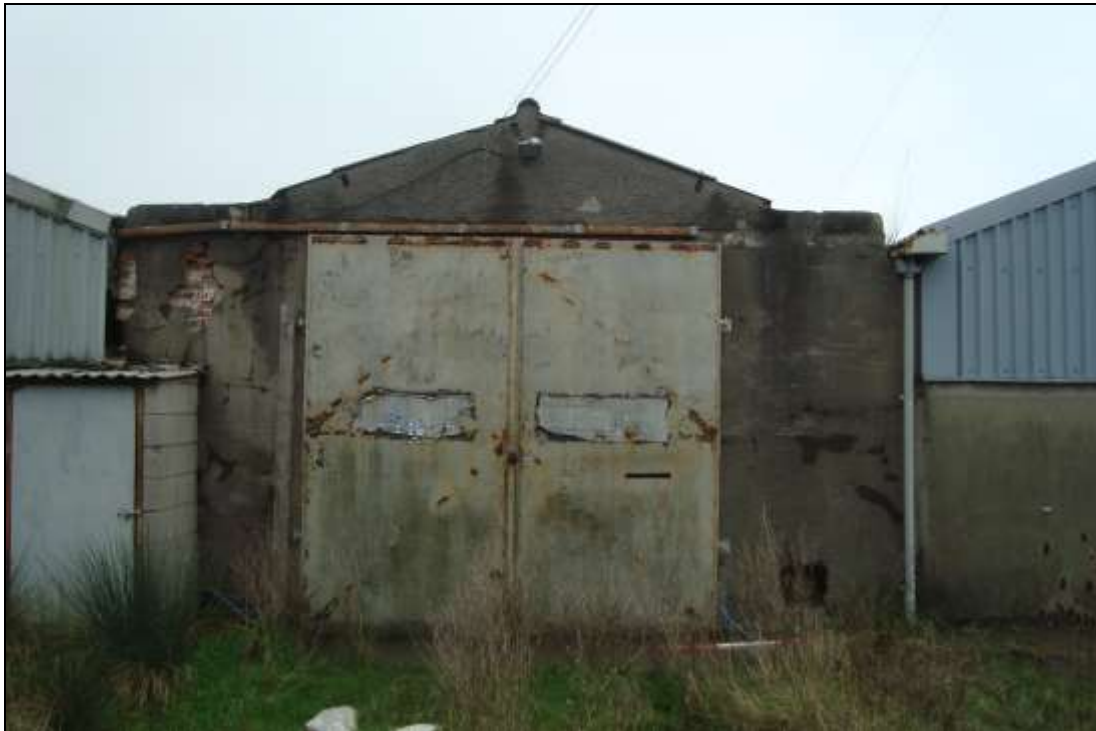
*Plate 102: All that remains of the Hawarden and Hunt Trainer is main gable end (east facing)*

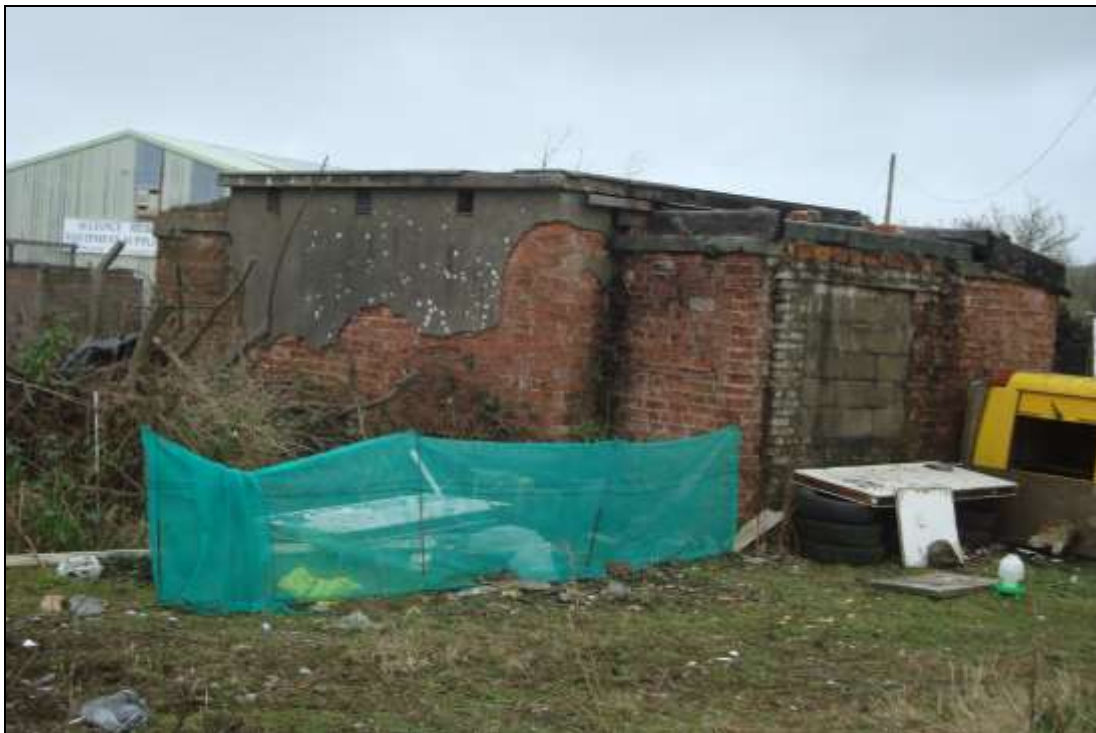
*Plate 104: Remains of a transformer sub-station. View to the North*

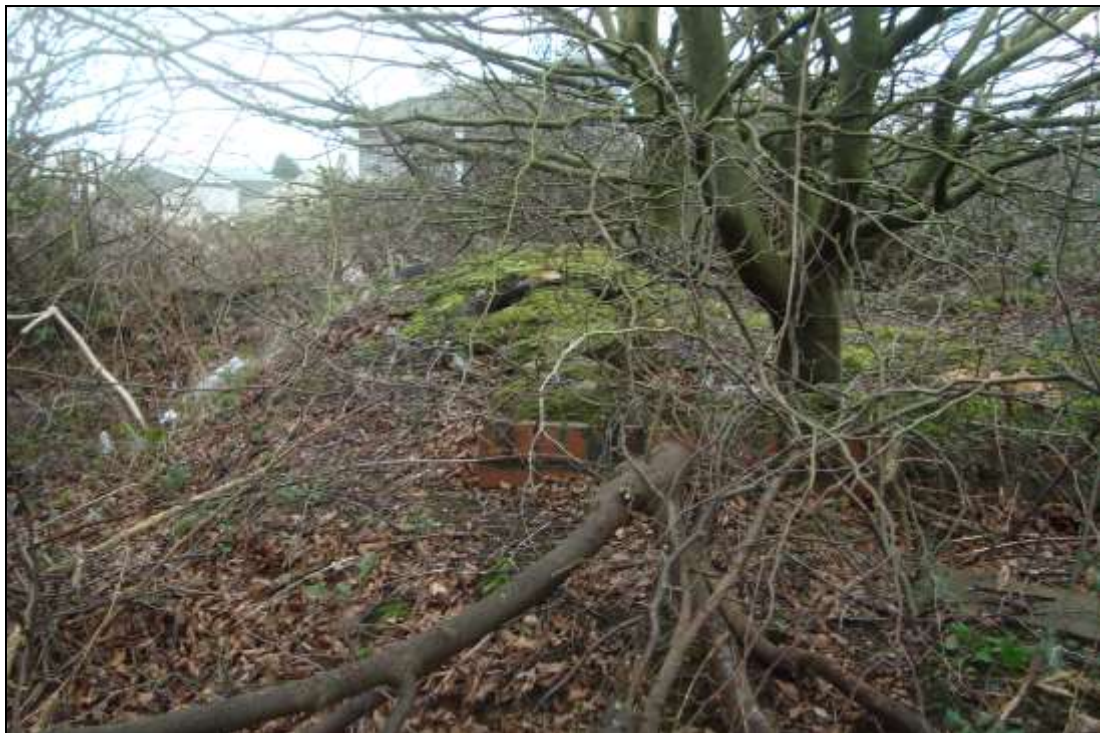
*Plate 105: Very little remains of the sentry box*

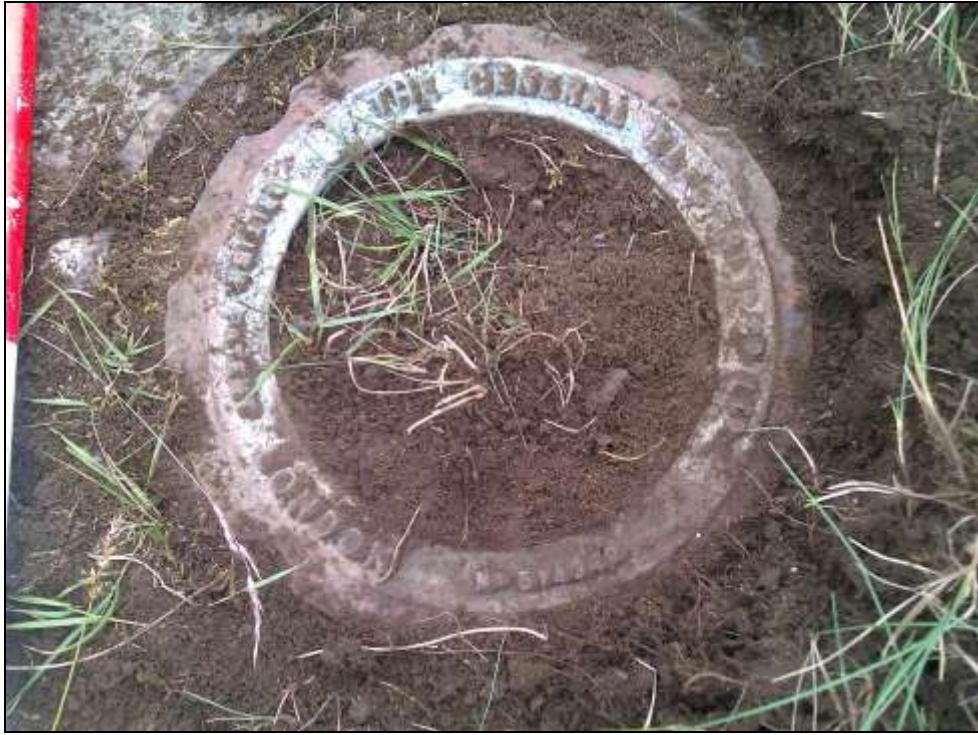
*Plate 106: One of the surviving taxiway edge lights (PRN 04238s)*
