# Hafod Flower Garden 'Mariamne's Garden', Hafod Estate Ceredigion Archaeological Evaluation

RHIF YR ADRODDIAD / REPORT NO. 2007/86  
RHIF Y PROSIECT / PROJECT RECORD NO. 63302

**HAFOD FLOWER GARDEN, 'MARIAMNES GARDEN', HAFOD ESTATE  
CEREDIGION  
ARCHAEOLOGICAL EVALUATION**

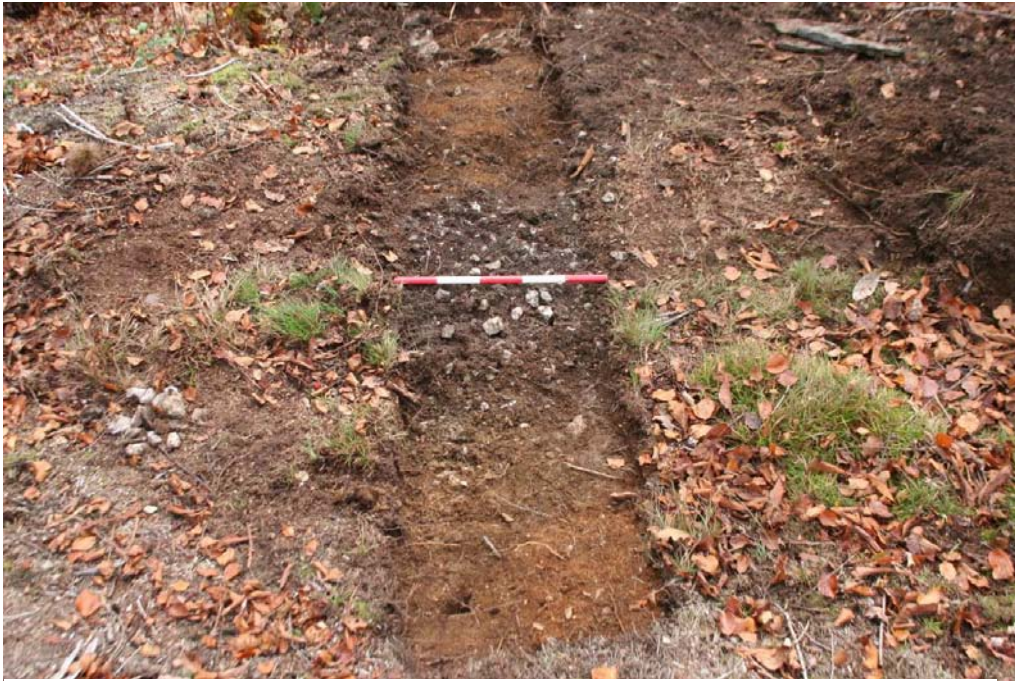
The path measured c.0.65-0.7m wide and was located to the northern end of the terrace running east-west. The path surface was made up of loosely laid angular quartz stones, with an average size of 50mm x 30mm x 30mm, simply laid on to the loose silty subsoil. The stones were not removed but the stone band appeared to be only one or two stones thick. The southern (downslope) edge of the terrace has clearly eroded and slipped downslope, and it is likely that the path was originally wider on this side.

Around 0.7m to the south and further downslope from the path and terrace several loosely laid flat stones were revealed. These stones measured on average 200mm x 100mm x 50mm, and appear to be the remains of a coarse revetment wall that has clearly slipped downslope over time. Remnants of this revetment wall are still visible further west along the lower edge of the terrace.

Plate 1: South-east facing shot of Trench 1. 1 x 0.5m scale

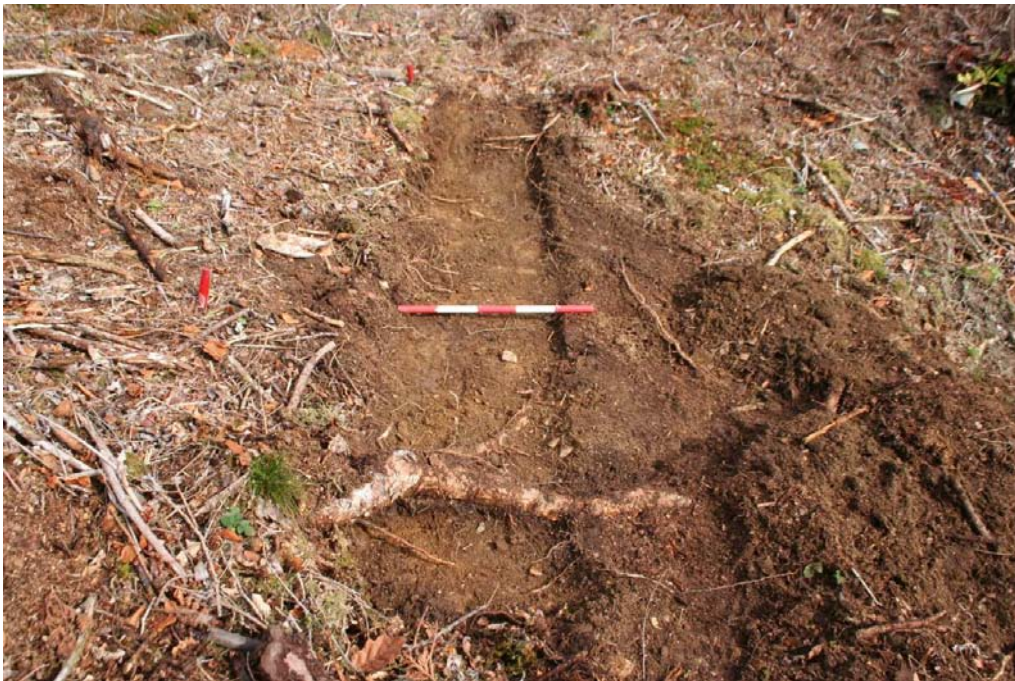
The trench measured 2.1m by 0.5m and was aligned north-south across the sloping ground. Between 0.05 and 0.1m of turf and leaf mould were removed overlying the subsoil, but no trace of a pathway was revealed. The lack of any quartz stones within the trench and the immediate area suggests that there may have been no formal surfacing to the path, or that it has completely eroded due to the nature of the sloping ground in this area.

Plate 2: North-east facing shot of Trench 2. 1 x 0.5m scale.

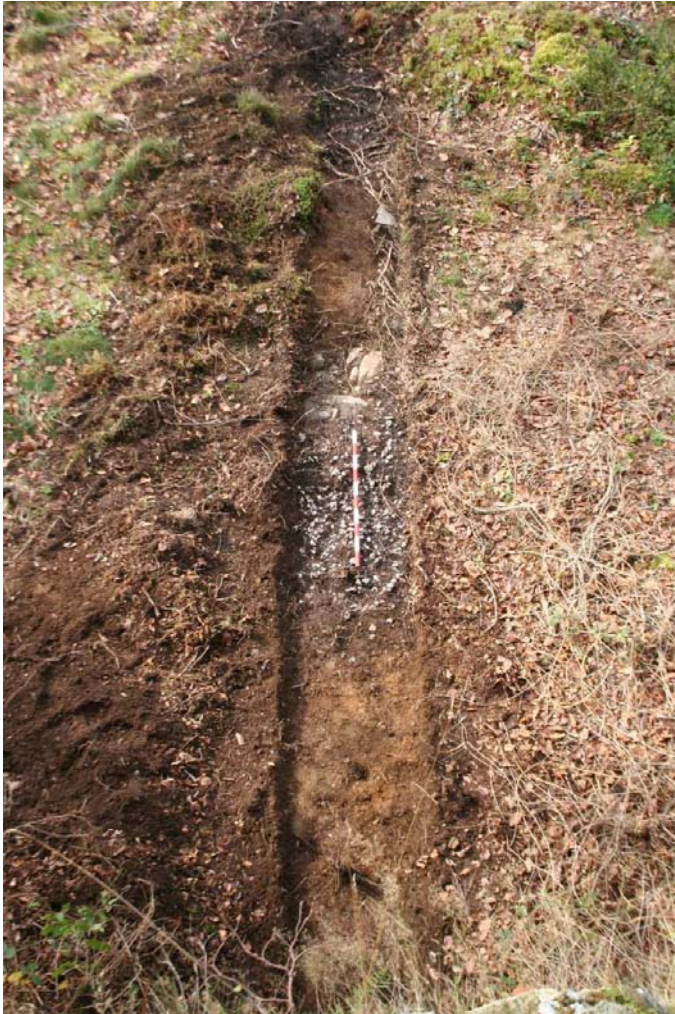
The central pathway measured at most 2.04m across and it was located approximately 2.38m to the southwest of the rock face to the northeast. The path surface was made up of loosely laid angular quartz stones, with an average size of 50mm x 30mm x 30mm, simply laid on to the loose silty subsoil, the same as the path revealed in Trench 1. The southwestern edge of the quartz-stone path was intermingled with an area of large flat loosely laid stones. These stones vary from 150mm x 80mm x 30mm up to 400mm x 200mm x 30mm, and appear to form part of a surface rather than a collapsed revetment wall. The edges of the path appear slightly splayed, being wider to the northwest than the southeast. The greater width of the pathway in this area may indicate this was indeed where pathways converged.

Approximately 1.4m further to the southwest the edge of a second path was revealed. This path was also made up of loosely laid angular quartz stones, with an average size of 50mm x 30mm x 30mm, simply laid on to the loose silty subsoil. The revealed edge of this path was disturbed by root action but it appeared to be curving, suggesting the path continued to run in a more southwesterly direction out onto a rocky outcrop where it meets with another path running towards some rock-cut steps taking the pathway down onto a lower terrace (a path marked on the 1:2500 Ordnance Survey map). The curve also suggested the path may have followed the contours to meet with the path visible within Trench 1.

Plate 3 (left): South-west facing shot of Trench 3. 1 x 1m scale.

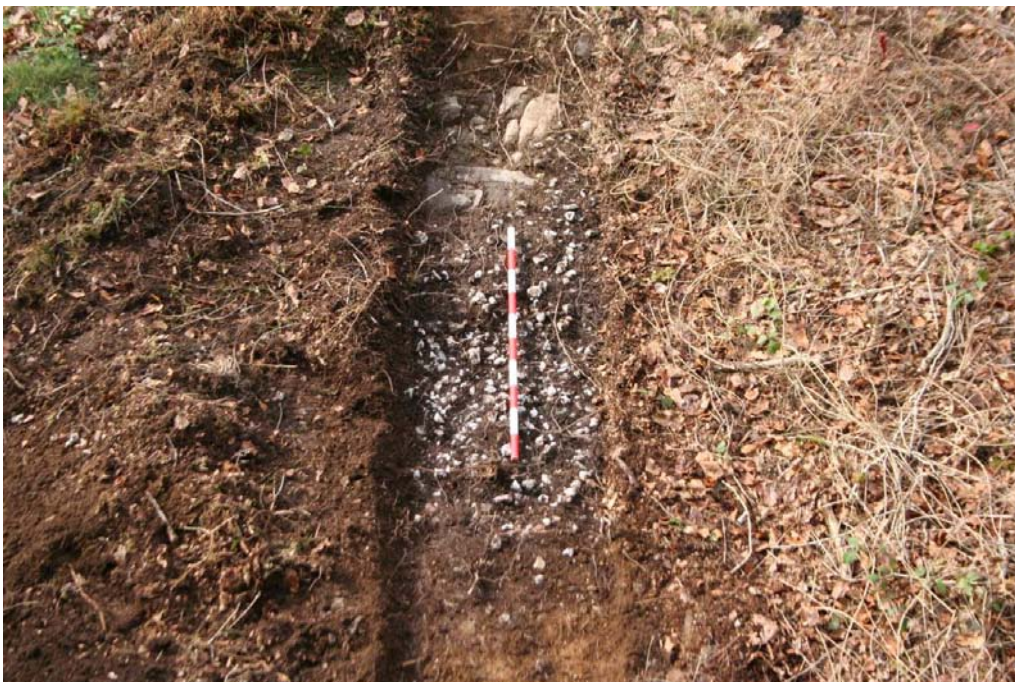
Plate 4 (below): Close-up of central pathway.

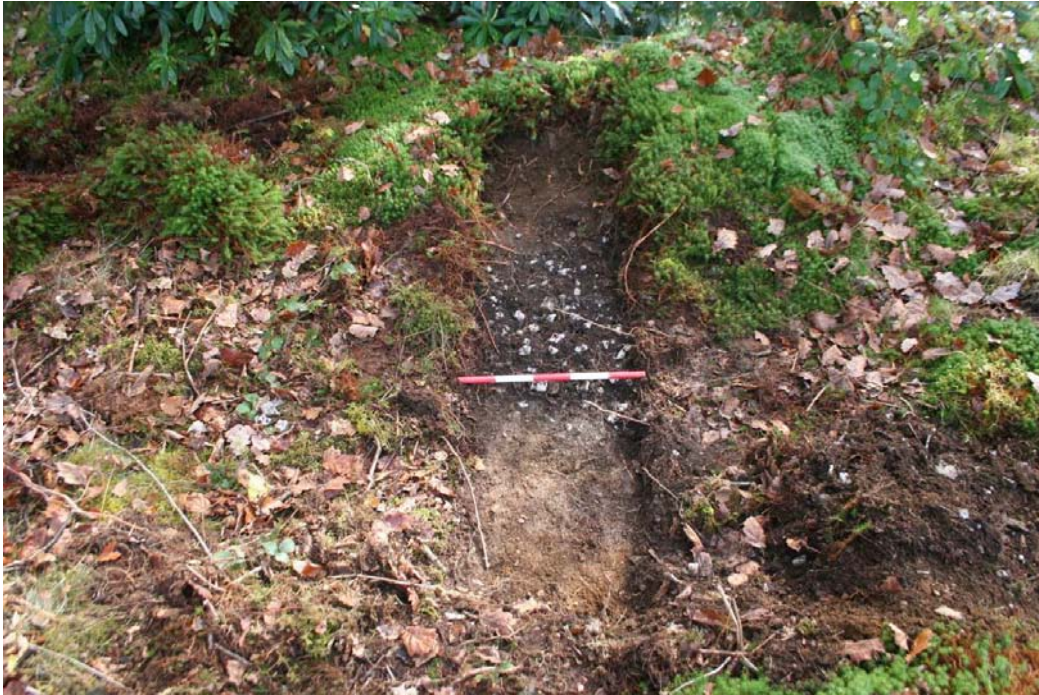
The path measured c.0.8m wide, running in a roughly northeast – southwest direction. As with all the other revealed paths this was also made up of loosely laid angular quartz stones, with an average size of 50mm x 30mm x 30mm, simply laid on to the loose silty subsoil.

Plate 5: South-east facing shot of Trench 4. 1 x 0.5m scale.

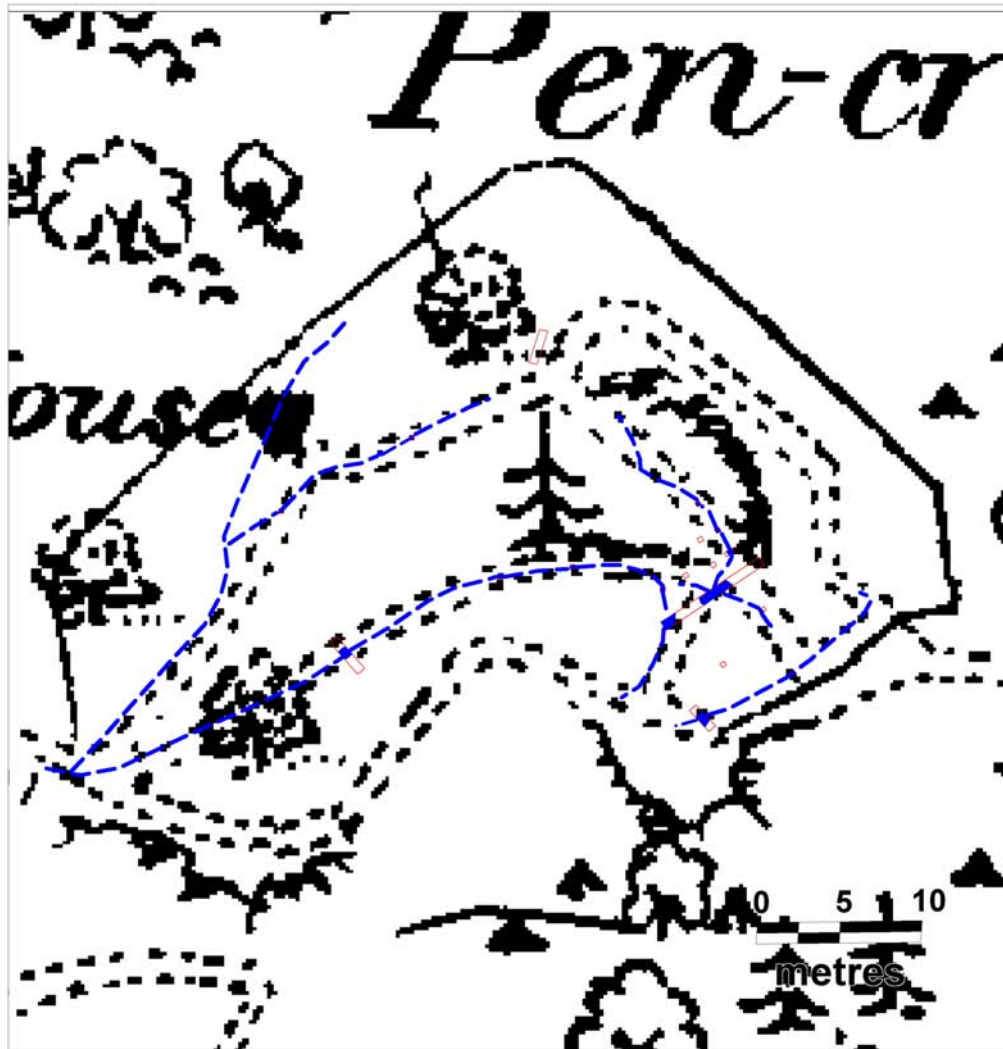
The trenches and test pits allowed the lines of many of the pathways to be established. Many of these paths correspond to the general routes shown on the 1:2500 1<sup>st</sup> edition Ordnance Survey map of 1888. However, excavation has revealed in greater detail the arrangement of the paths as they converge around the area of Trench 3, and excavations also show no evidence of a constructed pathway connecting the viewpoint/seat with the upper path as shown on the 1<sup>st</sup> edition Ordnance Survey map, although evidence of this may have been eroded away.

Figure 3: Copy of the OS 1:2500 1888, showing paths surveyed at that date. Overlaid on it are the position of trenches and pits, with blue dotted lines showing the path alignments confirmed by excavation.
