# A SURVEY OF DEFENDED ENCLOSURES IN CARMARTHENSHIRE, 2007-08: GAZETTEER OF ORDNANCE SURVEY GRID SQUARES SN51, SN52 & SN54

RHIF YR ADRODDIAD / REPORT NO. 2007/27  
RHIF Y PROSIECT / PROJECT RECORD NO. 62767

## SITE GAZETTEER OF 10KM GRID SQUARES SN51, SN52, SN53 & SN54

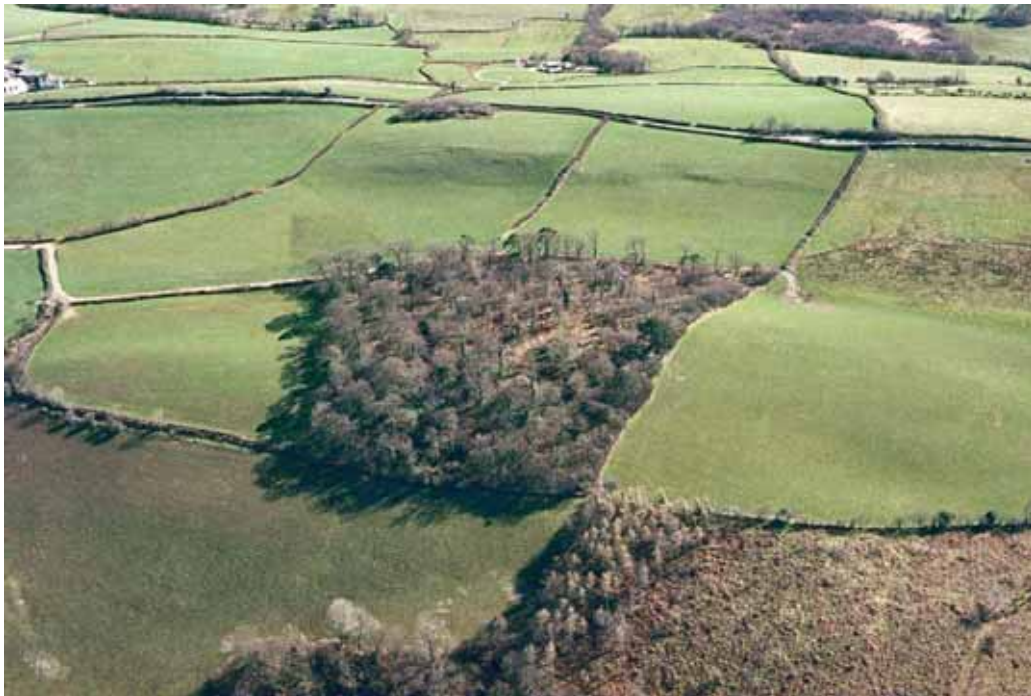
Aerial photograph of 641. RCAHMW Crown Copyright © reference DI2007\_1712.

The site lies at the eastern end of a small hilltop ridge or promontory within a valley at 210m above sea level, and was recorded by the RCAHM (1917) as a circular earthwork about 100 feet in diameter, formed by surrounding the summit of Pen y Garn hill with an earthen bank. It was then so thickly overgrown that a detailed examination proved impossible, and this has hampered visitors ever since. In 1968 the Ordnance Survey described the earthwork as a strong bank, up to 1.3m high that lies across the neck of the promontory and a scarped slope up to 1.3m high on the north, east, and south sides. There are two entrances, one in the west, and another in the south. Faint traces of a terrace were visible leading to the latter entrance from the southwest.

By 1994 the Cadw field monument warden reported that the site appeared much as that recorded by the Ordnance Survey, with rather an undulating upstanding bank on the southwest, west and northwest, and a pronounced scarp on the north and northeast. The western entrance was identifiable, but there was little evidence for any entrance on the south. No internal features were visible.

The enclosure lies in a small wood and is very overgrown with trees, bracken, brambles and scrub. The woodland makes the available views from the site difficult to assess.

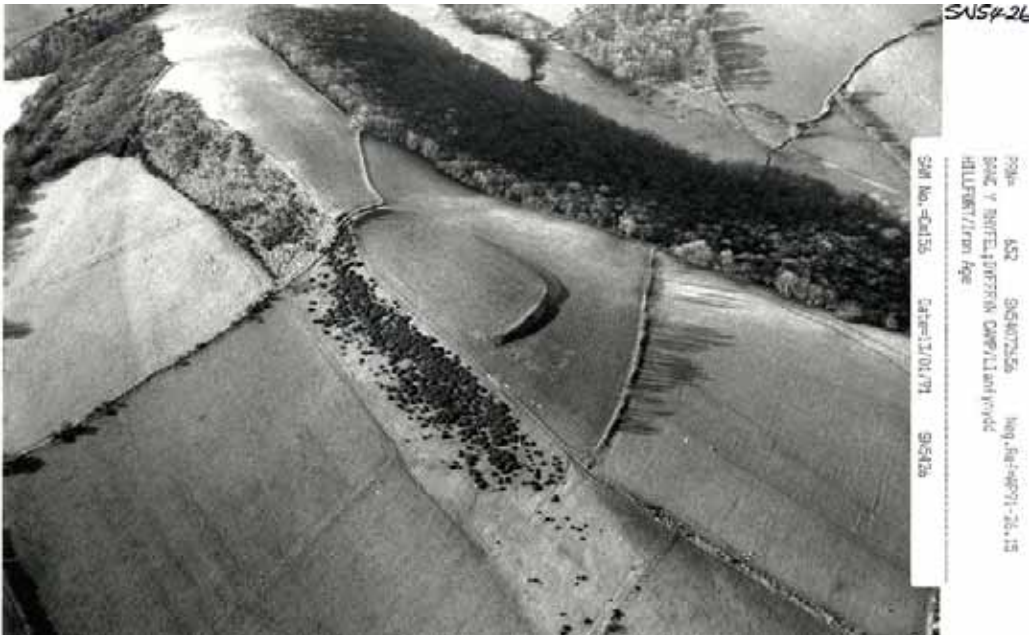
Aerial photograph of 652. Reference DAT AP91-26.15.

A small, oval, univallate enclosure, situated on an east-west running ridge at approximately 230m above sea level, that commands far ranging views across the valleys to the north and south. It is defended to the north, east and west by a single bank and ditch, and to the south by a naturally steep slope. In 1983, and subsequently reported in later visits, the Cadw field monument warden reports that the east and west ditches survive to an interior height of up to 1m, with an exterior height of up to 2m, and that the ditch is just traceable as a slight dip 0.15m deep on the east, 0.60m deep on the west. On the north there is a scarp giving a bank 2m high externally. The south slopes do not appear to have been artificially reinforced.

The simple entrance appears to have been in the southeast, between the bank and the natural slopes. No interior features are visible.

The interior and the northern scarp have been quite heavily ploughed in the past, and the whole site is now within improved pasture, with some areas of gorse.

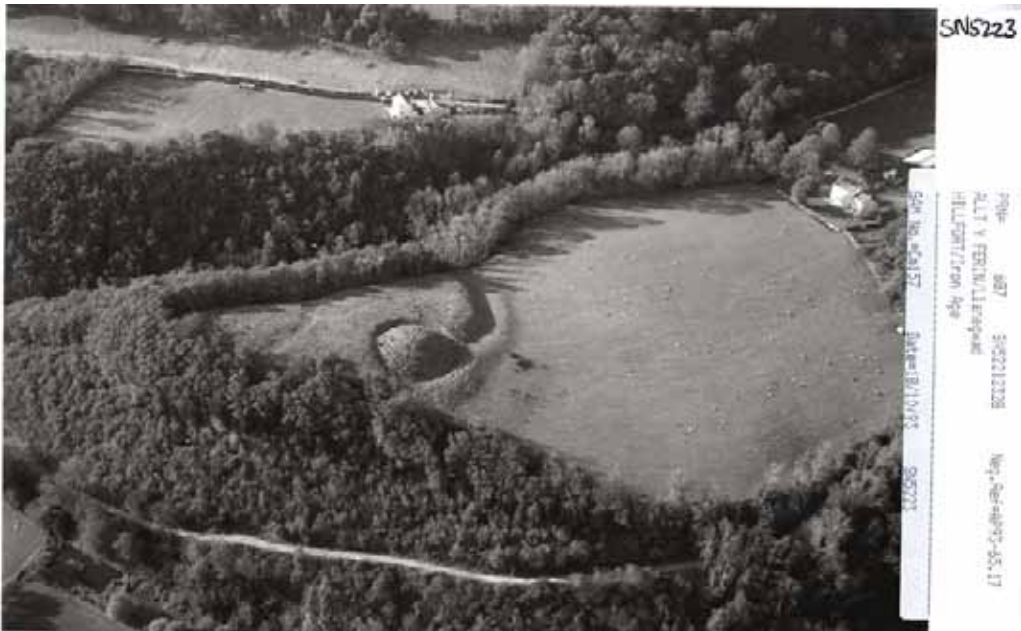
Aerial photograph of 687. Reference DAT AP93-65.17.

Allt y Ferin promontory fort is situated on a wooded promontory at some 80m above sea level with steep slopes on the east, west and south sides. On the north a well-preserved bank and ditch have been constructed across the neck of the promontory. The bank measures 3m high on the exterior, 1m high on the interior, and the ditch is approximately 1.4m in depth. HN Savory (1954) suggests a lateral entrance for the fort but no evidence appears to exist for this.

Some 800 years later the fort was re-used and adapted as a motte and bailey castle. The motte, 8m high, 12m diameter across the top, lies on the east side of the promontory and is surrounded by a narrow ditch with a 2m counterscarp. A bailey has been formed using the fort earthwork as a north boundary. A second slighter ditch and bank cuts off the tip of the promontory. It is uncertain whether this belongs to the Iron Age settlement or the later castle.

The whole scheduled area has in recent years been cleared of trees and scrub, and is now under improved pasture.

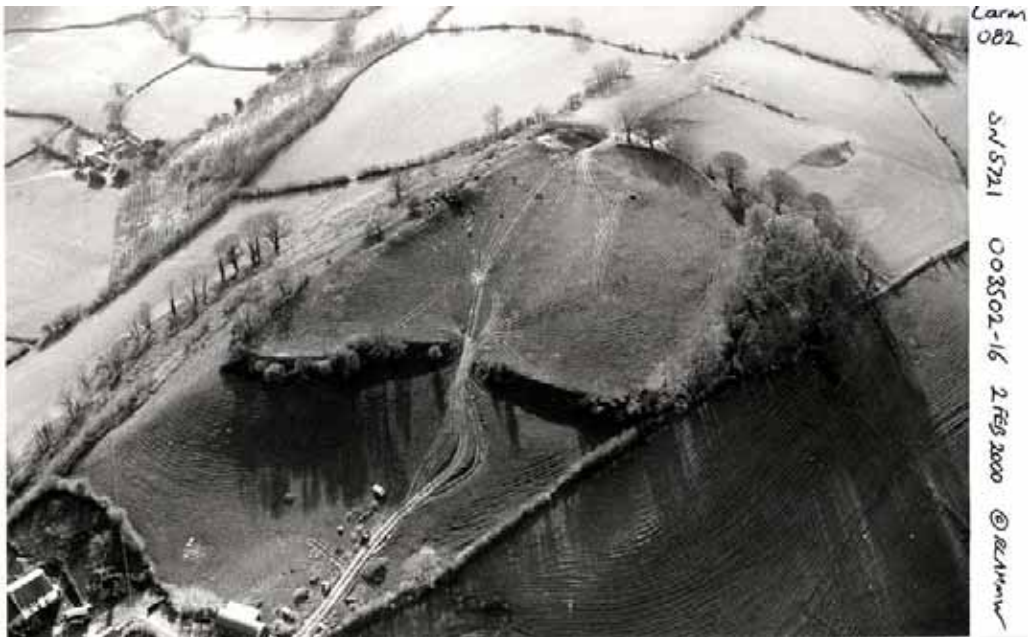
Aerial photograph of 704. RCAHMW Crown Copyright © reference 003502-16.

On the summit of a hill, at approximately 140m above sea level, with fine views in all directions lies the roughly rectangular, univallate hillfort of Grongaer. It is defended by a bank that measures 1.1m high internally and 5m high externally, with a slight berm visible outside the bank indicating the probable position of the ditch. There are no other traces of a ditch. Two simple entrances are present: one on the southwest and another on the northeast.

The bank is best preserved on the short northeast and southwest sides. The natural steep slopes that exist to the northwest and the southeast defend the long sides of the enclosure, and here the bank is not so pronounced. The surface of the interior is irregular, and occasionally broken by outcrops of rocks, but there are no signs of internal features.

The interior of the fort is covered with short grass and is used as rough grazing; the banks are covered with grass with some gorse.

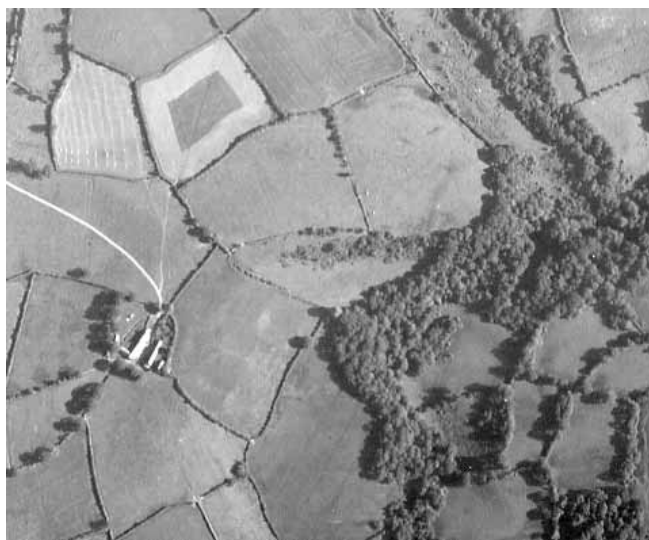
1946 aerial photograph of 4743. Reference – RAF 106G UK 1625 5101.

The RCAHM (1917) noted the field name of Cae Castell at this location but reported that it 'is not explained by any visible object and is now forgotten'. In 2008 the site visit discovered earthworks on the ground that established that this site was a southeast facing, triangular shaped, inland promontory fort, situated on a promontory created by the confluence of two streams. Ground to the east and south drops steeply to the streams below, and drawn across the level approach of the northwest side are two lines of defensive bank and ditch, that enclose an area of approximately 0.44ha.

The earthworks have been much reduced by ploughing. However, the curving inner bank and ditch are best preserved, and were traced for a length of approximately 86m. The inner bank has an internal height of c.0.3m and an external height of c.1.5m. The outer bank and ditch are visible, particularly on the west, but only as a slight earthwork. It was not possible to discern the position of the entrance.

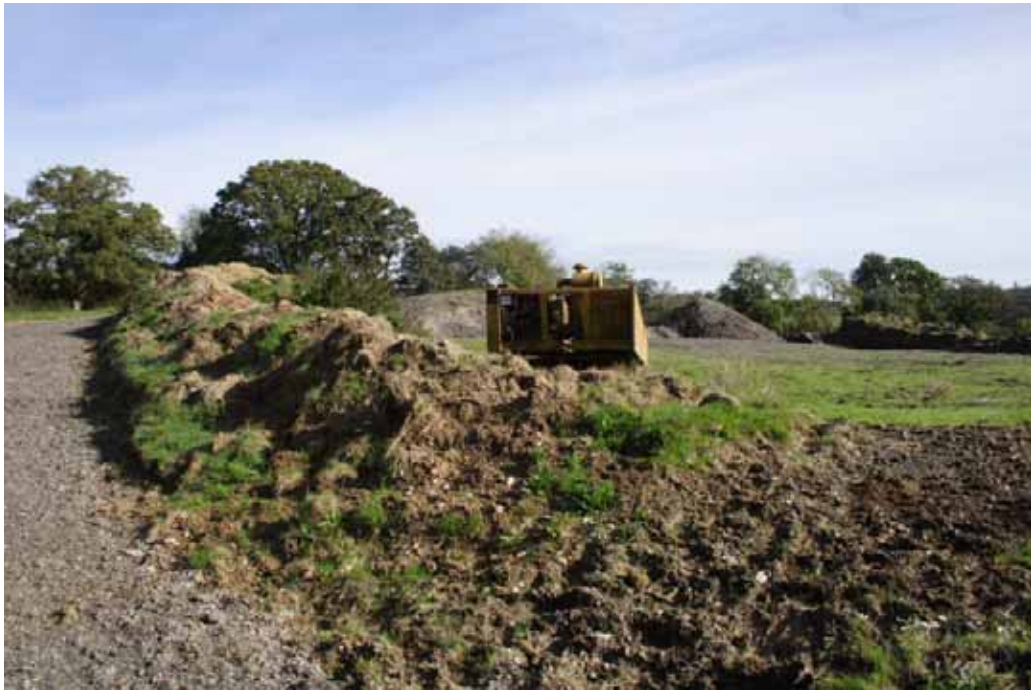
In 2007 it was discovered that the site had been destroyed. The spur of land had been quarried for shale to construct trackways. There is now no trace of the earthwork on the ground.

Looking NE across area of site now destroyed by quarrying

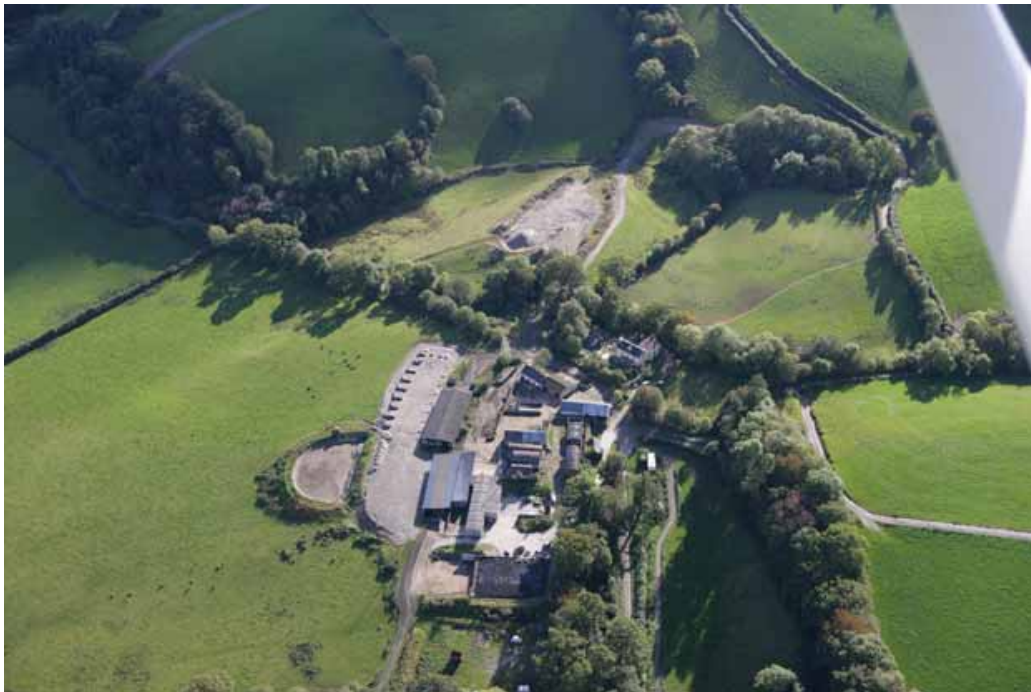
Aerial photograph of 11168. RCAHMW Crown Copyright © reference DI2007\_3339.

In a field south of Ynyswen House there was a southwest facing spur of land measuring 90m by 50m with natural steep sloping sides, especially at its southwest tip, and at the northeast end where the land dropped to the stream below. This spur of land appeared to have been adapted into a defended settlement. In 1985 Dyfed Archaeological Trust recorded it as a bivallate enclosure, with identifiable banks and ditches on the west and east slopes of the earthwork. No evidence of an entrance was noted.

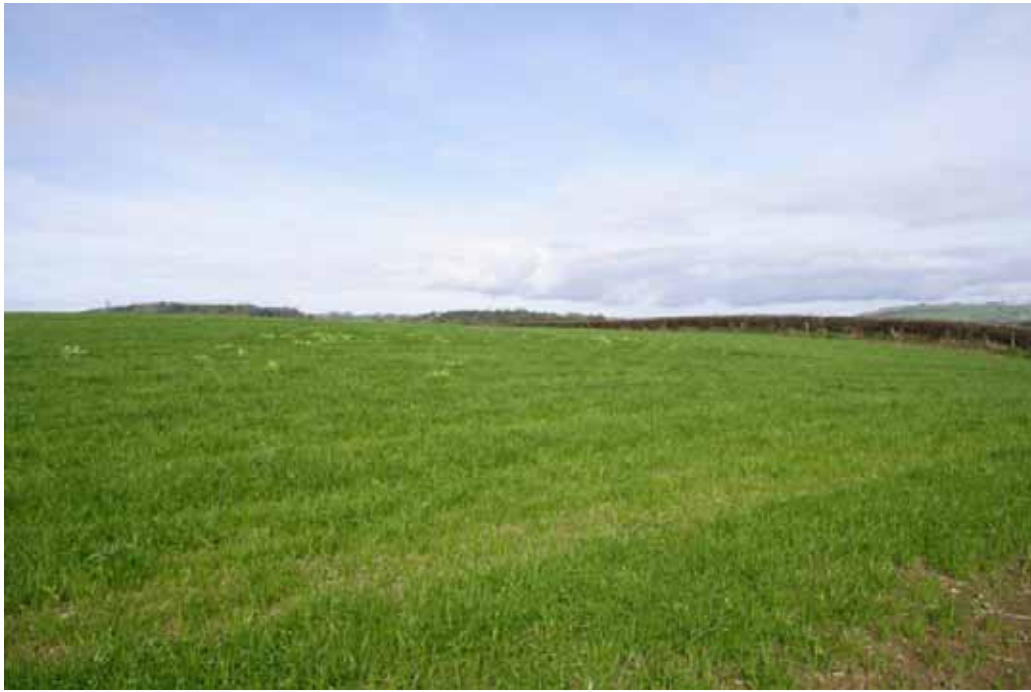
Nothing was visible on the ground in 2007. The site is within a field under arable; currently maize, and is regularly ploughed. It lies at 60m above sea level on a gentle southeast facing hillslope.

Facing NNW across area of cropmark site

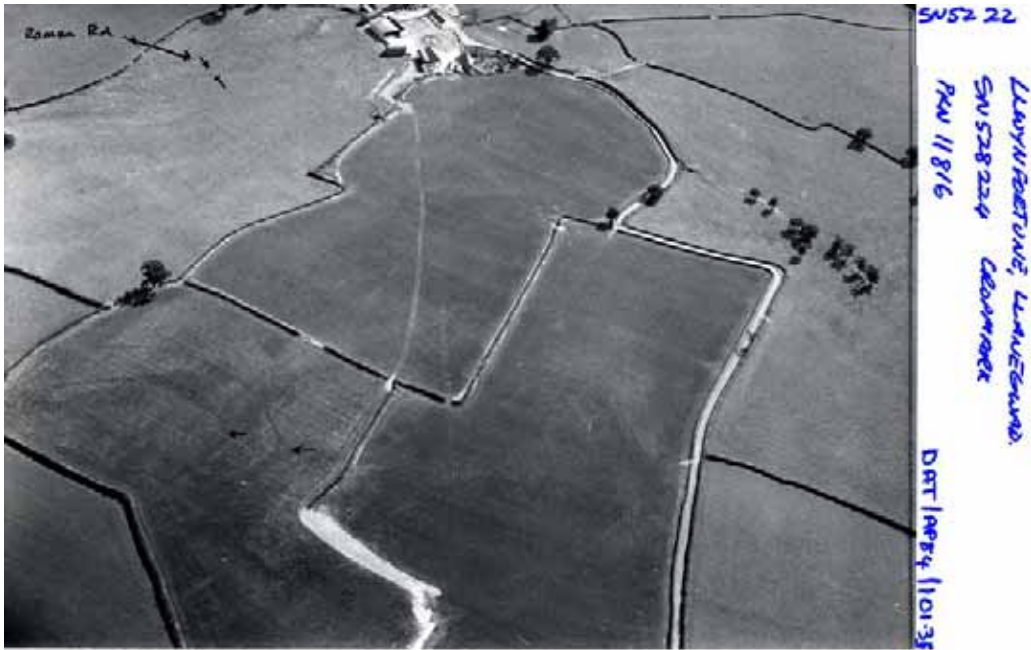
Aerial photograph of 11816. Reference DAT AP84-104.3.

A curving section of what appears to be a large bivallate enclosure or an enclosure with a concentric annex was noted during aerial survey in 1984. The whole circuit of the defences was not visible but it is probably circular in shape with two concentric ditches showing as dark cropmarks, but no sign of parching for the ramparts. The distance between the two ditches is about 30 metres.

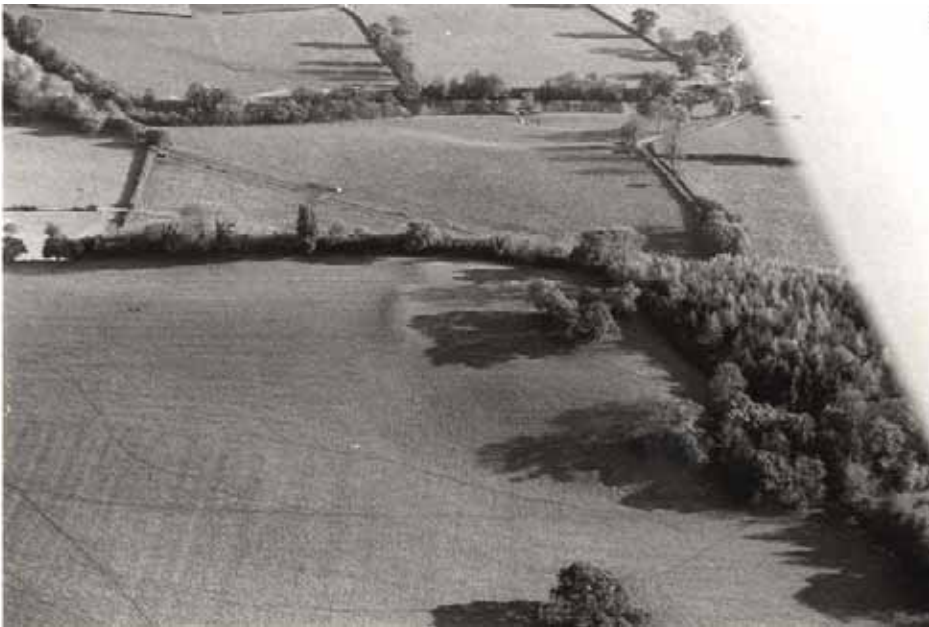
Aerial photograph of 16417. Reference DAT AP93-64.12.

The 2008 site visit was the first to this site and established that it was an inland promontory fort, situated on a south facing end of a narrow ridge of land at 60m above sea level. Steep slopes to the southwest and southeast naturally defended the enclosure, and to the north two lines of curving defensive bank had been drawn across the ridge of land to enclose an area of roughly 0.5 hectare. The outer bank had a maximum height of c.1.2m. The inner bank was c.1m high and had a visible outer ditch. There was c.27m between the two banks. Within the internal area of the promontory fort a telephone mast had been erected, and it had also been damaged by a small quarry; now extinct. The position of an entrance was not discernable.

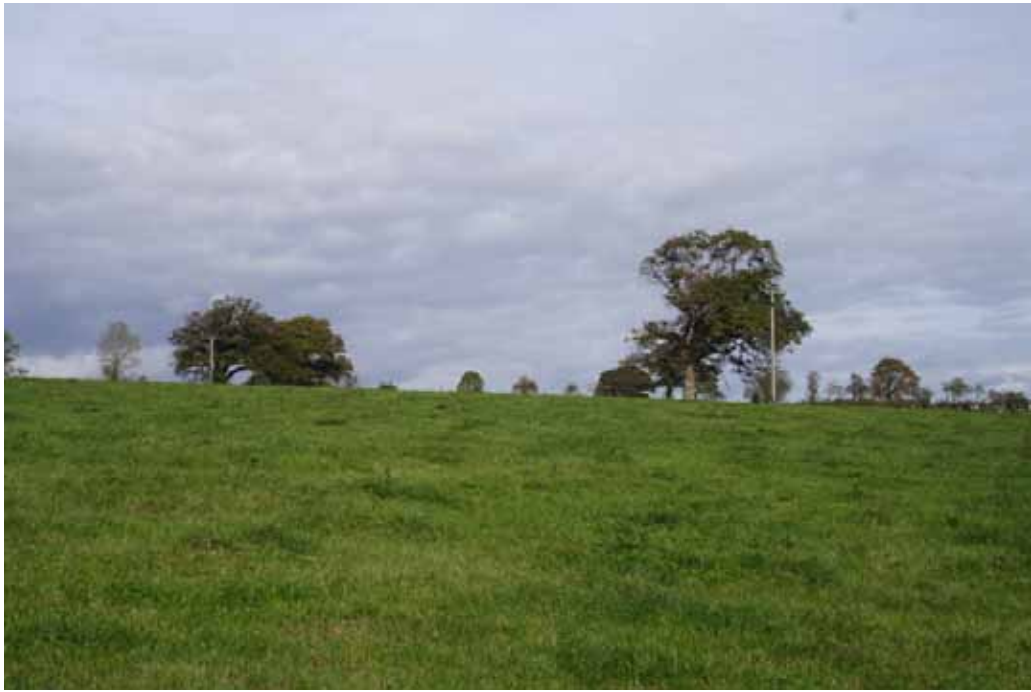
Nothing was visible on the ground in 2007. The site lies within a field of improved pasture at 40m above sea level, on a gentle southeast facing hillslope.

Looking NE across area of cropmark site

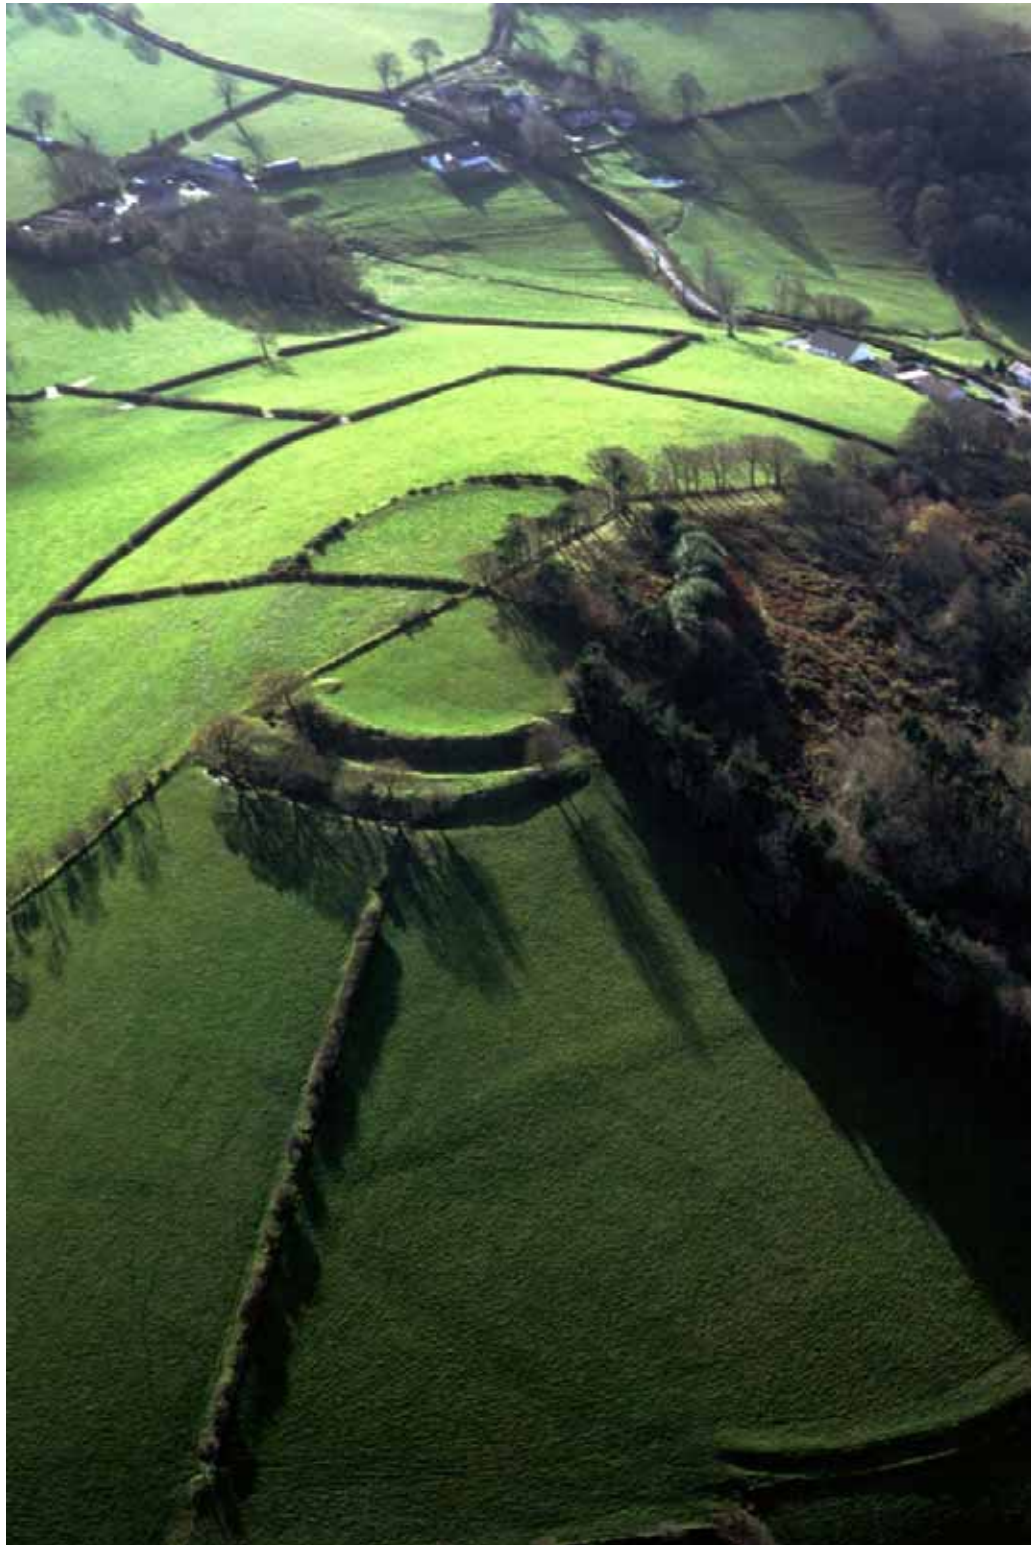
Aerial photograph of 741. RCAHMW Crown Copyright © reference 2002\_cs\_1600.

This is a fine example of a circular hillfort that crowns the summit of a hill reaching some 190m above sea level, to the south of Llanybyther. The enclosure has an approximate diameter of 110m, and is defended on the northeast by a double bank and ditch and by a single bank alone on all other sides. Incurved banks protected the entrance facing east, but in 1911 the RCHAM (1917) record that one of the banks together with a length of the continuing rampart were removed. Two parallel walls of upright stone slabs are said to have been found beneath the soil.

Impressive double banks and ditches are found in the northeast quadrant, although the outer ditch only survives in places. The ditch between the two banks is irregular and would appear to have been disturbed in the past. The northern half of the east entrance is well preserved. This part of the scheduled area is under rough pasture.

The northwestern quadrant is also well preserved. The single rampart here is 0.8 - 1m high internally and 1.3 - 1.6m high externally, with no trace of the ditch surviving. Much of the area is covered in bracken and the rampart is largely covered with laurels.

The dimensions of the bank in the southwestern section are similar to that of the northwestern section, with no trace of outer ditch. This quadrant has suffered from erosion by livestock over the years.

Within the southeast quadrant is where the bank, and half of the inturned entrance were removed. The bank is ploughed and very denuded. This area is under improved pasture.

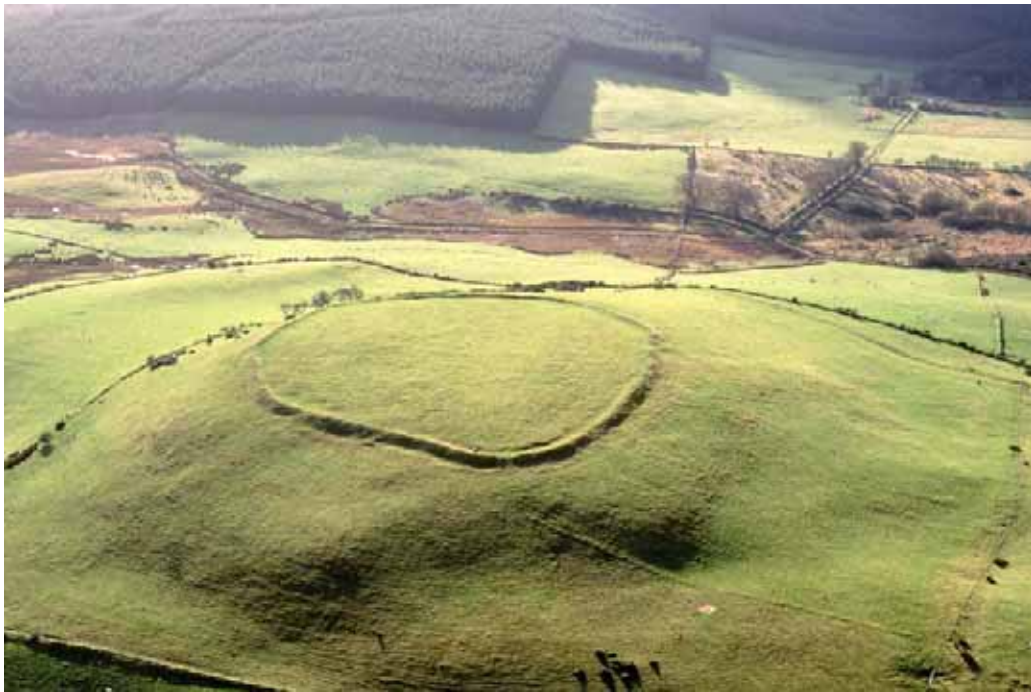
Aerial photograph of 787. RCAHMW Crown Copyright © reference 2002\_cs\_1640.

A very fine hilltop enclosure of approximately 1.2 hectares. It is sub-circular in shape, approximately 100m in diameter and defended by a single bank and ditch, with a simple entrance on the southeast. It is sited on the summit of a small knoll on Mynydd Pencarreg at 344m above sea level, and has commanding views of the surrounding area.

According to recent Cadw reports the bank has an external height of 1.8 - 2m, and an internal height of 0.7 - 1m. There are traces of the ditch in places. The Ordnance Survey reported in 1969 that plenty of stone was visible in the bank and within the enclosure, but no internal structures were apparent. More recently, erosion caused by livestock has revealed a rampart structure of soil and stones, and a possible stretch of rear rampart facing was visible on the north.

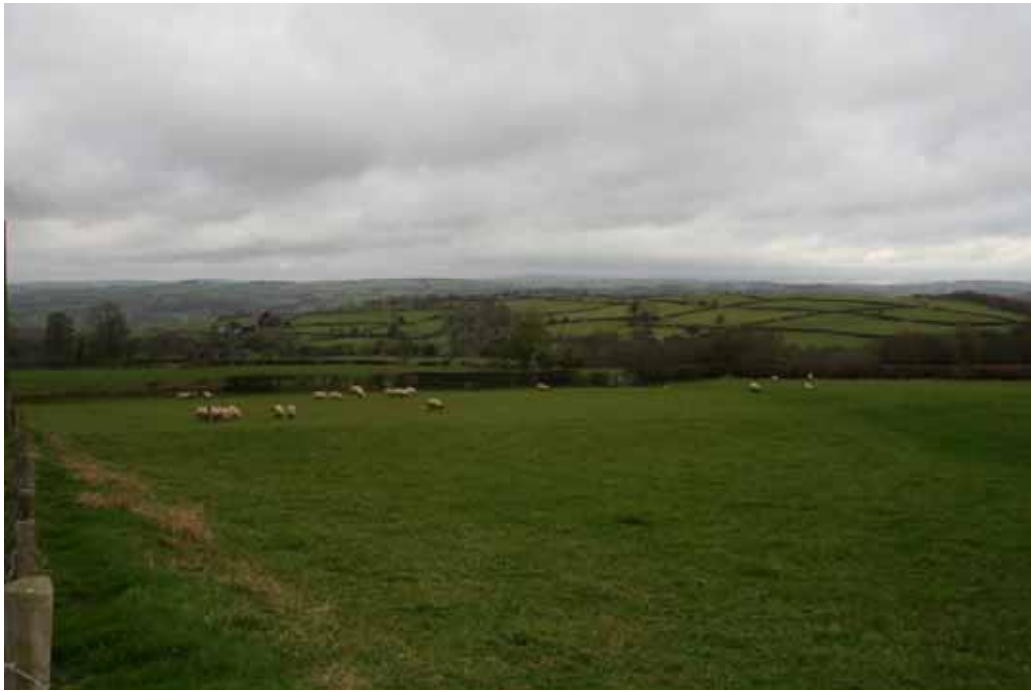
Looking N across circular earthwork of defended enclosure

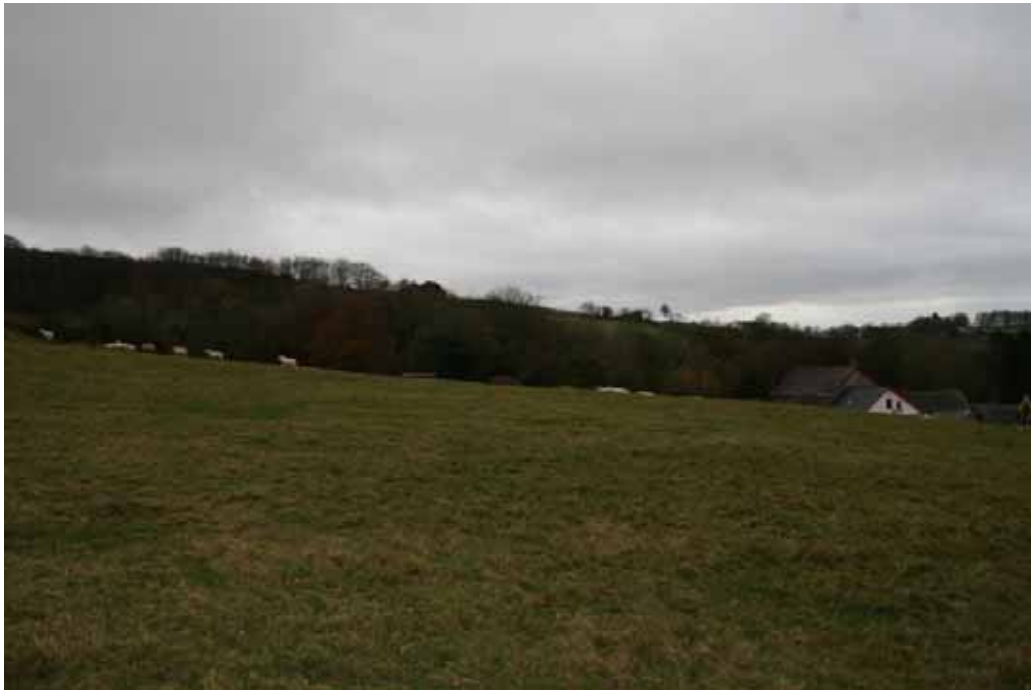
Looking S across area of site - nothing seen on ground

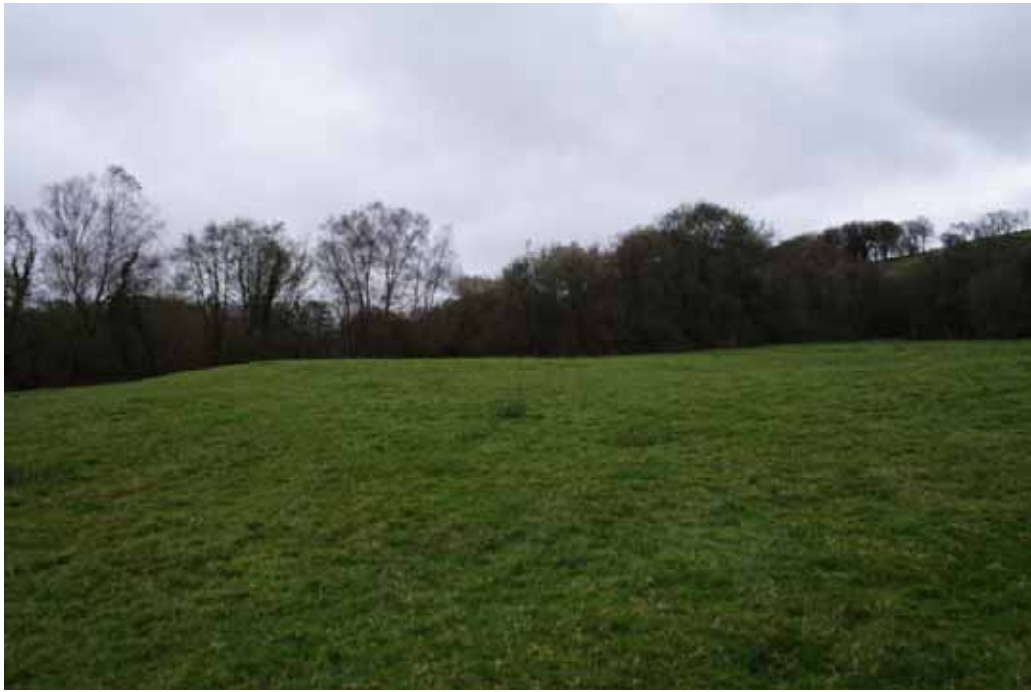
A sub-circular univallate enclosure located in a field of pasture at 170m above sea level. The site is on a gentle northeast hillslope, with a ploughed out bank that stands up to a height of c.1m and an outer ditch c.0.5m deep that tapers out on the downward slope. The bank encloses an area approximately 70m by 50m. The Ordnance Survey in 1968 recorded a simple entrance on the downhill north side, but this is not clear on the ground in 2007. The eastern side of the enclosure has been damaged by a modern field boundary. A depression in the interior is reputed to have been a cock-pit.

Facing approximately E across ploughed out enclosure earthworks

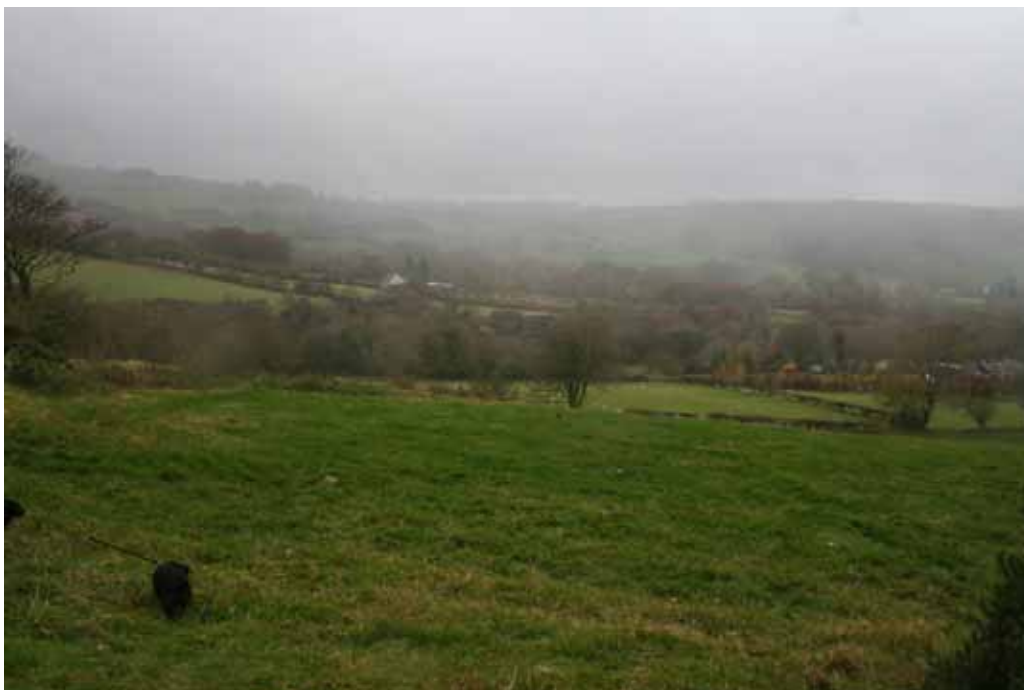
Taken on summit of hill looking approx. NW across earthwork site- bulldozed flat in 1999

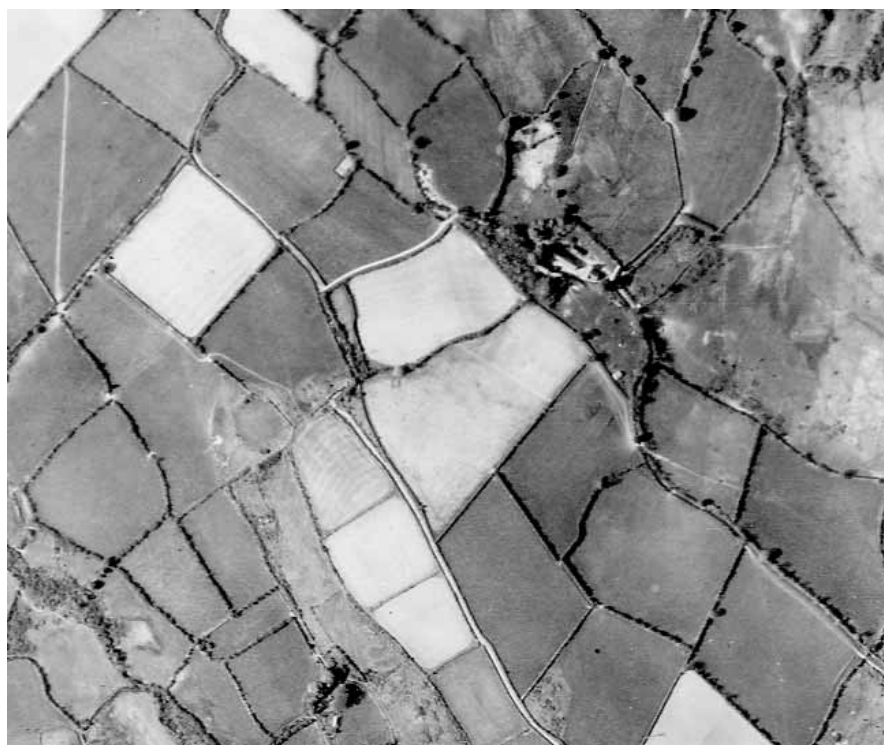
1946 aerial photograph of 819. Reference RAF 106G 1471 6046.

In 1972 the Ordnance Survey recorded this circular enclosure as a recognisable univallate earthwork. Situated on a steep west facing slope at 260m above sea level, it was 43m in diameter with a bank up to 1.9m high internally and 3.1m externally. A simple entrance was observed on the west side of the enclosure. A modern wall had damaged the enclosure on the eastern side. There was no evidence of any internal occupation.

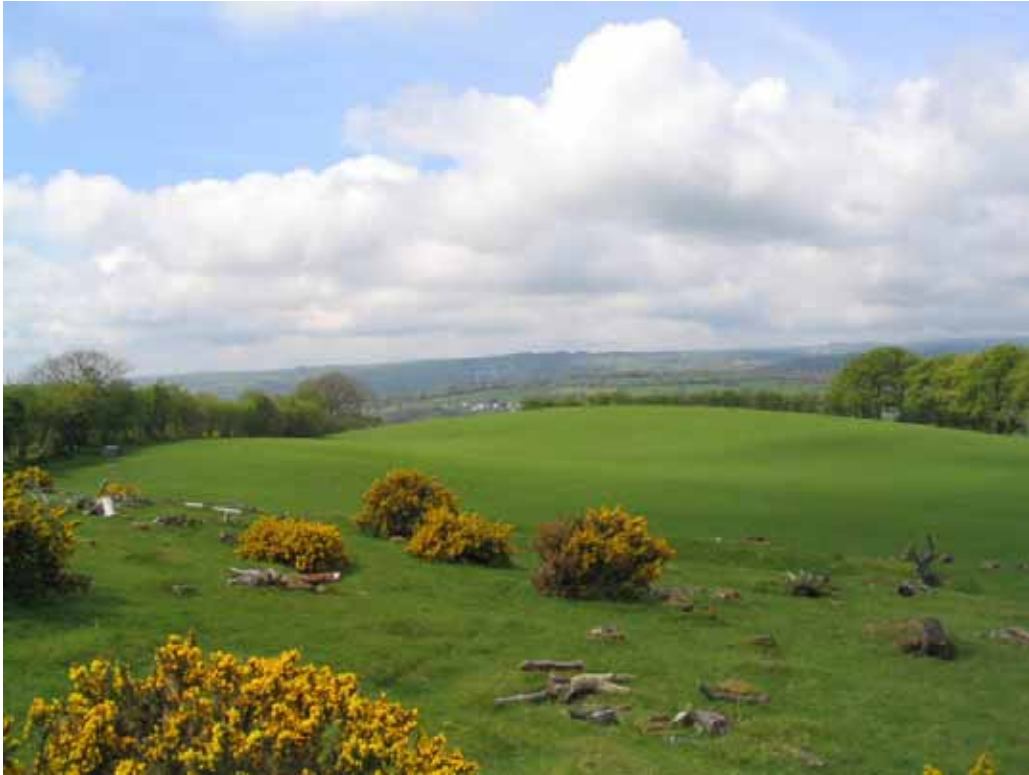
Looking W across internal area of enclosure earthwork
