# A SURVEY OF DEFENDED ENCLOSURES IN CARMARTHENSHIRE, 2007-08: GAZETTEER OF ORDNANCE SURVEY GRID SQUARES SN61, SN62, SN63 & SN64

RHIF YR ADRODDIAD / REPORT NO. 2007/27  
RHIF Y PROSIECT / PROJECT RECORD NO. 62767

## SITE GAZETTEER OF 10KM GRID SQUARES SN61, SN62, SN63 AND SN64

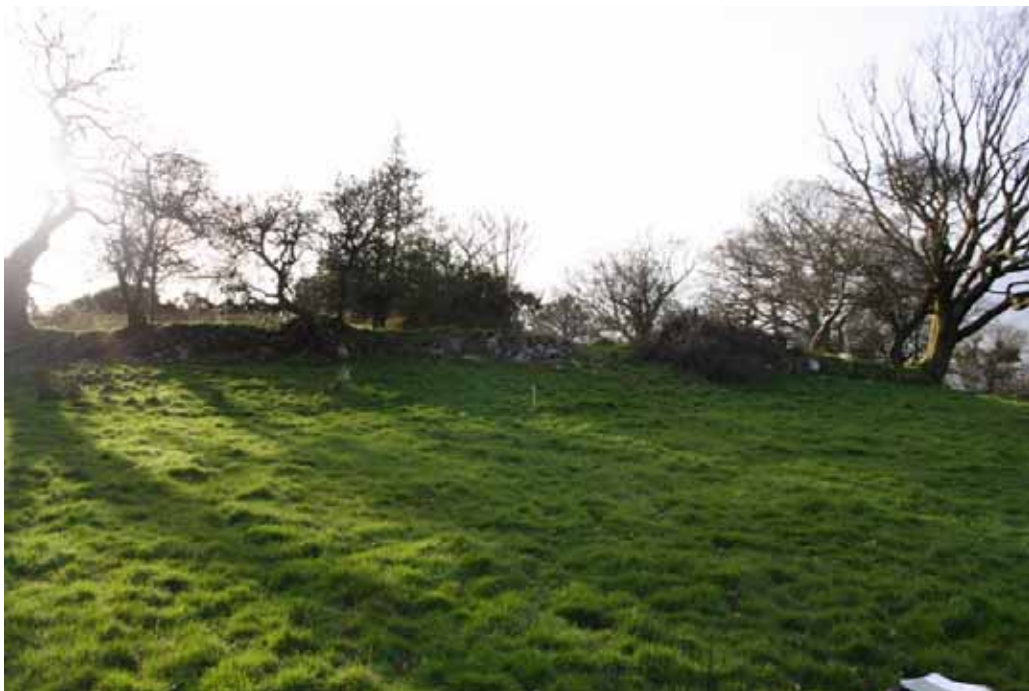
A circular defended enclosure situated on a hilltop at 140m above sea level. It has commanding views in all directions, particularly to the north and south. The Ordnance Survey visited the site in 1968 and recorded that a stone rampart was still visible on the northeast and southeast, with a maximum height of 0.8m. Elsewhere the rampart had gone but intermittent stone probably marked the course of the circular enclosure. The 2008 site visit found little had changed in the mean time. However, the stone rampart referred to by the Ordnance Survey would appear to be a later stonewall that re-utilises the earlier circular defences. Stone, possibly from the earlier defensive banks, has been used to build dry stonewalls along the line of the bank. There is little or no trace of an outer ditch on the ground, and no trace of an entrance. Although the size and shape of the earlier enclosure has been preserved by the later field boundaries, the site is all but destroyed.

Looking E at remains of earth and stone enclosure bank re-utilised as a field boundary

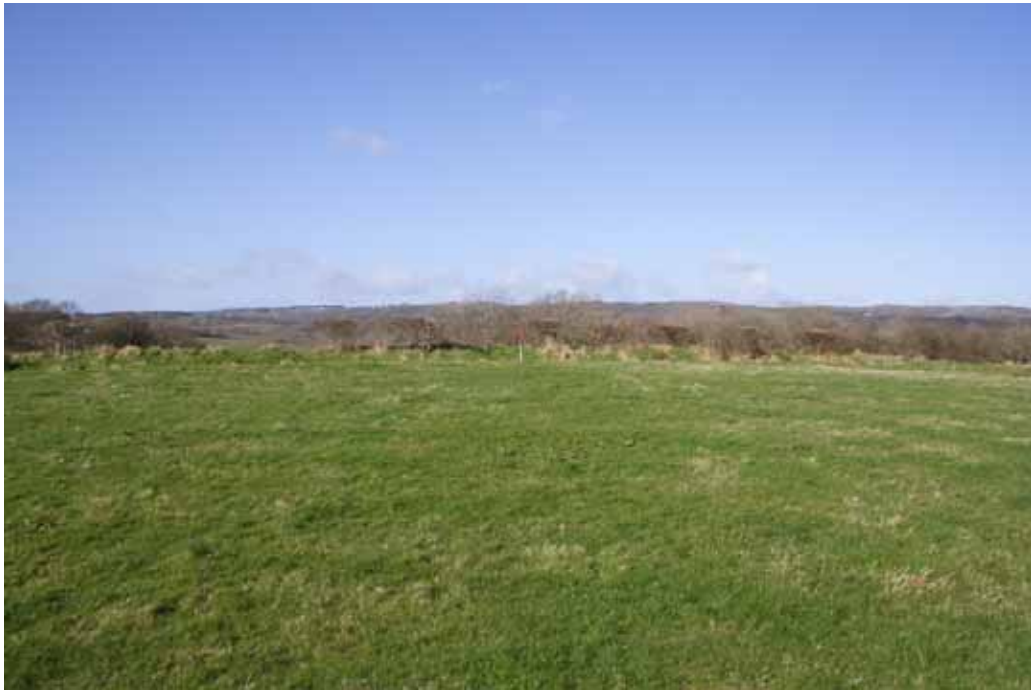
The remains of a possible bivallate enclosure identified from a 1947 aerial photograph. The site is located on a local summit at 80m above sea level, with commanding views in all directions. The Ordnance Survey could find no trace of an earthwork in 1968. In 2008 there was no trace of an earthwork on the ground either. The area was a scene of military activity during the Second World War, evidenced by the concrete pill box (PRN 63957) 60m to the southwest of this site's location.

Looking NE across area of putative cropmark enclosure

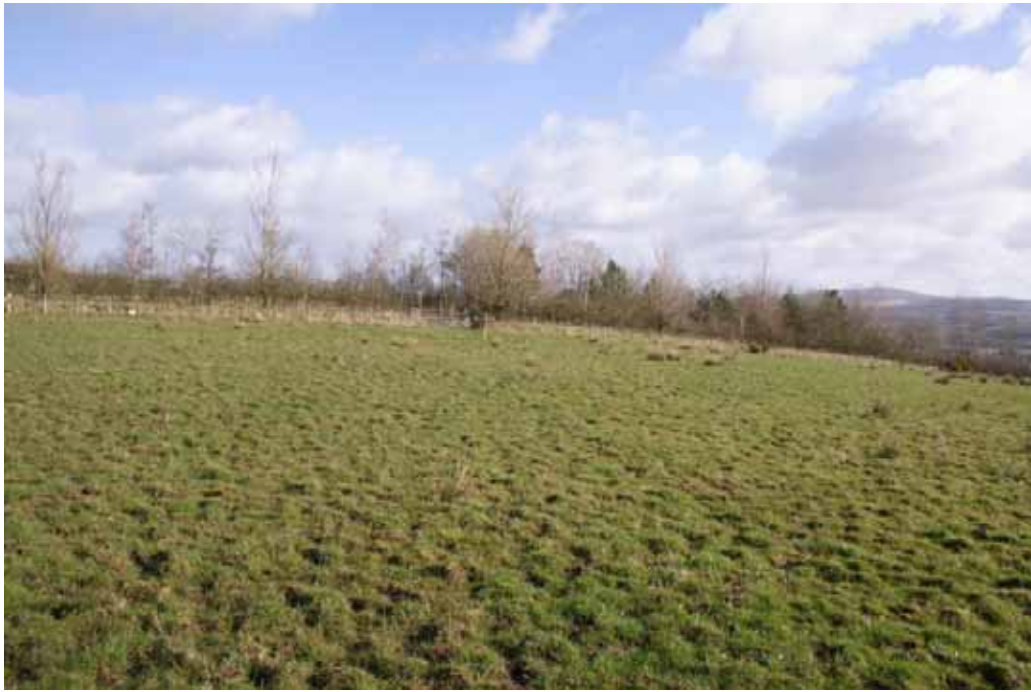
A circular, univallate defended enclosure located on a gentle southeast facing hillslope at 120m above sea level. The Ordnance Survey (1969) recorded that the enclosure measured c.70m in diameter, with a bank 1.2m high. There was no trace of a ditch but a simple entrance was identified on the east. In 2008 the earthwork has been much reduced by ploughing. The defensive bank is not complete and where it does exist is much spread and reaches a maximum height of only c.0.35m. The entrance on the east side is not visible. However, an outer ditch is just discernable on the north close to the boundary fence, and on the southeast.

Looking NW across low earthwork of defended enclosure

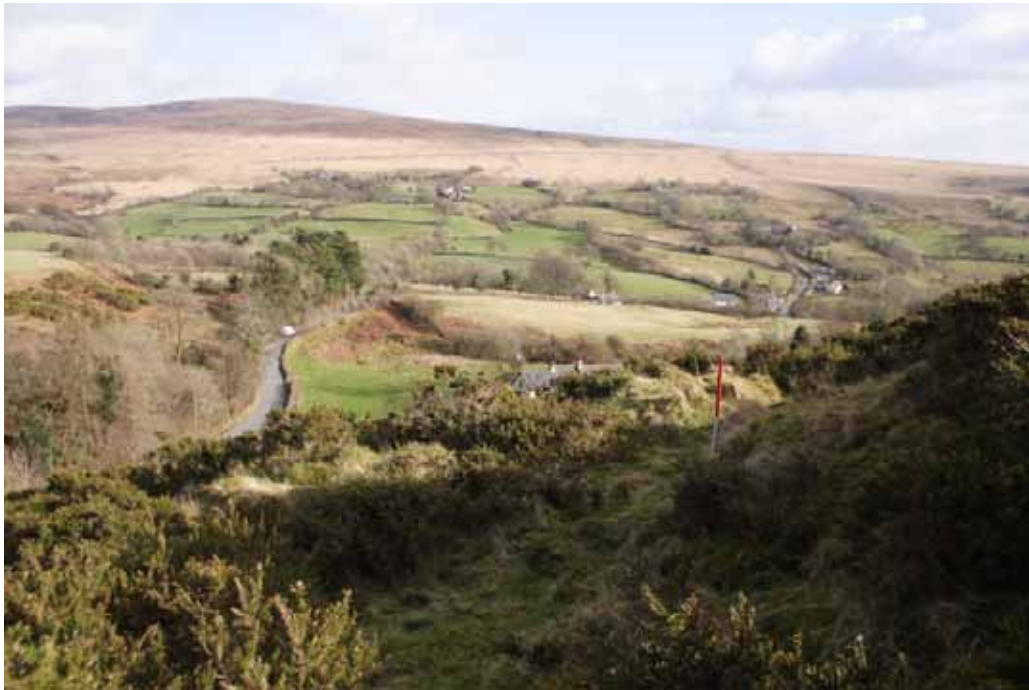
A sub-circular, univallate enclosure that lies on the northeast facing slope of a rocky outcrop at 250m above sea level. In 2008 a single bank appears to enclose an area of approximately 60 - 70m in diameter. The bank is not complete and is not visible on the east where it dwindles to nothing beneath dense gorse growth. However, where it is best preserved on the south it reaches an internal height of as much as 1.5m. A 1.2m gap in the bank on the east may indicate an entrance. The interior of the enclosure is quite steeply sloping, with rock breaking through the surface. There are some level areas that appear to be terraced into the slope, but dense gorse growth prevented further investigation. The quarrying undertaken in the area over the years also hampers an accurate interpretation of the site. There are remains of a modern stonework structure, concrete plinth and metal fittings on the northwest side of the site.

Looking SE from internal area of enclosure towards defensive bank

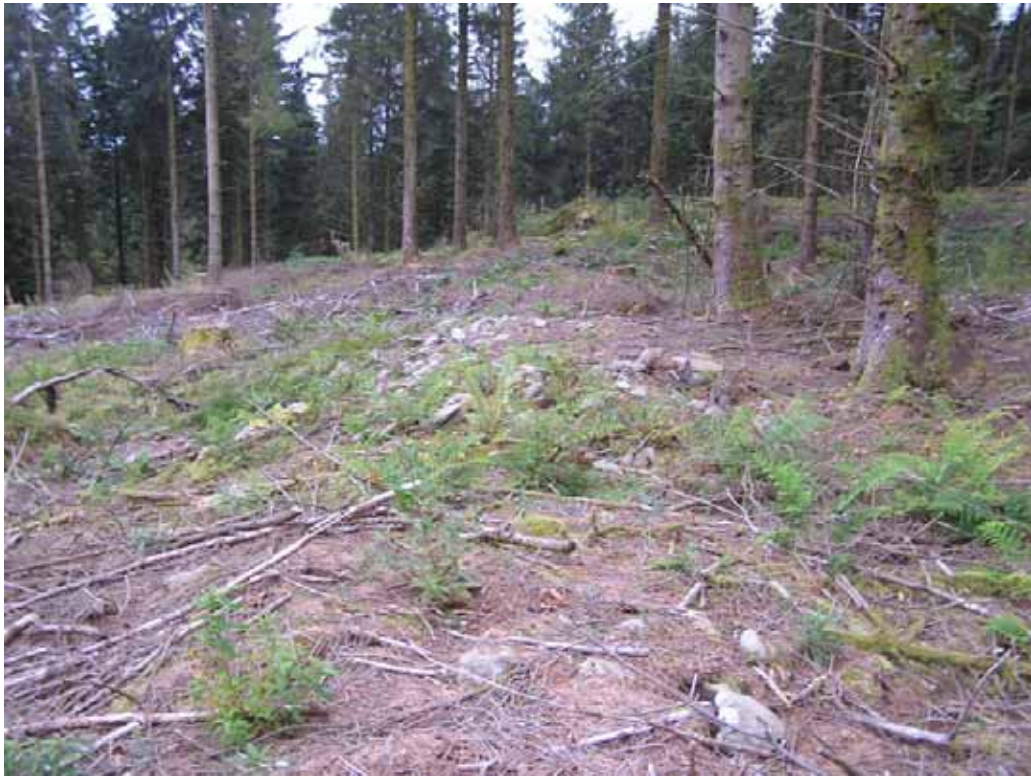
A univallate, sub-circular defended enclosure situated at the west end of a broad ridge at 280m above sea level. To the north, south and west the land falls steeply away and forms a natural defence for the internal area. On the east the defensive circuit is completed by a curved length of wall, 150m long, by 5m wide and 0.6m high. There is no external ditch and no certain evidence of an entrance. The defensive wall does not appear to have ever encircled the whole hill. It is probable that the wall has been greatly reduced over time by stone robbing.

The sloping interior is roughly circular, approximately 120m in diameter, and is now heavily disturbed by forestry activity, after at least two phases of planting. A quarry cut into the steep south slope has also damaged the site.

Looking N along remains of enclosure bank within woodland

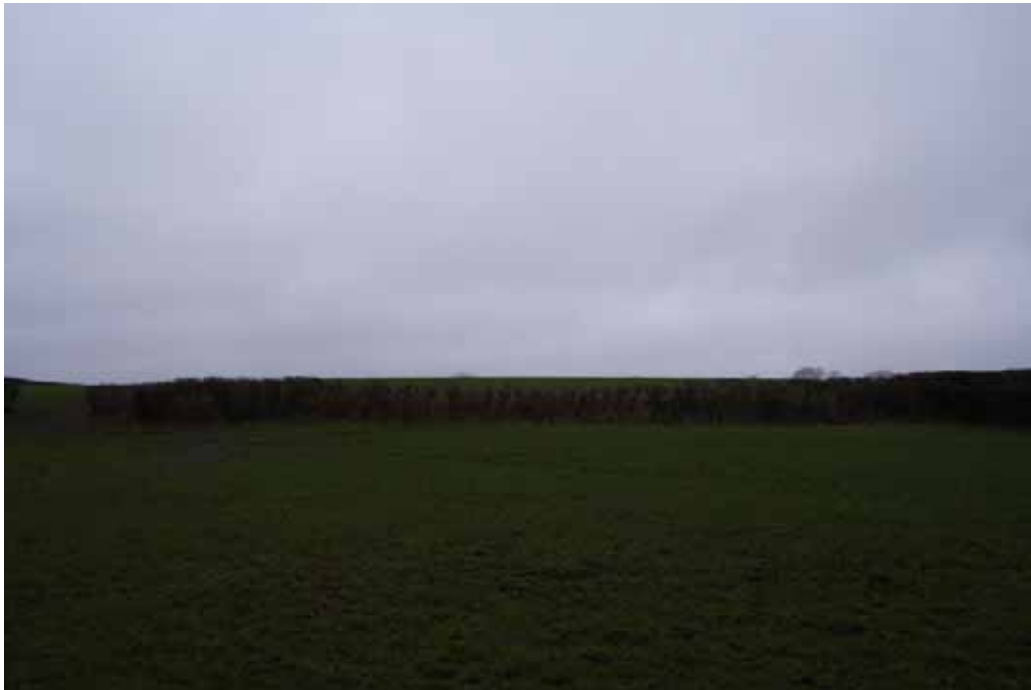
An apparent circular enclosure situated on a gentle southwest facing hillslope at 170m above sea level. A hedge grows along the circular boundary of the enclosure, making it stand out on aerial photographs, and the interior forms a pasture field. The diameter of the enclosure is approximately 100m. In 2008 the site visit found no trace of any banks or ditches. There was no evidence of an entrance into the enclosure, apart from the one used today that is southeast facing, but no earthworks are associated with it. There is quite a marked difference between the ground level of the enclosed circular field and those fields to the north and northeast, with a drop of c1.5m between them, which does give an appearance of there being a bank here. However, this may be exaggerated by what appears to be a modern drainage ditch around the perimeter of the circular hedgebank in this area.

Looking NW at hedgebank boundary that possibly marks outline of circular enclosure

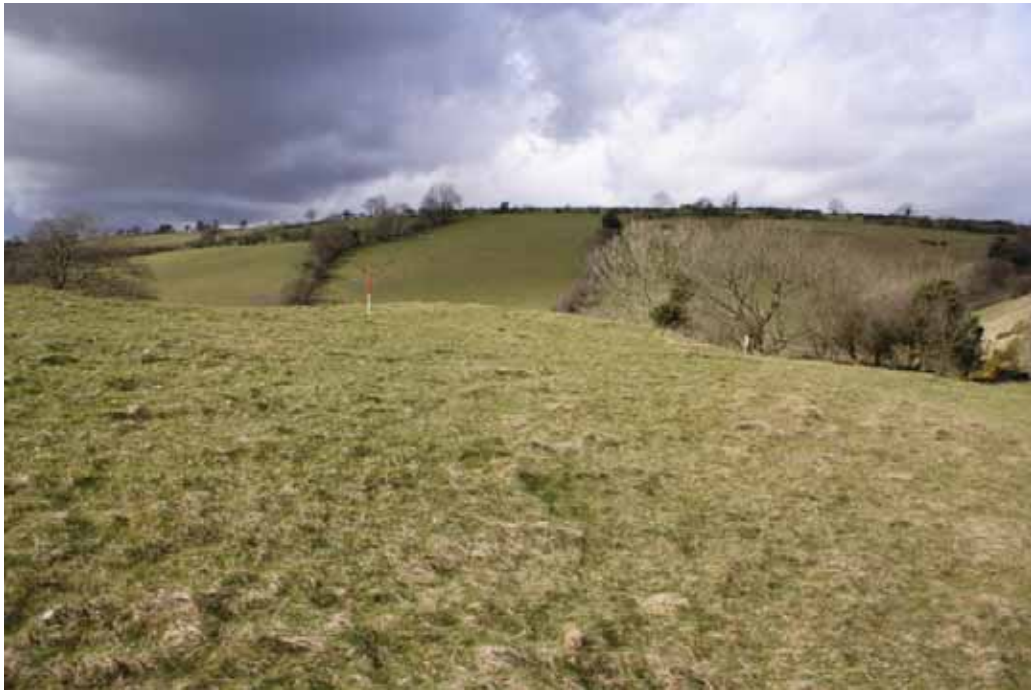
A small roughly rectangular enclosure, approximately 40m north-south and 35m east-west, situated on a low knoll at the south end of a ridge of land at 230m above sea level. In 1917 the RCAHM reported that the earthwork remains were very faint. By the 1970s the Ordnance Survey report that, though weak, it was still possible to trace the defences around the circumference of the knoll's summit. The knoll is naturally well defended by steep slopes in all directions except on the north where the likely approach to the site would be along the ridge. It is on this north side that scarping has produced a low curving bank on top of a scarp with a maximum height of 1.5m. This earthwork was visible in 2008, as was a faint trace of an outer ditch in this area. However, on the ground there was now no trace of a bank surrounding the summit of the knoll.

The area has been heavily ploughed over the years and the site now has a smooth spread profile. In 2008 there was no evidence for an entrance on the ground. The site is under pasture, with gorse growing on the steep natural slopes.

Looking WNW towards earthwork of defended enclosure

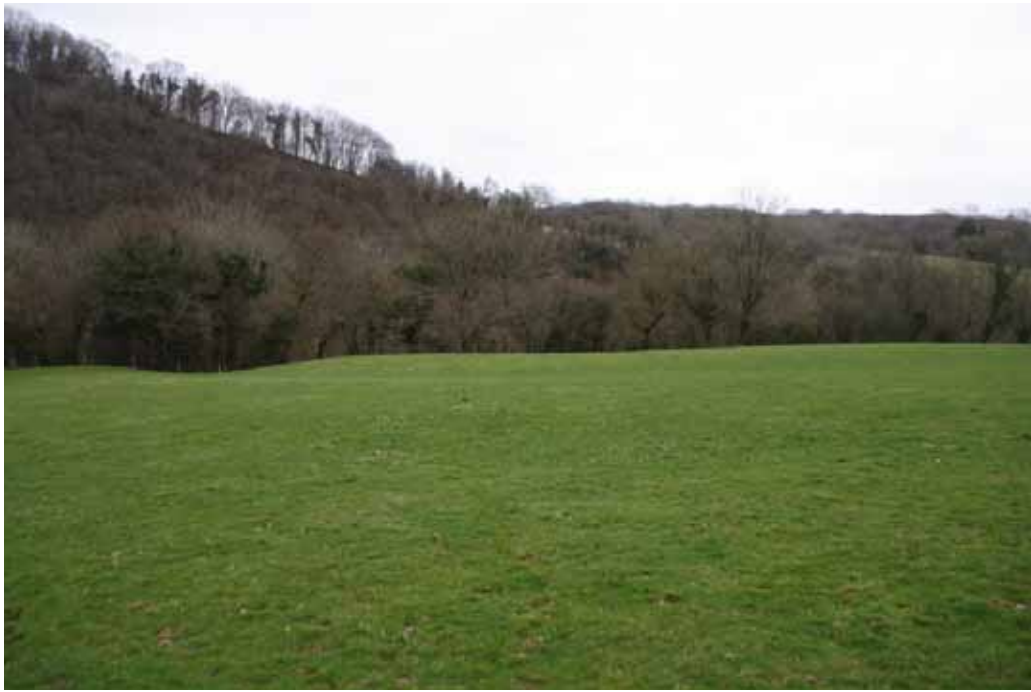
In 2008 the site's condition had changed little since the earlier Ordnance Survey visit except that the earthwork appeared more spread, and a faint suggestion of an inner bank on the edge of the ditch could be seen. There did appear to be a faint trace of a second outer ditch beyond the northwest end curving around to the south, but it was very weak. It is difficult to judge the size of the enclosure but it would appear to be approximately 90m by 50m to the furthest extent of the ditches. It would have enclosed an internal area of c.60m by 40m. No entrance was visible on the ground. The interior of the enclosure has a slightly hollowed appearance.

Looking E across enclosure outer bank and ditch

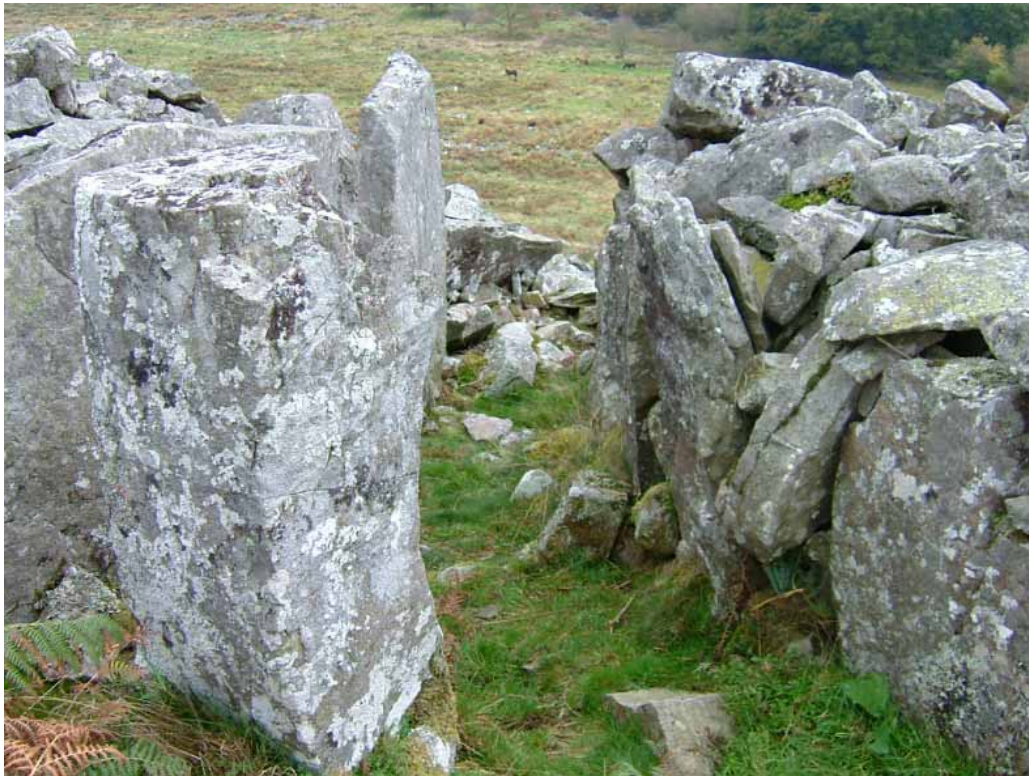
At least eight gateways have been identified. The main entrance is on the northeast end with a double portal and there is a single broad gateway on the southwest side. There are six "posterns"; four on the northwest side and two on the southwest.

Facing SE looking at one the southeastern postern gateways

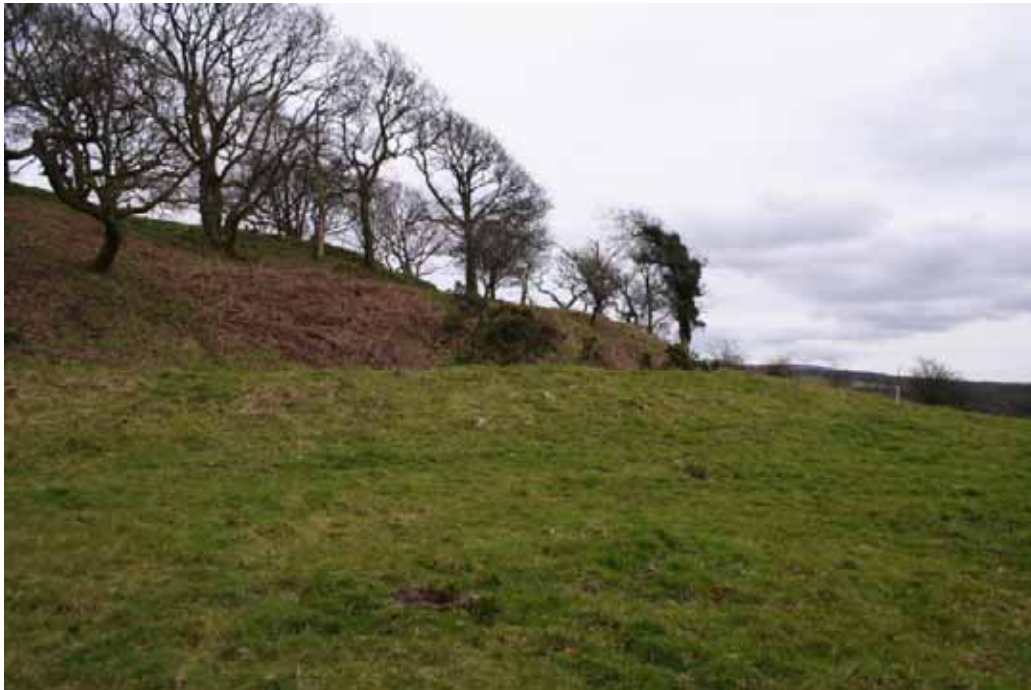
Looking S at curving defensive bank of possible hillfort

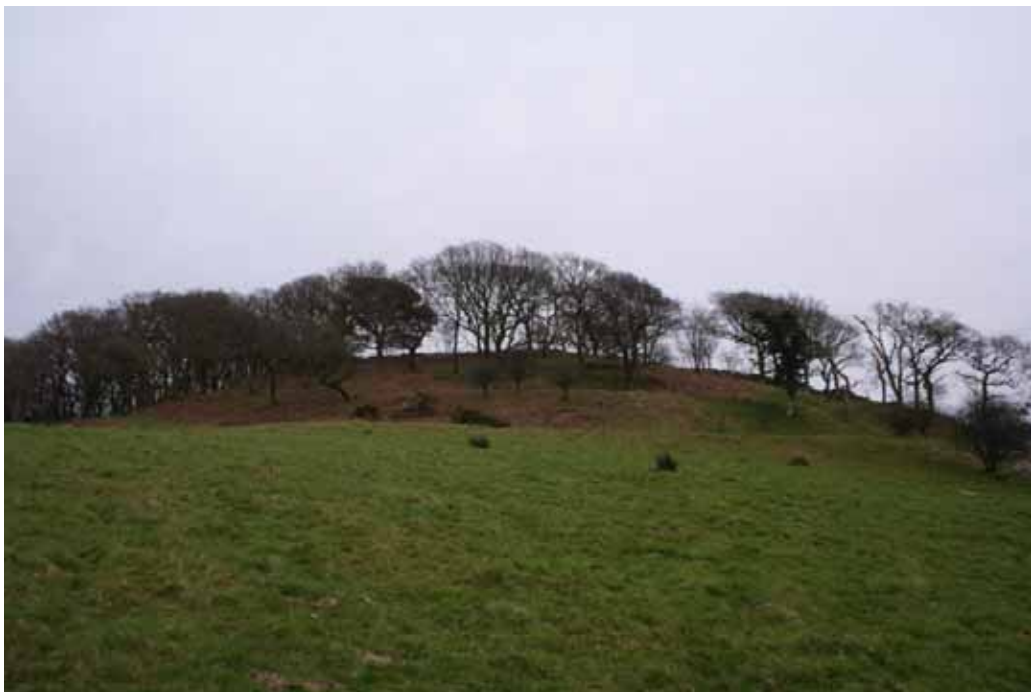
Looking E at curving defensive bank of possible hillfort

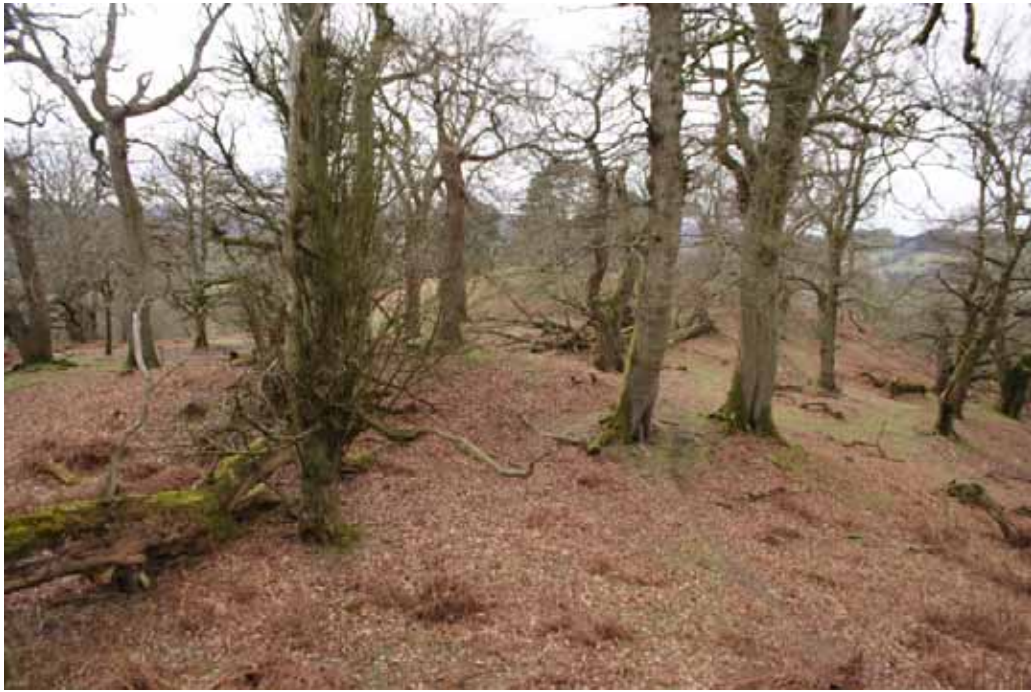
Looking SW at defensive bank and ditch of inland promontory

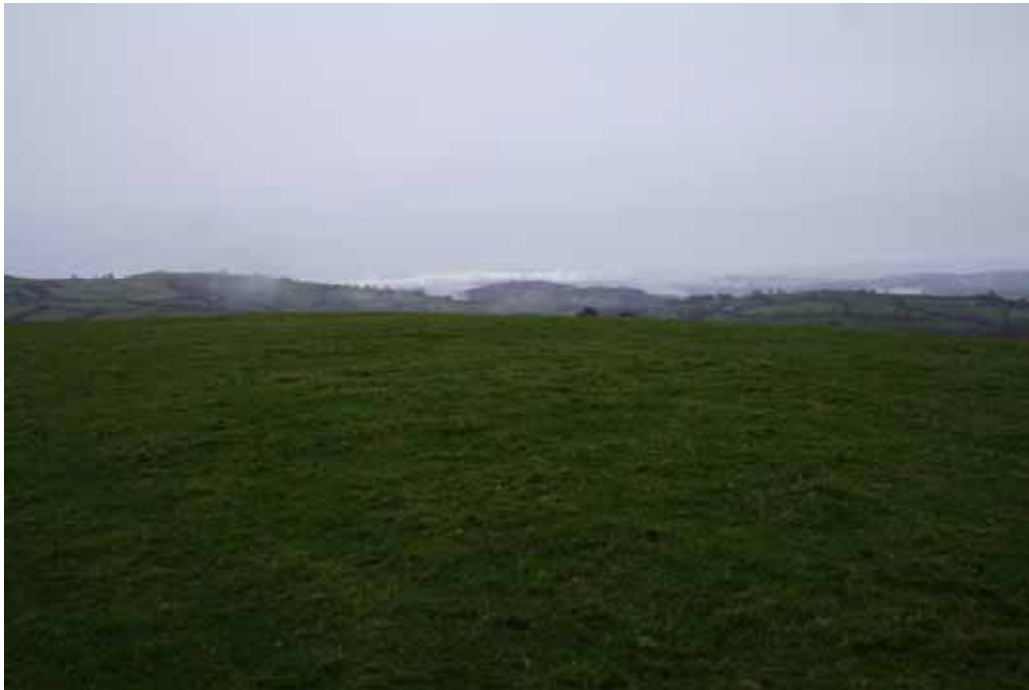
Looking SW across site of crop mark enclosure - located on summit of hill - enclosure ditches just visible in places

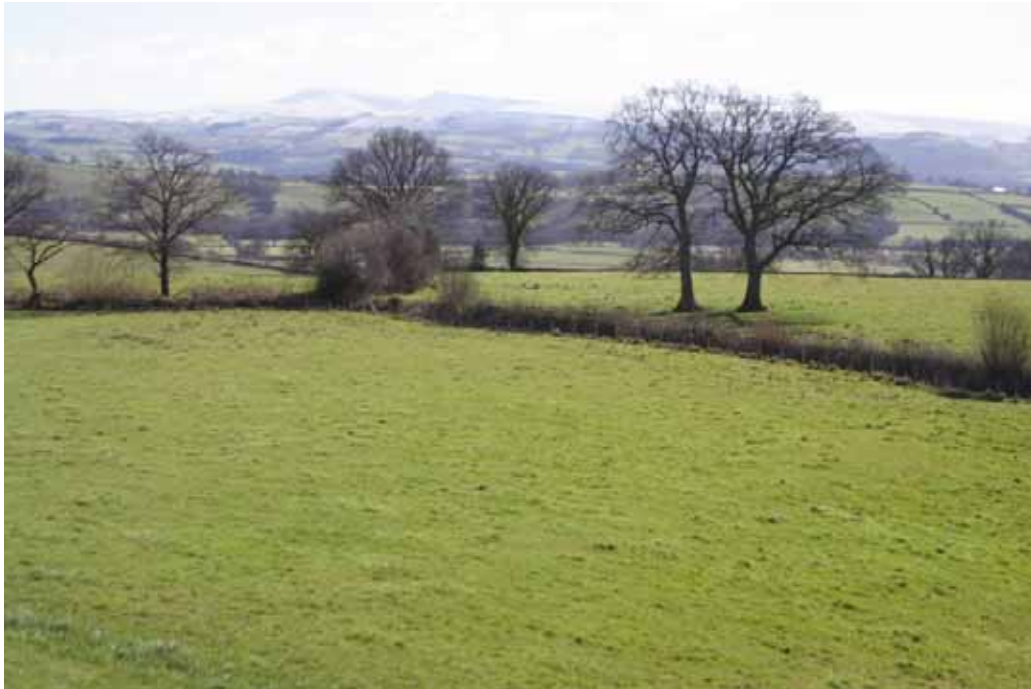
Looking SE across area or cropmark circular enclosure

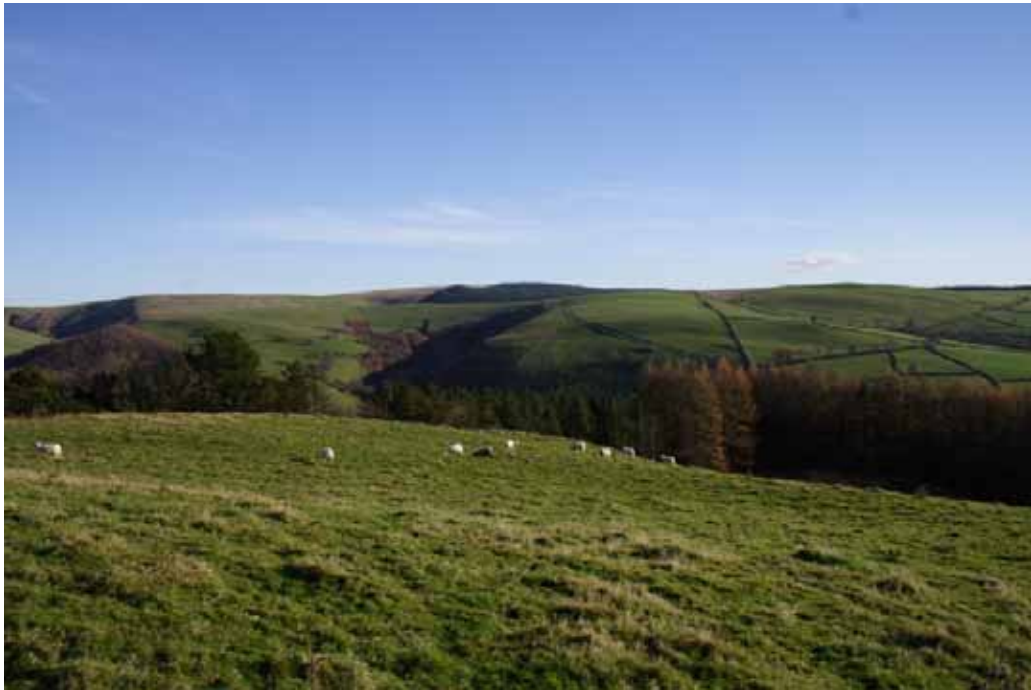
A polygonal defended enclosure located during aerial survey in 2002 by the RCAHMW. It is situated towards the summit of a hill at 280m above sea level, on a southeast facing slope. Measuring approximately 65m by 80m the enclosure would appear, from the aerial photographs, to survive as a low earthwork. However, the 2007 site visit found the area to be one of rough pasture where no earthworks could be traced on the ground.

Looking NE across site of crop mark enclosure site - identified by aerial photo.
