# **A SURVEY OF DEFENDED ENCLOSURES IN PEMBROKESHIRE, 2006-07: GAZETTEER OF ORDNANCE SURVEY GRID SQUARE SM92**

RHIF YR ADRODDIAD / REPORT NO. 2007/01  
RHIF Y PROSIECT / PROJECT RECORD NO. 54269

## SITE GAZETTEER OF 10KM GRID SQUARE SM92

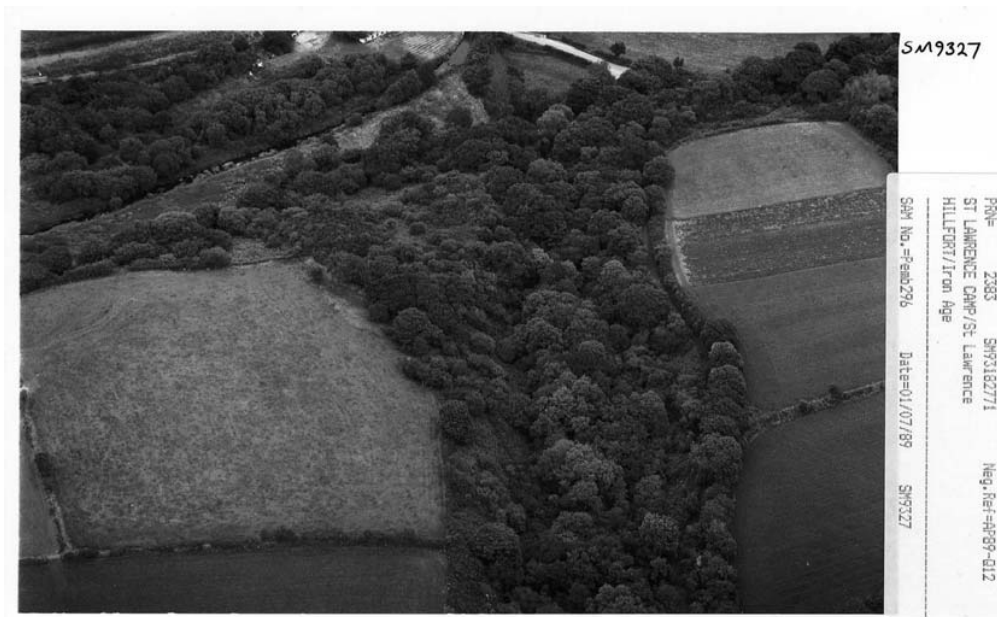
Aerial photograph of 2383. Cambria Archaeology reference AP89-Q12.

St Lawrence Camp is an inland promontory fort lying at 65m above sea level naturally defended by steep slopes to the north, east and west that fall away by 20m to valley bottoms. Land rises gently away from the site to the west. The roughly triangular internal area measures c. 40m E-W and 35m N-S. A rampart runs across the neck of the promontory for c.50m. The bank is 2m above the interior of the fort and 2.3m above the ditch. A low counterscarp bank runs along the outer lip of the ditch. The whole of this defensive system is c.15m wide. There is a much-altered entrance at the southern end of this defence. Cadw's field monument warden noted two further lines of bank and ditch outside the main defence, while Crossley has this as a bivallate fort.

The interior is under unmanaged deciduous woodland. The outer earthworks have been damaged by cattle trampling in the past.

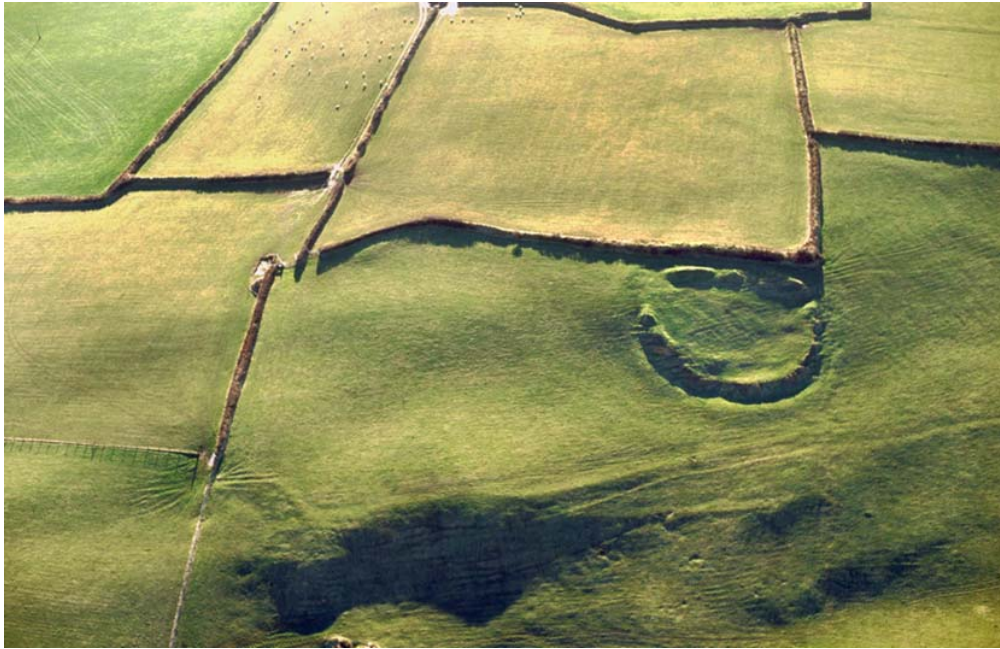
Aerial photograph of 2385. RCAHMW Crown Copyright ©  
reference DI2006\_0956.

Ford Camp is a small, circular, earthwork defended enclosure lying on a north-facing slope at 60m above sea level. The sloping interior measures approximately 47m in diameter and is defined by a bank. The bank rises c.0.7m-1.0m above the interior and exterior, though in places is up to 1.7m high internally. Aerial photographs show a slight ditch on the north and west sides, but this is not readily visible on the ground. The entrance probably lay on the southwest side.

The bank is in poor condition, with several breaks in it and with animal erosion exposing the core of the bank causing it slip downhill. The interior is under pasture.

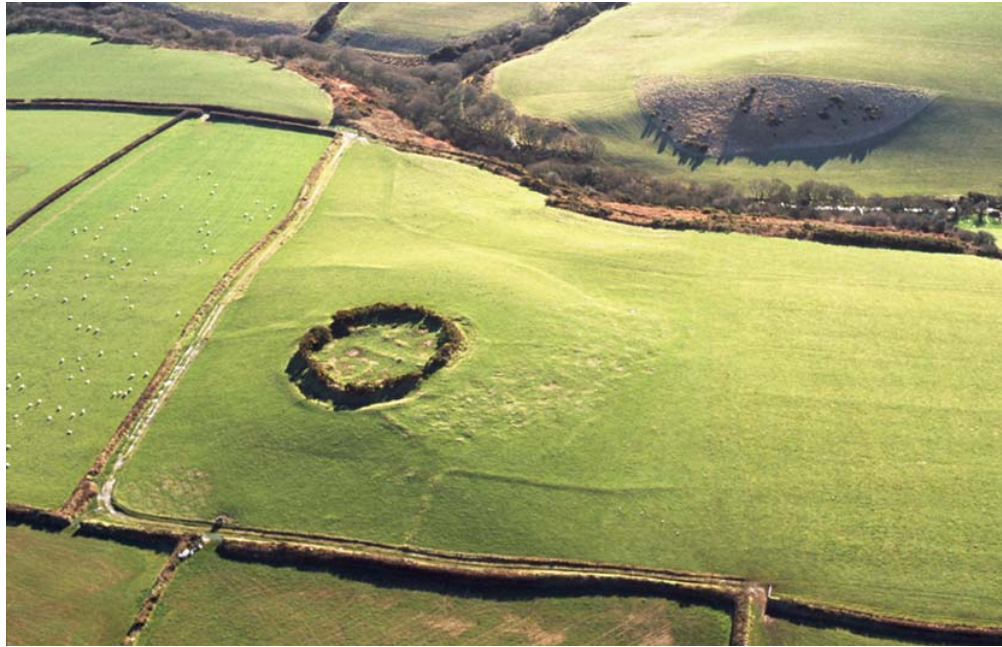
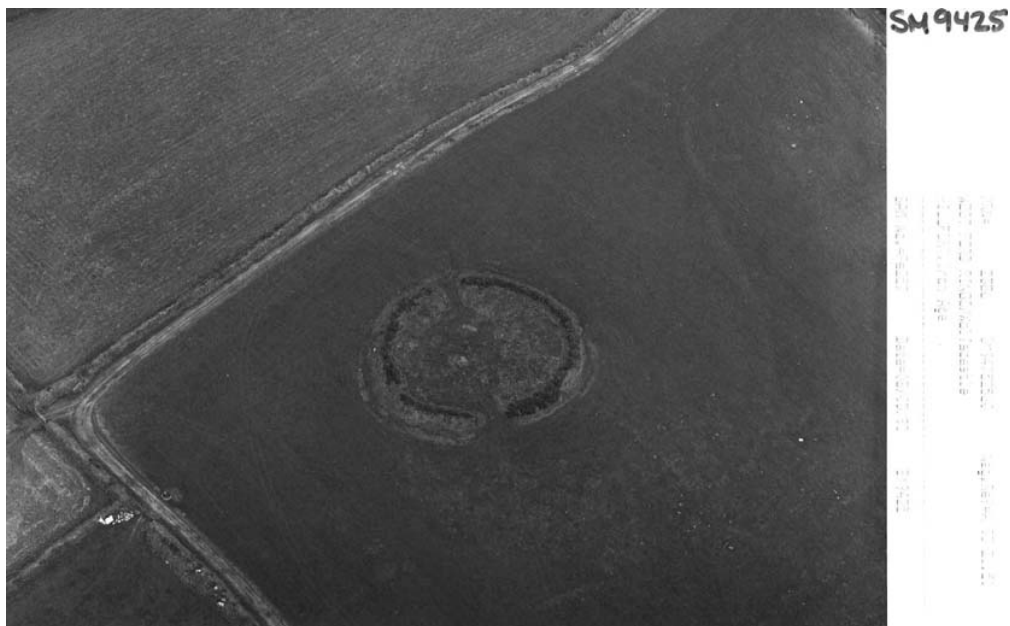
Aerial photograph of 2386. RCAHMW Crown Copyright © reference DI2006\_0737.

West Fort Rings is a small, sub-circular, earthwork defended enclosure lying on a very gentle southeast-facing slope at 85m above sea level. To the south of the enclosure the land falls more steeply away to a stream 30m below. The site is defined by an earthwork bank, ditch and counterscarp bank. The bank rises up to 1m above the interior and 2m above the ditch. The counterscarp bank is just 0.2m high. The whole system is c. 9m wide. There is a slightly in-turned entrance on the southeast side. The interior is c. 45m in diameter. The interior is now undulating. However, the Ordnance Survey in 1964 and 1966 recorded two earthwork, circular huts just inside the entrance, one on either side. At a later date only the northern most hut, 10m diameter was recorded, with the southern part of the enclosure containing a series of banks. These are not now readily detectable.

Aerial photographs show a series of small undulations outside the enclosure on the north and west sides, and possibly contemporary field boundaries to the south.

The interior and exterior of the enclosure are under improved pasture. The banks are under scrub.

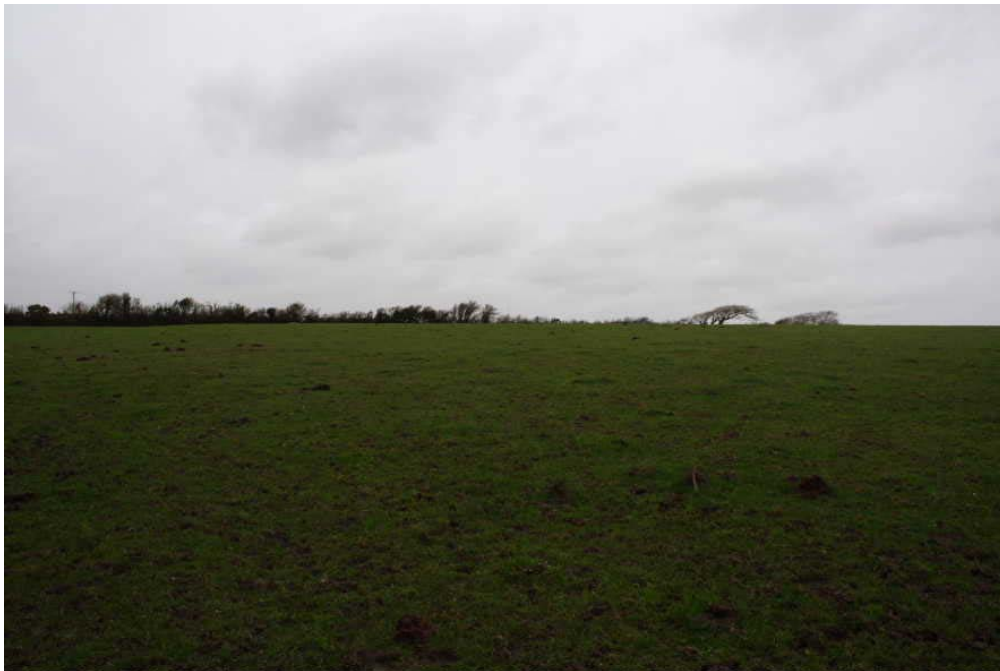
Vertical aerial photographs (Meridian 1955) show a crop-marked ditch defining a sub-circular enclosure. The enclosure is about 55m in diameter internally and has a clear east-facing entrance. The photographs seem to show a slightly raised interior.

On the ground the site is marked by low earthwork bank surrounding a slightly raised and dished interior. It has clearly been plough-levelled and very little trace of it now survives.

The site occupies a gentle southeast-facing slope at c.90m above sea level. In 2006, the site was under improved pasture.

Ground photograph looking NE over low earthwork enclosure 2399.

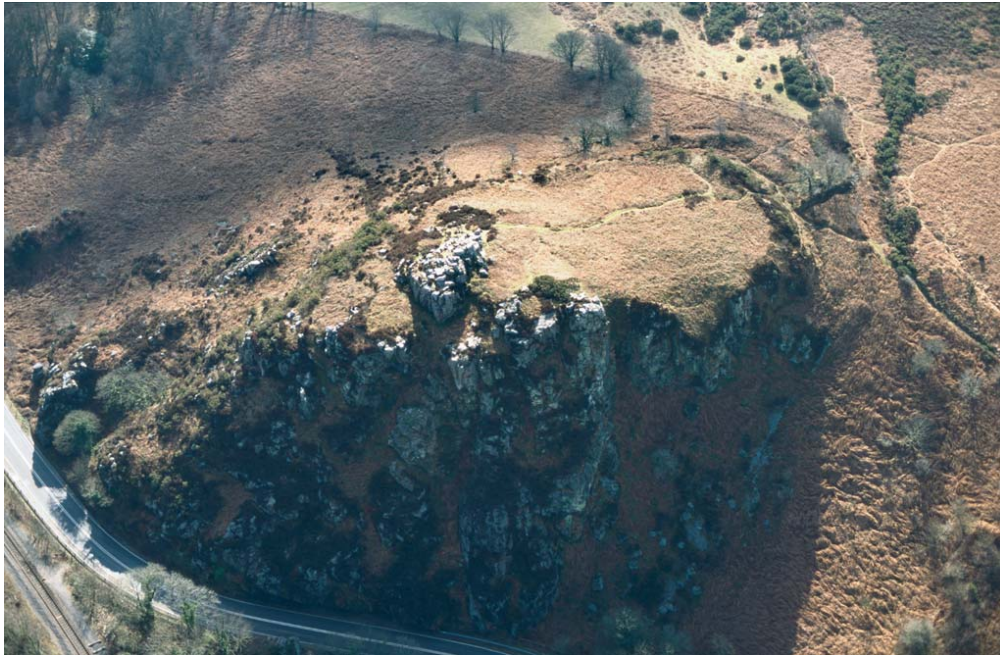
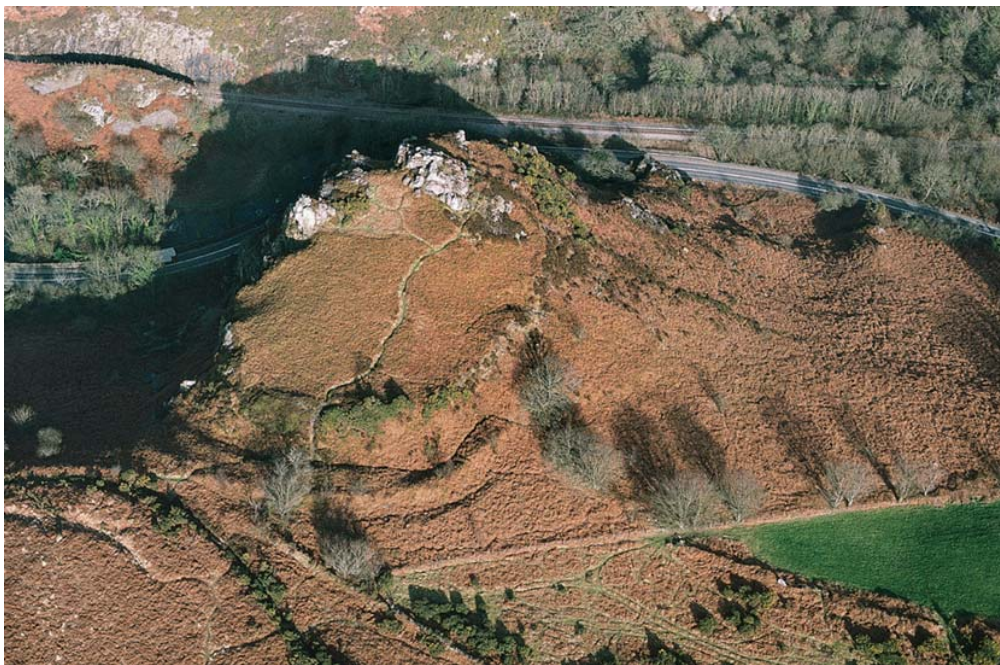
Aerial photograph of 2400. RCAHMW Crown Copyright ©  
reference DI2006\_1538.

The hillfort at Great Treffgarne Rocks is dramatically sited on a rocky spur overlooking the valley of the Western Cleddau at 80m above sea level. To the north, east and southeast land falls precipitously away to the river 50m below. To the west land falls 10m into a saddle before rising again to a high point 1.5km away. The roughly oval interior, 75m E-W and 53m N-S, is defended by a single bank and ditch, and by a second bank and ditch on the easily approachable west side. On the east side the bank is incorporated into the rocky outcrop over vertical cliffs. The inner bank stands up to 4m on the west side, and the outer bank 1.7m. The ditches are well-defined. The entrance lies on the south side and is marked by a slight in-turning of the banks. The site is under bracken with scrub on the inner bank.

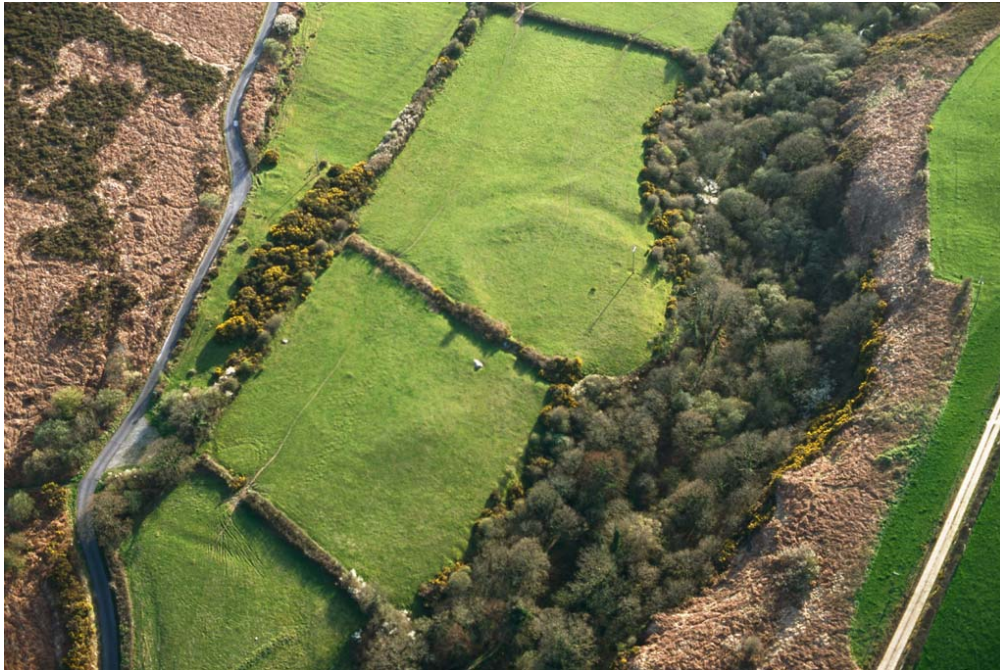
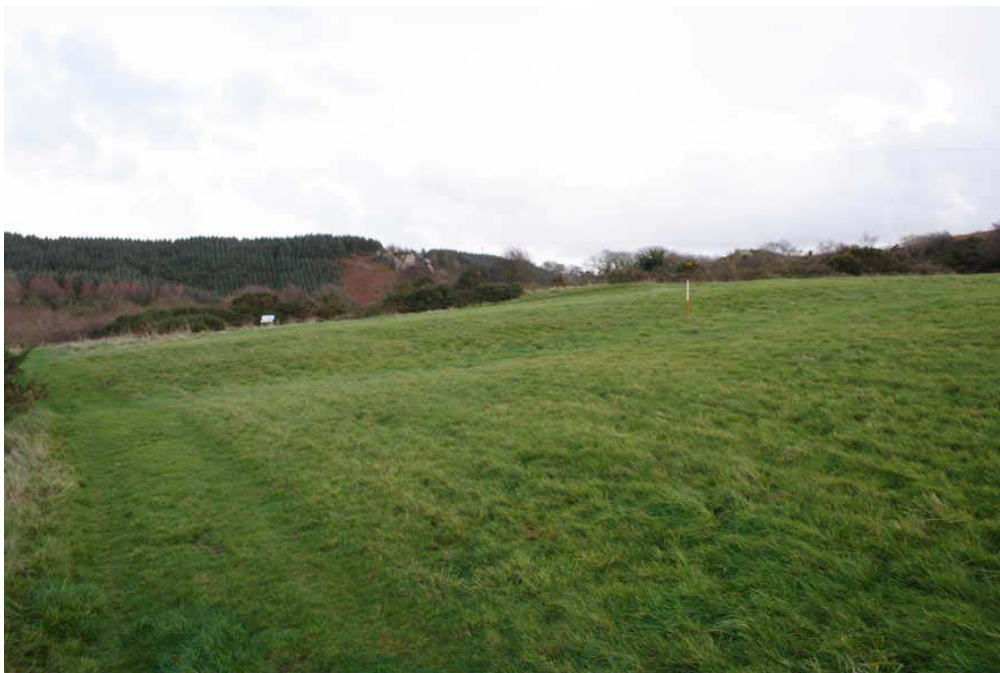
Aerial photograph of 2403. RCAHMW Crown Copyright © reference DI2006\_1564.

This is a small, earthwork, sub-circular defended enclosure lying on a north-facing slope between 40m and 50m above sea level. Immediately to the north the slope steepens as it falls away to Nant y Coy 10m below. The break of slope defines the edge of the enclosure on the north side and a hedge-bank lies along the defensive bank on the east side. Elsewhere the defensive circuit is marked by a curving bank c.0.3m high internally with an external ditch. Aerial photographs suggest that the rampart continues along the crest of the slope on the north side. There is no trace of an entrance on the ground, but the aerial photographs suggest it may be below the hedge-bank on the east side. The internal sub-circular area of the enclosure is c.45m diameter.

Slight, undefined earthworks on the west side of the enclosure may be evidence of outworks, aerial photographs, however, suggest a natural gully.

The site is under improved pasture.

Ground photograph looking SE over enclosure earthworks.

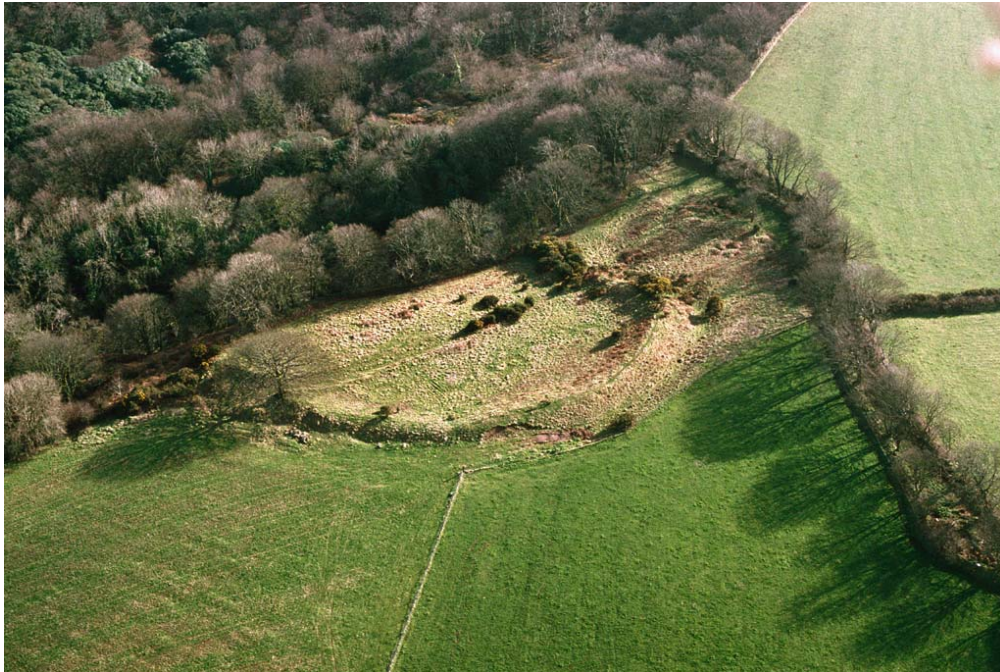
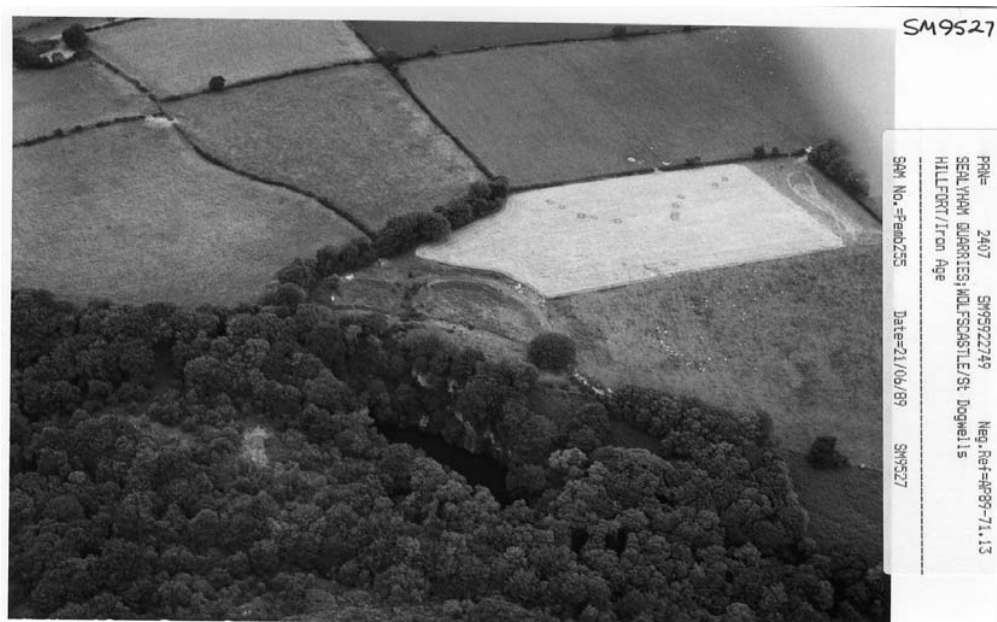
Aerial photograph of 2407. RCAHMW Crown Copyright © reference DI2006\_1563.

Sealyham Quarry is a fine example of a defended enclosure, albeit one that has been damaged by quarrying.

It is located on a gentle southwest-facing slope at c.80m above sea level. The cliff of a long-abandoned quarry now defines the eastern side of the site. It is likely, given the topography, that the defences never formed a complete circuit, but relied on a steep slope on the east side as a natural defence, making this a scarp-edge site or inland promontory fort. This is not certain, and can now never be proved. The original size of the fort is also unknown.

The main defence consists of a curving bank and ditch, enclosing a semi-circular area c.65m SW-NE and 38m SE-NW with the quarry face defining the east side. The bank is c.2m high and the ditch up to 1.2m deep. A rectangular annexe c.40m by 20m is attached to the southwest side of the main enclosure. This is defined by a low bank and ditch to the west, a low bank to the south and the quarry face to the east. In-line gaps through the south side of the annexe bank, and the bank on the north and south side of the main enclosure are from an old track. The location of the original entrance is unclear.

The interior of the enclosure is covered with bracken and the defences by bracken and gorse.

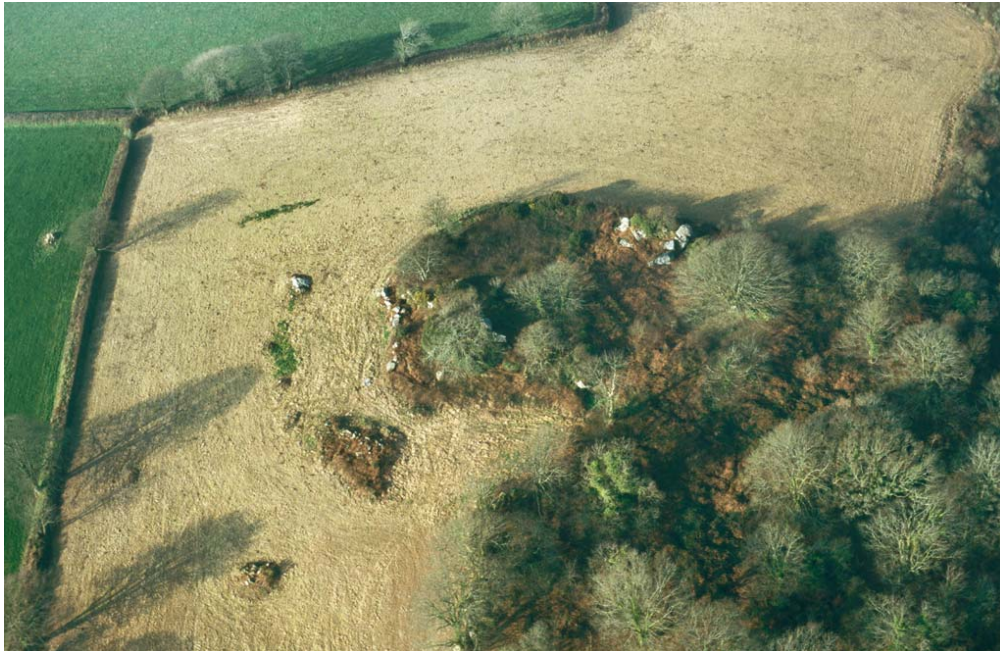
Aerial photograph of 2408. RCAHMW Crown Copyright ©  
reference DI2006\_1547.

An oval, univallate defended enclosure c. 80m E-W and 40m N-S occupies a blunt inland promontory 85m above sea level, from which land falls away steeply to the north, east and southeast. The single rampart incorporates Sealyham Rocks in its circuit. The bank survives up to 2m high above the interior and 3m above the exterior. The defences are difficult to make out on the east side where they run into scrub. On the northwest side and south side the ditch to the bank has been plough-filled. In 1973, the Ordnance Survey noted a fragment of dry-stone walling in the bank on the northeast side. A break in the defences on the southeast side is probably the original entrance. The interior is uneven and bracken-covered.

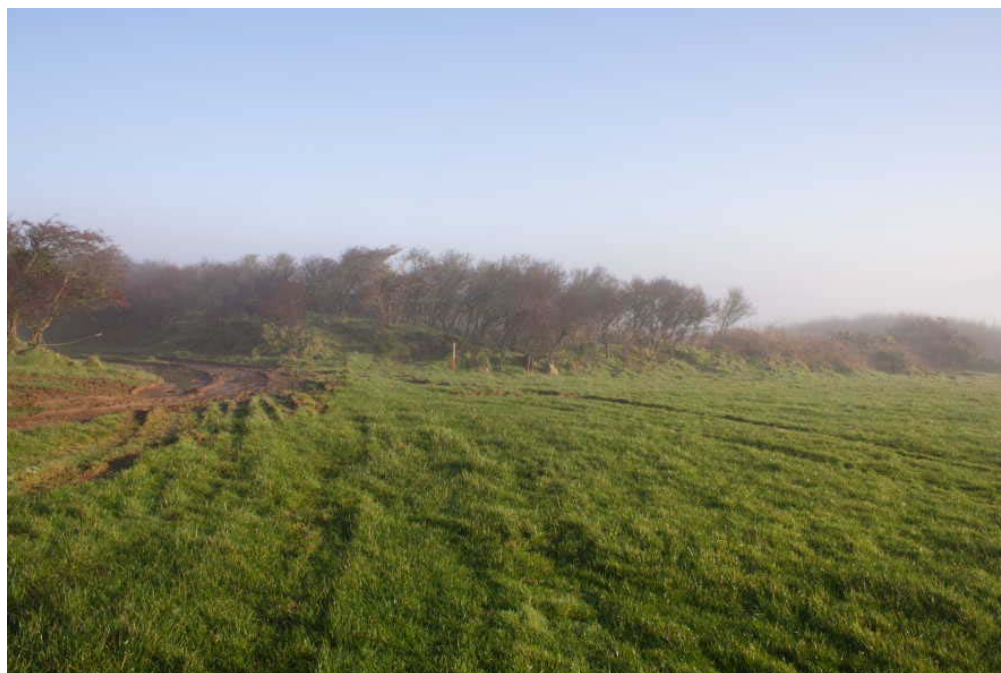
Aerial photograph of 2413. Cambria Archaeology reference AP86-18.5.

Castell Pentre is a small, sub-circular, earthwork defended enclosure, c.50m across internally, occupying a southeast-facing slope at 170m above sea level. The site is very overgrown with gorse, blackthorn and bracken and so is consequently difficult to characterise. The defences can, however, be made out. These consist of a bank and a ditch. The bank is best preserved on the north, northwest and west sides where it stands up to 1.5m high. A road has disturbed and probably destroyed the bank on the east side. An external ditch is visible on the south and southeast sides. A track runs along the location of the ditch on the northwest and north sides obscuring it. There is no obvious entrance.

The site is suffering damage from burrowing animals, particularly badgers, and also from cattle trampling.

Ground photograph looking E towards earthwork enclosure.

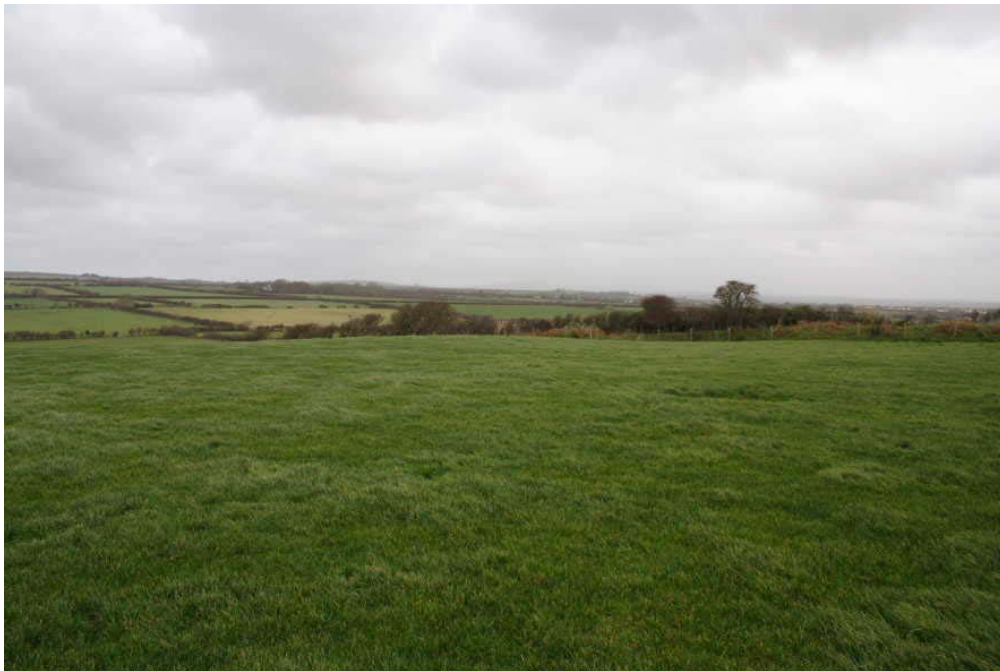
Rosemary Rath is a, small earthwork defended enclosure. It occupies a north-facing slope at 60m above sea level, some 75m south of a rounded hilltop. Immediately to the north the slope steepens and falls into a small valley. It is unclear from the surviving remains of this site whether this scarp-edge provided sufficient natural defence without the addition of a rampart, or whether the defences were a complete circuit - the RCAHM in 1925 considered it was the former. The remains of the site comprise a low, spread, crescentic bank, c.75m long and 0.5m high, representing the defences on the south side of the enclosure. The bank stops some 23m short of the scarp-edge. The bank encloses an area c. 65m diameter. The RCAHM noted a west-facing entrance.

P Sambrook in 1999 noted a slight linear depression outside, south, of the bank, possibly of a second line of defence, indicating that this is a bivallate enclosure.

A bank up to 1.5m high attached to the eastern end of the crescentic bank and forming two sides of a rectangle lying in a field to the east may outworks/entrance to the enclosure.

The Ordnance Survey state that this site was bulldozed in 1965, but would seem to have suffered severe plough-damage prior to this date. In 1925 the crescentic bank stood up to 6ft above the interior and 8ft above the exterior - there was no trace of a ditch. The site is under improved pasture.

Ground photograph looking NE over low earthworks of enclosure 2422.

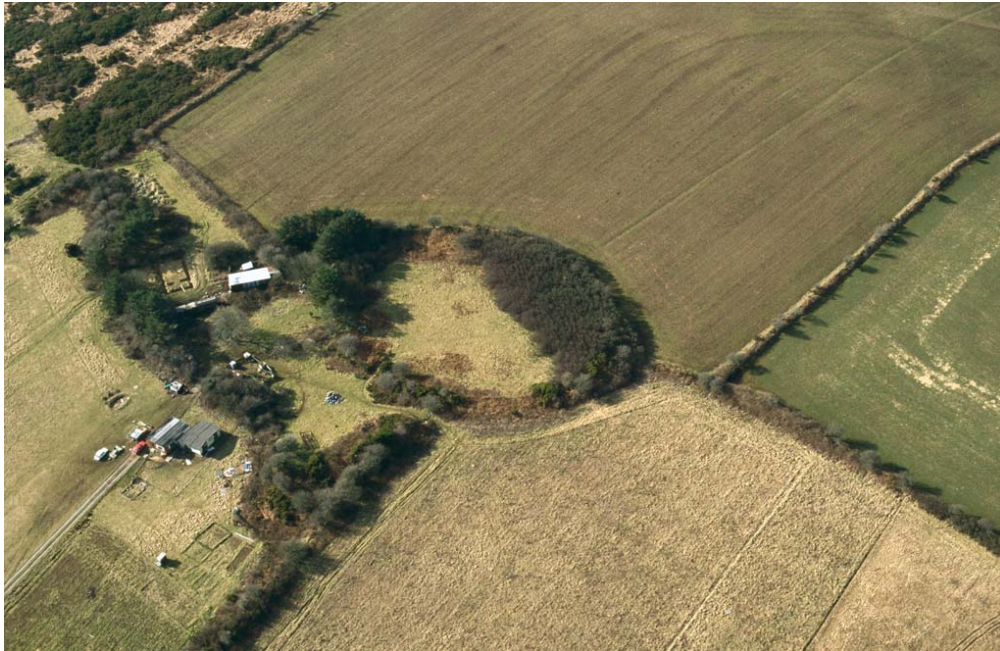
Aerial photograph of 2426. RCAHMW Crown Copyright ©  
reference DI2006\_1546.

Plumstone Rath is a univallate, oval, earthwork defended enclosure, with a sub-rectangular annexe attached to its south side, occupying a gentle southeast-facing slope at 130m above sea level. The oval enclosure is 85m SW-NE and 55m SE-NW internally, and is surrounded by a bank that rises 1.3m to 1.6m above the interior and 2.6m to 3.3m above the exterior. There is no trace of a ditch. An entrance through the bank on the south side leads into the annexe. The annexe is c.70m E-W and 30m N-S and is defended by a bank which rises up to 1m above the interior and 3m above the exterior. There is no trace of a ditch. The western side of the annexe has been damaged by a house (now ruined) and its enclosures. There is no surviving external entrance into the annexe. The defensive banks are scrub-covered and the interior of the main enclosure and annexe are under improved pasture.

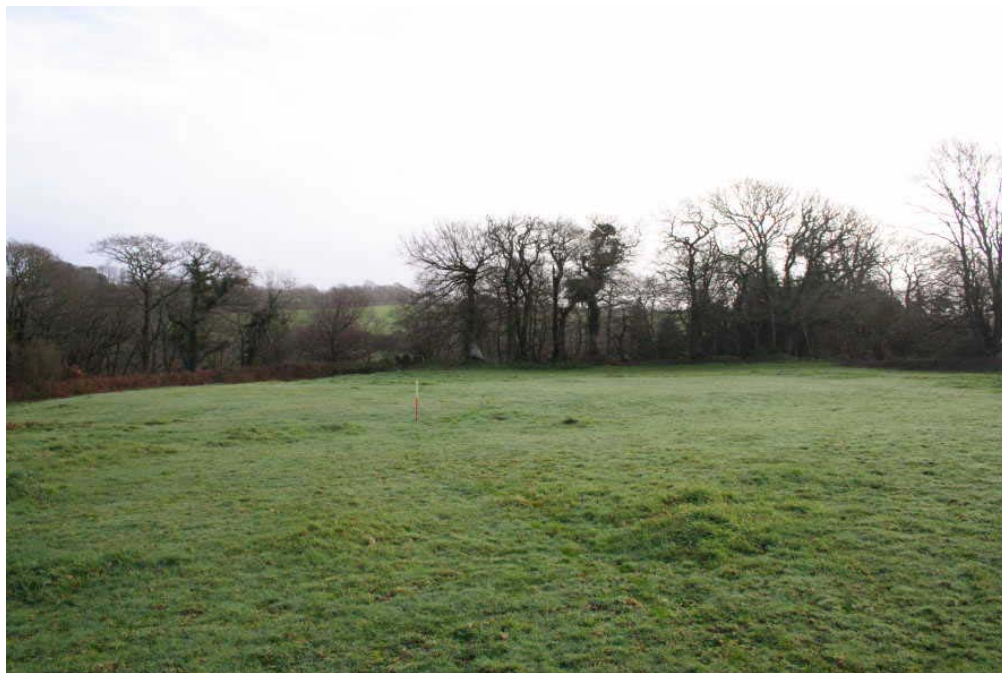
Cannon Hill is a small defended enclosure occupying an east-facing slope at 50m above sea level on the edge of a steep valley side that falls away immediately to the east of the site to a small stream c. 15m below. The enclosure measures approximately 48m N-S and 37m E-W internally, and is defined by a low earthwork defence. On the west side this comprises a 0.5m high, spread, curving bank with traces of an external ditch. On the south side a field-bank overlies the defence and on the north side the bank fades, but seems to have a gap, possibly an entrance. The east side is marked by a scarp with traces of an external ditch. The interior and most the defensive circuit is under improved pasture with deciduous woodland on the slopes on the east side of the site.

Ground photograph looking E over low earthwork enclosure 2459.

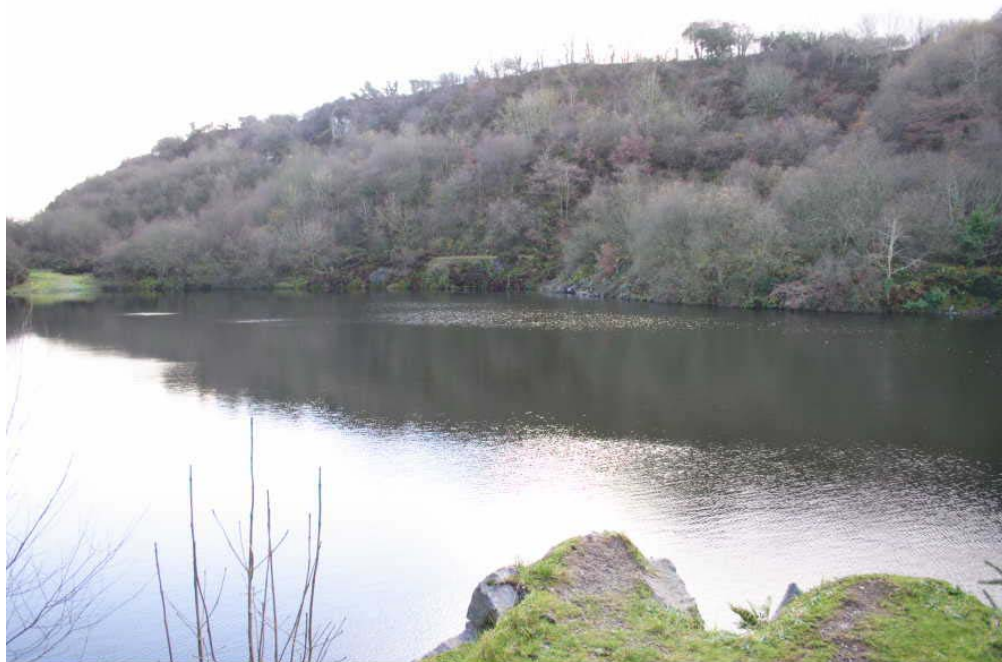
Ground photograph looking S over site of former earthwork enclosure 2461 destroyed by quarry.

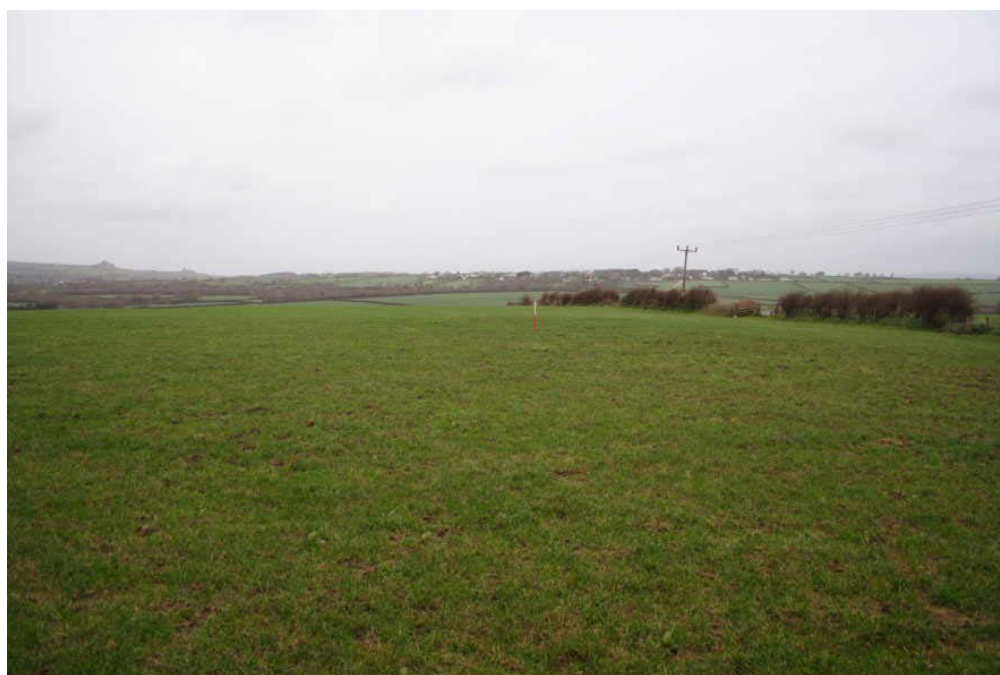
Ground photograph looking N over earthwork enclosure 2464.

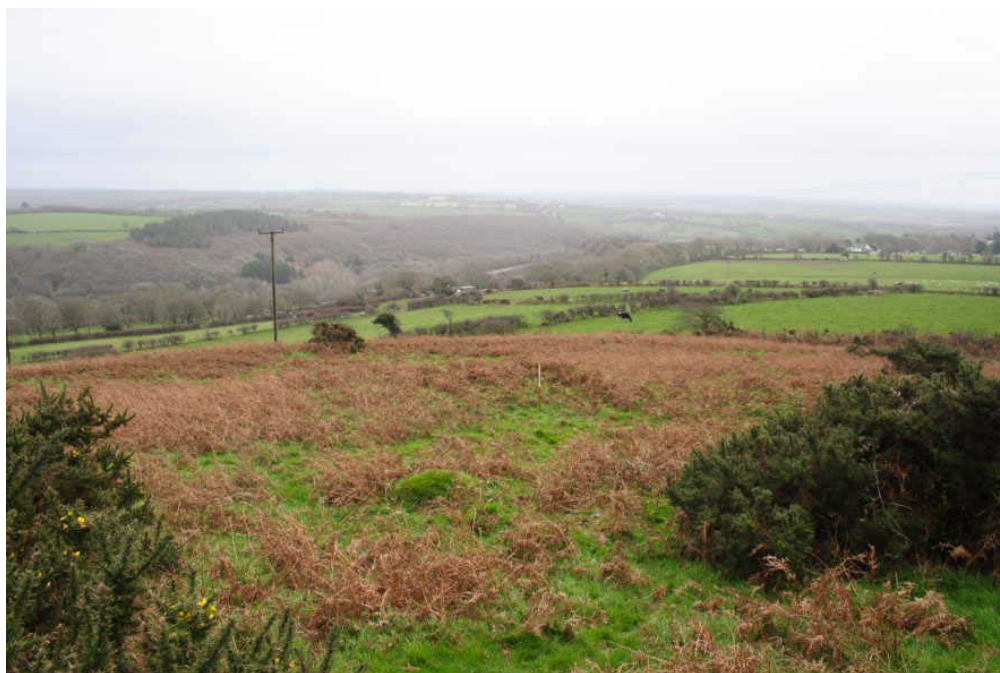
Ground photograph looking SW over interior of enclosure.

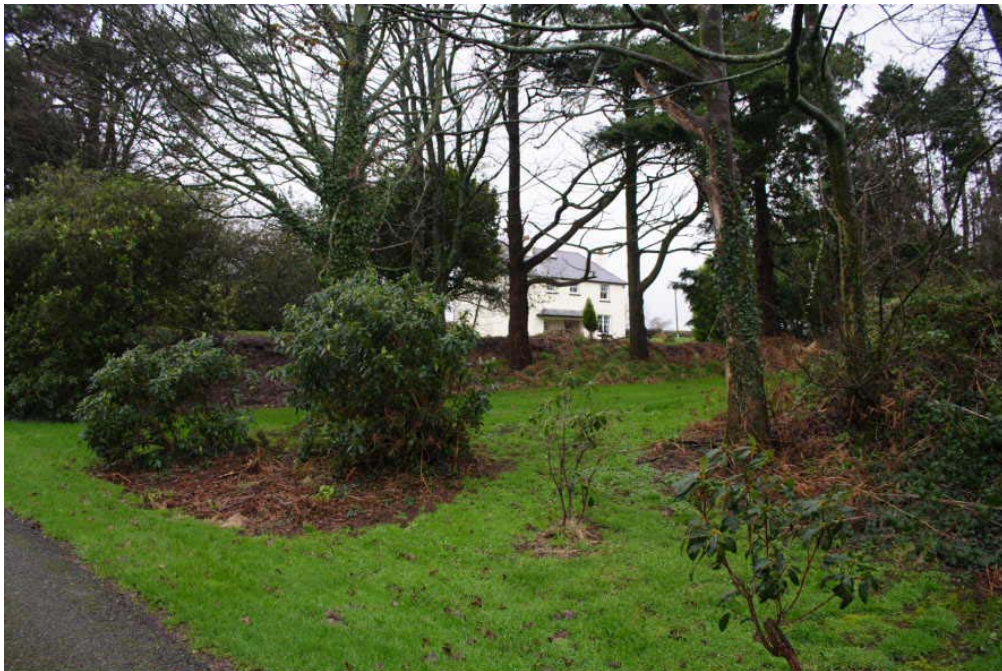
Ground photograph looking E over interior of enclosure 2471.

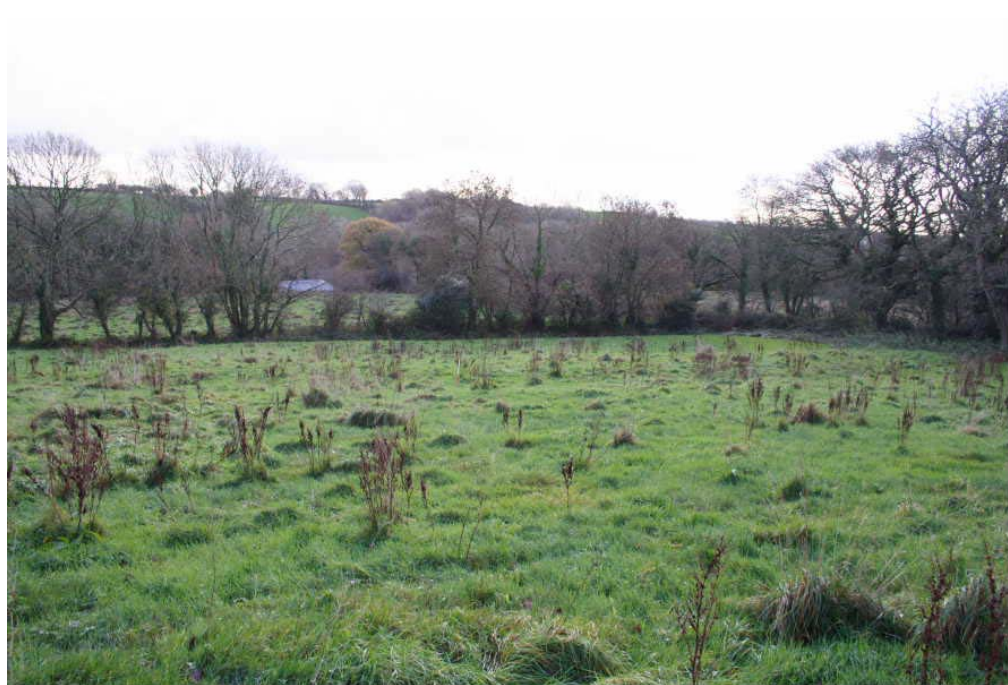
Ground photograph looking SE over earthwork enclosure 4584.

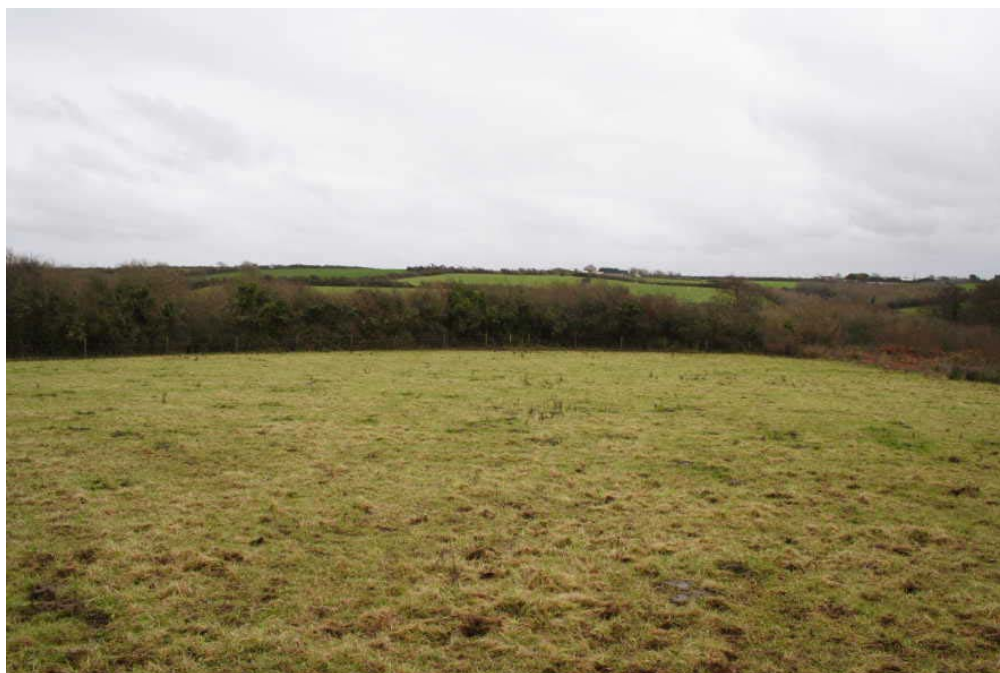
Ground photograph looking S over site of supposed cropmark enclosure 8392.

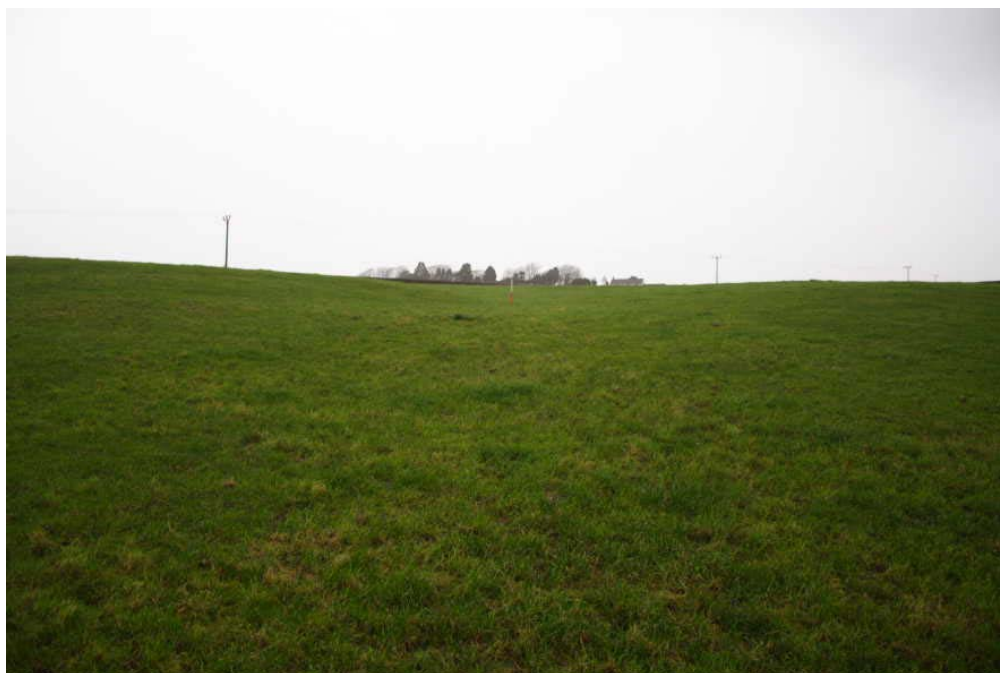
Ground photograph looking N into interior of enclosure 14240.

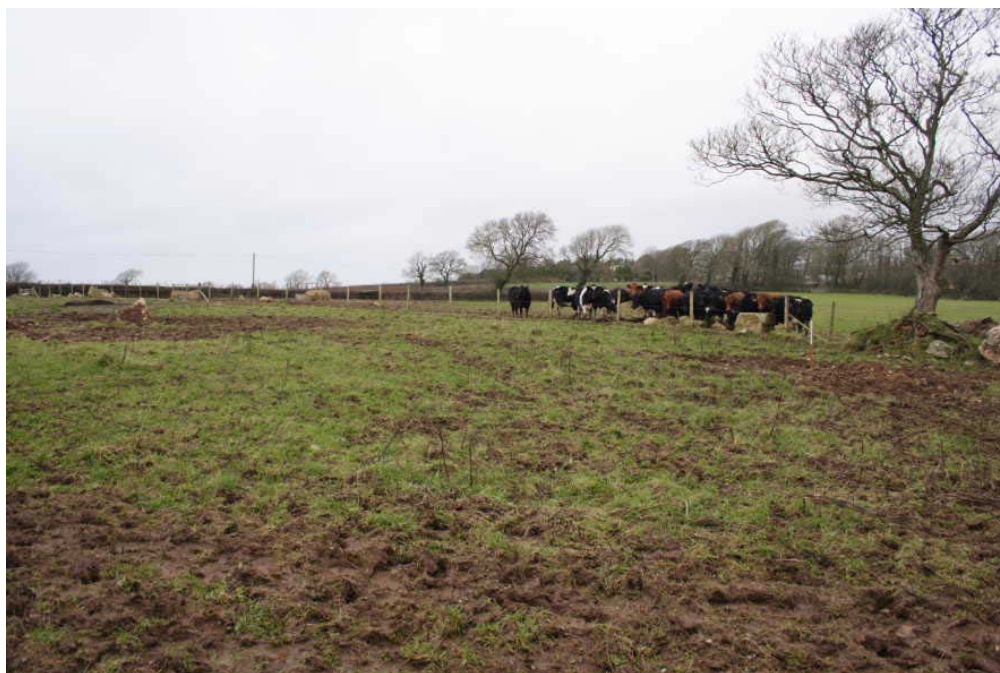
Ground photograph looking NW over site of former enclosure 14241.

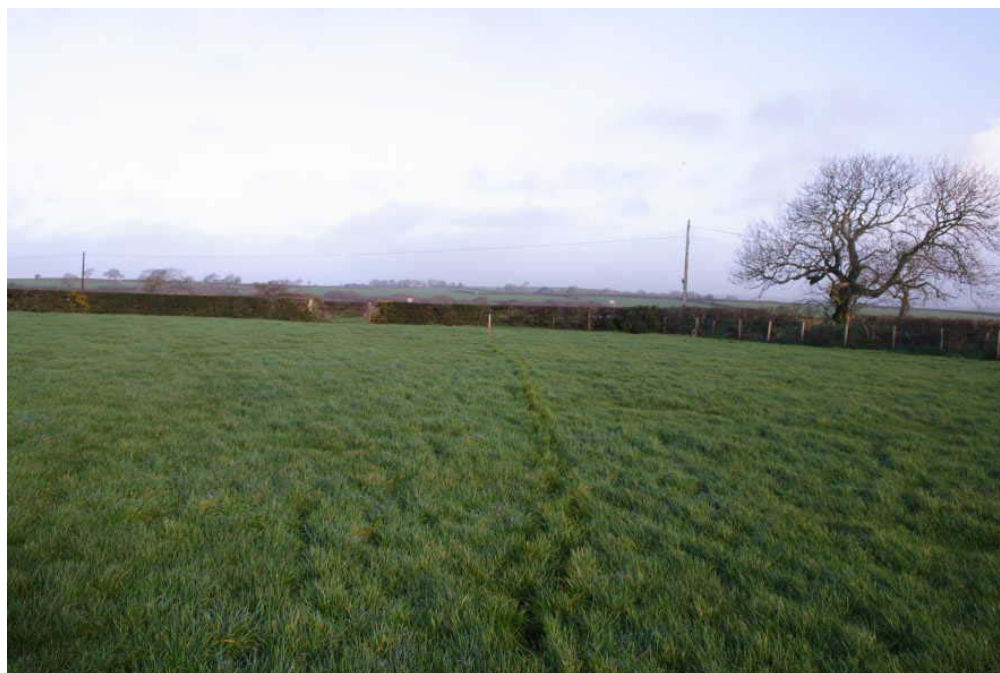
Ground photograph looking N over site of cropmark enclosure 14329.

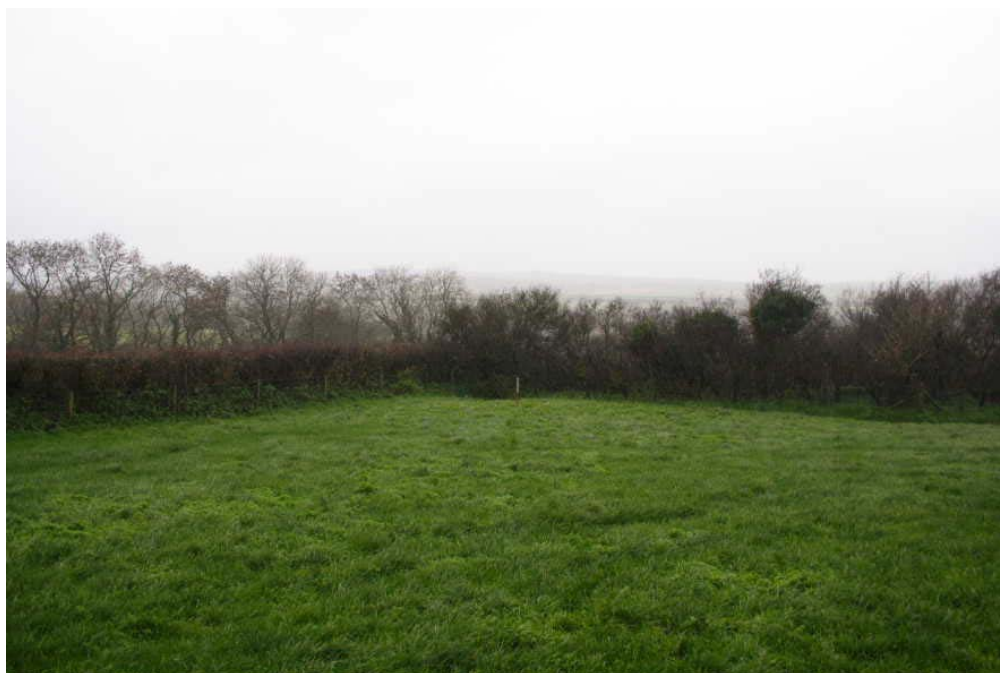
Ground photograph looking W over site of cropmark enclosure 35760.

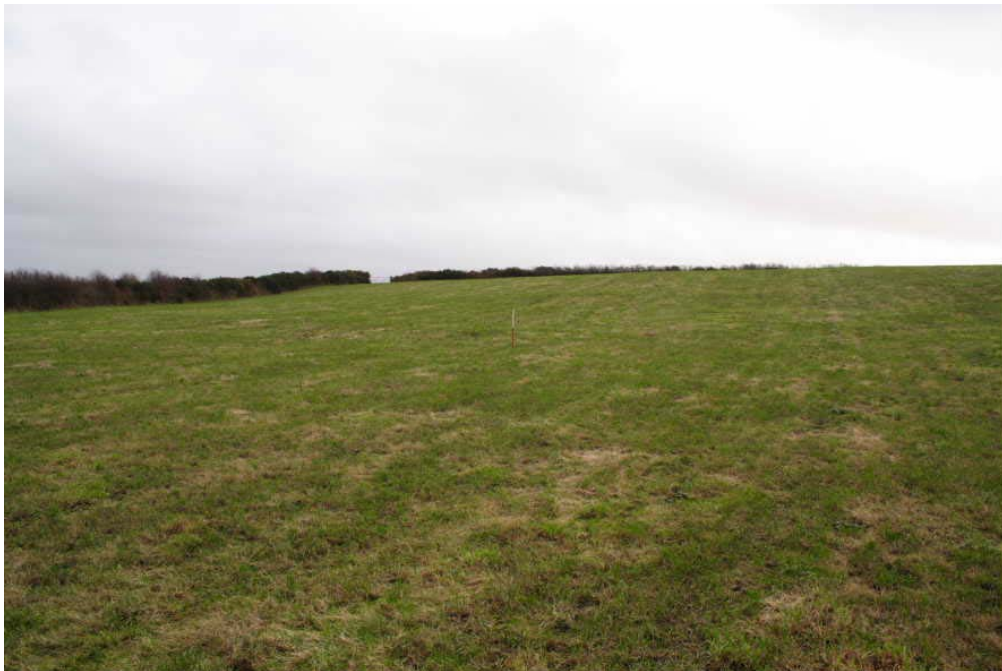
Ground photograph looking SE towards earthwork bank of 35778.
