Hen Gastell, Llanwnda A Medieval Defended Site

Summary of Excavation Report

HEN GASTELL, LLANWYNDY A MEDIEVAL DEFENDED SITE

By Jane Kenney of Gwynedd Archaeological Trust

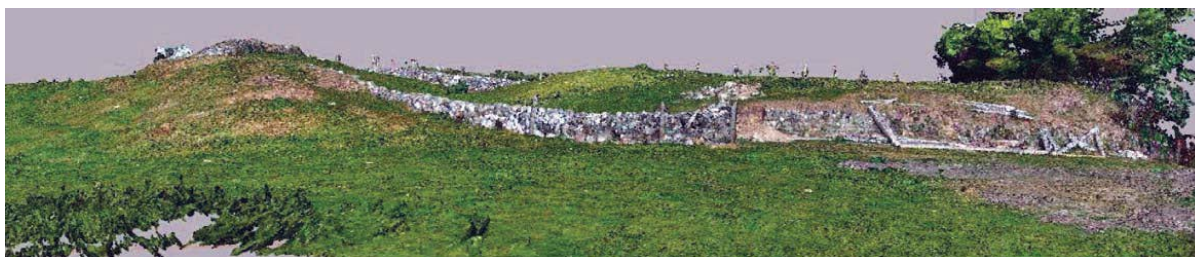
Hen Gastell from the west (view taken from digital 3D model)

Hen Gastell is a defended enclosure situated on the southern end of a low ridge of glacial gravels. A large, steep-sided ditch cuts across the end of the ridge and there is a substantial bank on the outside of the ditch. Inside the ditch is a small, flat platform, measuring approximately 30m by 14m, originally surrounded by a slighter inner bank, and defined on its southern side by a steep slope. Later stone walls cross the site, and the sloping sides have been revetted with stone to stop them eroding.

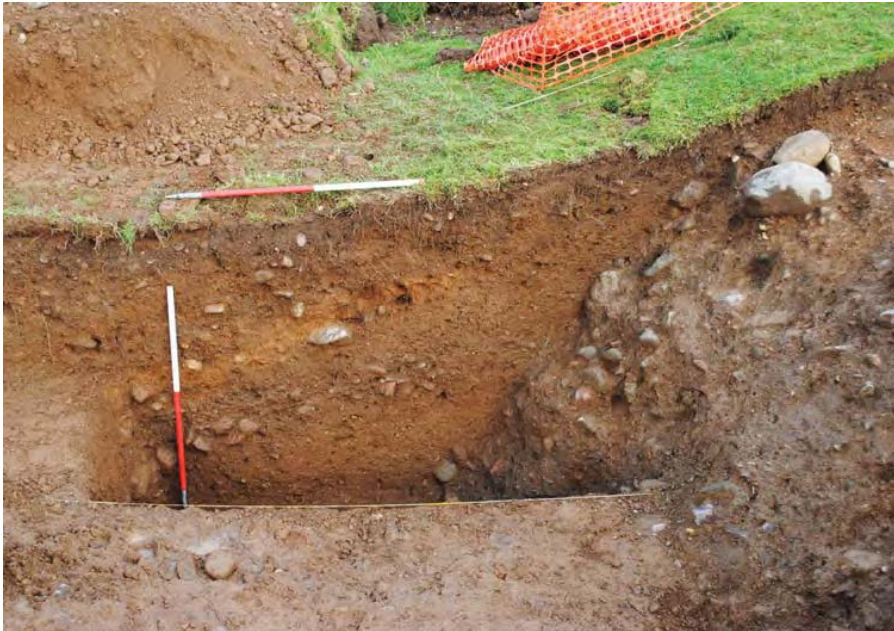
Section of ditch in the trial trench

The excavation of the trial trench showed that the ditch was massive and steep-sided. The outer bank at its full height before erosion would also have been substantial. However the geophysical

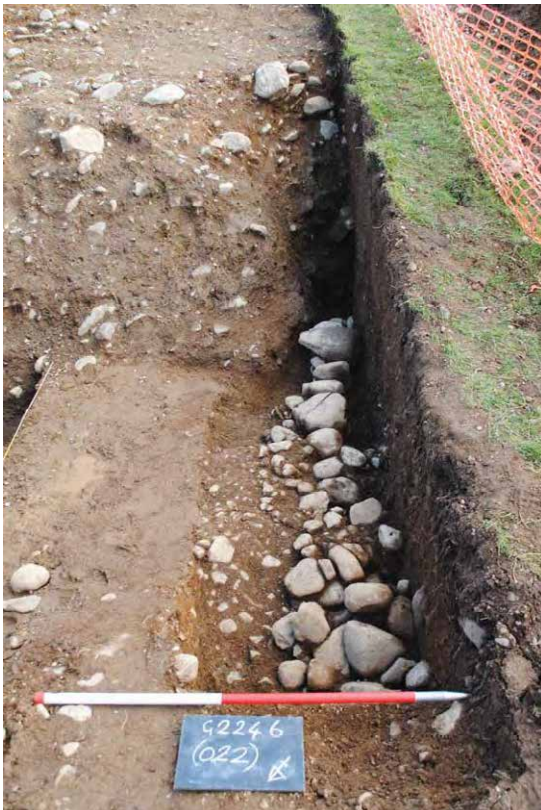
End of possible semi-subterranean building in evaluation trench

The trial trench revealed evidence for a possible semi-subterranean building constructed in the largely infilled ditch. Only the very end of this was found and no dating evidence was recovered but it is most likely to date to the 16th to 18th centuries AD. A trackway cut through the outer bank and the field walls forming a small paddock may have been associated with this proposed building.

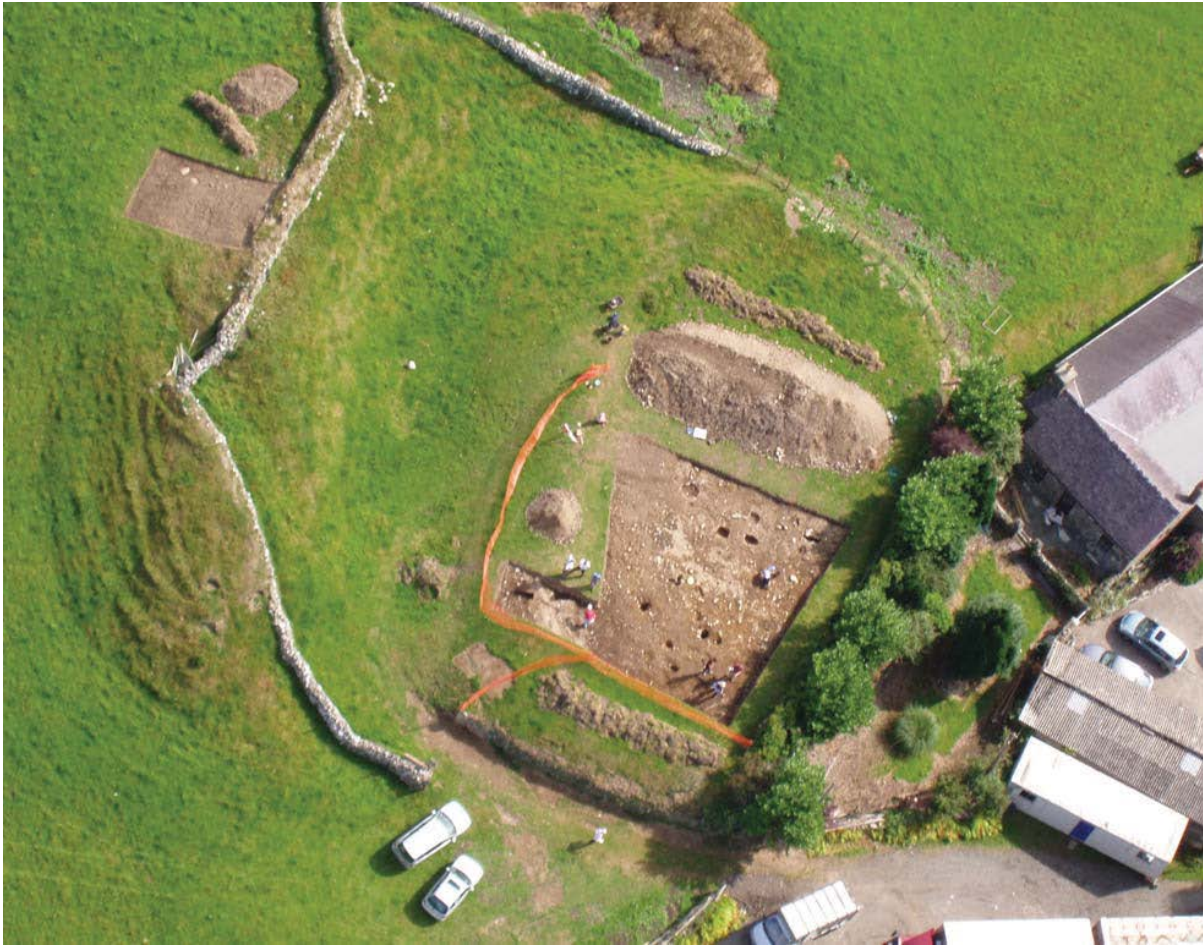
Site under excavation from the air (copyright Alan K Hole)

The large scale excavation was carried out in 2014 and aimed to find out more about the monument by targeting the inner platform on which the original occupants must have lived. The object was to find out what date the monument was and how it was used.

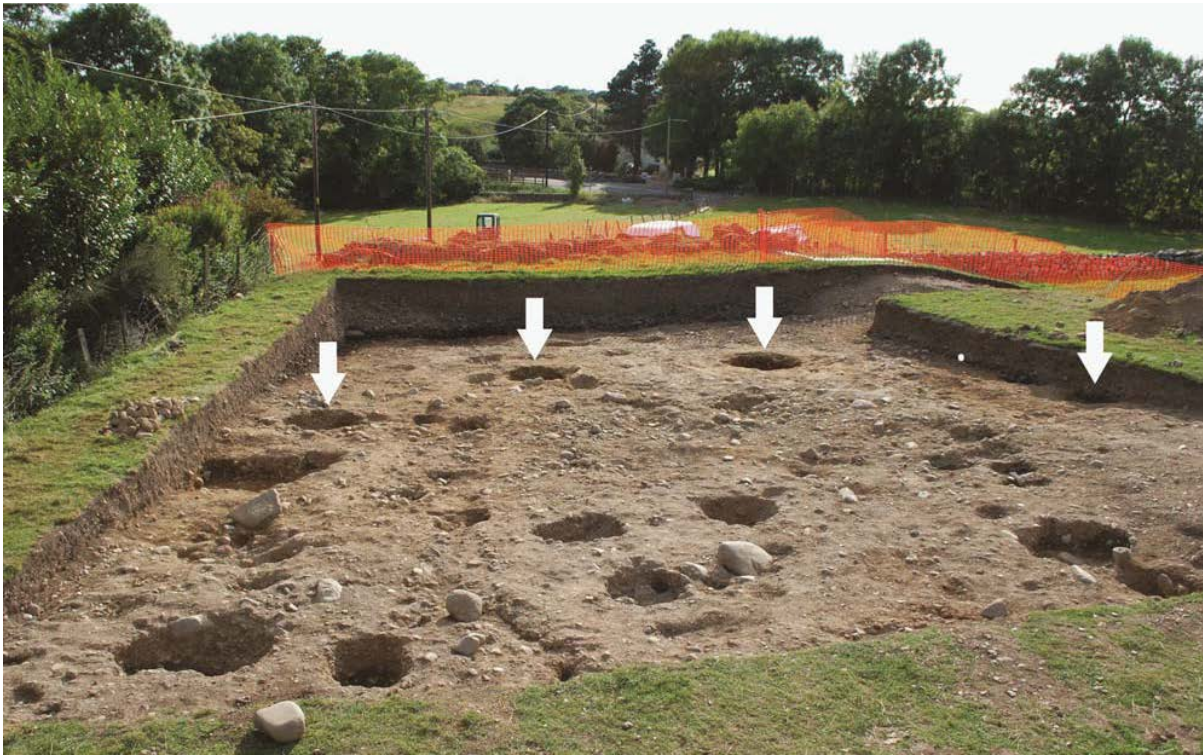
Arc of postholes marked by white arrows

The arc of large postholes and the line of postholes on the south-eastern side seem to have supported the wall of a timber building. If the arc is projected it can be seen that another feature (**015**) found in the trial trench was on the same arc and was almost certainly another posthole. The straight line of postholes suggests that the building could not have been completely circular but that one wall at least was straight. It is probable that all the other postholes supported internal structures within the building. Some of the postholes had rectangular post-pipes suggesting squared timbers were used, indicating that considerable time, effort and skill was used in the construction.

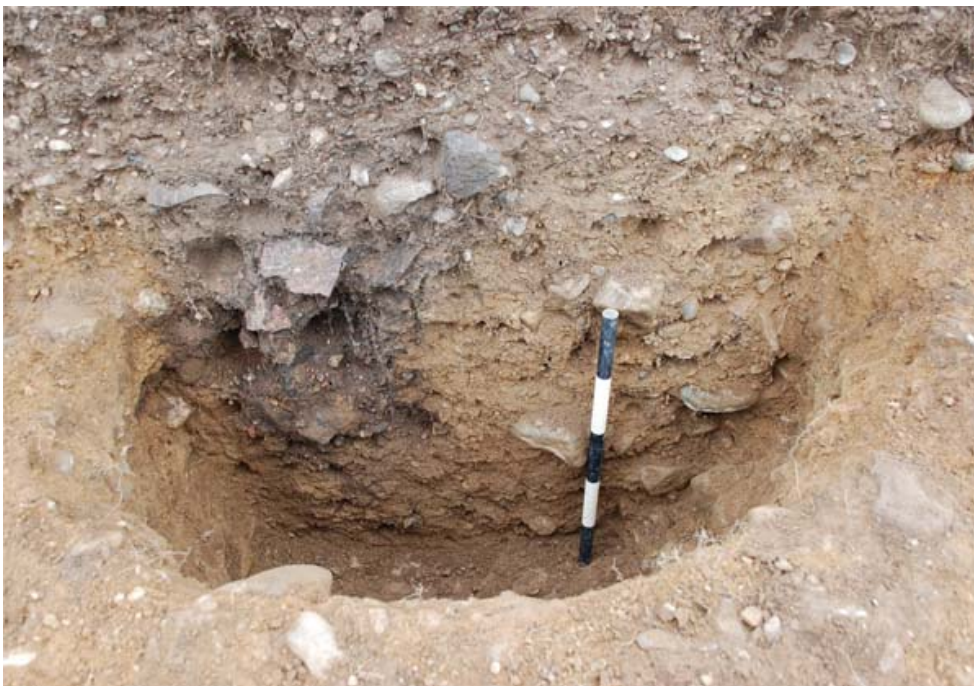
*Posthole **2108** half sectioned showing burnt stone in post-pipe*

The post-pipes in postholes **2068** and **2108** were filled with dark soil containing a lot of burnt stone and fragments of burnt bone. It appeared that the posts had been removed and the burnt stone had been used to fill the resulting hole. The burnt stone probably came from a dump around the inside of the inner bank, described below.

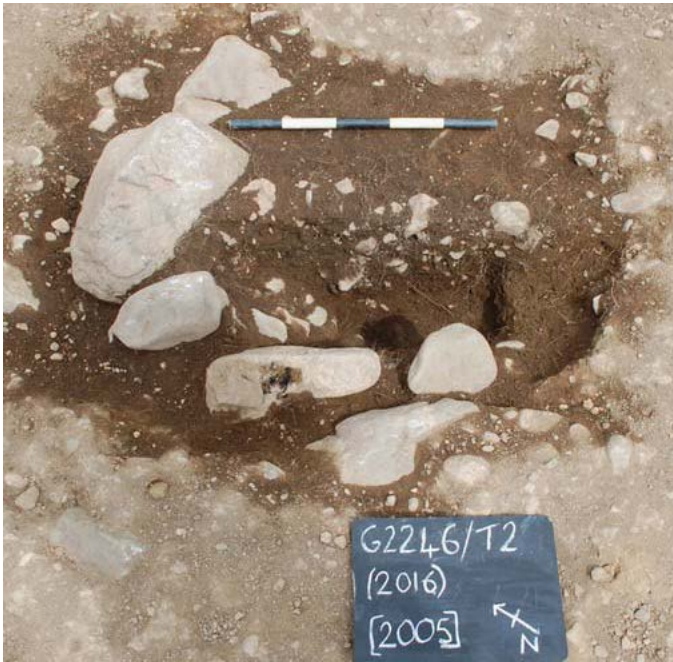
Packing stones in posthole 2005

As well as forming the end of the arc posthole **2068** also formed the start of a straight line of postholes running west-south-west to east-north-east close to the south-eastern edge of the trench. The other three postholes on this line (**2005**, **2083** and **2087**) were also very substantial, measuring up to 1.2m long and up to 0.92m wide; however they were shallower and no more than 0.45m deep. No post-pipe was recognised in **2087**, which seemed to have been disturbed, but **2005** contained a nearly rectangular post-pipe measuring 0.65m by 0.22m. It also had large packing stones. Posthole **2083** probably also had a post-pipe but this was not as well-preserved.

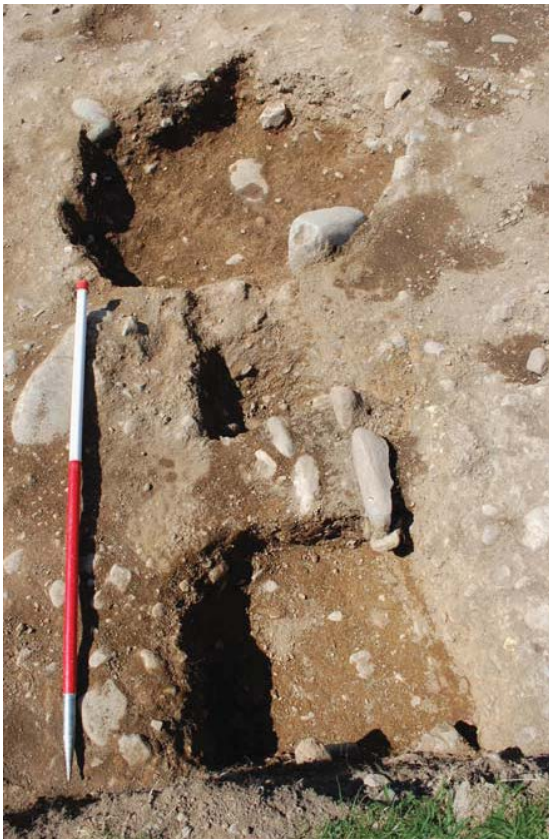
Posthole 2102 and beam slot 2104

A feature, initially recorded in the trial trench, was reopened and the area around it explored. This appears also to have been a posthole (**2102**). A straight slot (**2104**) ran north-east from posthole **2102**, and extended beyond the limits of the excavation. It measured more than 1.26m long by up to 0.66m wide, and was at most 0.30m deep. A few of the larger stones in its fill appeared to be packing stones, probably used to pack a timber beam in place. This may therefore have been the foundation cut for a horizontal beam to support a timber superstructure.

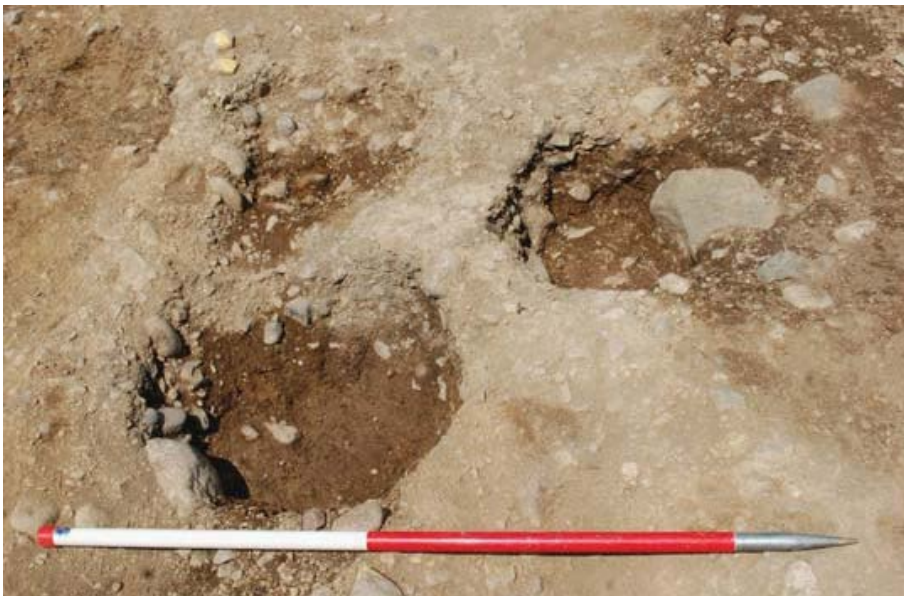
Pits 2076, 2078 and 2081 fully excavated

Three small pits and a shallow hollow were excavated just north-west of the centre of the building. The three pits (**2076**, **2078**, **2081**) were roughly circular, up to 0.6m in diameter.

These features are interpreted as the remains of a blacksmithing forge, with pit **2078** being the base of the smithing hearth. Pit **2076**, with its hammerscale, was probably the foundation cut for a wooden block to support a small metal anvil. Waste from the smithing was dumped or accumulated in feature **2067**, which may have been a working hollow. The knife from pit **2078** and fragments of bar iron in **2067** represent the types of small objects being produced.

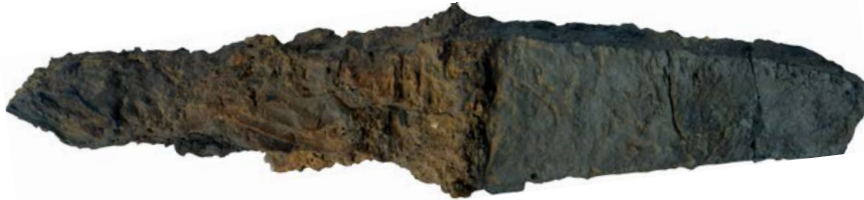
Iron knife found in pit 2078

Pit **2078** was the smallest feature in the group. It was sub-circular with steep sides and a flat base. Near the base lay a lump of heat-reddened clay, which might have been part of a floor or collapse from a superstructure. The fill of this pit also contained metal-working debris, including a large piece of slag that had formed in the base of a smithing hearth. There was also a timber nail and a small iron knife with traces of mineralised organic remains, probably a handle, on its tang.

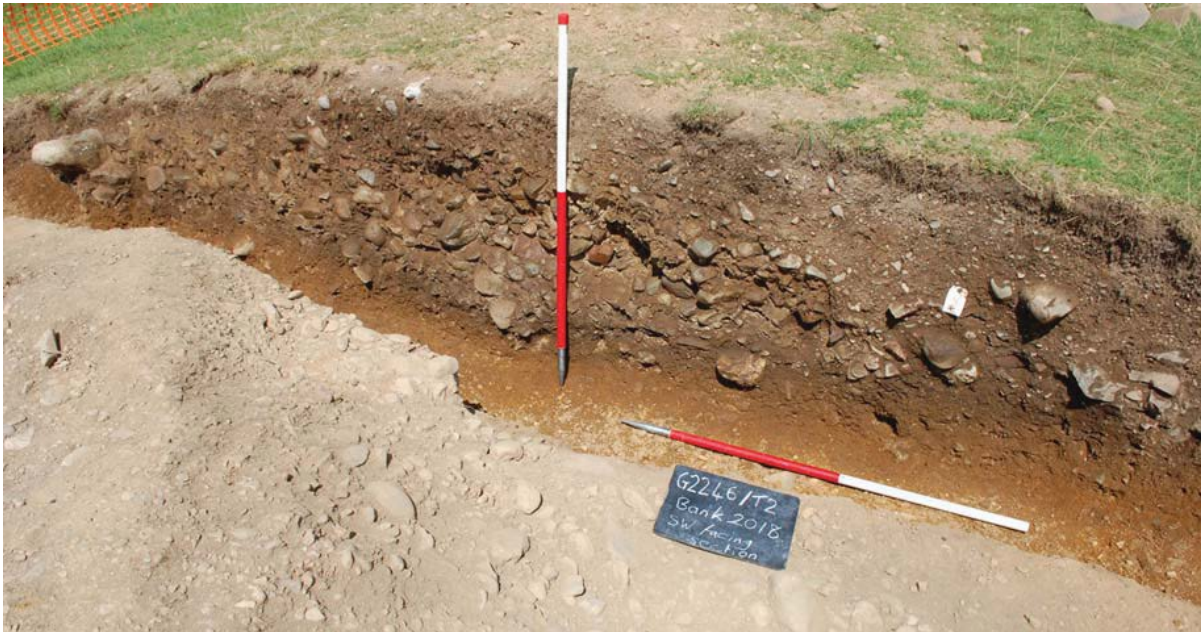
Section through the inner bank

In both places the bank was seen to be a substantial feature, up to 0.7m high, despite being heavily eroded. It was built mainly of rounded cobbles and gravel, and rested on a layer of soil, which would have been the ground surface when the bank was built. Over this ground surface and under the bank in the south-western corner of the trench was a dark silty layer containing charcoal and burnt bone with some heat-shattered stone. This seemed to be the remains of activity pre-dating the bank.

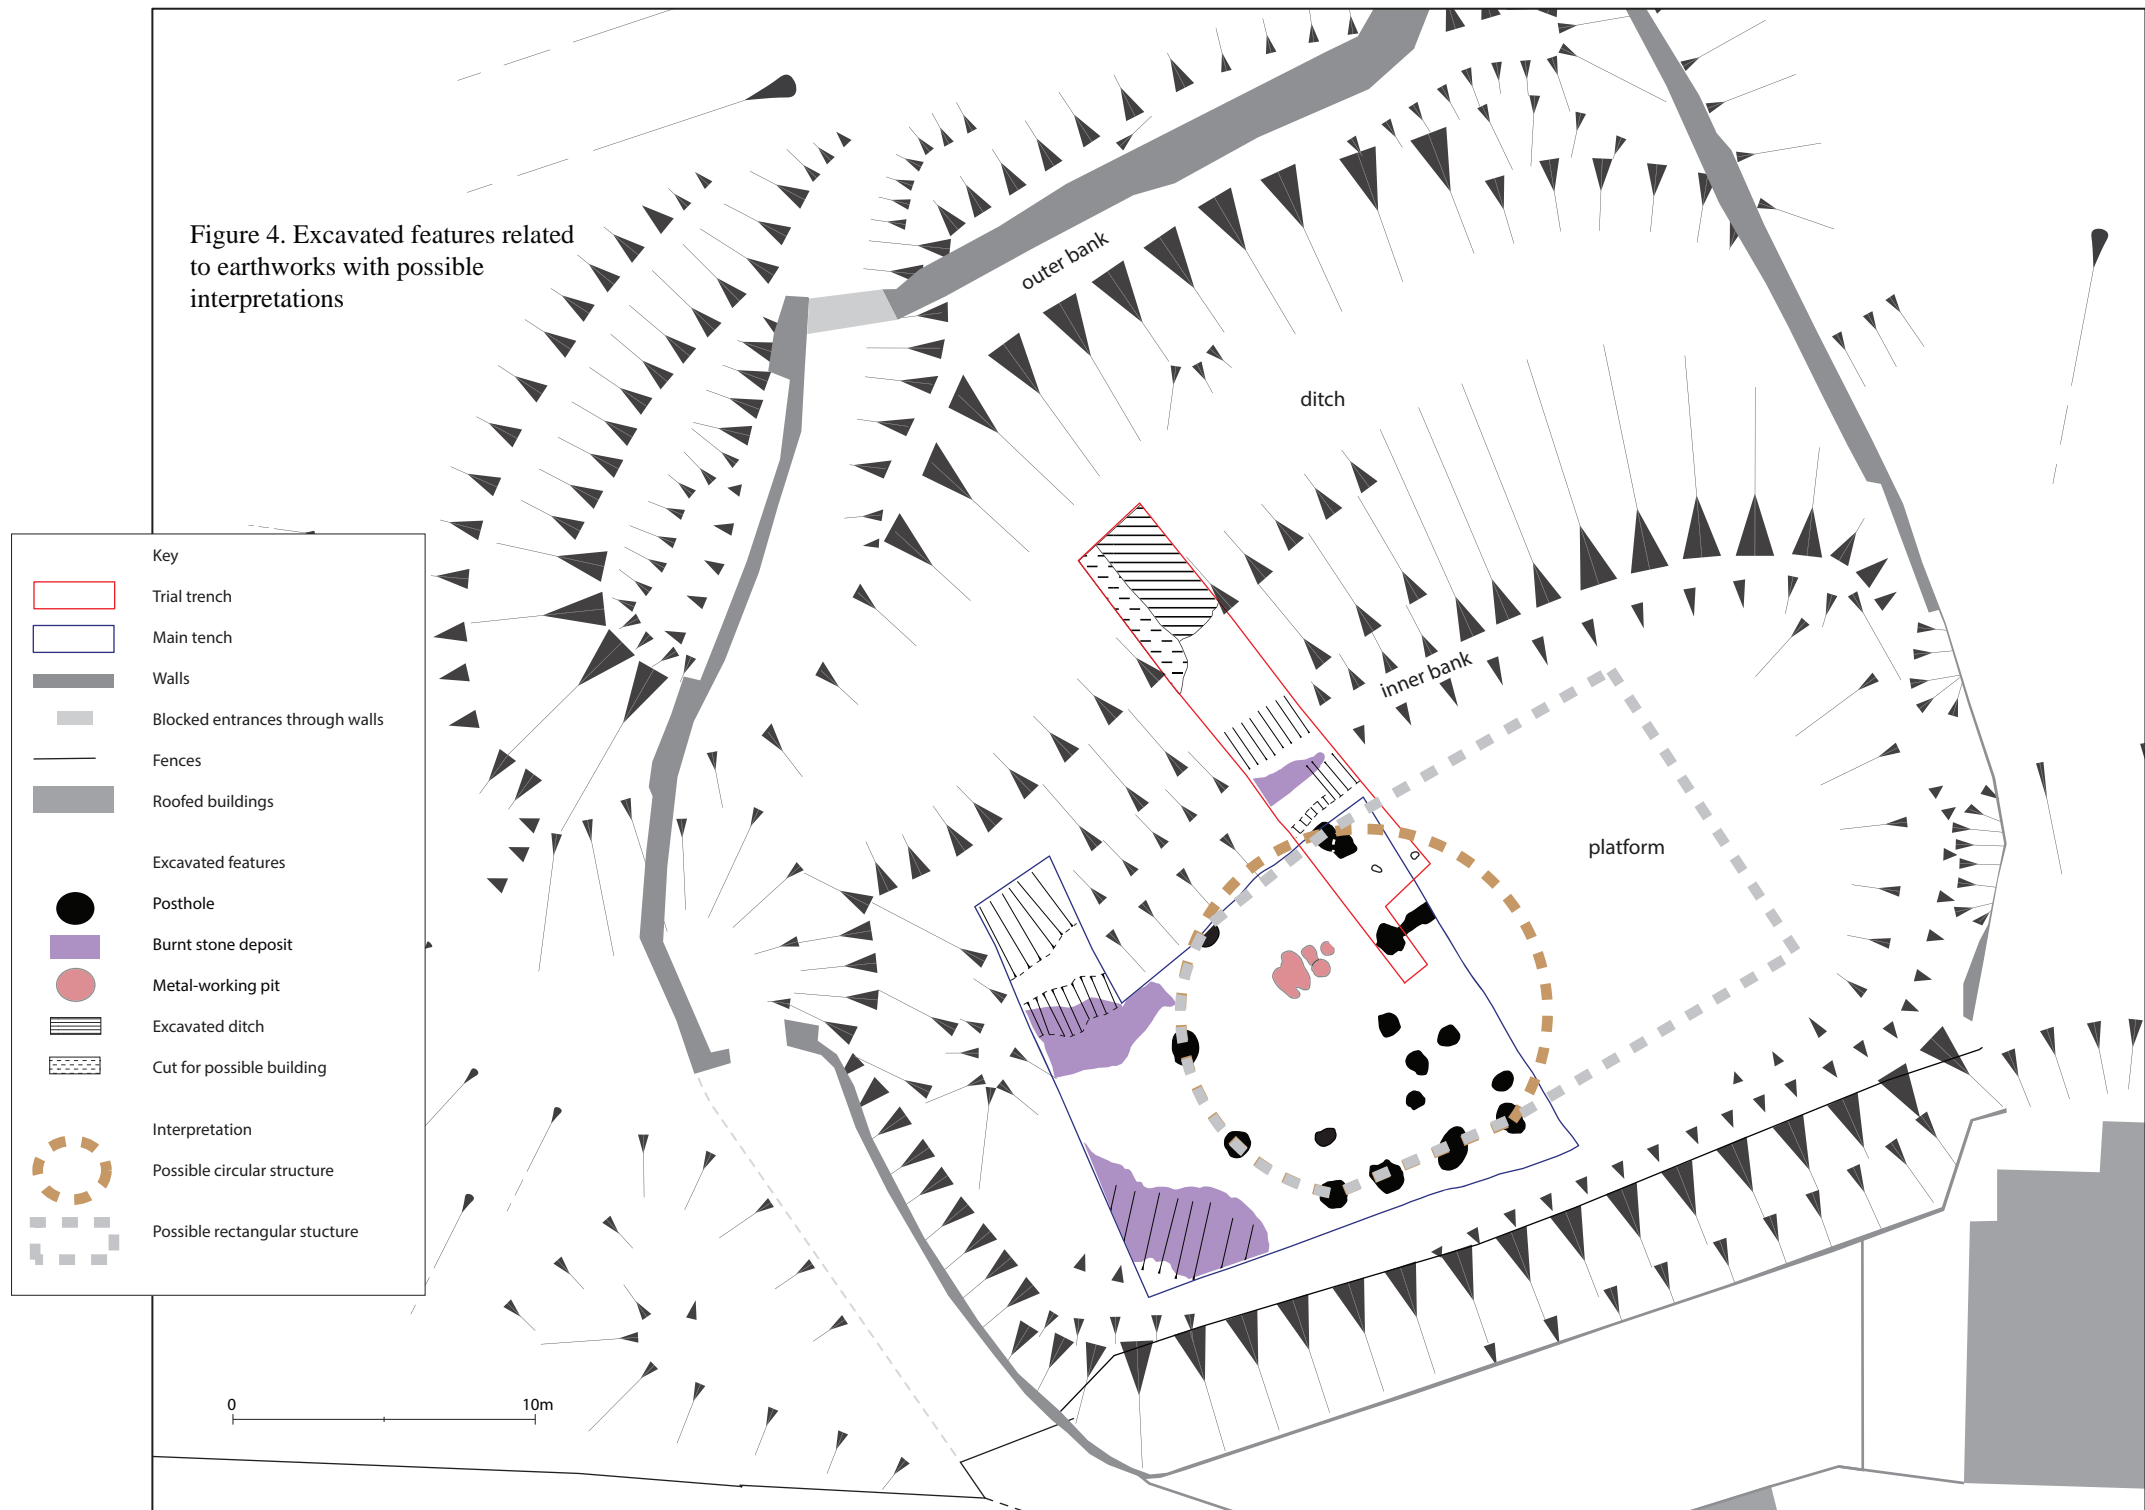
Figure 4. Excavated features related to earthworks with possible interpretations

The postholes revealed in the excavation of Hen Gastell suggest the presence of a large timber building dating to the 11th or 12th centuries AD. As the full area of the inner platform was not excavated the plan of the building remains open to discussion (figure 4). There are two probable alternatives for the building plan; sub-circular or sub-rectangular. A circular structure with one side flattened would fit the evidence well and would fit neatly in the space available with room for ancillary buildings in the eastern end of the platform. In this reconstruction the building would have been about 12m in diameter. However the flattened side suggests that this could alternatively be interpreted as the western end of a rectangular building with at least one curved end. This could have been up to between 18m and 20m long depending whether the eastern end was curved or straight. Both alternative interpretations leave several internal postholes unexplained, although it is probable that they supported internal structures inside the building.

In either case the large postholes with post-pipes up to 0.5m in diameter suggest that this was a substantial building, possibly with a second storey. A two storey building, especially a type of tower, would make the site more defensible as defenders on top of the building could fire down on attackers that might storm the outer bank.
