BOULSTON MANOR, PEMBROKESHIRE: BUILDING RECORDING

Prepared by Dyfed Archaeological Trust
For CADW

RHIF YR ADRODDIAD / REPORT NO. 2012/27
RHIF Y PROSIECT / PROJECT RECORD NO. 102767

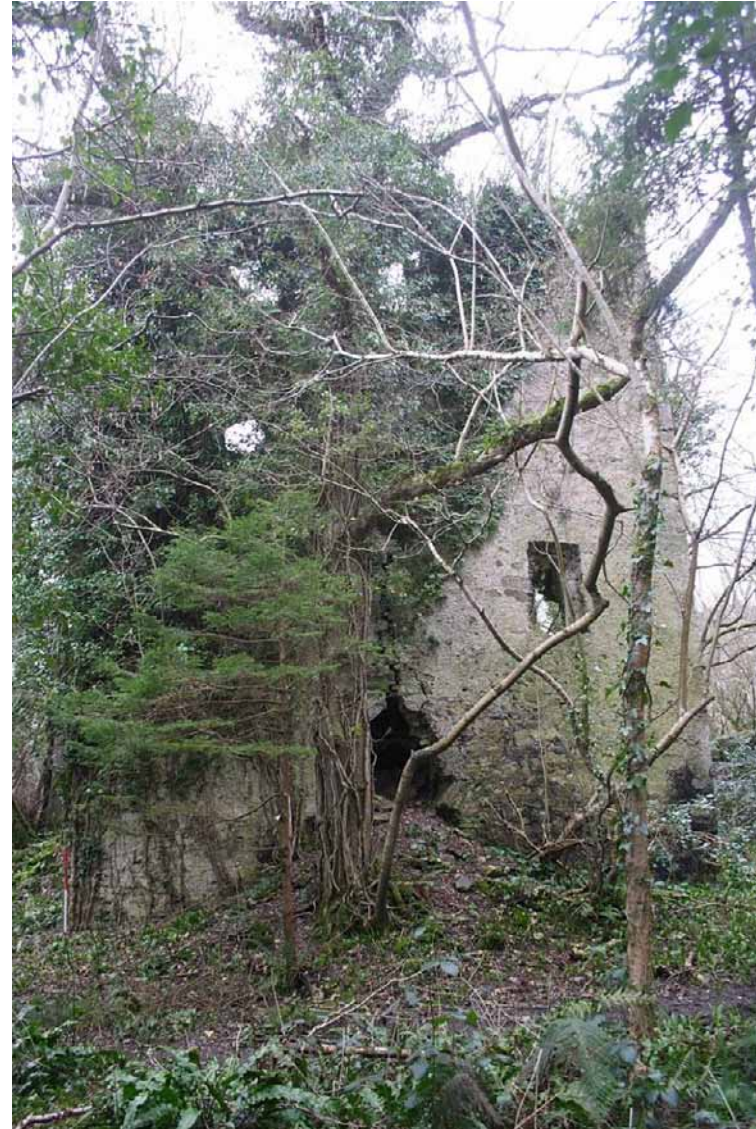
There is a ground floor arch, presumably for an entranceway, in the centre of the east gable tower wall, just visible above the build-up of rubble and soil (photo 9). The top of the arch has collapsed, which has caused stonework immediately above to fall in, and a large crack has opened the full height of the tower. This entrance opens into a narrow space 0.8m wide, and opposite a blocked narrow splayed opening in the undercroft wall.

Photo 8: The eastern face of the Eastern Tower. 1m scale.

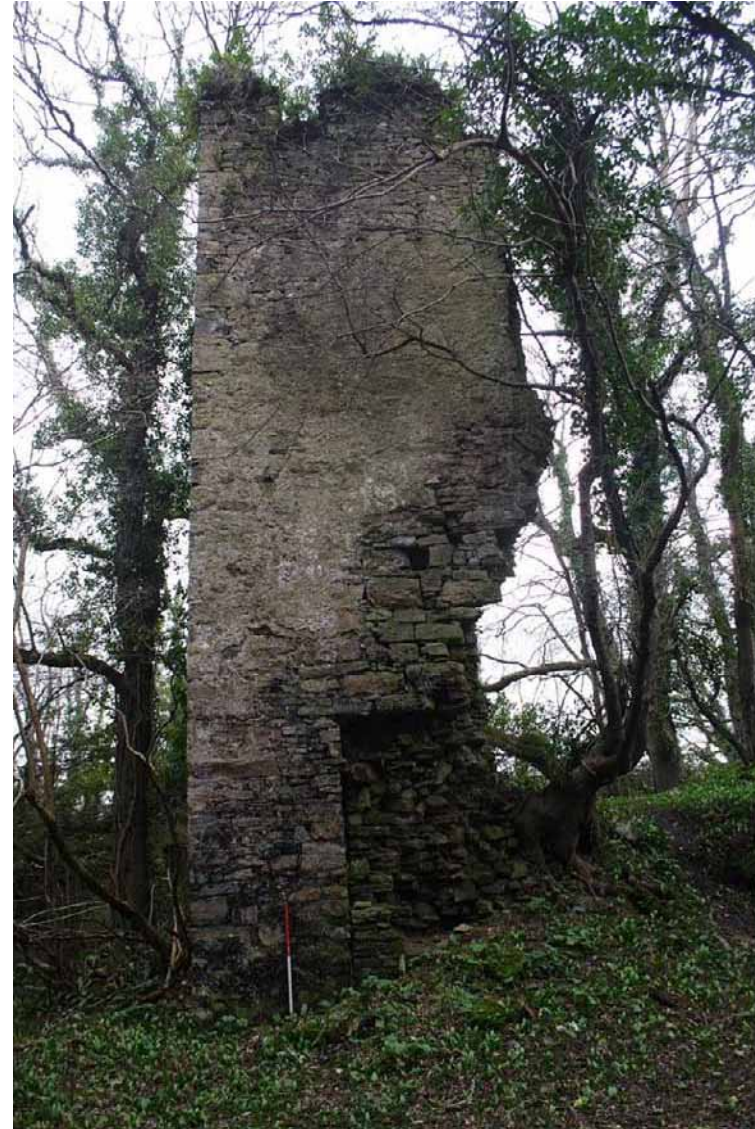
The eastern tower was a stair tower, impressions and some footings for the stairs remain (photo 11). The tower is 8.7m by 3.2m in area and four storeys high. The north and south tower walls have been built around and over (incorporating) the earlier undercroft walls (photo 10), the southern of these earlier wall segments being thicker and higher, almost to second floor level. The internal (west) tower wall has been built directly on top of the east wall of the undercroft. The stonework of the earlier walls generally consisted of smaller lime mortared rubble. The remainder of the tower is built of mortared random rubble and is still largely rendered.

Photo 10: Northern face of Eastern Tower, clearly showing earlier segment of walling. 1m scale.

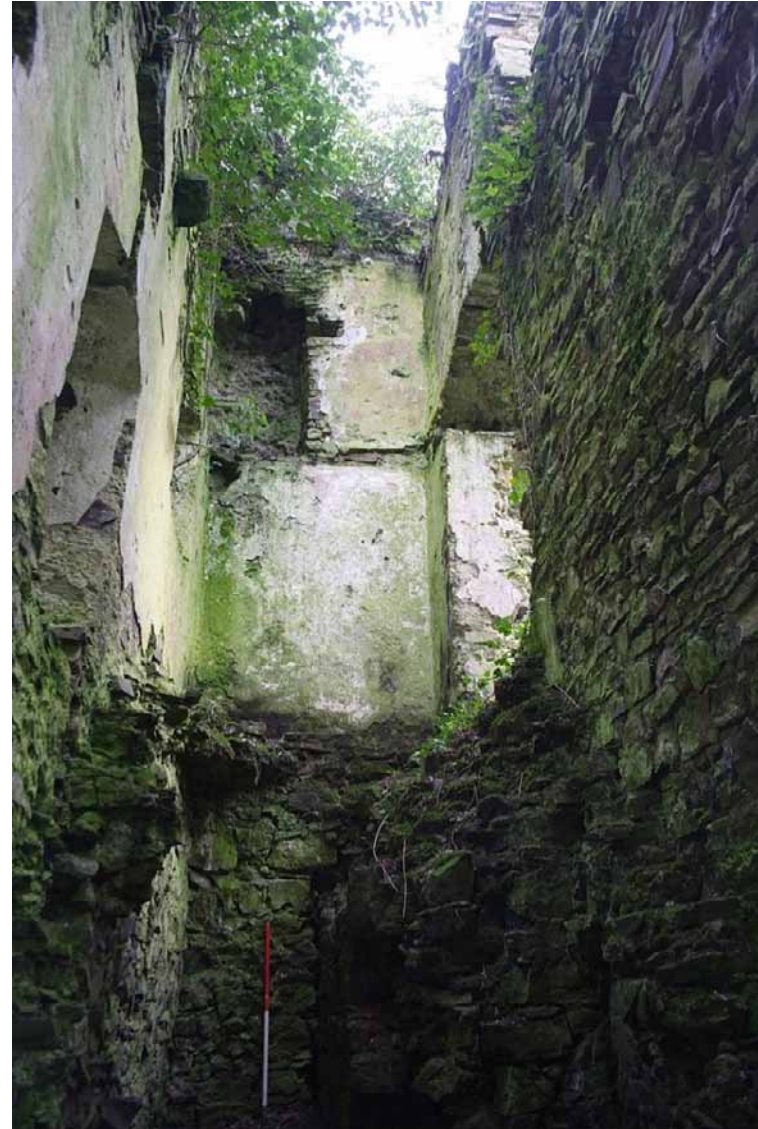
The staircase is built into both side walls from the first floor to second floor, 1.7m wide. This is accessed from the first floor interior (i.e. from the west), with a window in the gable wall providing light. The window is splayed internally, low-arched, but squared on the outer wall. A similar window on the second floor provides light at the top of the stairs, with another second floor window slightly higher and offset to the south. Remains of two further second floor windows are visible where the tower would have met the side walls for the main hall. The stairs enter the second floor at the southern end of the western wall. Another set of stairs leads from the second to the third floor directly above the first floor stairway entrance. These stairs may not extend the full width of the tower and they end in the middle to come out of a centrally placed door in the west wall. Corbels for the stair beam are visible at this point. There is a window at the top of the stairs in the east wall. Davis (1989) records a partition at the top of the stairs, separating the southernmost c.2.7m. There are the remains of a fireplace in the south wall at this level (photo 12).

Photo 12: Interior of Eastern Tower showing different floor levels and 3rd floor fireplace. 1m scale.

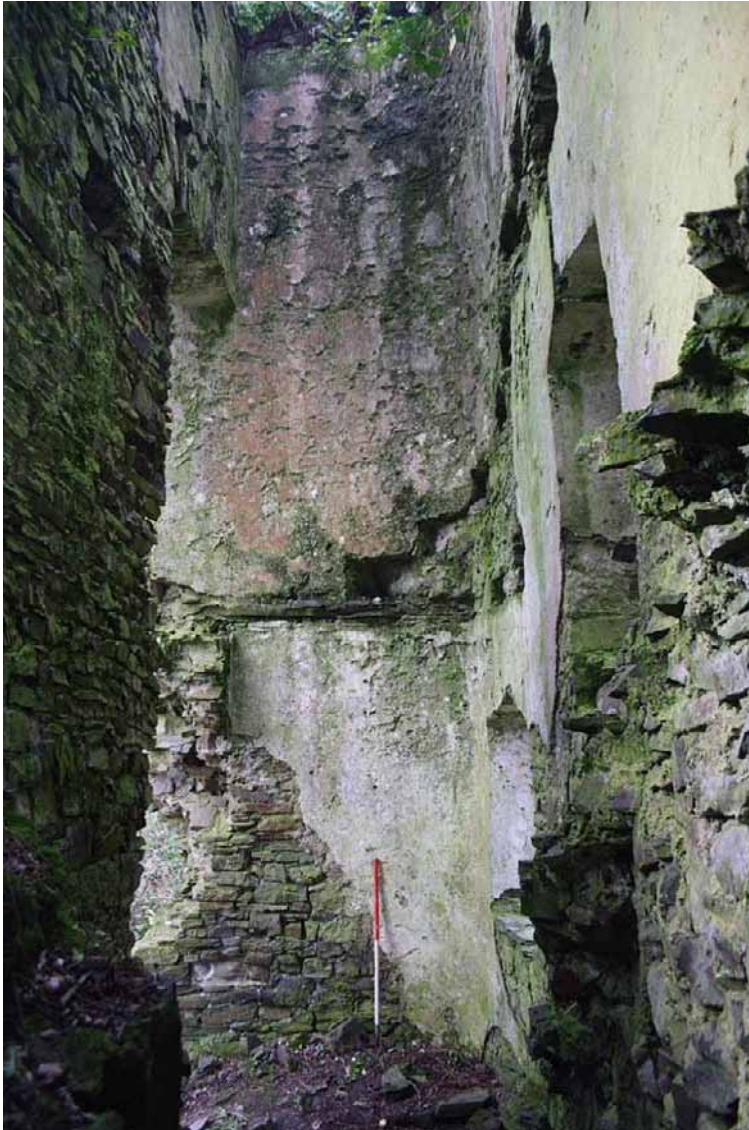
The interior of the staircase tower is rendered in smooth white plaster on all but the western side (photos 11 & 12). At second floor level this appears to have been painted pink/red (photo 13). The internal northeast corner is rounded the full height of the tower.

Photo 13: Interior of Eastern Tower showing pinker internal render on 2nd floor. 1m scale.

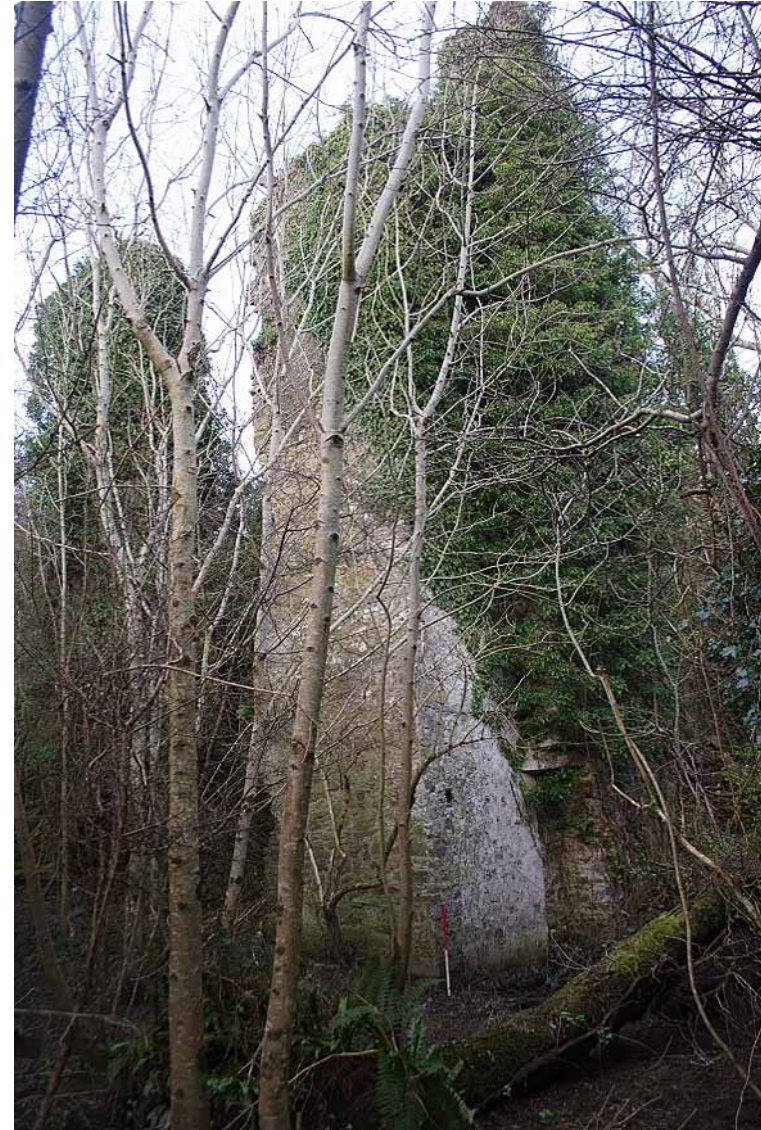
At the west end of the main hall the corners and most of the gable wall of a tower survives, with a large opening in the gable wall running the full height of the tower (photos 14 & 15). It is built in a similar style of lime-mortared random rubble and partially rendered externally, plastered internally. This tower survives to a similar 4-storey height, 7.3m north - south and c.6.2m east - west.

Photo 14: General view of Western Tower, looking northeast. 1m scale.

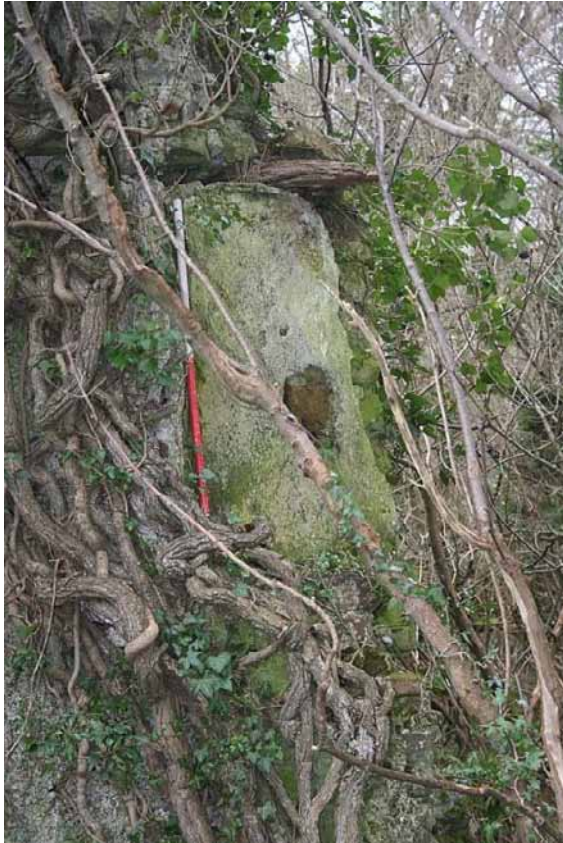
Photo 25: 1st floor window remains in the southern wall of the Western Tower, also showing surviving timber lintel. 1m scale.

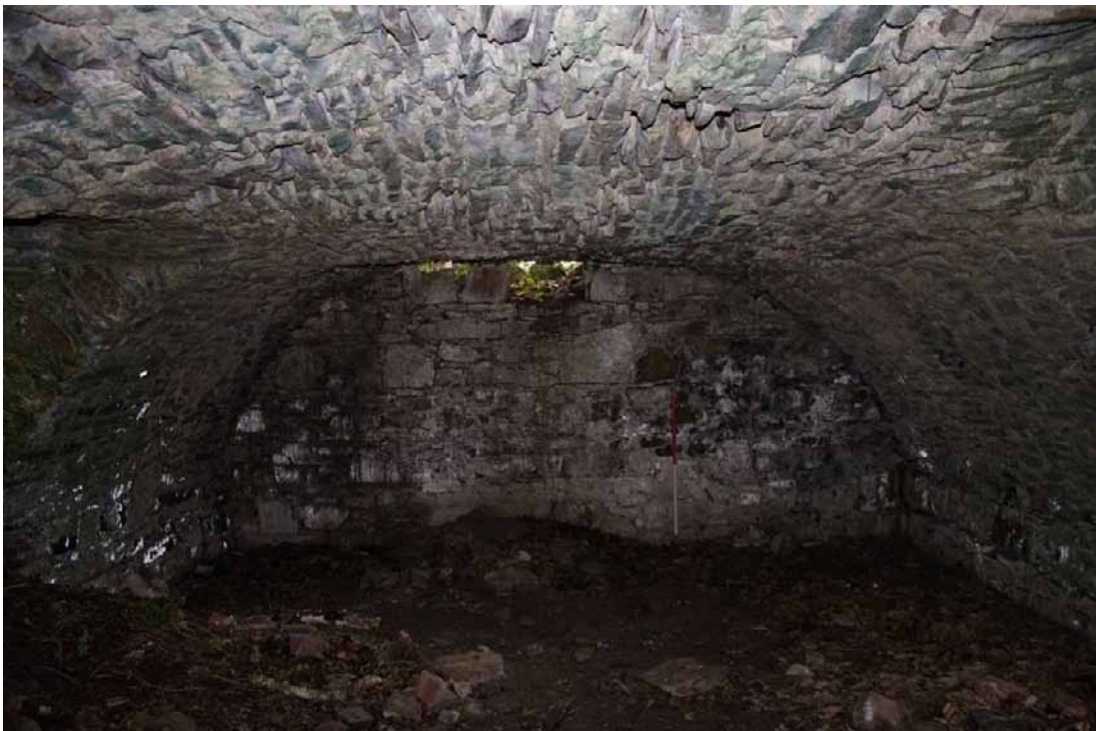
Photo 32: The interior of the undercroft looking west, showing the collapse in the ceiling and upper courses of the western wall. 1m scale.

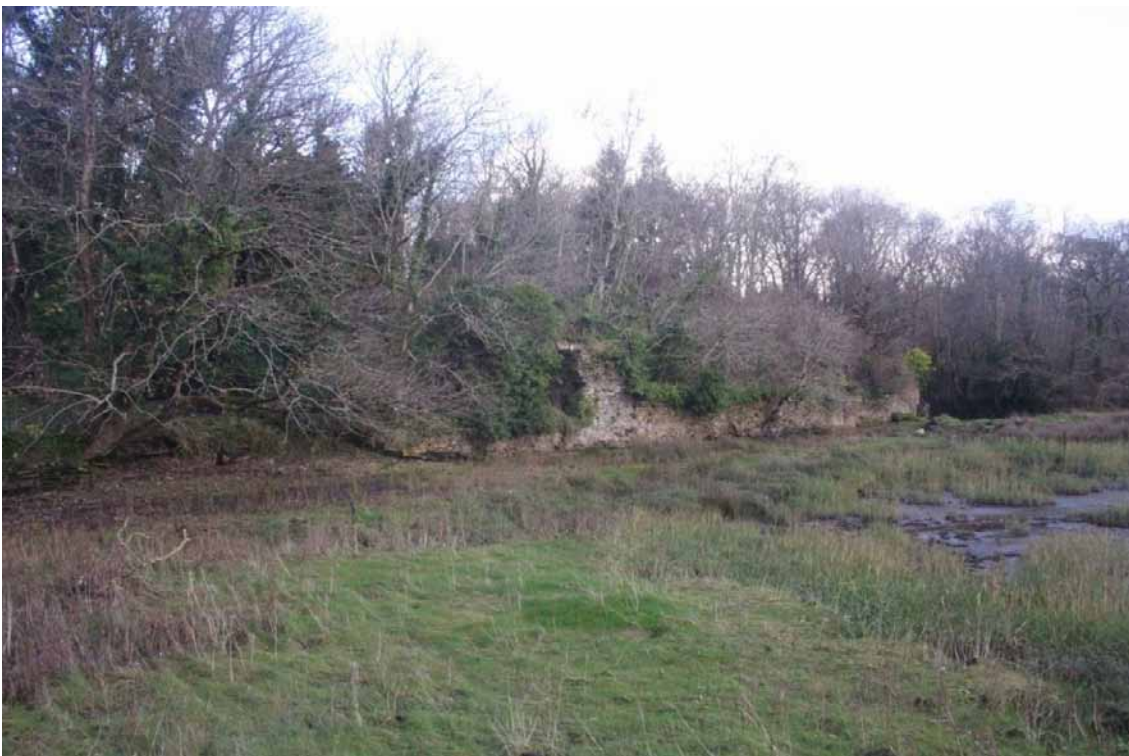
The remains all lie at the edge of the Western Cleddau, which is already undermining the long southern wall of the garden enclosure. The mortar has been washed out of much of the lower courses, and many of the facing stones have been removed exposing the rubble core behind. Erosion from tidal action will increase with rising sea levels. Climate change is recognised by the Welsh Assembly Government as one of the biggest threats facing the planet. Loss of landscape and heritage caused by it will have a negative impact on the quality of life in Wales and that 'without intervention our distinctive historic environment will degrade' (Environment Strategy for Wales, Welsh Assembly Government 2006). It is estimated that during this century temperatures will rise by 1 – 2 degrees centigrade, that there will be a 2% - 9% rise in precipitation and that sea level will rise by 180mm – 790mm (Wales: Changing Climate Challenging Choices, National Assembly for Wales 2007). Climate change and rising sea levels will: increase coastal erosion; inundate currently dry sites; create more extreme weather conditions promoting erosion of upstanding remains, particularly on areas such as sand dunes. Human responses to climate change will also impact on the historic environment, as new sea defences will be required whilst others will be abandoned under 'managed change'.

Photo 34: Looking northeast at the southern wall of the Garden Enclosure.

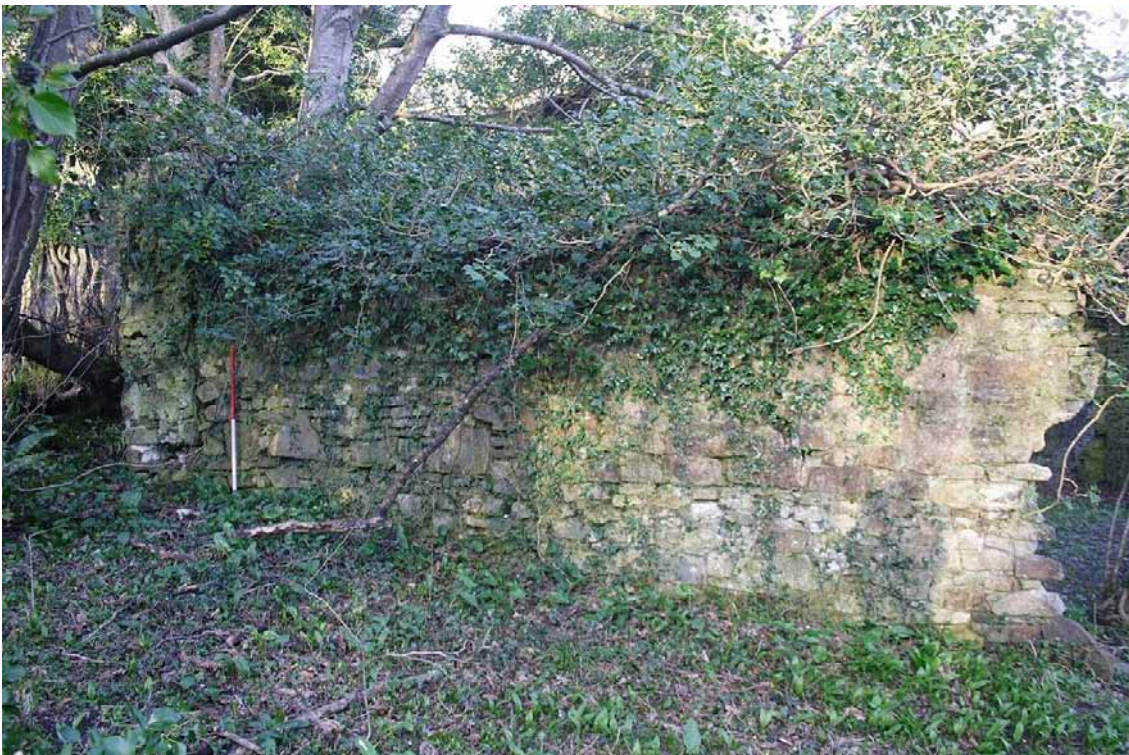
Photo 46: View looking east at the eastern wall of the Southwest Enclosure. 1m scale.

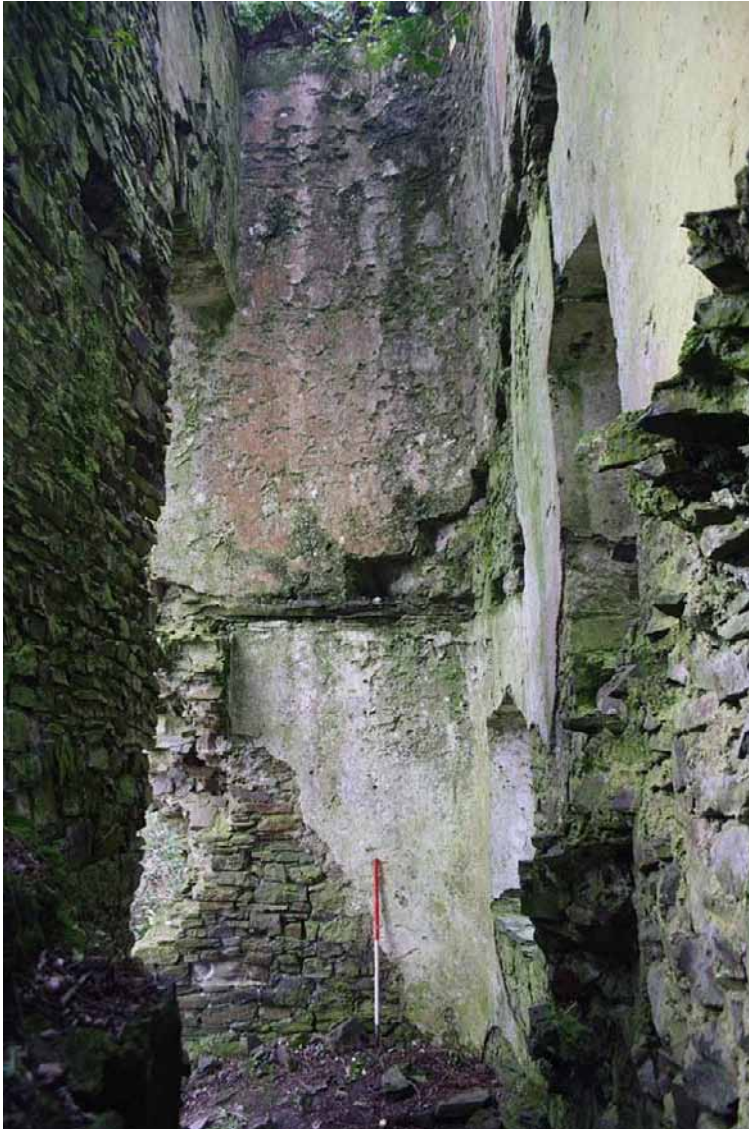
Photo 13: Interior of Eastern Tower showing pinker internal render on 2nd floor. 1m scale.

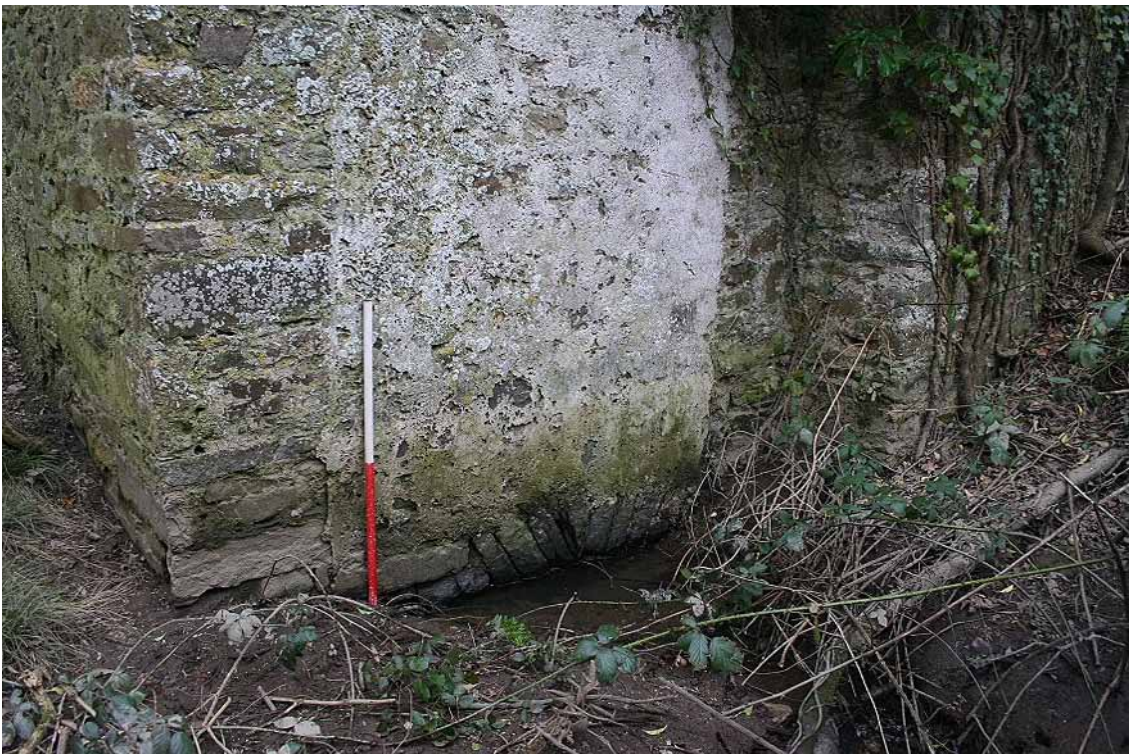
Photo 22: Stream emerging from the culvert on the south side of the Western Tower. 1m scale.

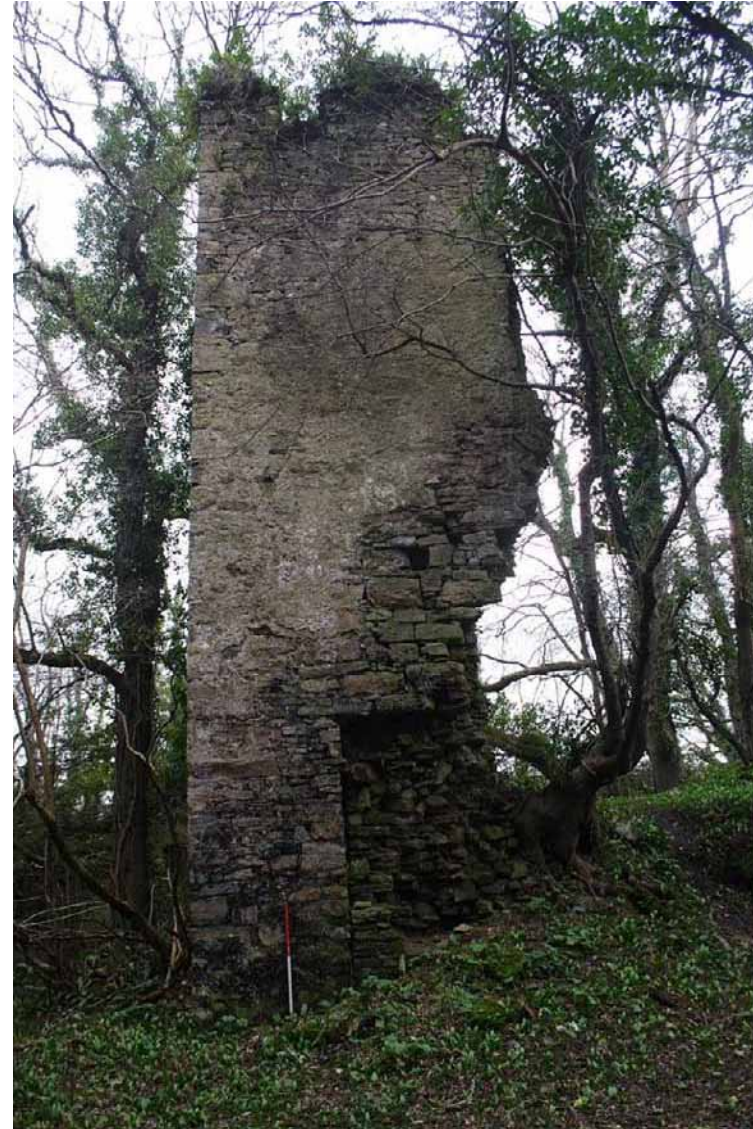
Photo 10: Northern face of Eastern Tower, clearly showing earlier segment of walling. 1m scale.

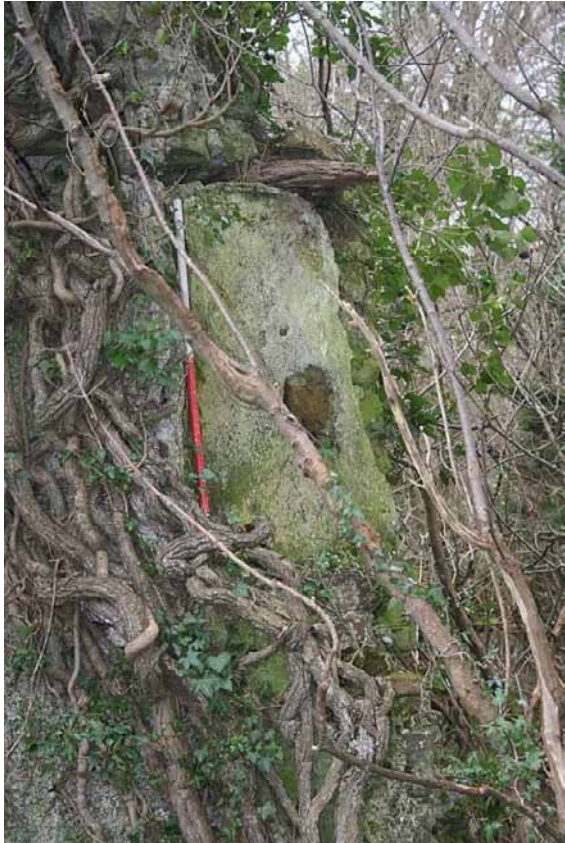
Photo 25: 1st floor window remains in the southern wall of the Western Tower, also showing surviving timber lintel. 1m scale.

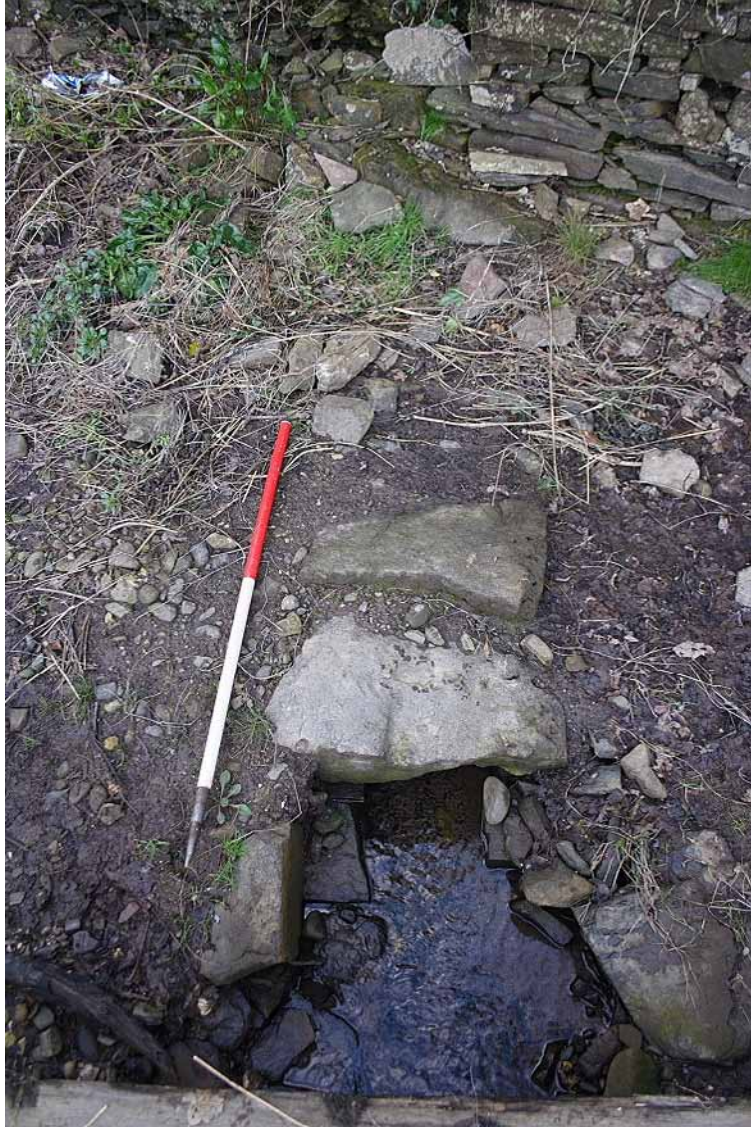
Photo 53: Culverted stream running out from underneath the Southwest Enclosure, looking north. 1m scale.
