# GGAT 112: Second World War Military Airfields of South Wales

Year 2-Airfield Hinterland

A report for Cadw  
by Paul W Huckfield BA

GGAT report no. 2013/024  
Project no. GGAT 112

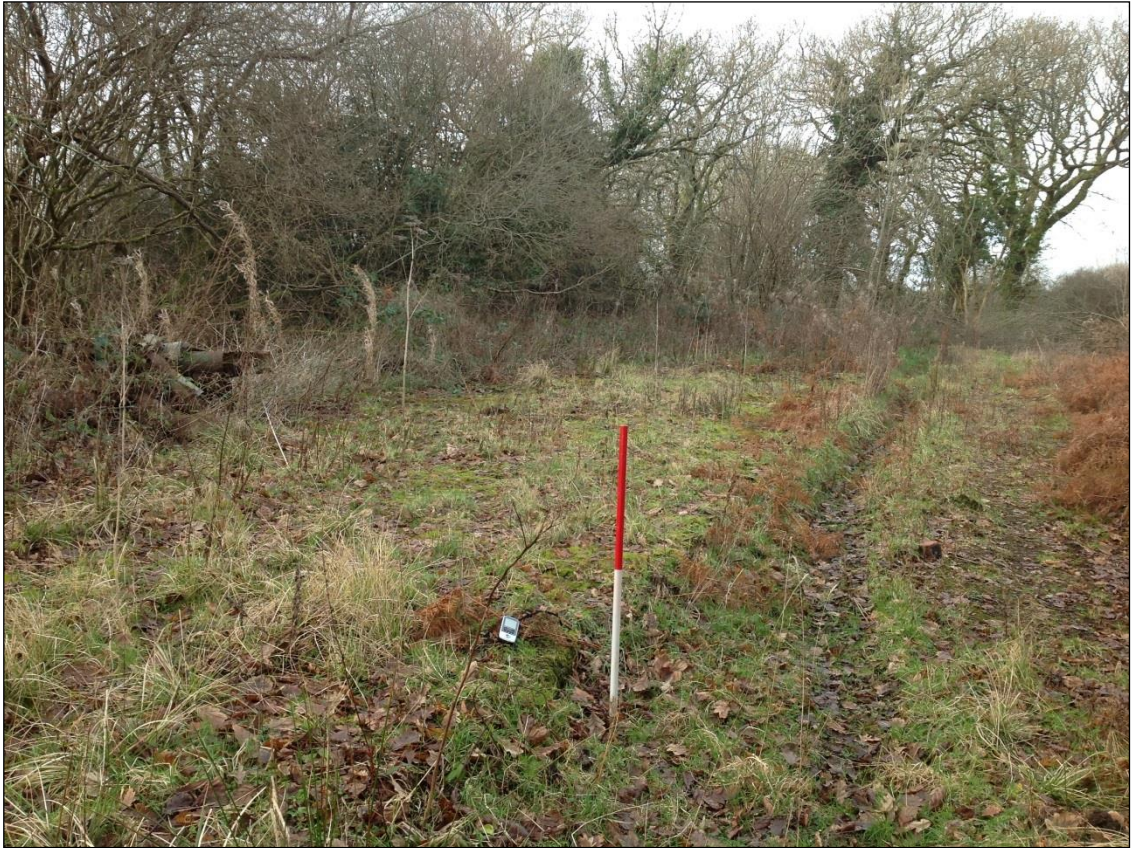
*Plate 9: Remains of the Laing type airwomens quarters.*

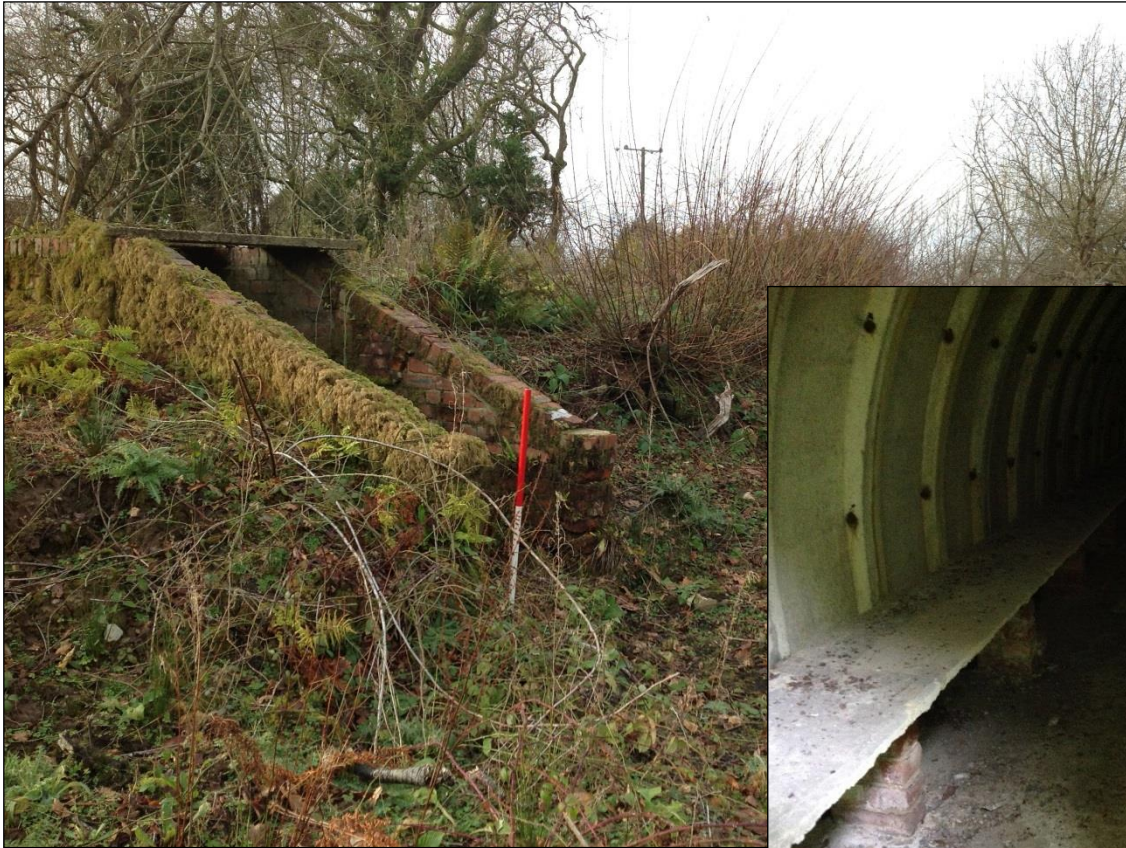
| <b>Condition</b> | Damaged |
| <b>Condition rating</b> | Fair |

*Plate 10: Air raid shelter. Concrete skimmed internal seating.*

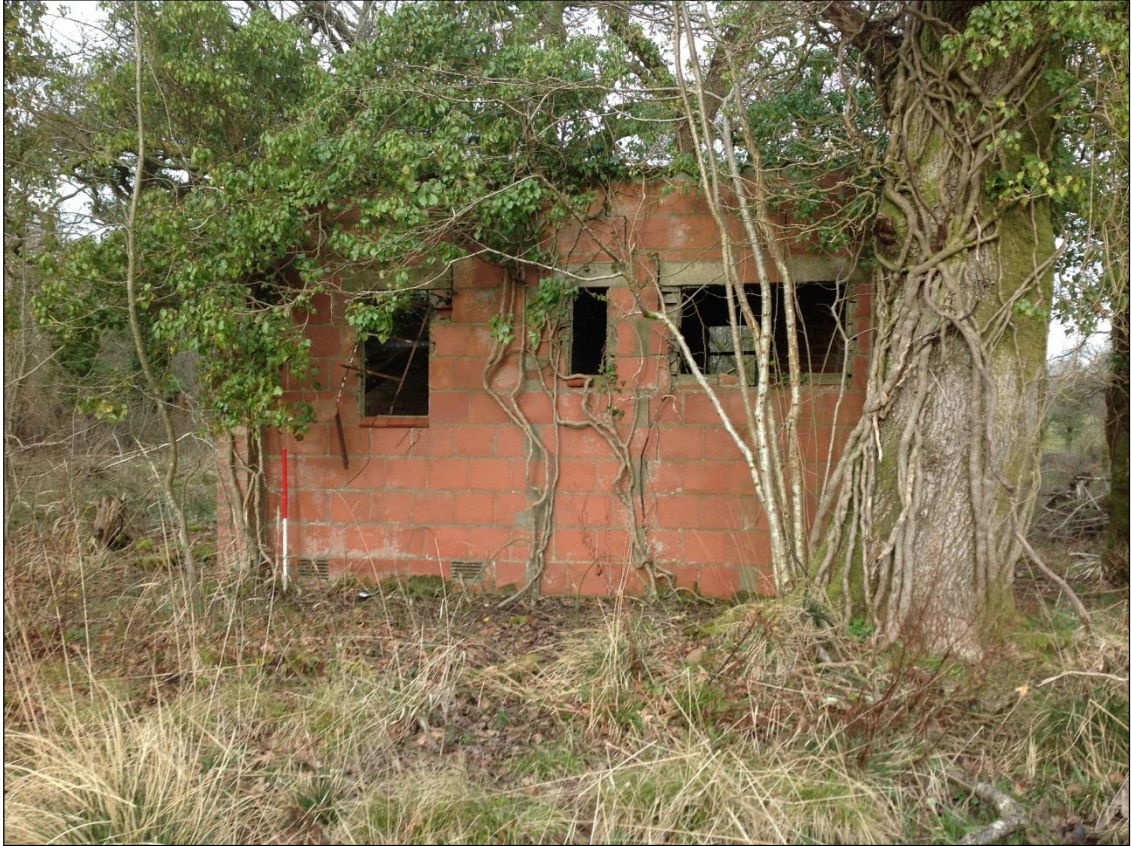
| <b>Condition</b> | Damaged |
| <b>Condition rating</b> | Poor |

*Plate 11: Front elevation of the sergeant's latrine block*

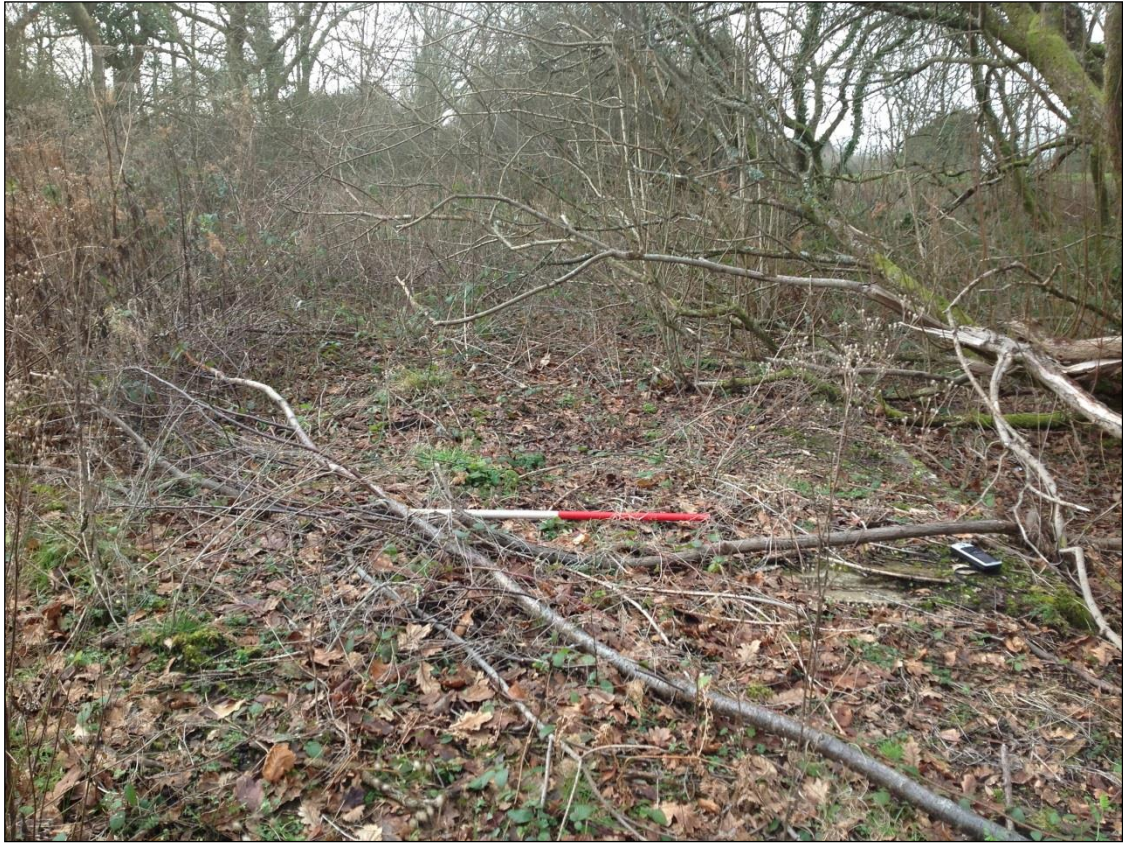
| <b>Condition</b> | Near Destroyed |
| <b>Condition rating</b> | Destroyed |

*Plate 12: The heavily overgrown sergeant's quarters.*

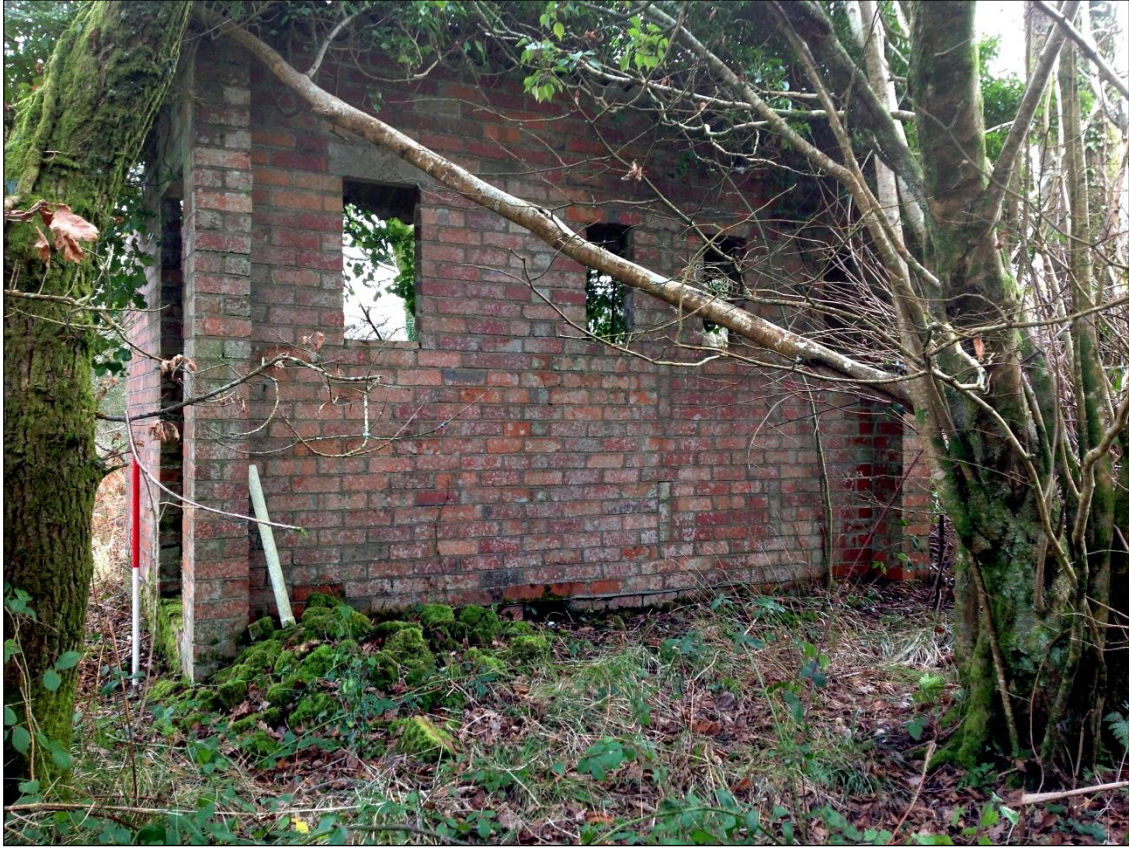
| <b>Condition</b> | Near Destroyed |
| <b>Condition rating</b> | Poor |

*Plate 13: The range of four windows along the frontal elevation of the latrine block.*

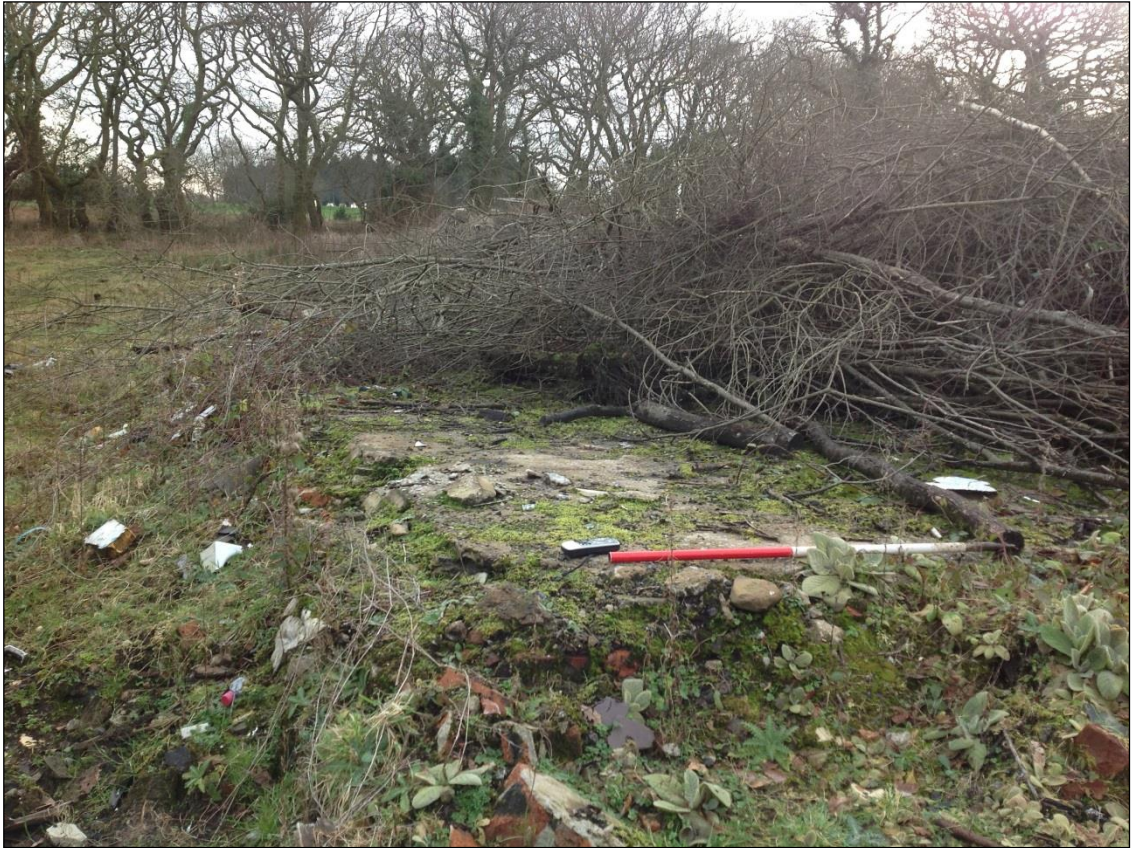
| <b>Description</b> | A linear concrete apron, heavily damaged, is all that survives of the ablutions block. This 36'x16' Nissen was constructed of corrugated steel sheets which were laid horizontally on the inside and on the outside were 26-gauge corrugated iron sheeting. The Nissen had wooden or brick ends each containing two windows and a doorframe they could be erected quickly and its arched shape made it very strong. |
| <b>Condition</b> | Near Destroyed |
| <b>Condition rating</b> | Destroyed |

*Plate 14: Beneath the cleared scrub lie the remains of the ablutions block.*

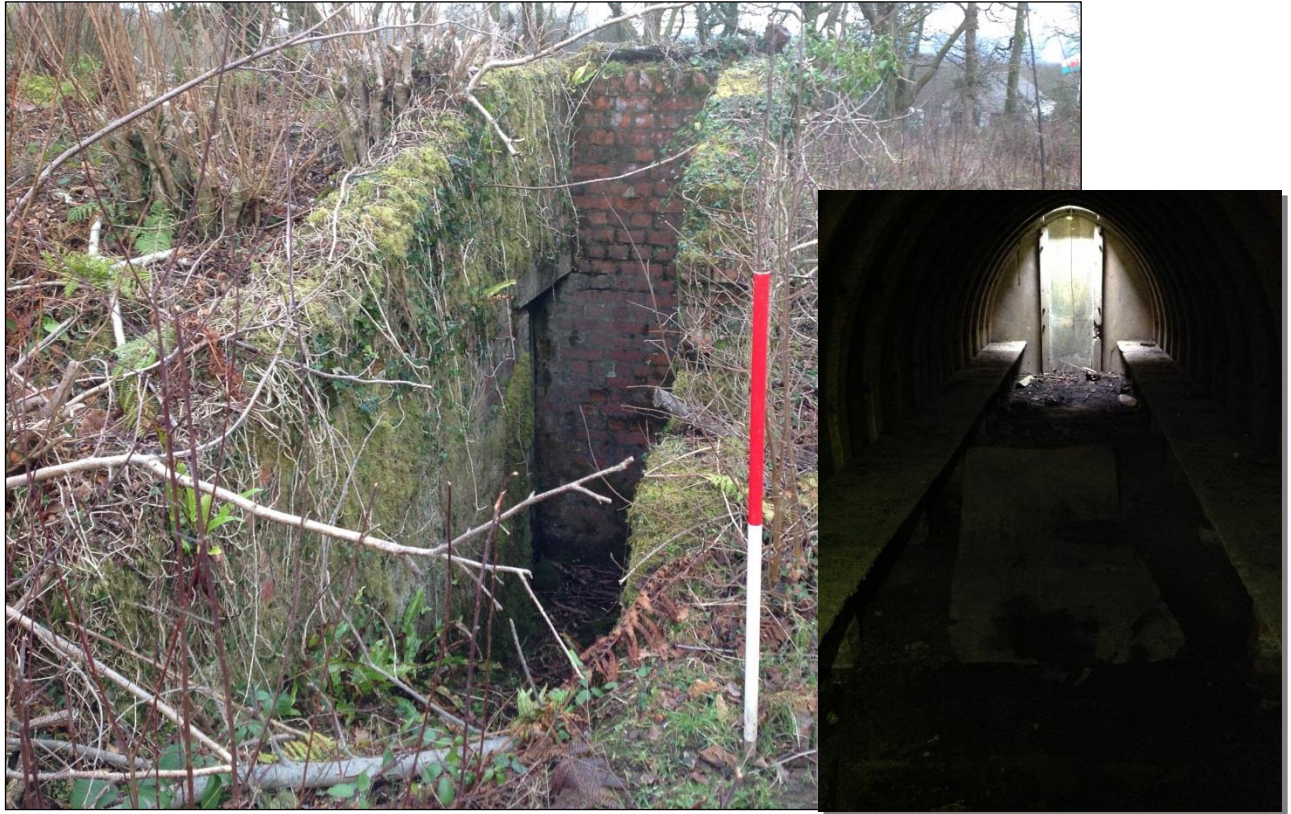
| <b>Condition</b> | Damaged |
| <b>Condition rating</b> | Fair |

*Plate 15: The second of the two Stanton shelters on the WAAF site.*

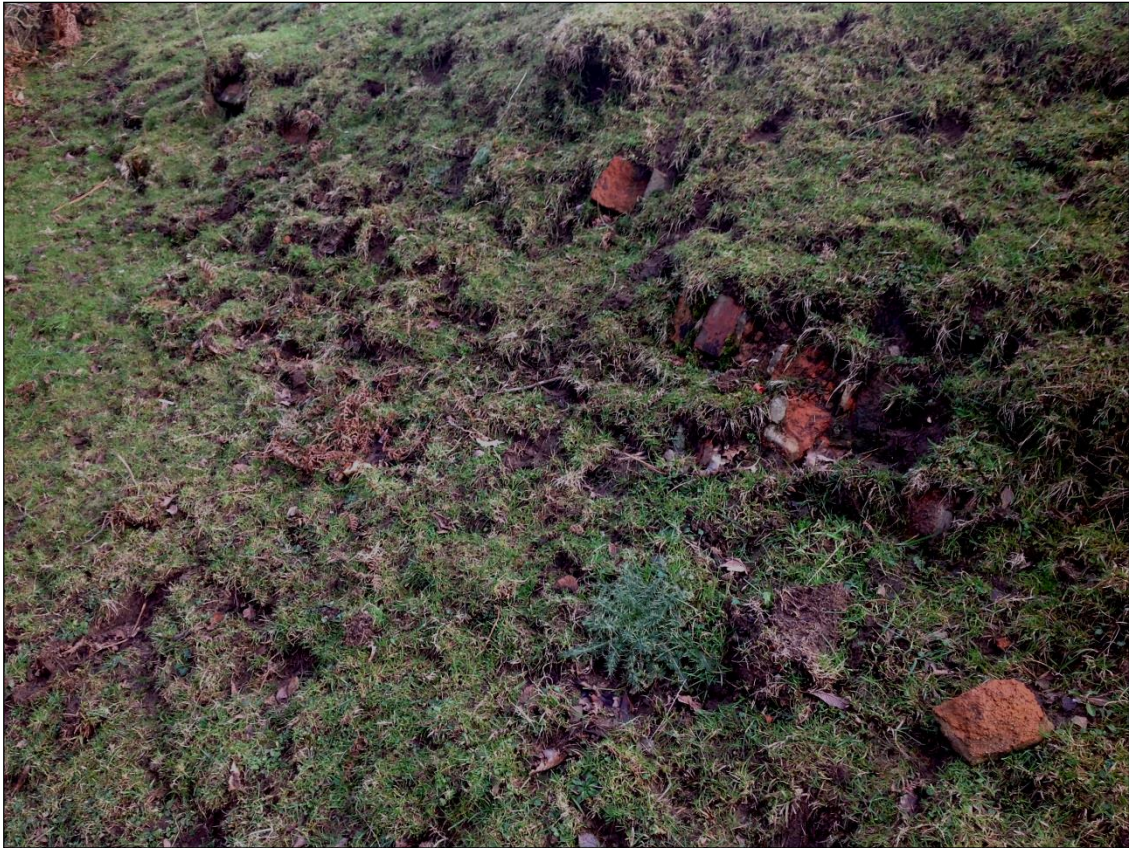
| <b>Condition</b> | Destroyed |
| <b>Condition rating</b> | Destroyed |

*Plate 16: Demolition rubble is all that remains of the Operations Blocks water tank*

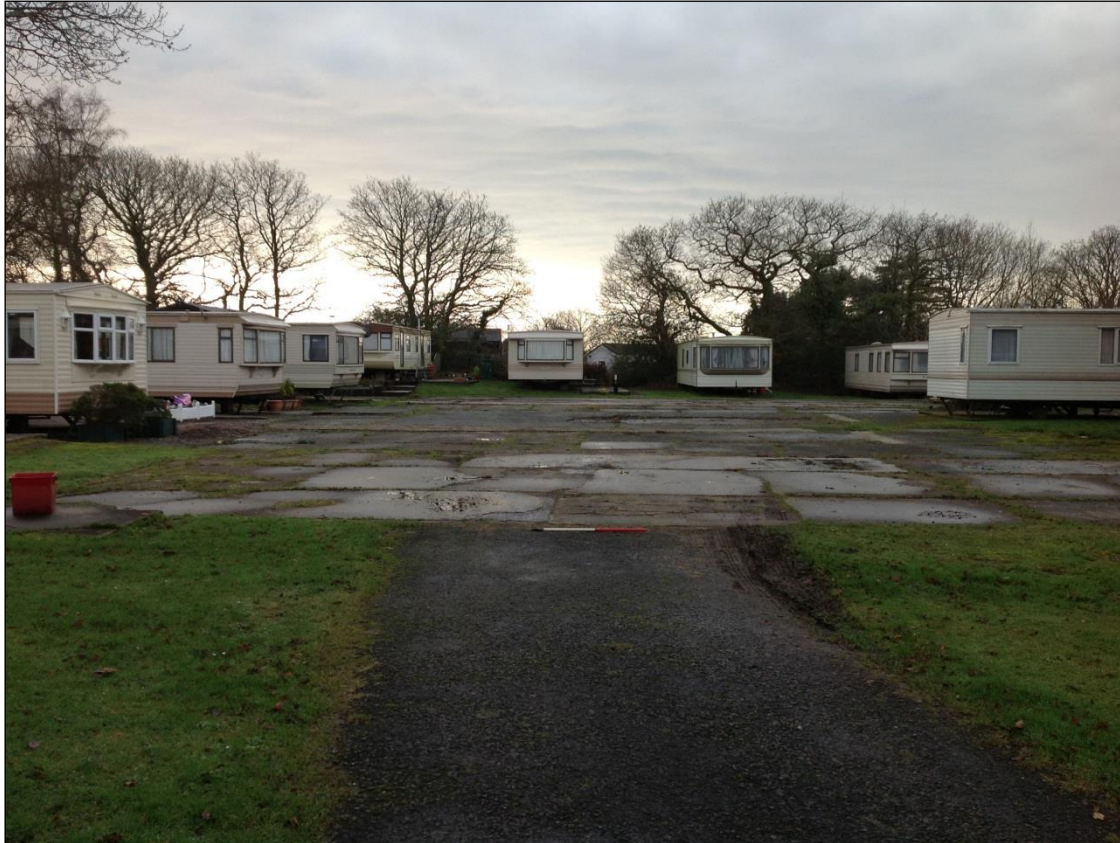
| <b>Condition</b> | Near Destroyed |
| <b>Condition rating</b> | Near Destroyed |

*Plate 19: Dining Room for 1200 & Cinema Projector room. View to the south.*

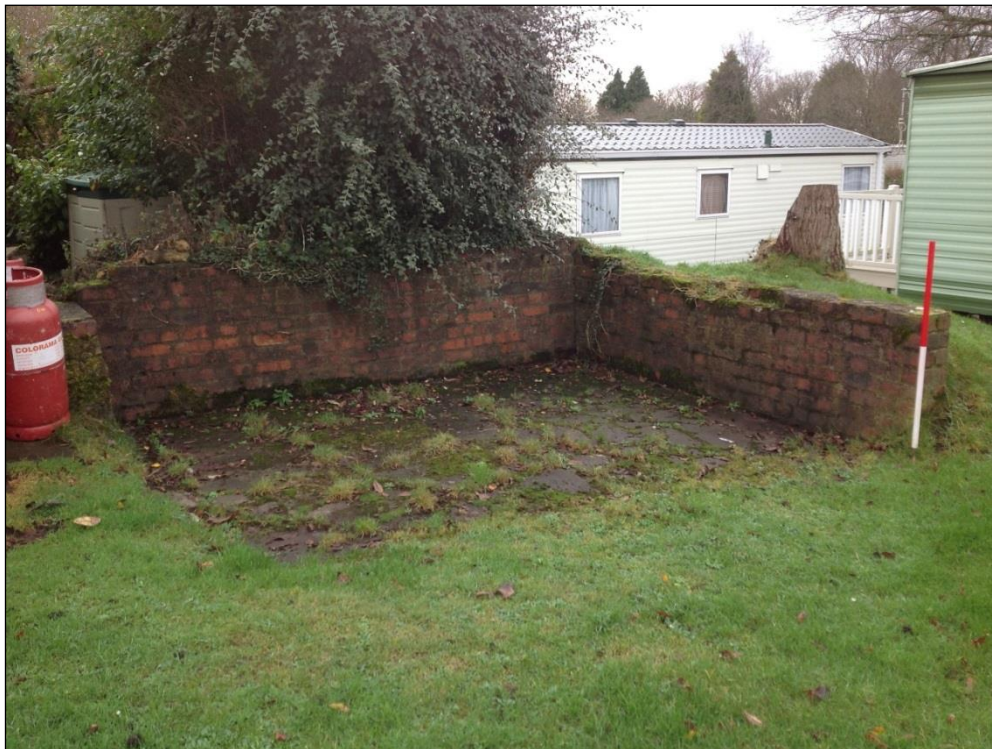
| <b>Condition</b> | Near Destroyed |
| <b>Condition rating</b> | Poor |

*Plate 20: Unknown brick structure*

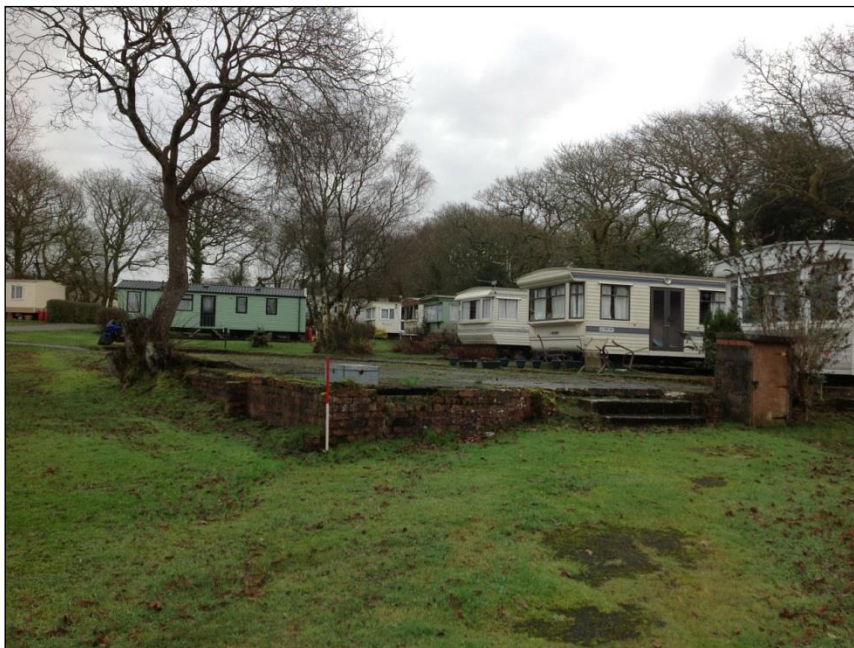
| <b>Condition</b> | Near Destroyed |
| <b>Condition rating</b> | Poor |

*Plate 22: Entrance to the Gymnasium. View to the northeast*

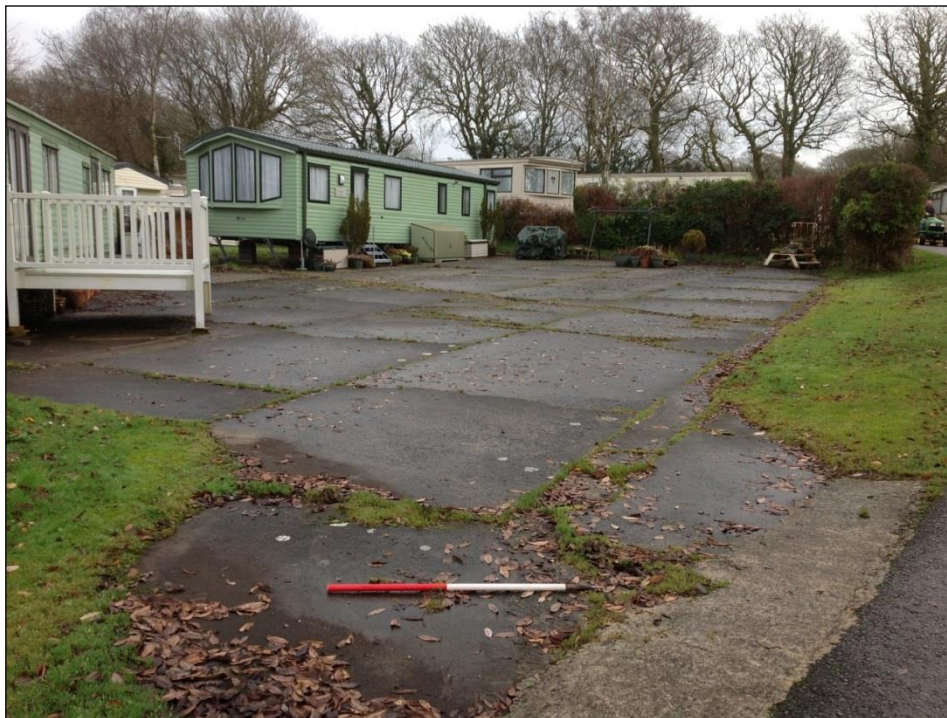
| <b>Condition</b> | Near Destroyed |
| <b>Condition rating</b> | Poor |

*Plate 23: All that remains of the sites fuel compound.*

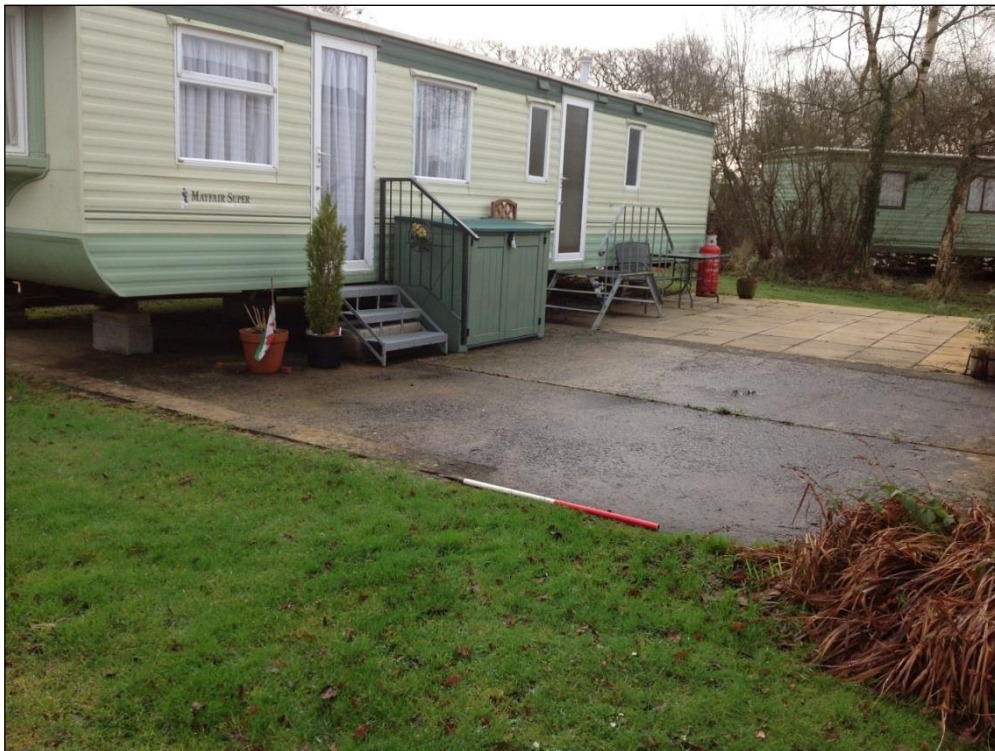
| <b>Condition</b> | Near Destroyed |
| <b>Condition rating</b> | Poor |

*Plate 24: The remains of the Grocery and Local Produce Store*

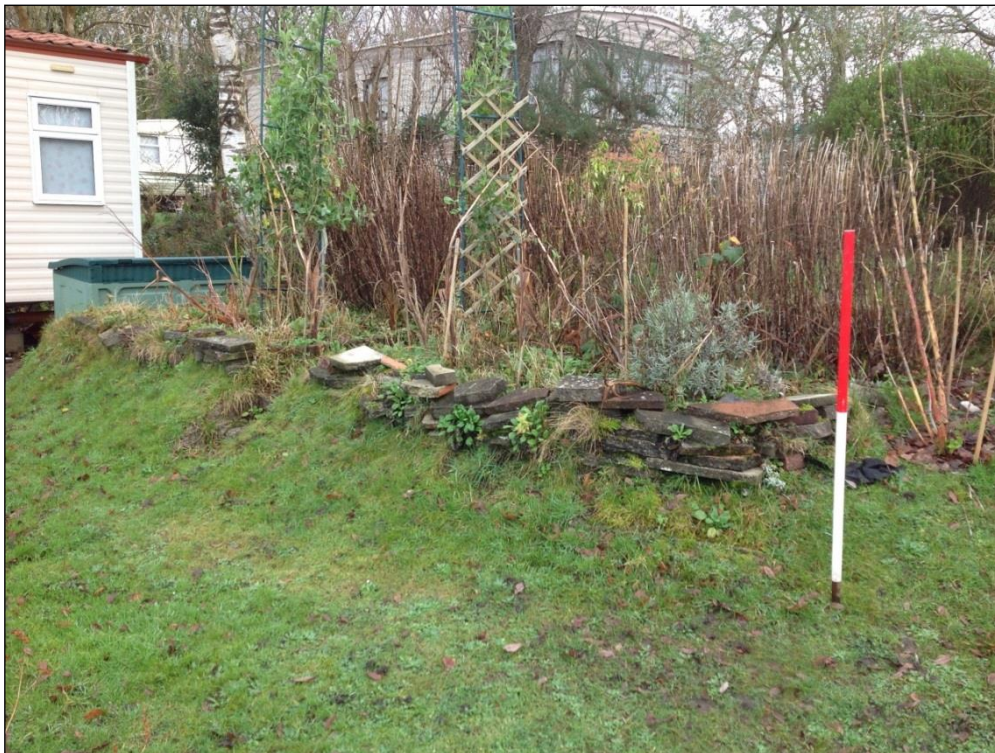
| <b>Condition</b> | Near Destroyed |
| <b>Condition rating</b> | Near Destroyed |

*Plate 25: Set of heavily overgrown steps, which may have led up to a blast shelter.*

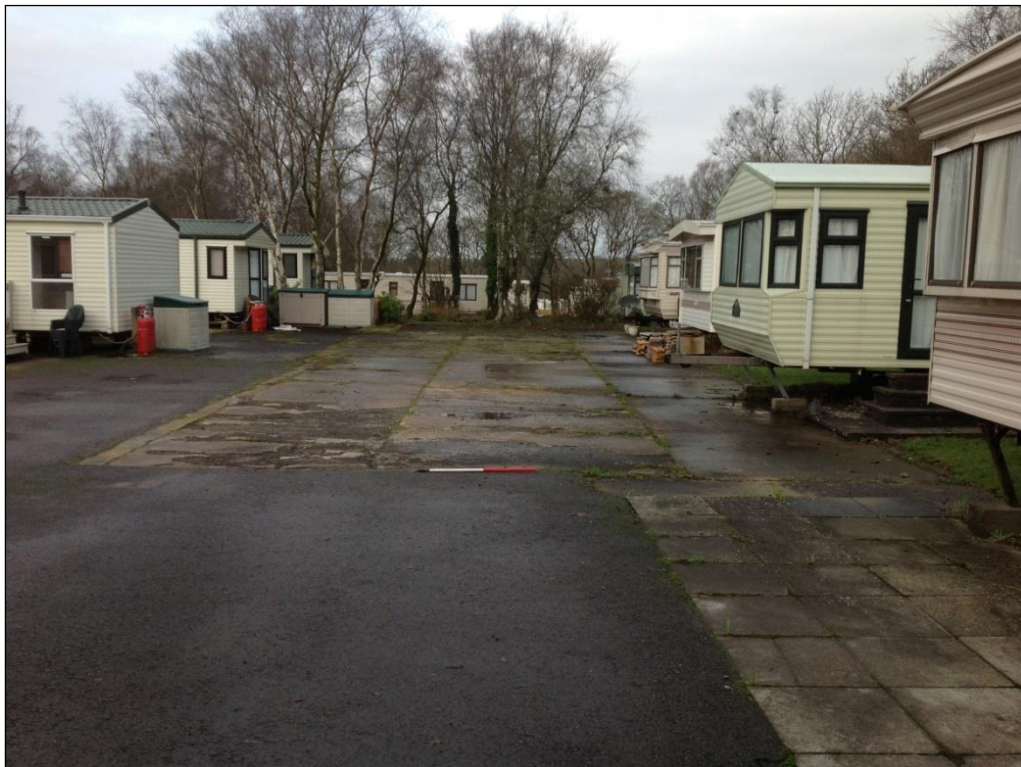
| <b>Condition</b> | Near Destroyed |
| <b>Condition rating</b> | Poor |

*Plate 26: NAAFI Building (part of the Institute & NAAFI structure)*

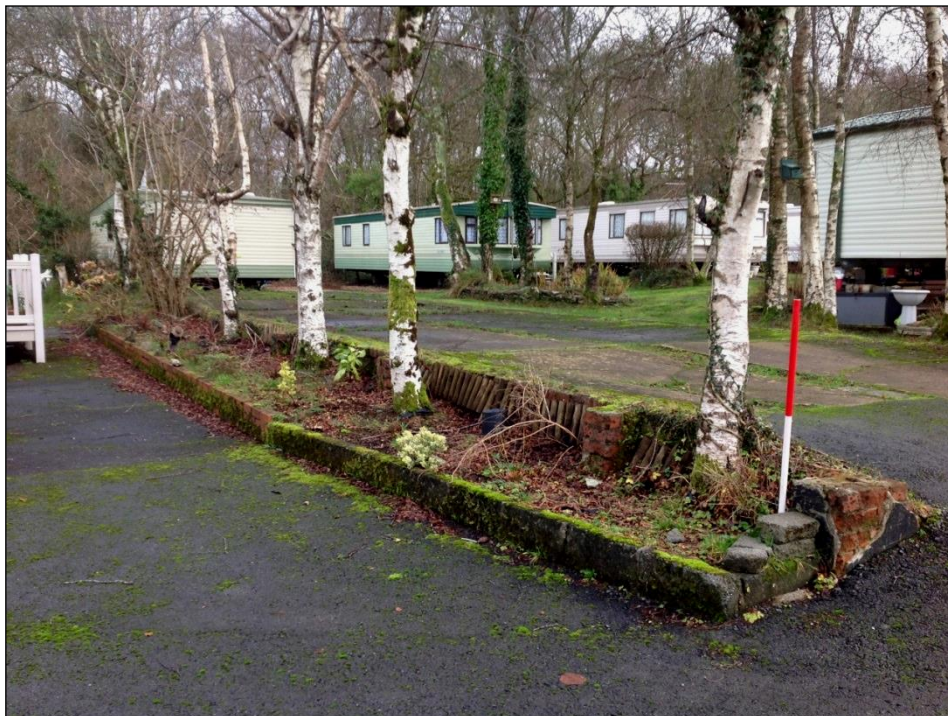
| <b>Description</b> | All that survives of the institute is linear concrete apron. This is revetted on the western flank by four course of brickwork and segregated at intervals by the bricks bases of external piers. The western flank is also broken by a central set of steps which once led into the building. |
| <b>Condition</b> | Near Destroyed |
| <b>Condition rating</b> | Poor |

*Plate 27: View along the remains of the Institute Buildings west wall*

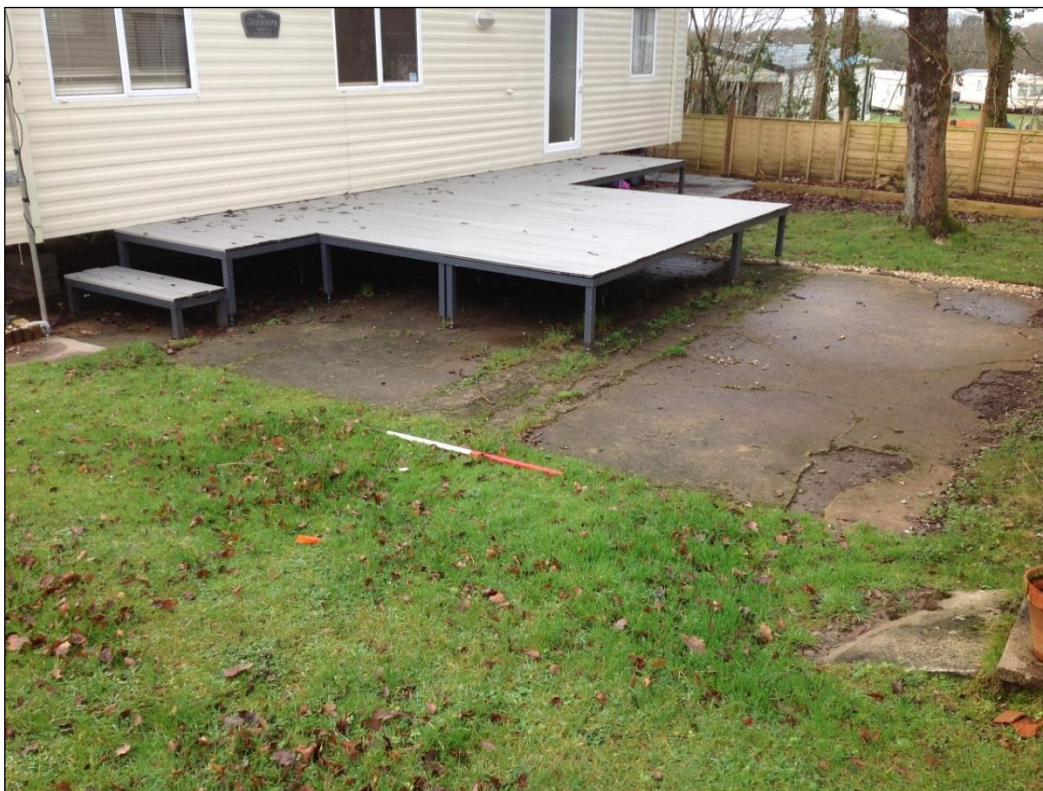
| <b>Condition</b> | Near Destroyed |
| <b>Condition rating</b> | Poor |

*Plate 28: Remains of the airmen's ablutions building*

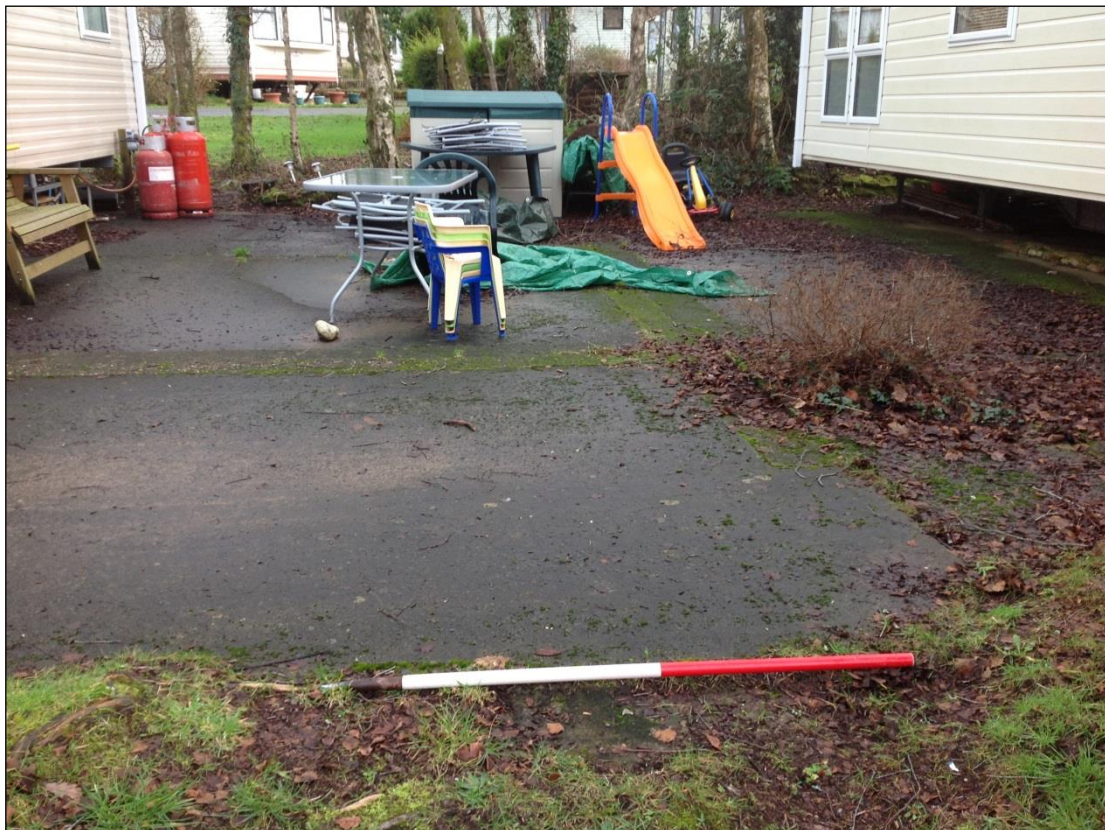
| <b>Condition</b> | Near Destroyed |
| <b>Condition rating</b> | Poor |

Plate 29: Gas decontamination centre type 'G'. View to the east

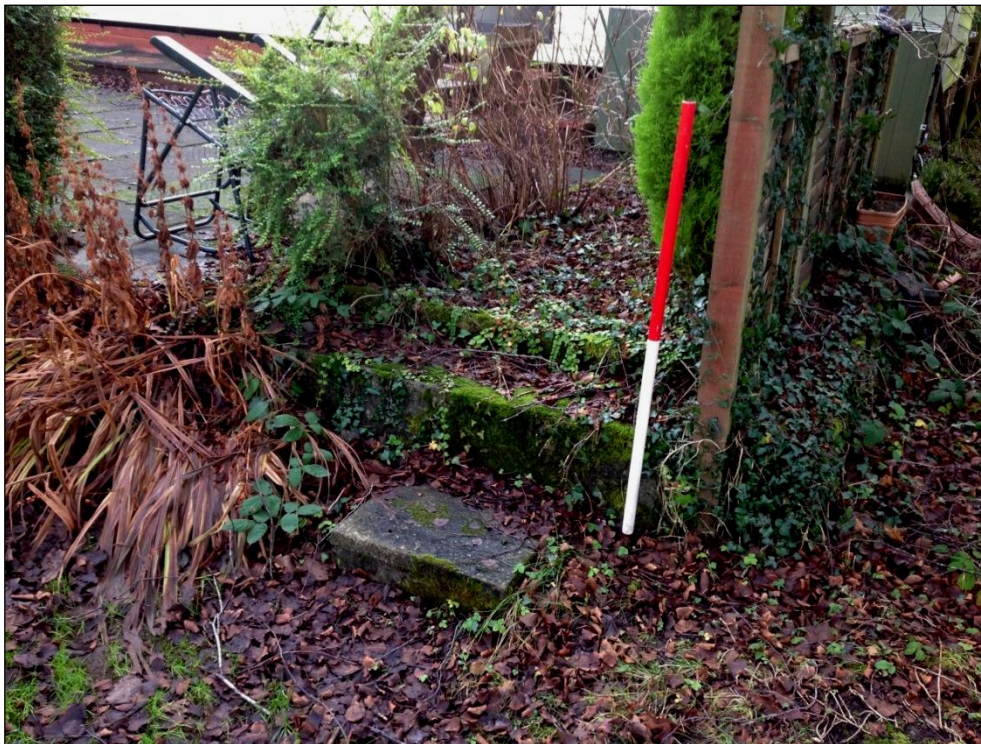
| <b>Condition</b> | Near Destroyed |
| <b>Condition rating</b> | Poor |

*Plate 30: A set of three steps still visible at its western end of this unknown structure.*

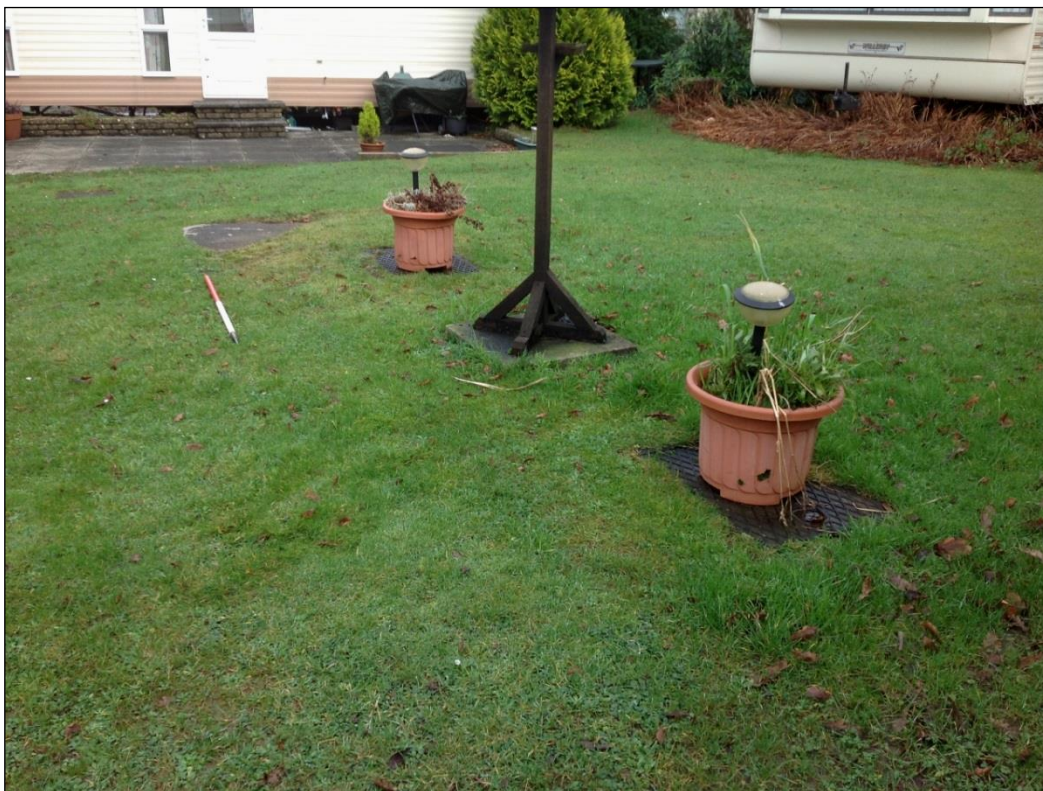
| <b>Condition</b> | Destroyed |
| <b>Condition rating</b> | Destroyed |

*Plate 31: Remains of brickwork, from a possible blast shelter, beneath the turf layer*

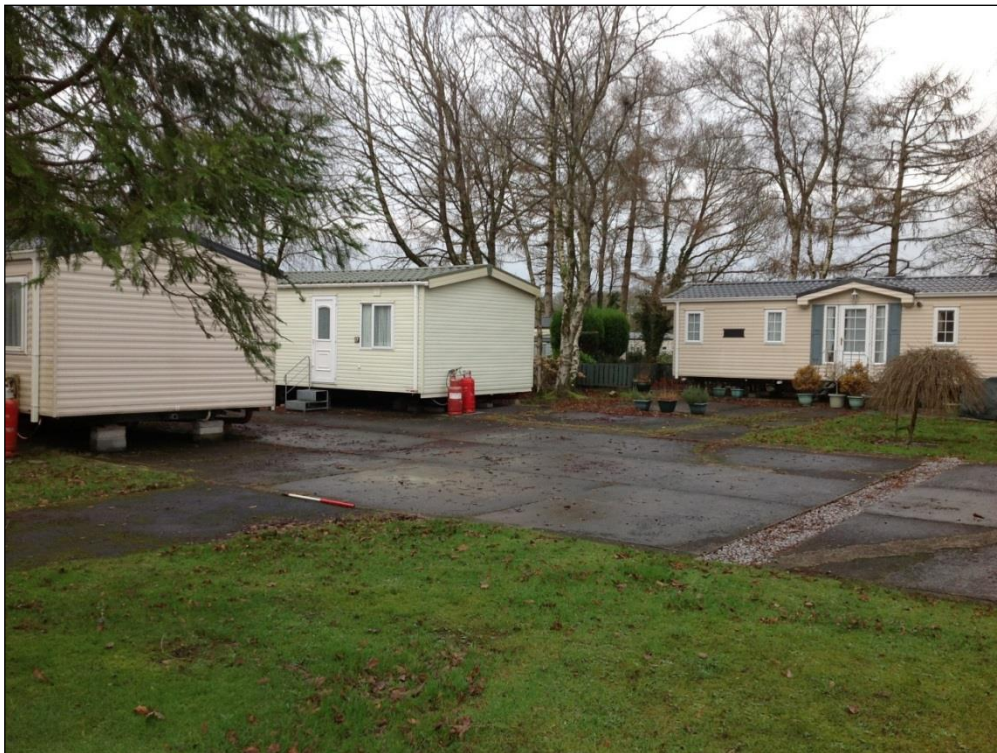
| <b>Condition</b> | Near Destroyed |
| <b>Condition rating</b> | Poor |

*Plate 32: Very little remains to distinguish the Barbers, Tailors and Shoemakers shop building*

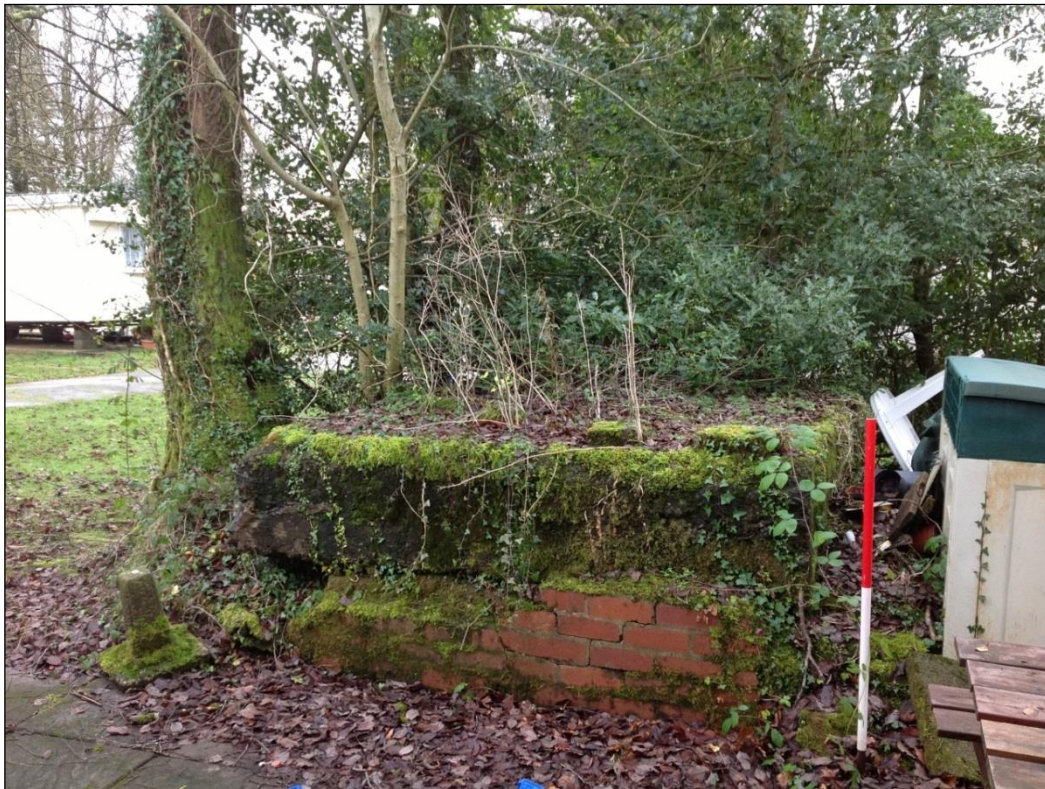
| <b>Condition</b> | Near Destroyed |
| <b>Condition rating</b> | Poor |

*Plate 33: The reinforced plinth to house the site generator*

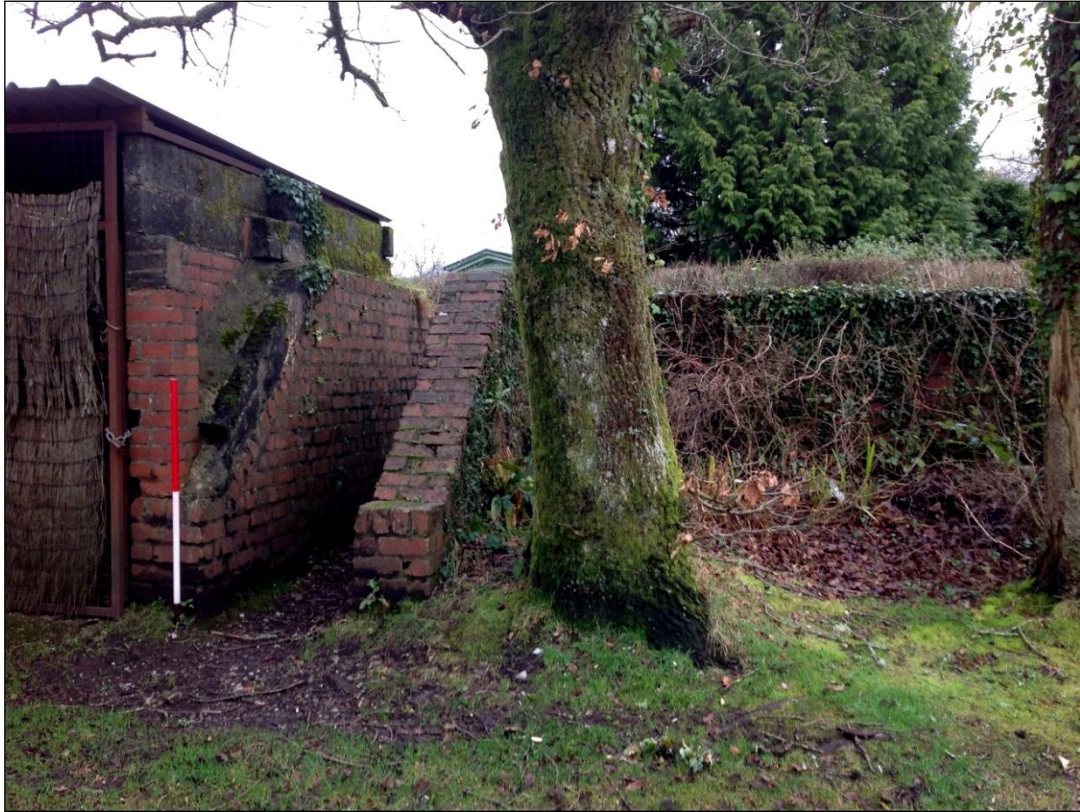
| <b>Condition</b> | Near Destroyed |
| <b>Condition rating</b> | Damaged/Converted |

*Plate 34: The western entrance with the modern addition to the left.*

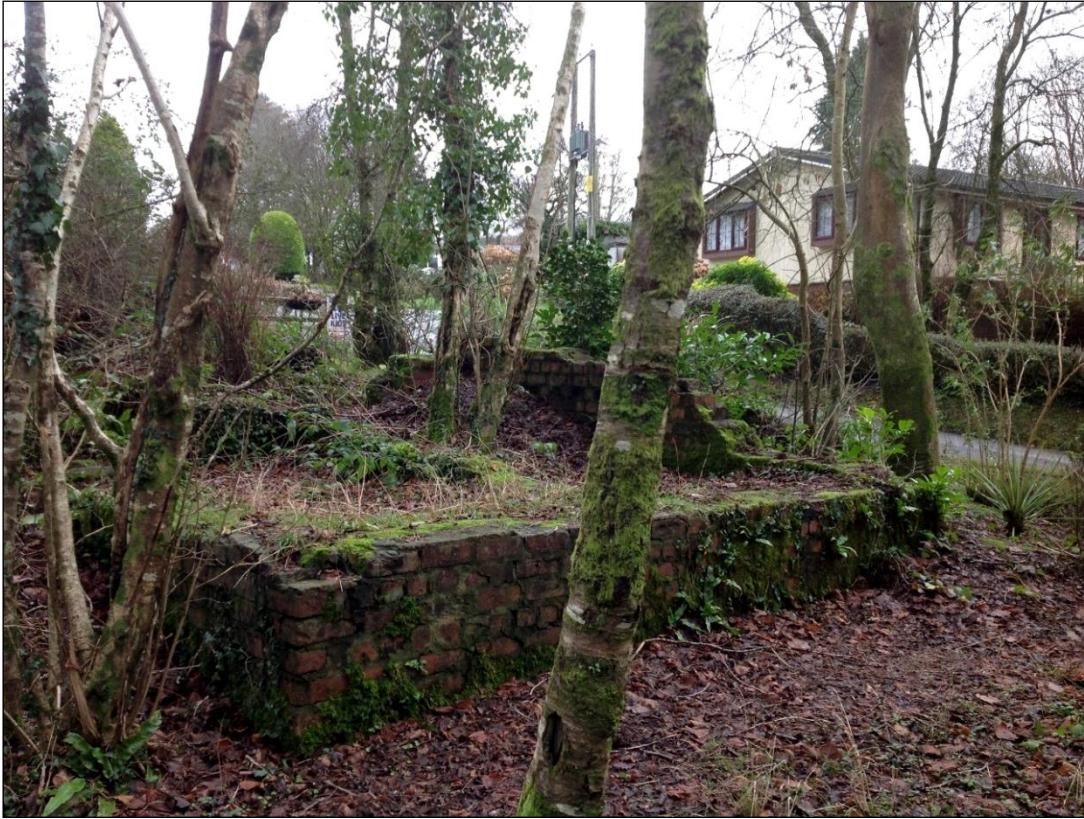
| <b>Condition</b> | Near Destroyed |
| <b>Condition rating</b> | Poor |

*Plate 35: Remains of the Picket Post at the Communal site entrance. Note the two cells, possibly housing the prophylactic room*

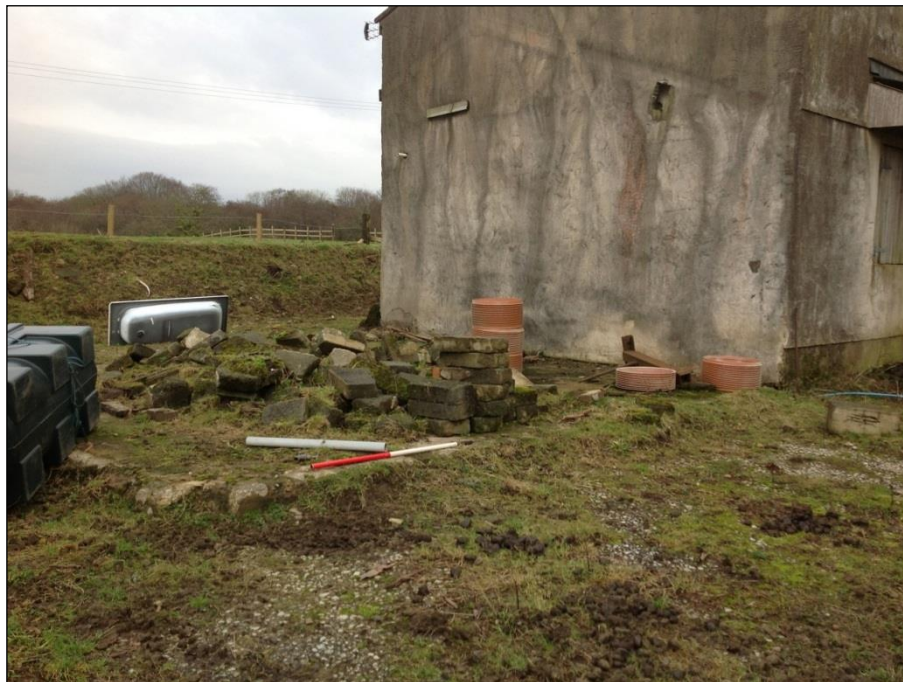
*Plate 37: Little now remains of the building 151.*

| <b>Description</b> | <p>A heavily damaged linear concrete apron is all that survives of the airmens quarters. A later addition, constructed of blockwork walls, has been added to the northern half of the apron. This is now also damaged.</p> <p>Airmen were accommodated in the standard 'Nissan type' huts. The structure would have been semi-circular in section and comprised of a prefabricated curved corrugated iron sheeting over an internal steel frame. The structure would have had beds, wooden lockers and a stove.</p> |
| <b>Condition</b> | Near Destroyed |
| <b>Condition rating</b> | Destroyed |
