# GGAT 112: Second World War Military Airfields of South Wales

Year 2-Airfield Hinterland

A report for Cadw  
by Paul W Huckfield BA

GGAT report no. 2013/024  
Project no. GGAT 112

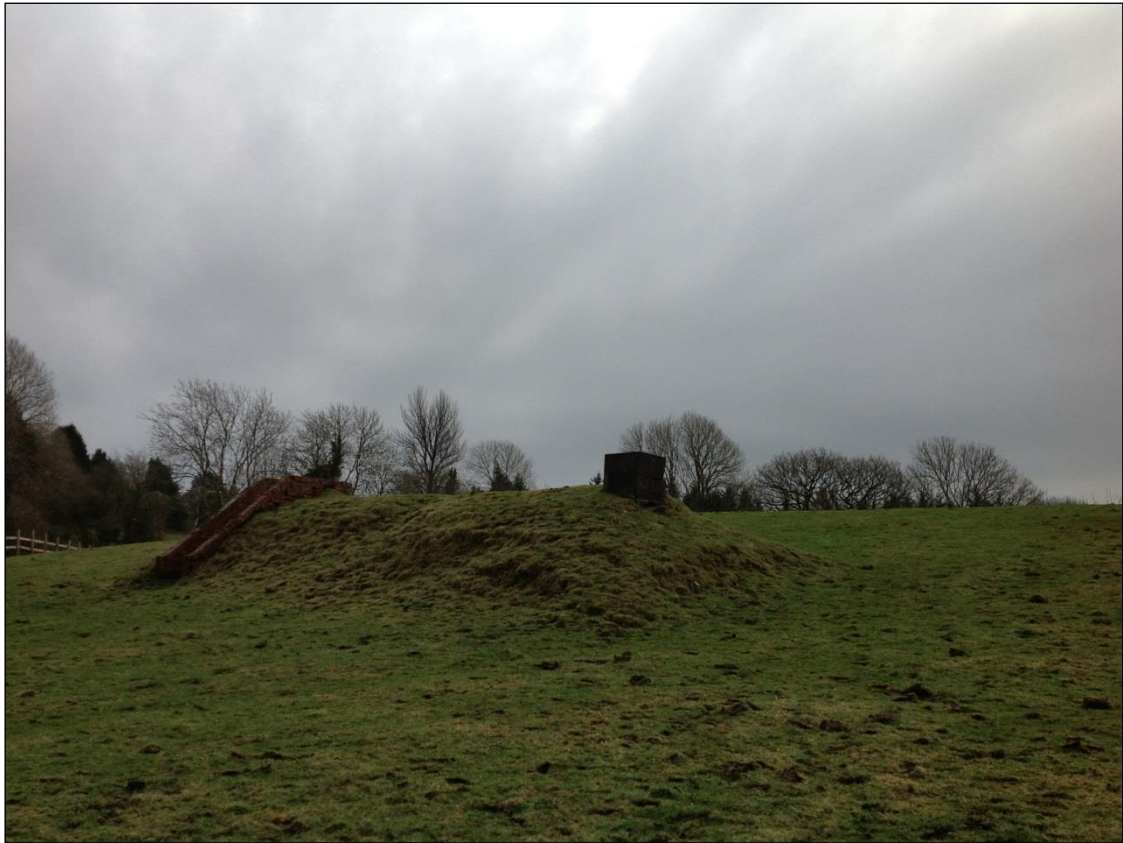
| <b>Condition</b> | Damaged |
| <b>Condition rating</b> | Fair |

*Plate 39: Stanton Air Raid Shelter. View to the east.*

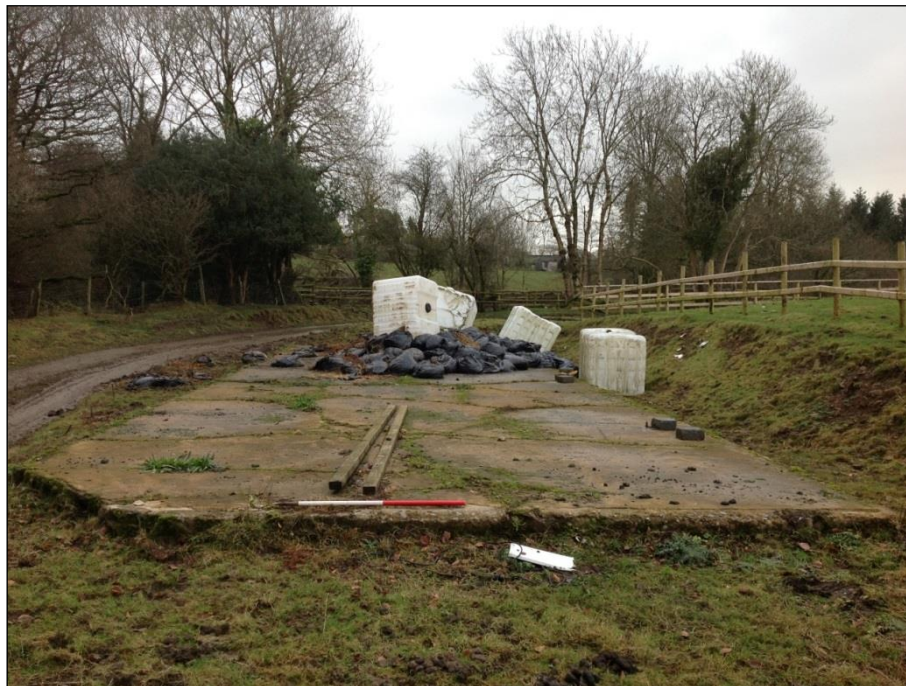
| <b>Condition</b> | Near Destroyed |
| <b>Condition rating</b> | Destroyed |

*Plate 40: Remains of the Officers Quarters (Dwg no. 13903/40).*

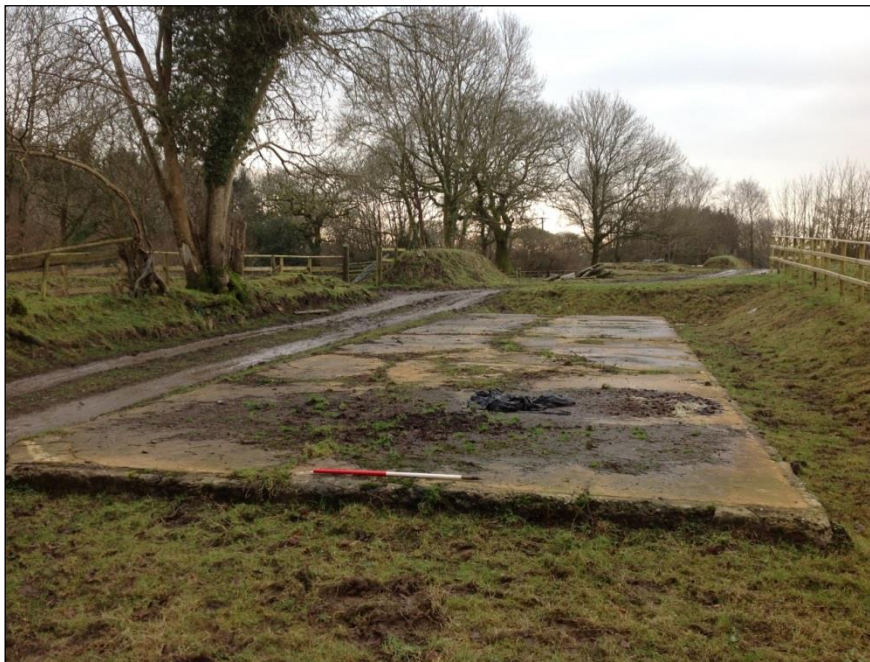
| <b>Condition</b> | Near Destroyed |
| <b>Condition rating</b> | Destroyed |

*Plate 41: Concrete apron on which the Officers Quarters stood.*

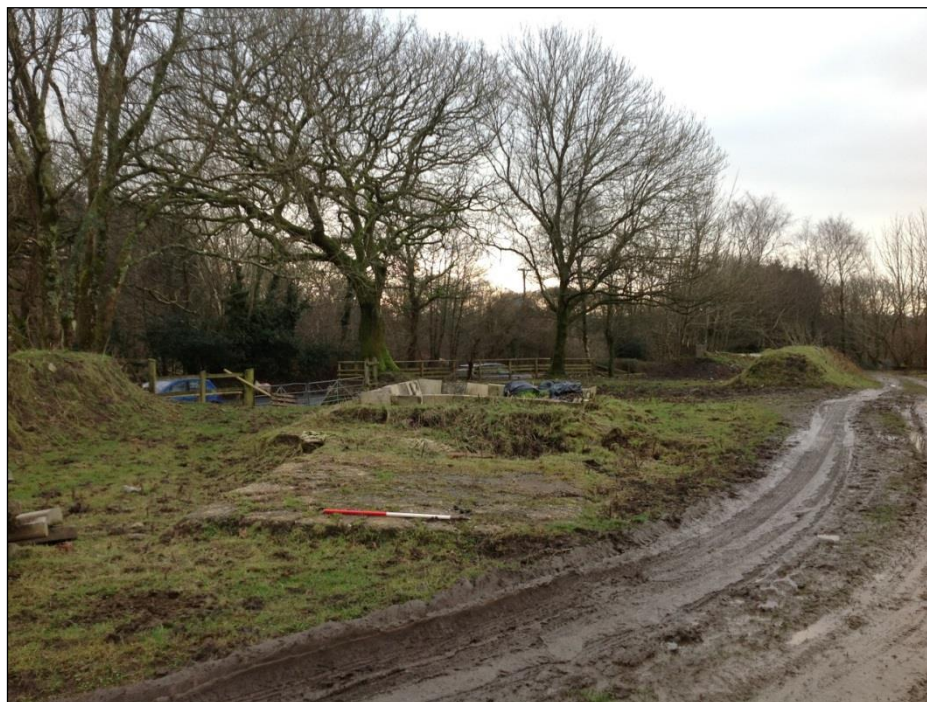
| <b>Condition</b> | Near Destroyed |
| <b>Condition rating</b> | Destroyed |

*Plate 42: Very little now remains of the Picket Post at the entrance to Site No.6.*

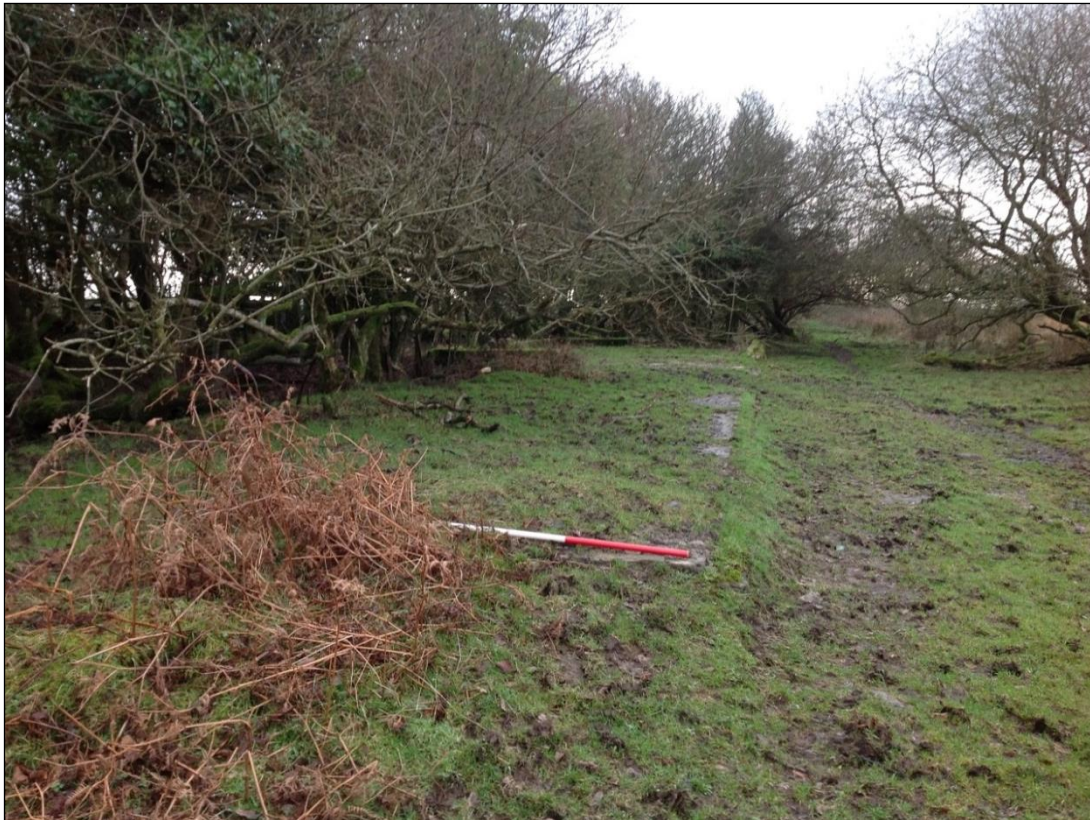
| <b>Condition</b> | Near Destroyed |
| <b>Condition rating</b> | Very Bad |

*Plate 44: Barrack hut 372. View to the south.*

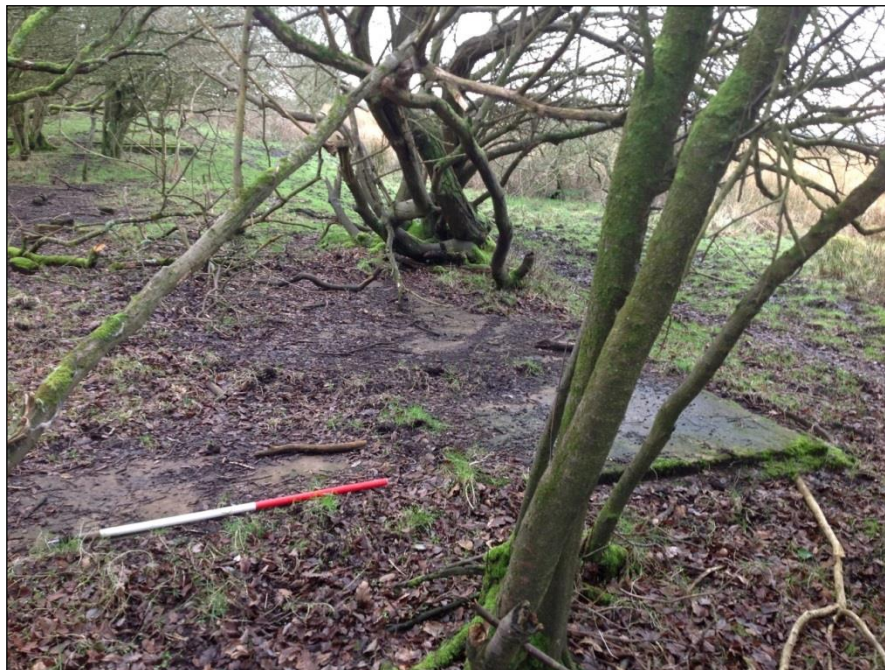
| <b>Condition</b> | Near Destroyed |
| <b>Condition rating</b> | Destroyed |

*Plate 46: The overgrown base of barrack hut 370.*

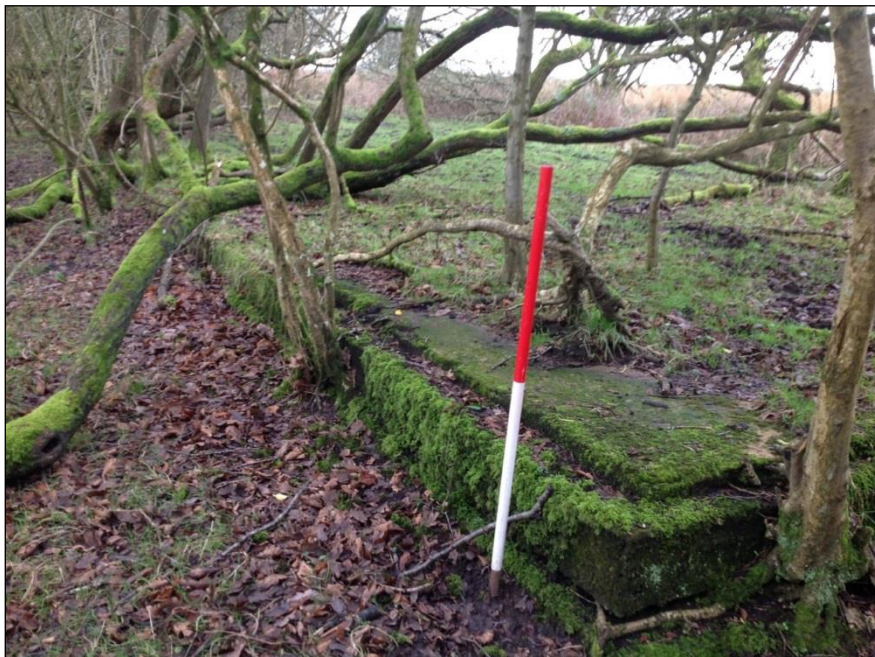
| <b>Condition</b> | Near Destroyed |
| <b>Condition rating</b> | Destroyed |

*Plate 47: The stepped base of PRN 07854w.*

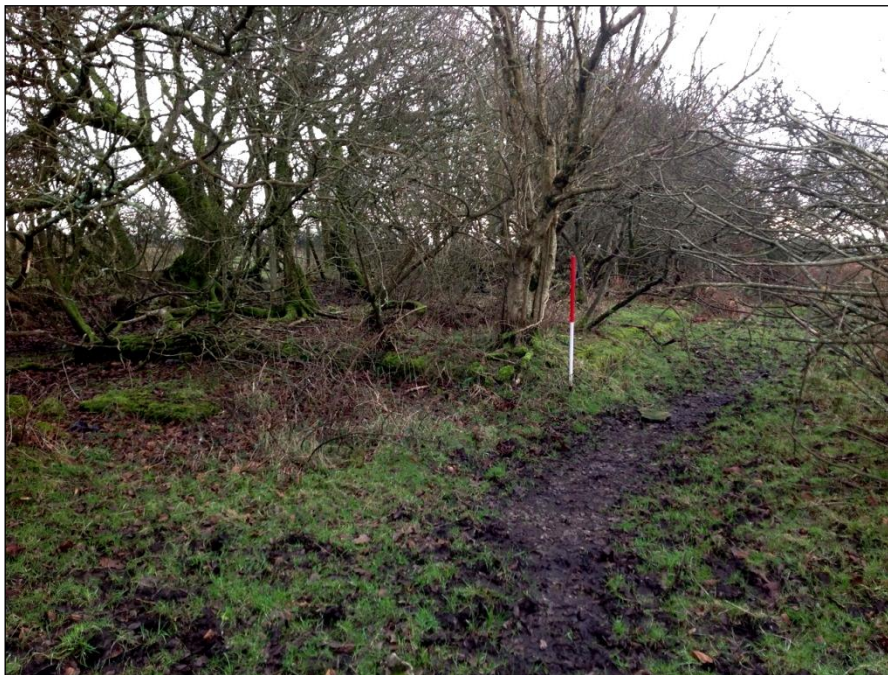
| <b>Condition</b> | Near Destroyed |
| <b>Condition rating</b> | Destroyed |

*Plate 48: Remains of Army Guard Unit barrack hut 368.*

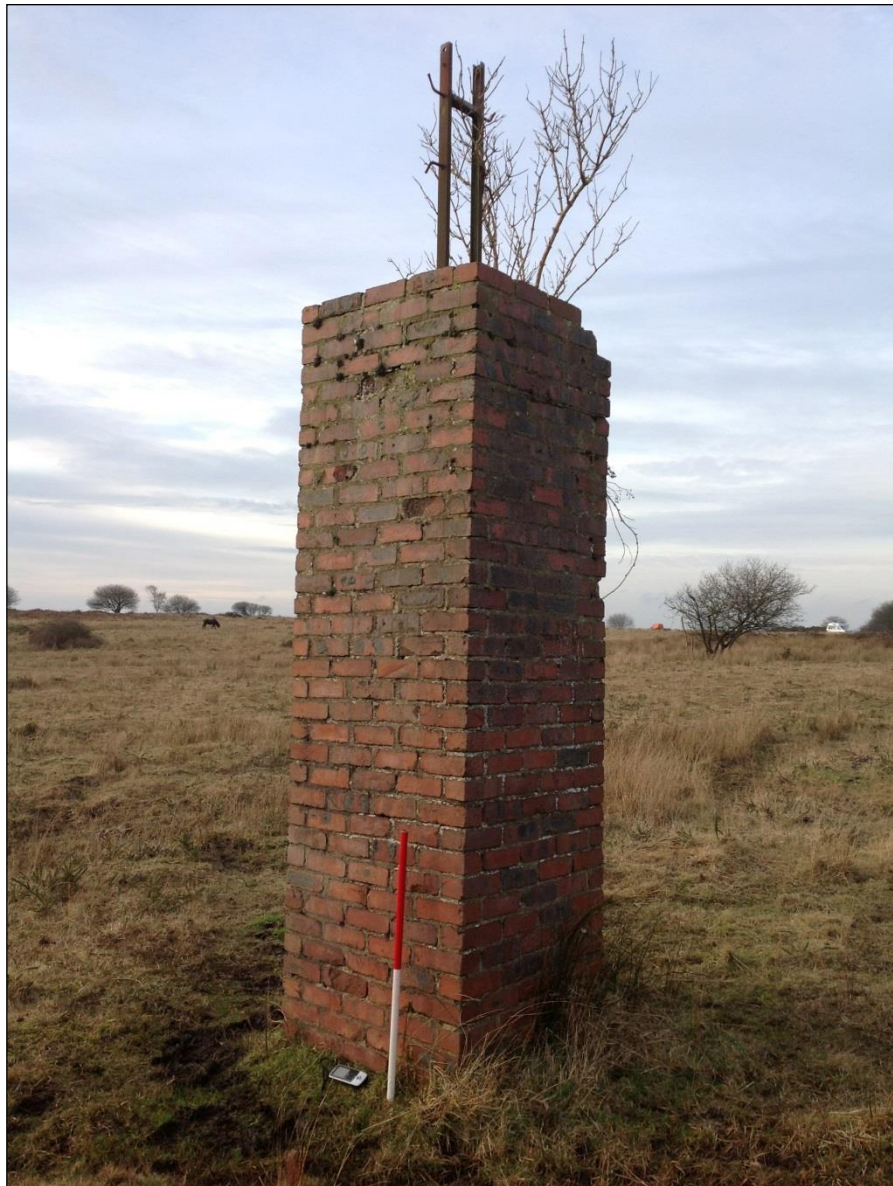
| <b>Condition</b> | Damaged |
| <b>Condition rating</b> | Fair |

*Plate 49: The southern of the pair of brick beacon towers*

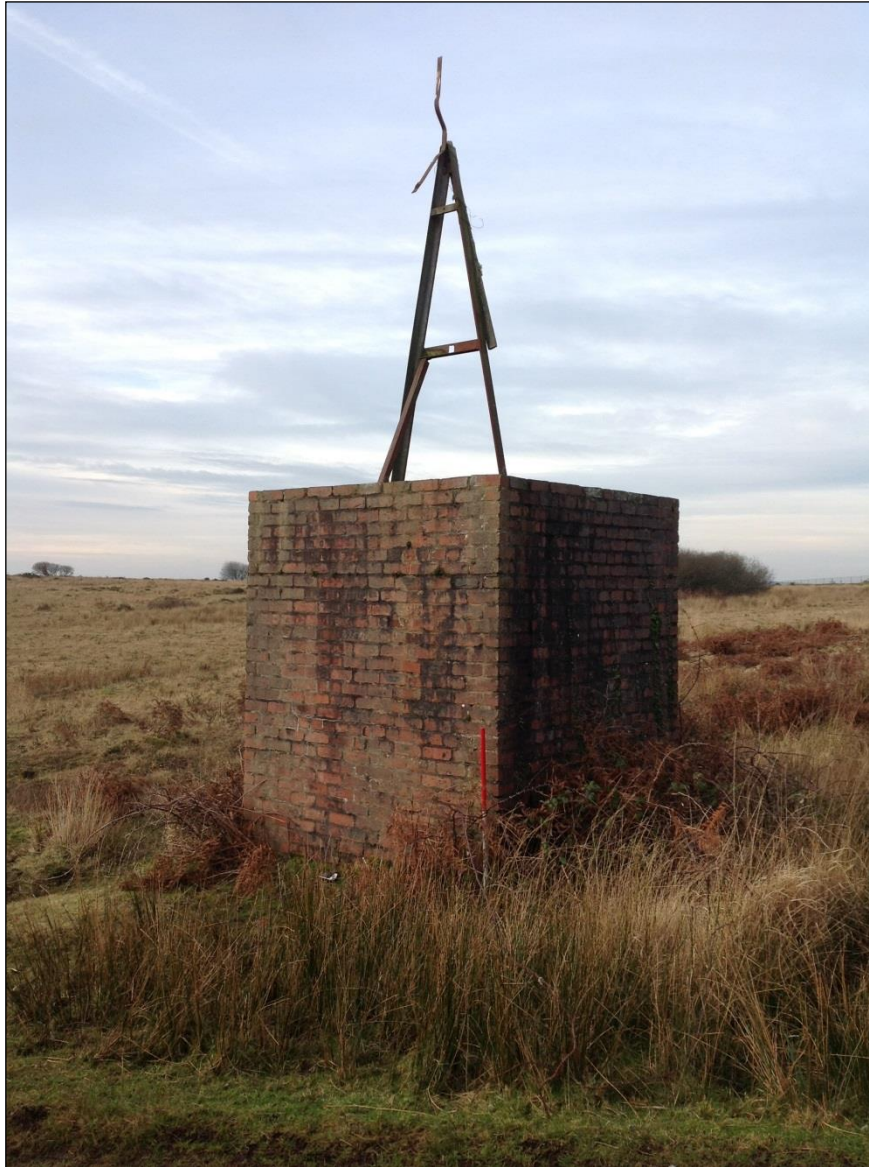
| <b>Condition</b> | Damaged |
| <b>Condition rating</b> | Fair |

*Plate 50: The southern airfield beacon PRN 06770w.*

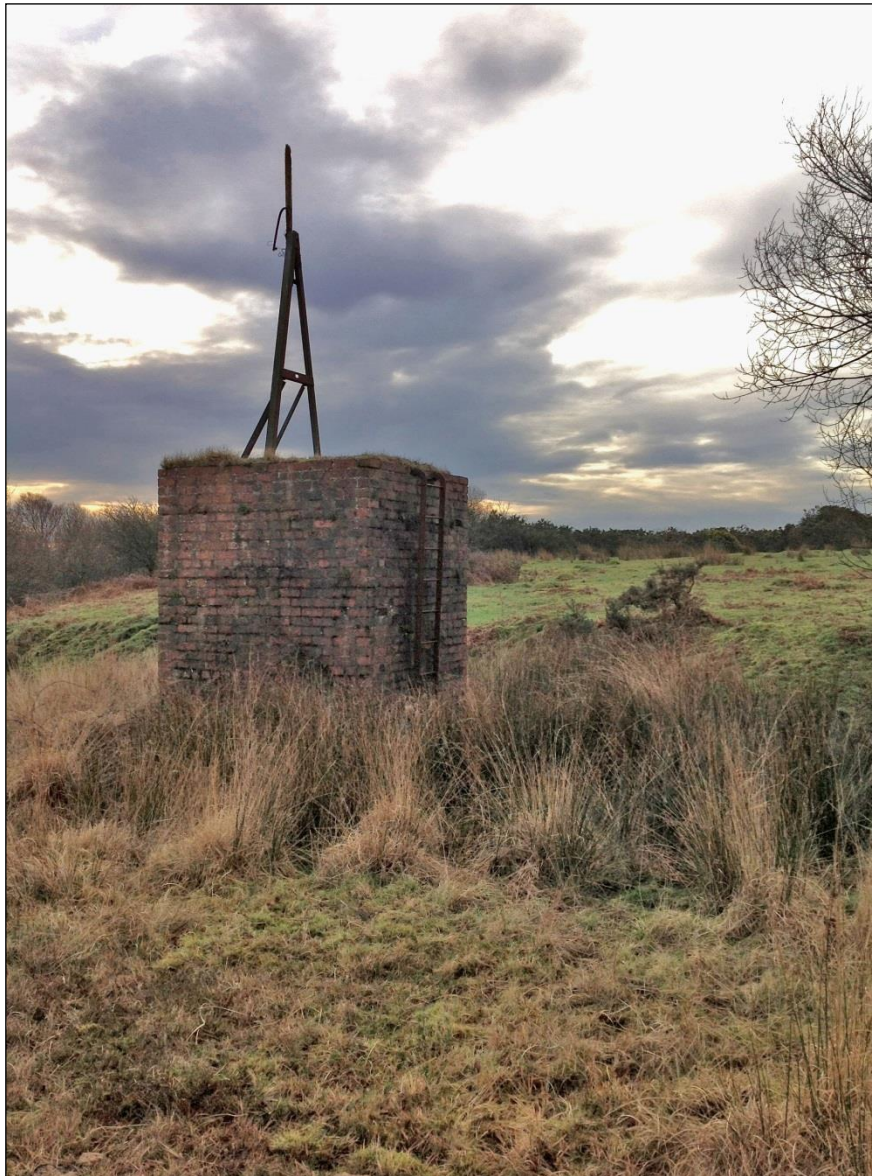
| <b>Condition</b> | Damaged |
| <b>Condition rating</b> | Fair |

*Plate 51: Northern beacon PRN 07858w.*

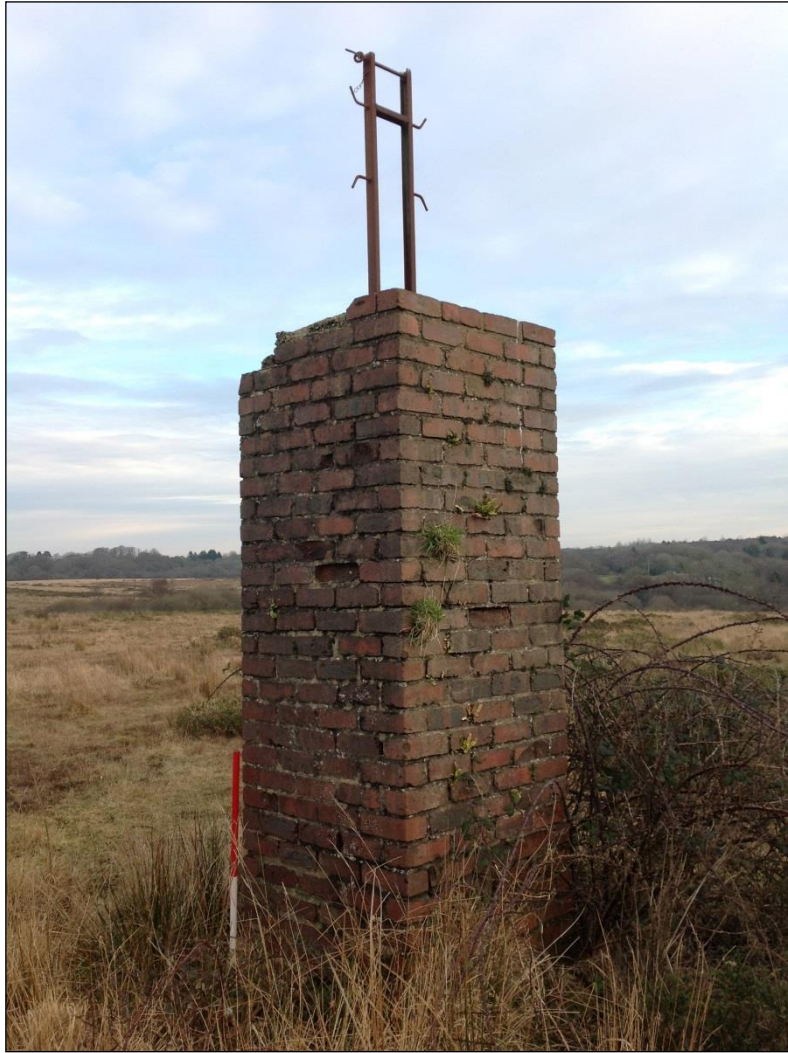
| <b>Condition</b> | Damaged |
| <b>Condition rating</b> | Fair |

*Plate 52: Northern airfield beacon PRN 06767w.*

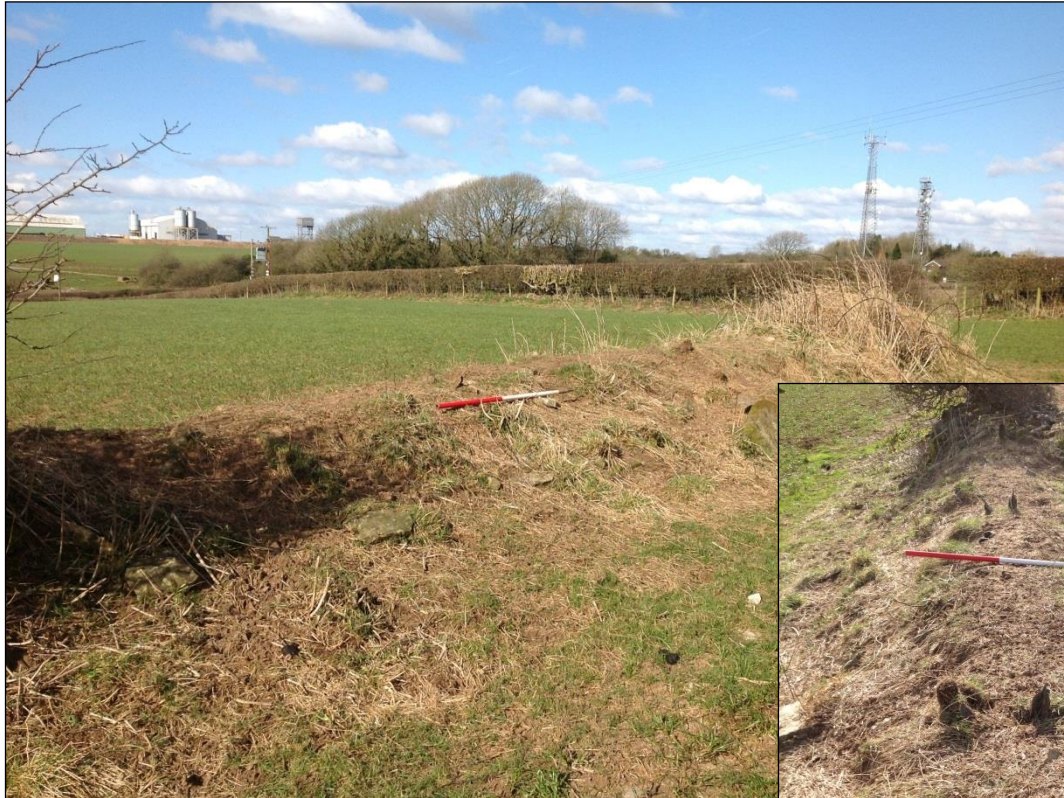
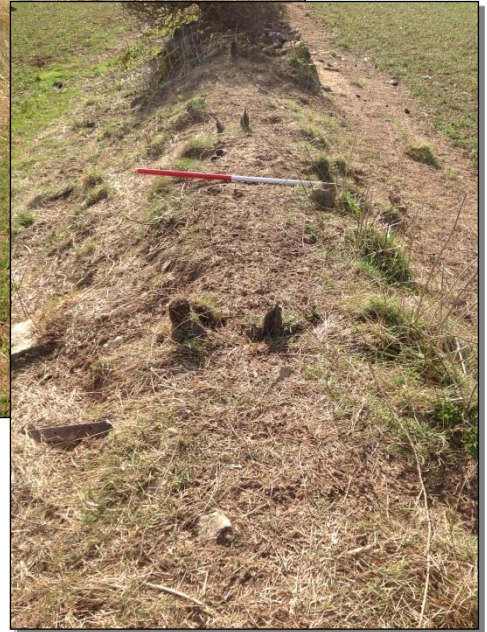
*Plate 63: The linear earthen bank with the remains of the cast-iron railings protruding from the top.*

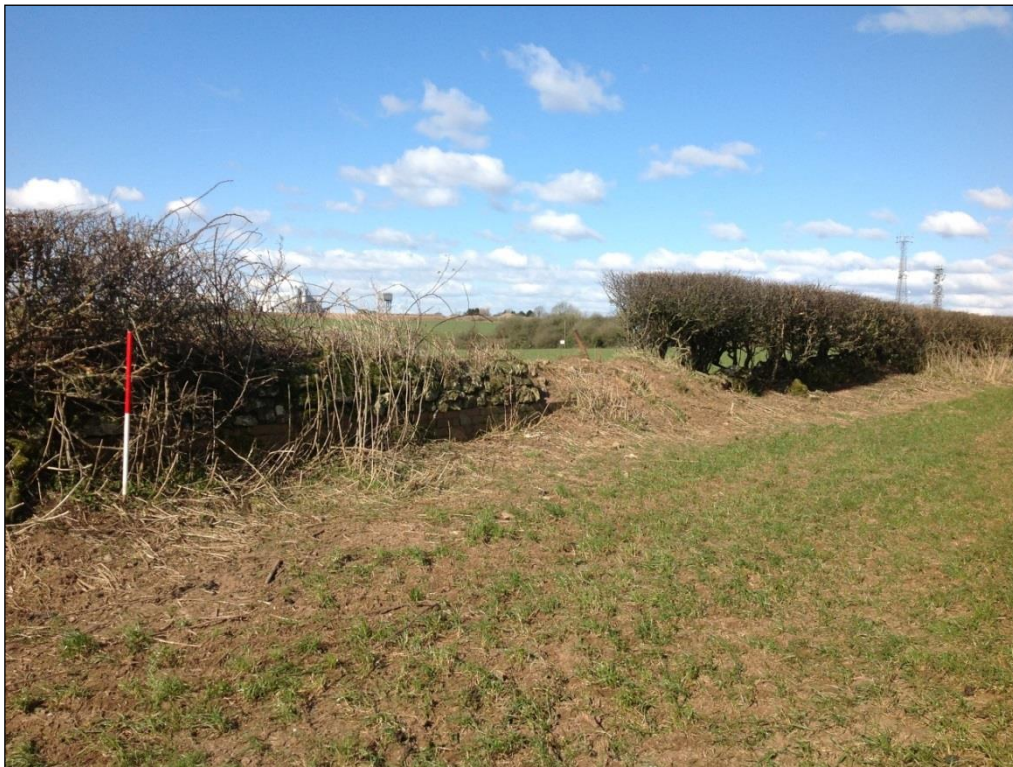
*Plate 64: Remains of the earthen mound and drystone walling on top of the modern brick layer*

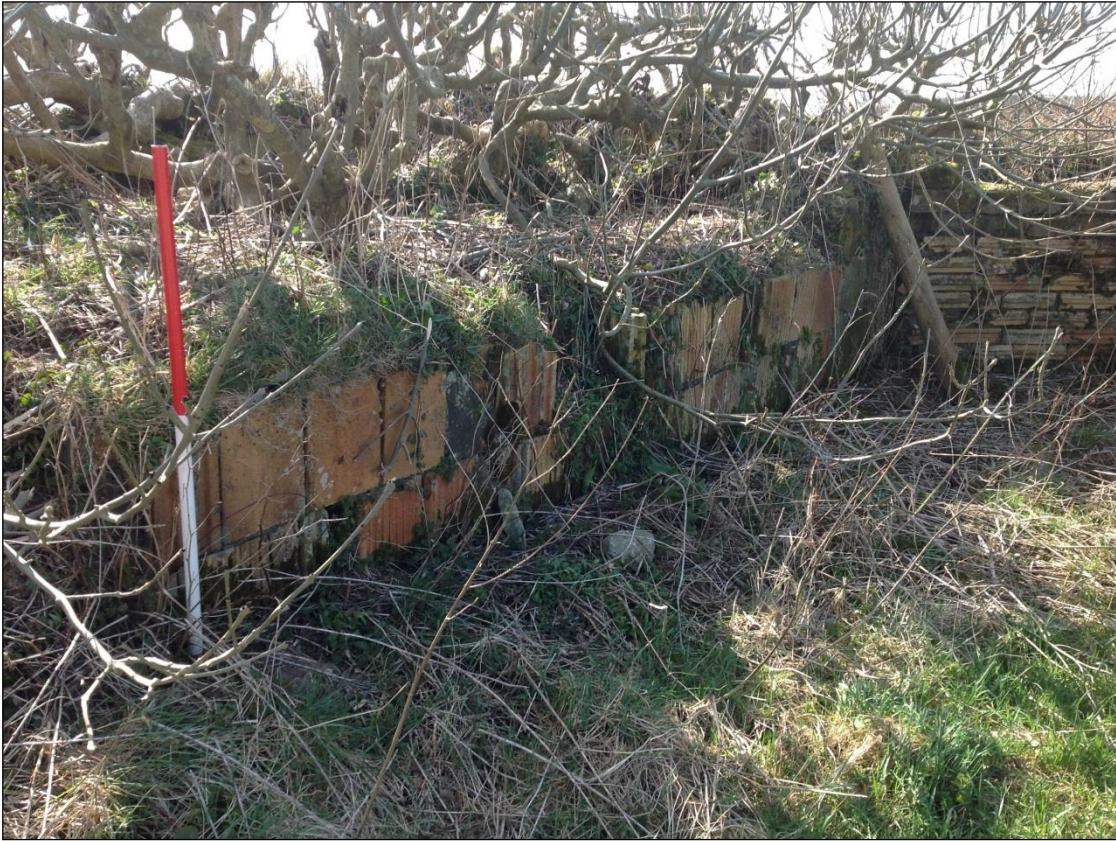
*Plate 69: Hollow terra cotta blocks (usually employed for internal partitions) have been used to construct this defensive feature.*

| <b>Condition</b> | Near Destroyed |
| <b>Condition rating</b> | Poor |

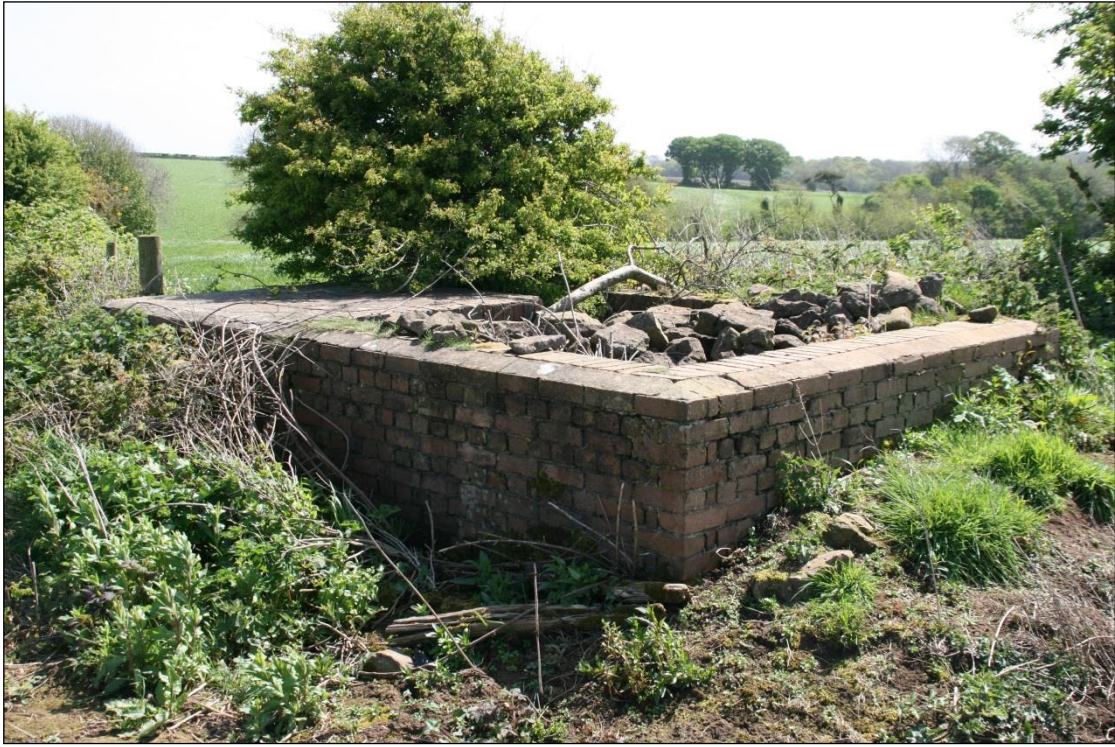
*Plate 70: One of the surviving LAA emplacements at RAF Stormy Down.*

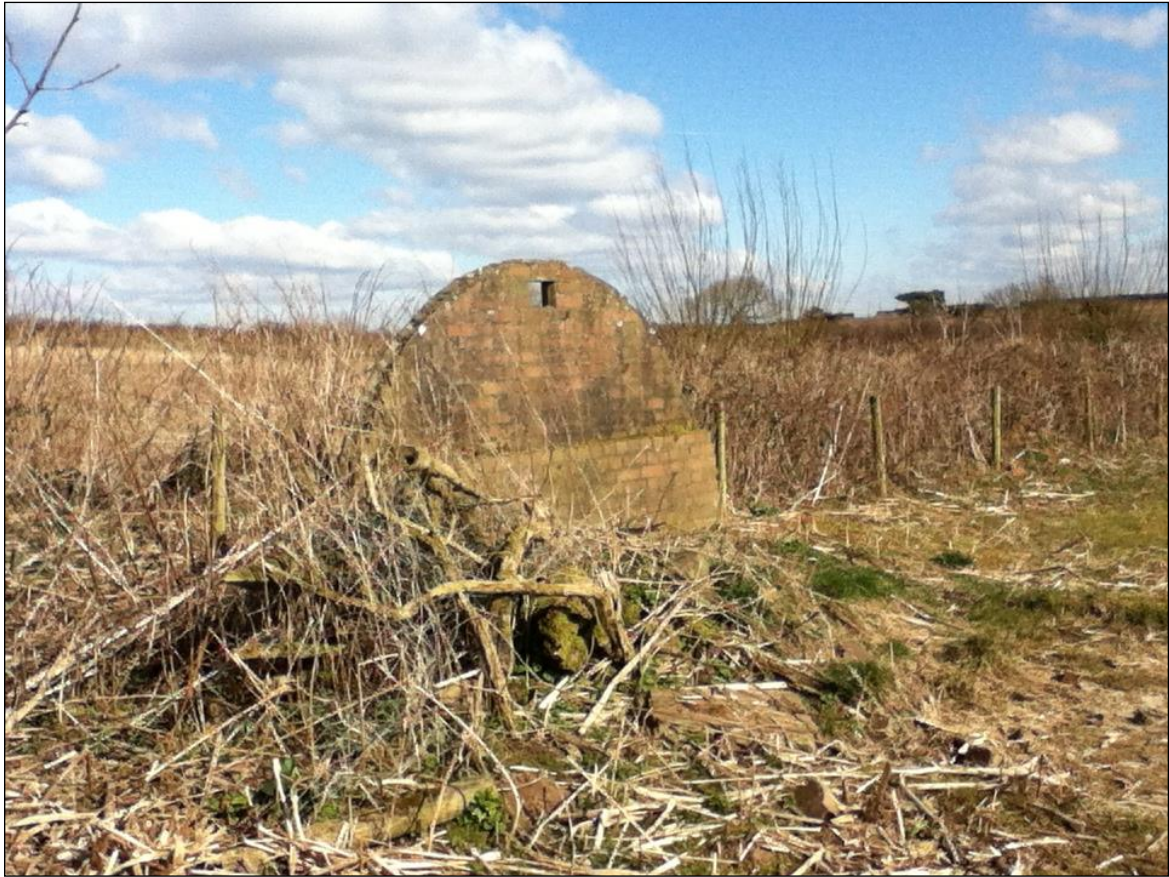
| <b>Condition</b> | Near Destroyed |
| <b>Condition rating</b> | Very bad |

*Plate 71: Remains of the rear end of a Turners curved asbestos hutting structure.*

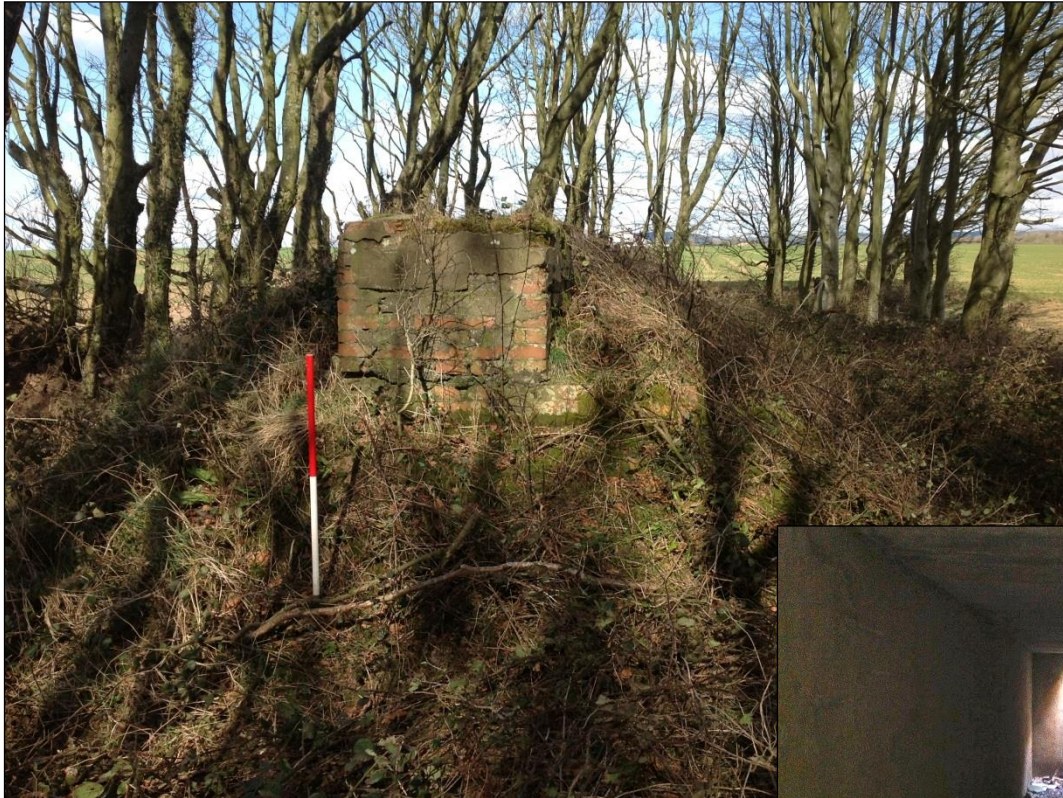
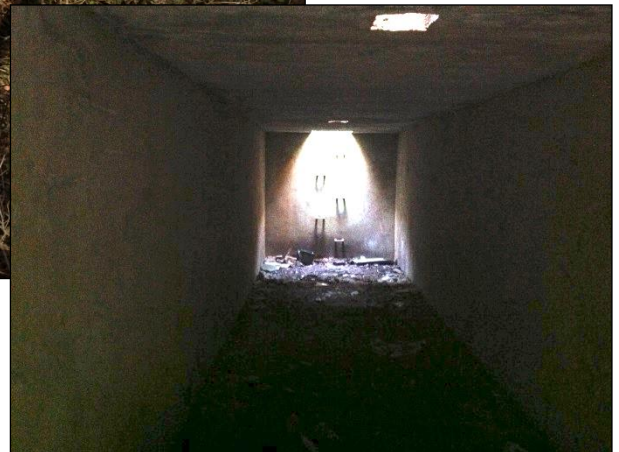
| <b>Description</b> | A semi-sunken munitions store associated with the LAA emplacement (PRN 07400m) that lies to the south. The square interior is concrete lined and the shelters exit has a set of rungs instead of a ladder. The earthen covering and internal structure remains intact, however, the protruding brick exit hatch along with the entrances flanking walls have damage to their exposed brickwork. |
| <b>Condition</b> | Damaged |
| <b>Condition rating</b> | Fair |

*Plate 72: (Above) The brick escape hatch at the southern end of the munitions store. (Right) The Interior of the store. Note the 'C' ring style rungs at the rear of the structure.*

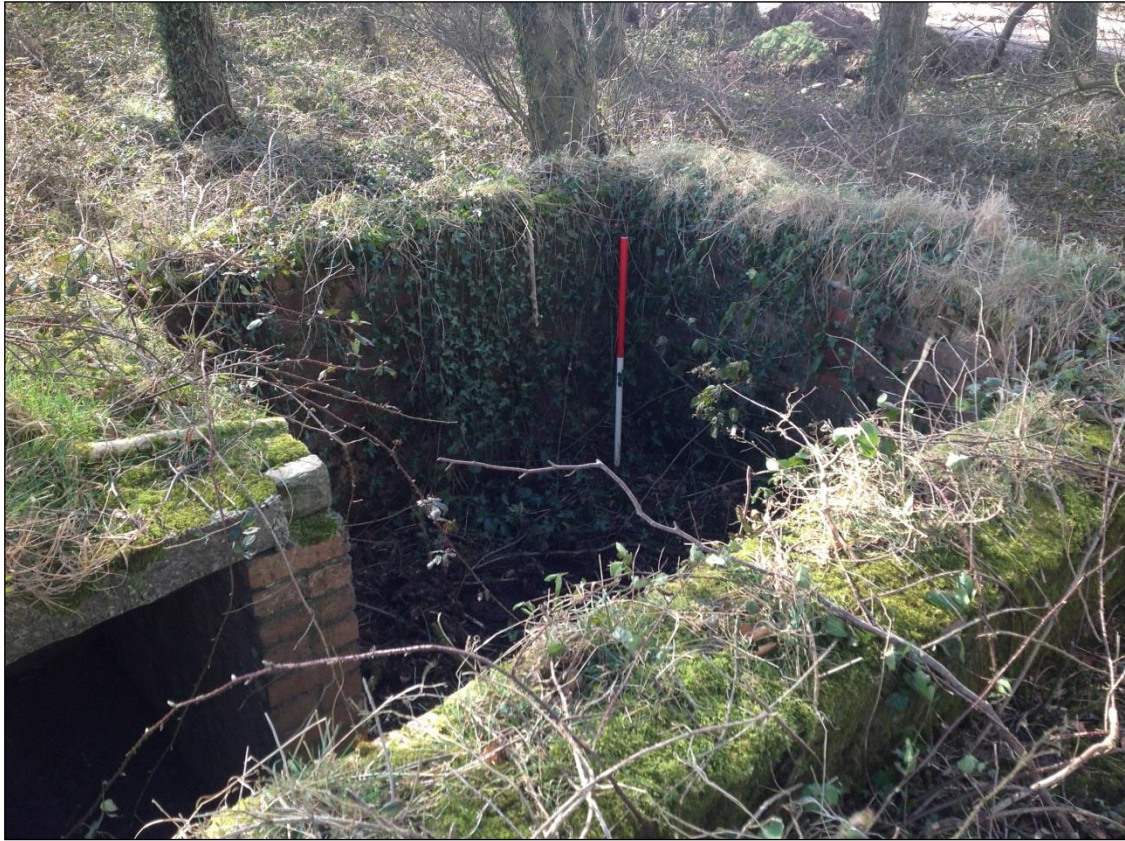
| <b>Condition</b> | Near Destroyed |
| <b>Condition rating</b> | Poor |

*Plate 73: Interior of the LAA emplacement PRN 07400m*

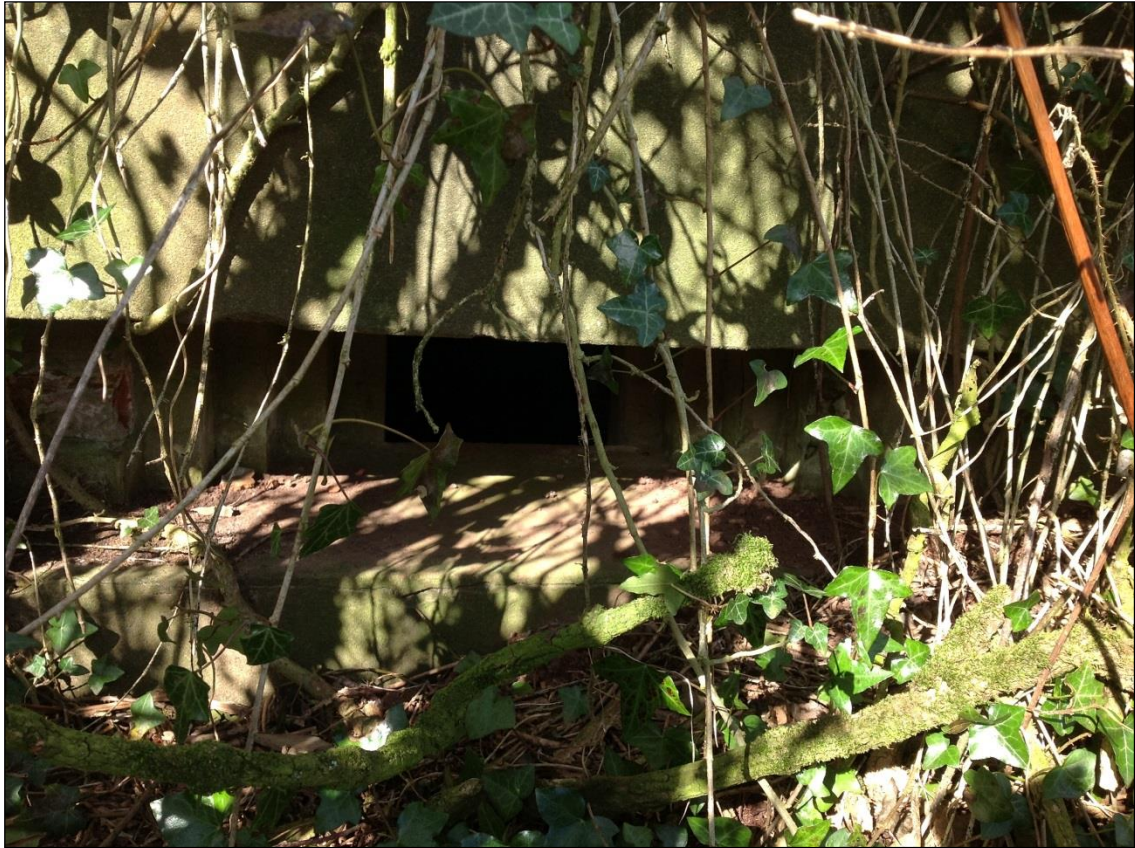
| <b>Condition</b> | Near Destroyed |
| <b>Condition rating</b> | Near Destroyed |

*Plate 74: The south facing embrasure of the type FW3/26 pillbox..*

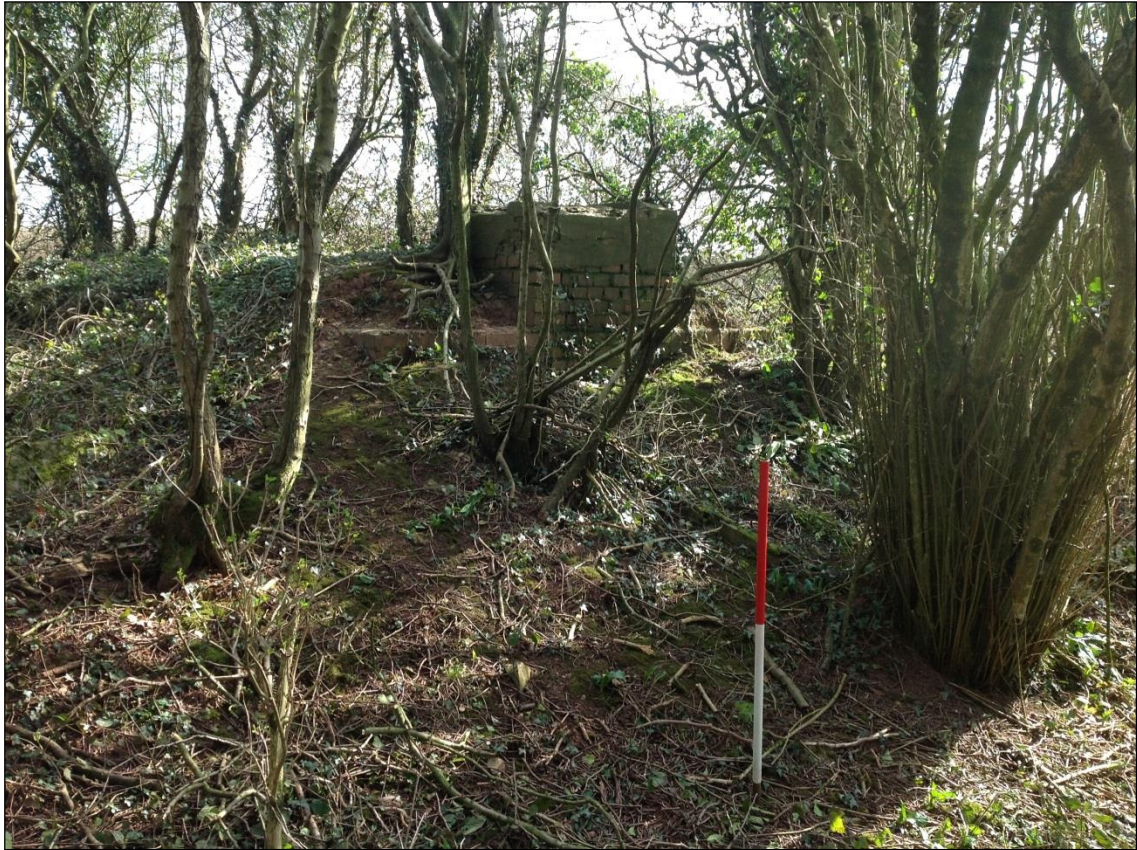
| <b>Condition</b> | Near Destroyed |
| <b>Condition rating</b> | Fair |

*Plate 75: The western end of the structure, showing the escape hatch.*

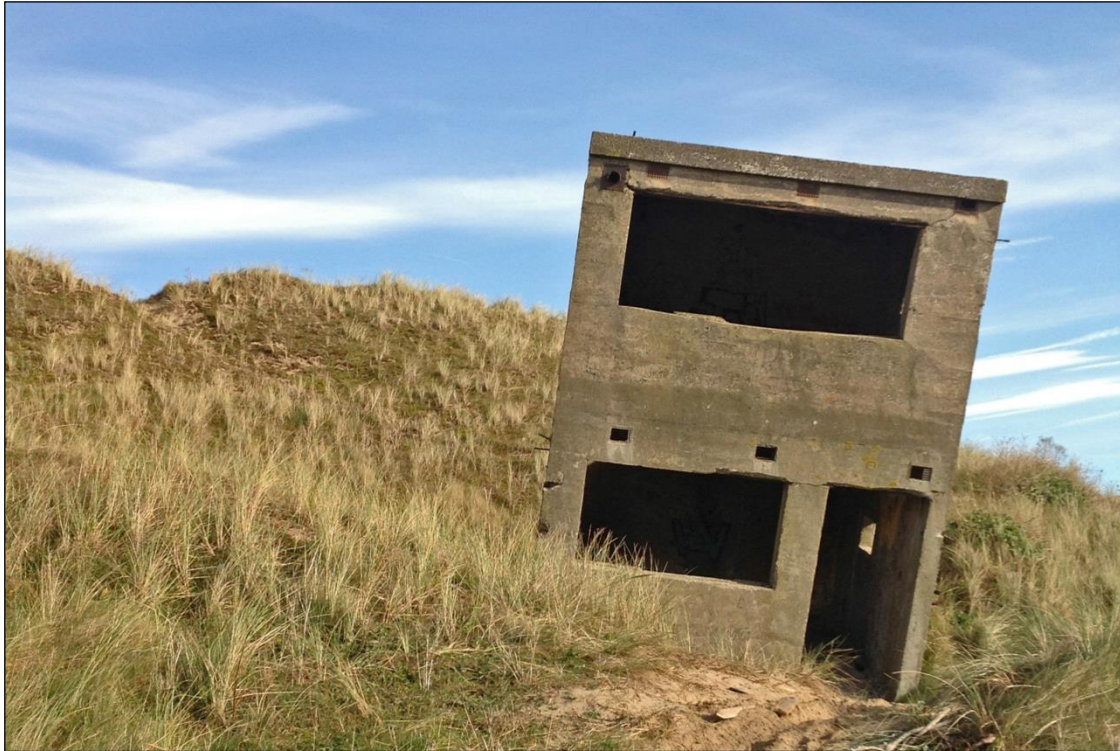
| <b>Condition</b> | Near Destroyed |
| <b>Condition rating</b> | Very Poor |

*Plate 78: The remaining quadrant tower of the Margam training range: Not the angle of the building*

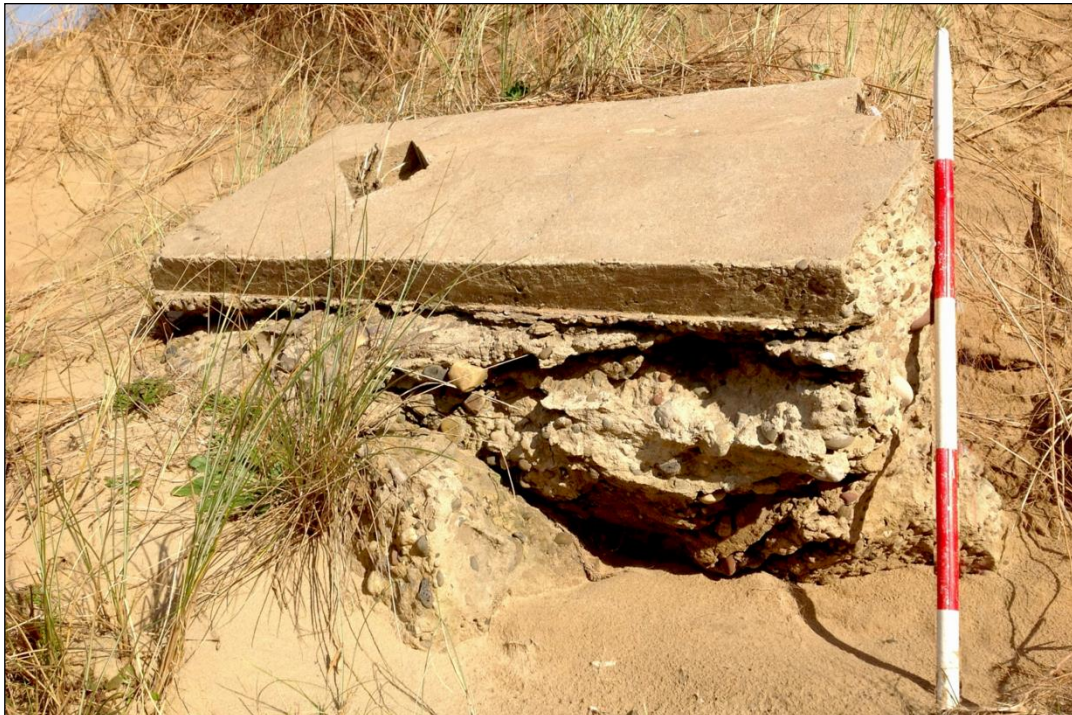
| <b>Condition</b> | Destroyed |
| <b>Condition rating</b> | Destroyed |

*Plate 79: One of the large pieces of concrete that may once have been an observation post.*

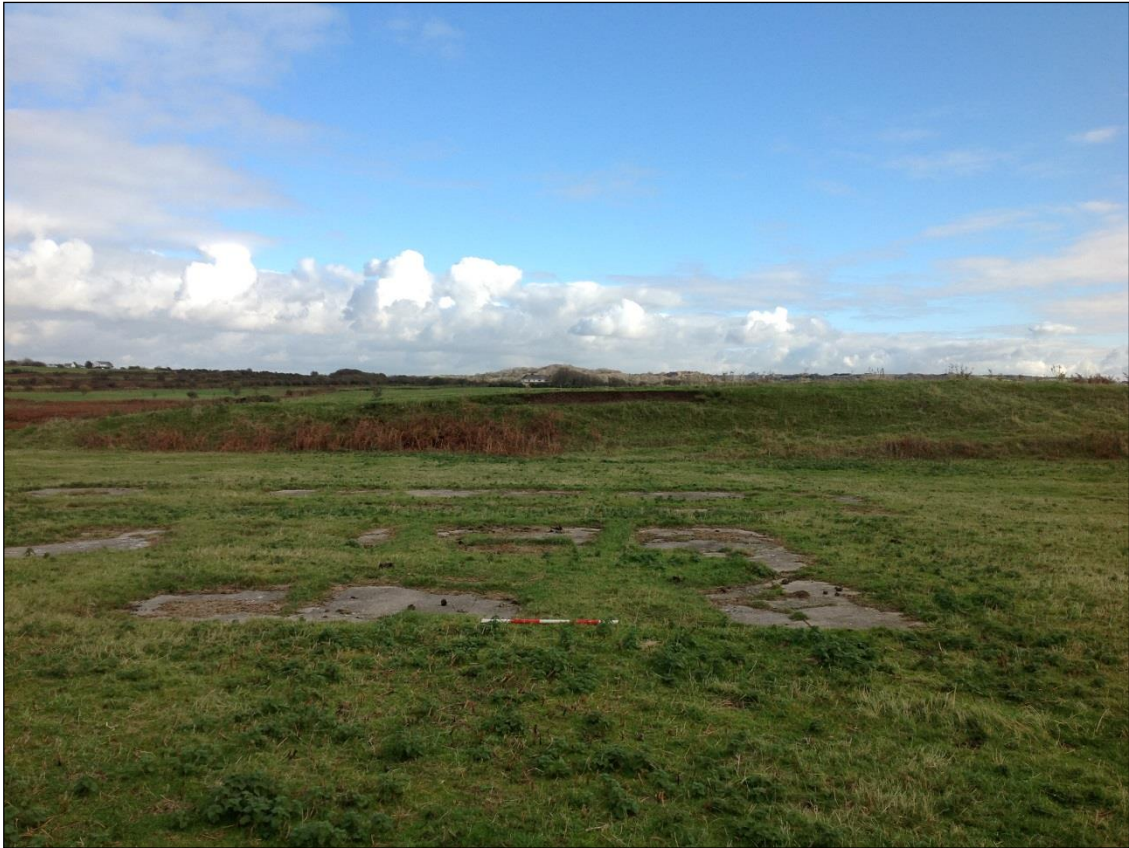
| <b>Condition</b> | Near Destroyed |
| <b>Condition rating</b> | Near Destroyed |

*Plate 81: Remains of the 2 concrete aprons with the earthwork PRN 07410 in the background.*

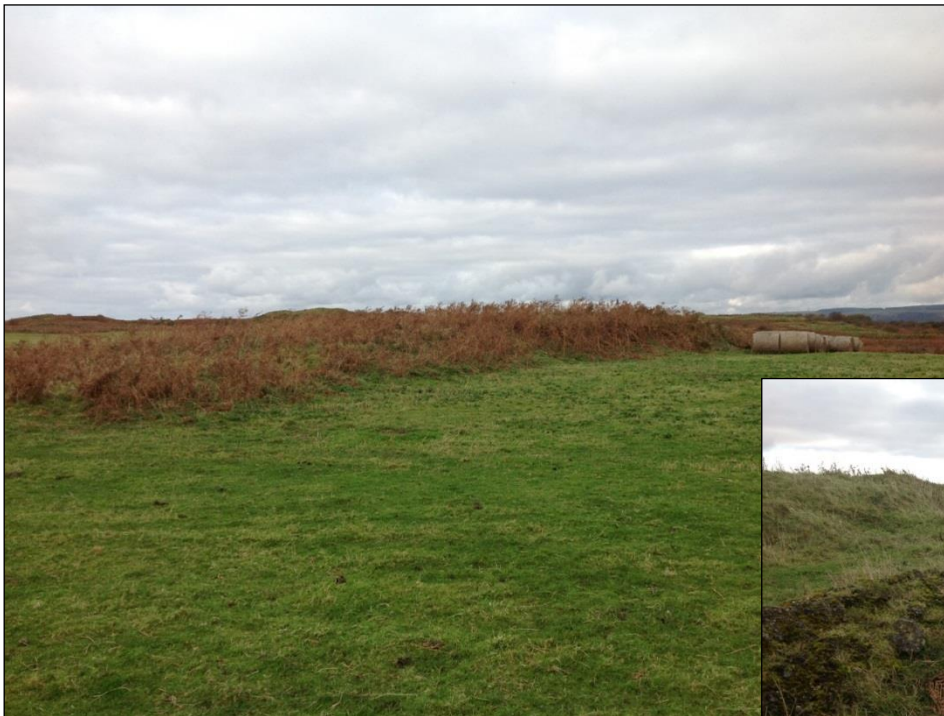
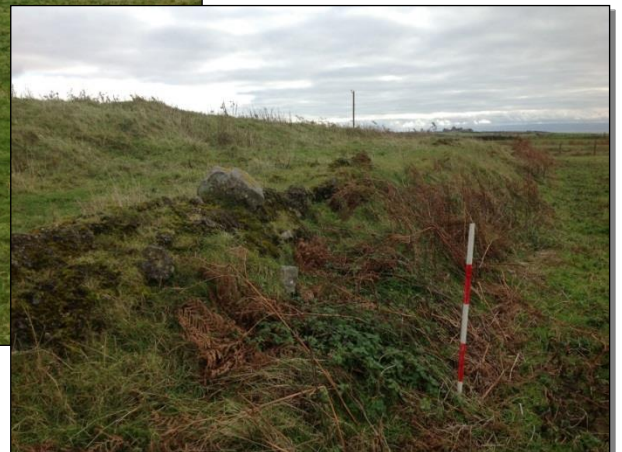
| <b>Condition</b> | Damaged |
| <b>Condition rating</b> | Fair |

*Plate 82: Two views of the earthwork.*
