# GGAT 112: Second World War Military Airfields of South Wales

Year 2-Airfield Hinterland

A report for Cadw  
by Paul W Huckfield BA

GGAT report no. 2013/024  
Project no. GGAT 112

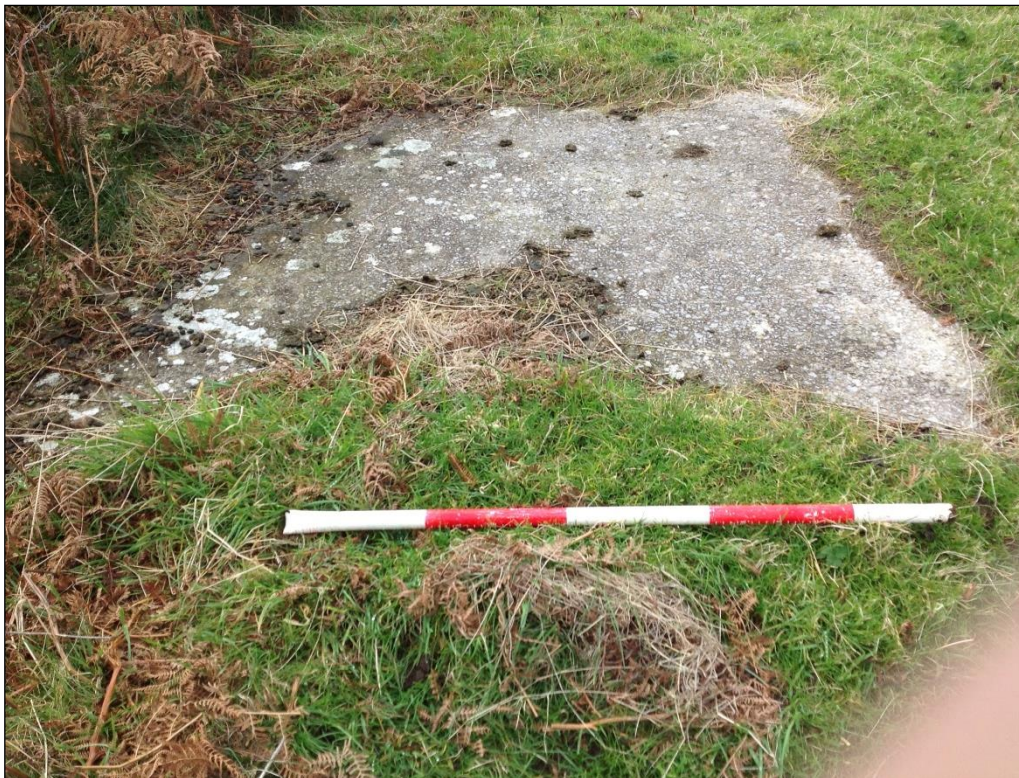
| <b>Condition</b> | Near Destroyed |
| <b>Condition rating</b> | Destroyed |

*Plate 83: A small square concrete apron of unknown use.*

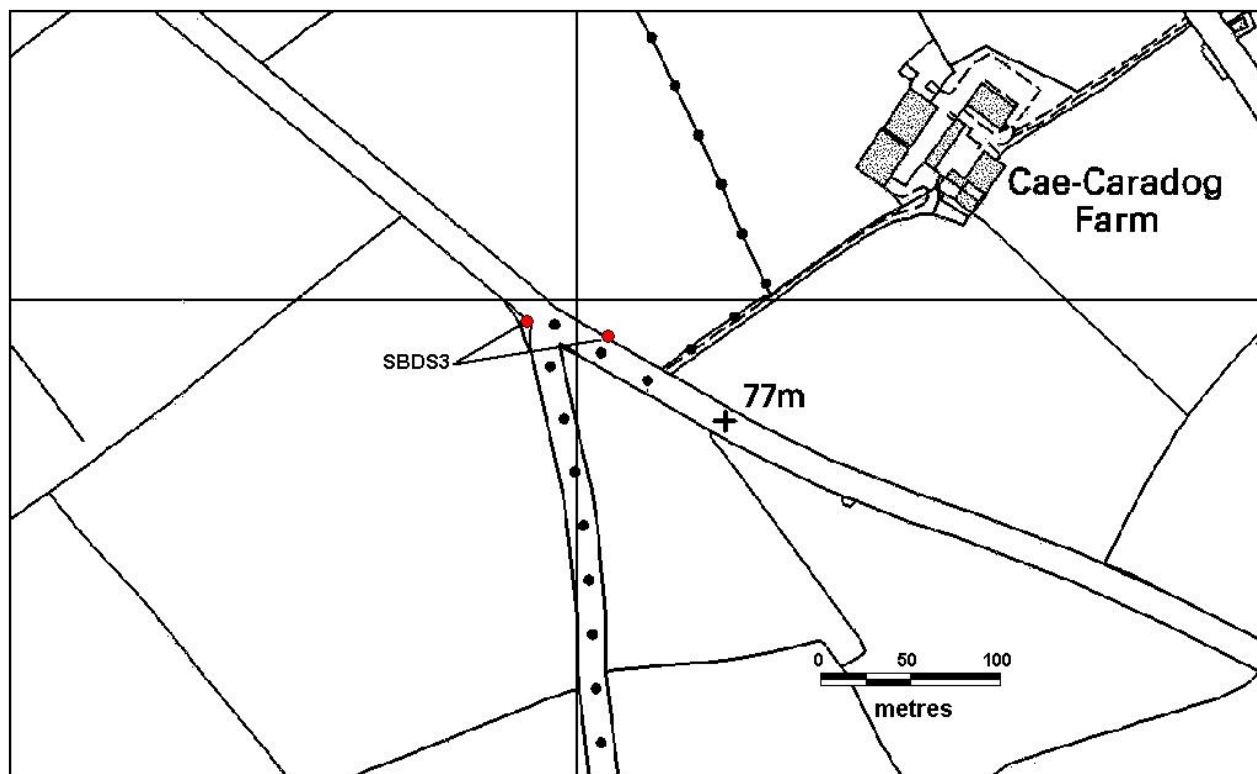
Plate 86: Remains of the roadblock on the B4524 at the junction of Hoel Las.

| <b>Description</b> | <p>A roadblock formed by two concrete cubes, (NGR SS 90969 72988 and SS 91016 72980) located in opposite hedgerows flanking the B4524 at the junction with Hoel Las. The cubes are constructed from concrete and are approximately 90cm by 90cm. Both are now heavily overgrown and almost indistinguishable from the rest of the hedgeline. The eastern of the pair has suffered minor damage to one face from a sidearm hedge trimmer.</p> <p>Aerial photographs reveal that the eastern of the two cubes originally stood adjacent to its western counterpart and was moved, probably post war, to allow easier traffic flow.</p> <p>Though not strictly part of the fixed defences for No.6 SLG, the close proximity of this roadblock nevertheless suggests that it may have been utilised in its defence.</p> |
| <b>Condition</b> | Damaged |
| <b>Condition rating</b> | Fair |

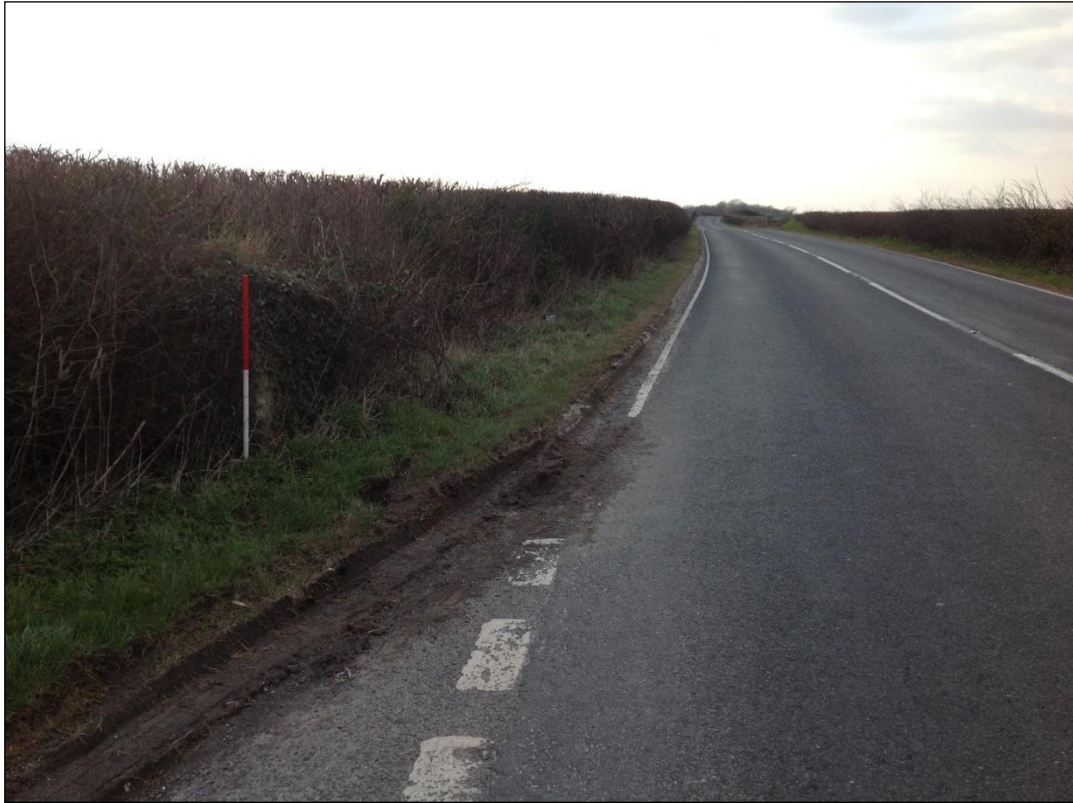
*Plate 87: Remains of the western cube. Looking northwest along the B4524.*

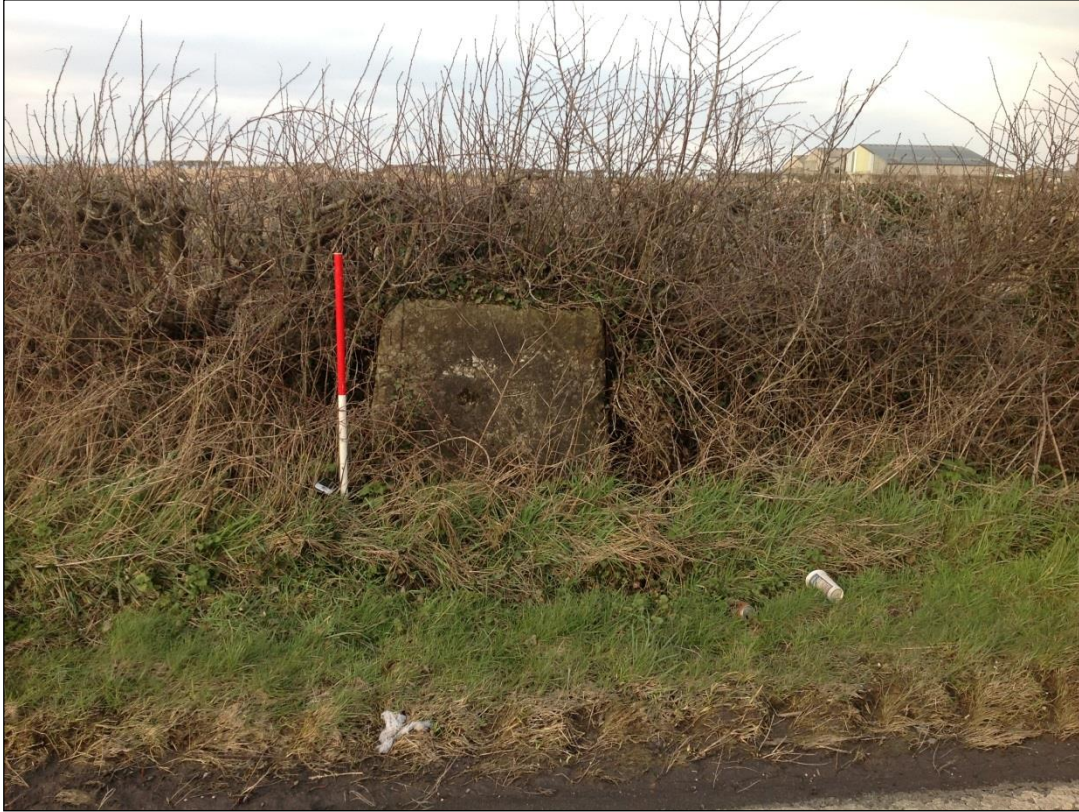
*Plate 88: The second cube now lying to the east of its original location*

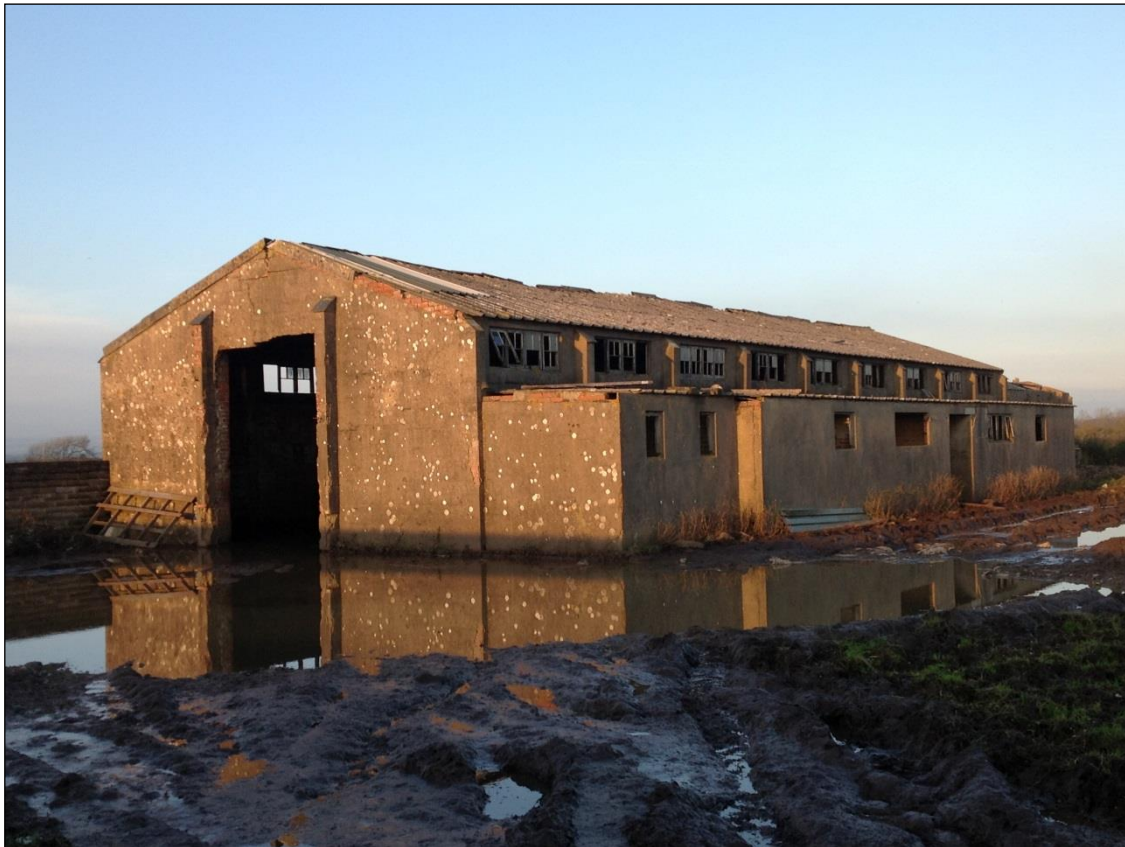
The small chapel added to the northeast elevation converted the structure into a church, with the congregation seated in the gym facing the altar and chancel. This extension is in a poor state of repair, with the end gable wall

*Plate 89: Gymnasium and Chapel building. View to the north.*

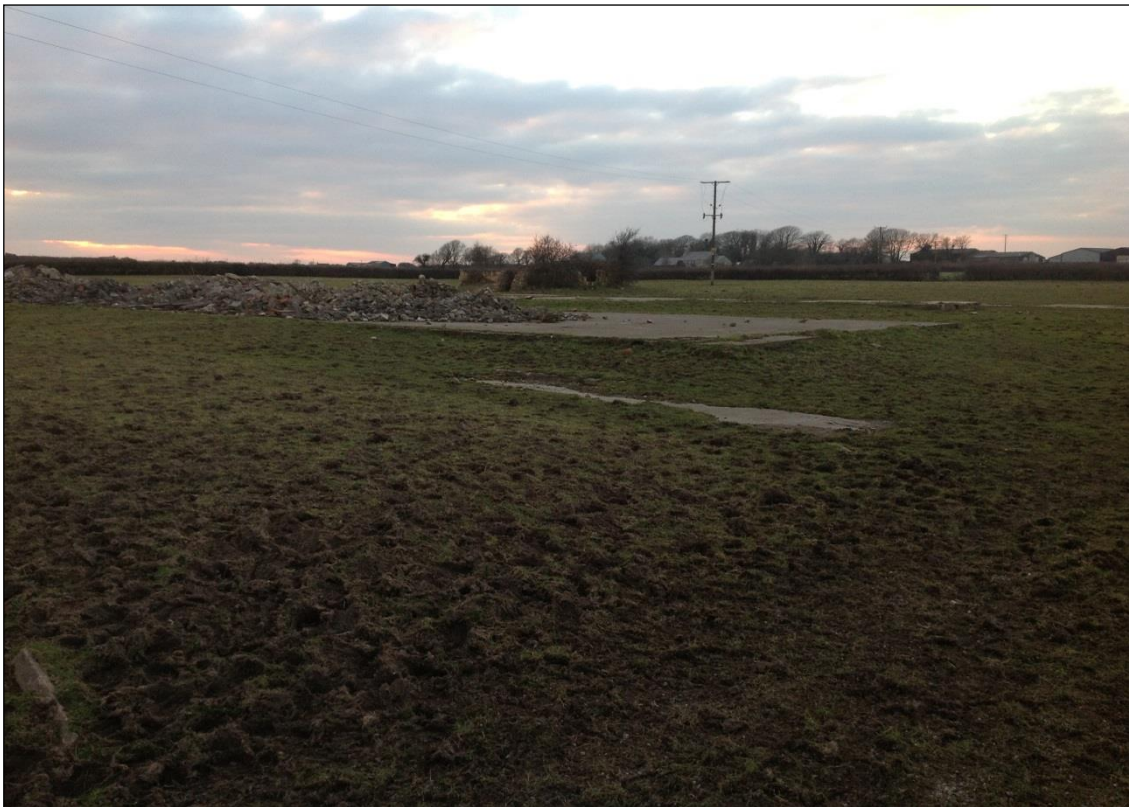
*Plate 90: Very little now remains of the Sergeant's Mess.*

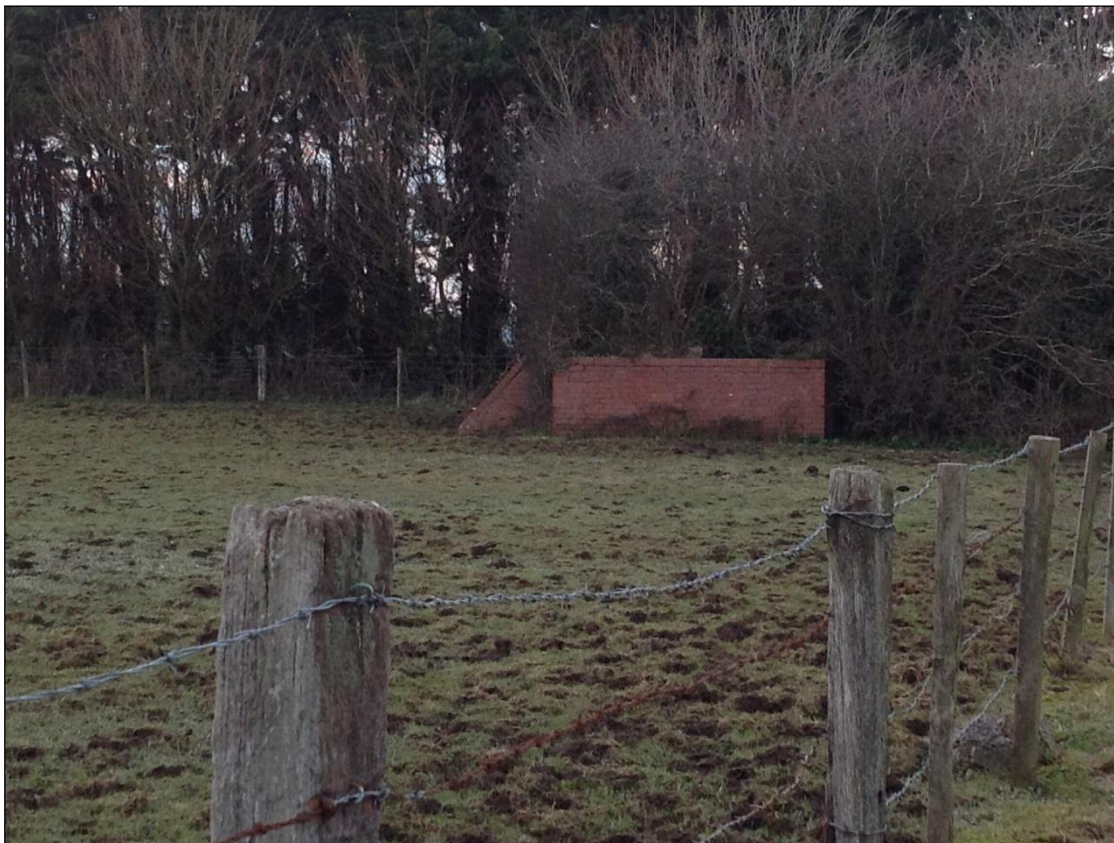
*Plate 91: A brick blast shelter located towards the northeast boundary of Site No.1*

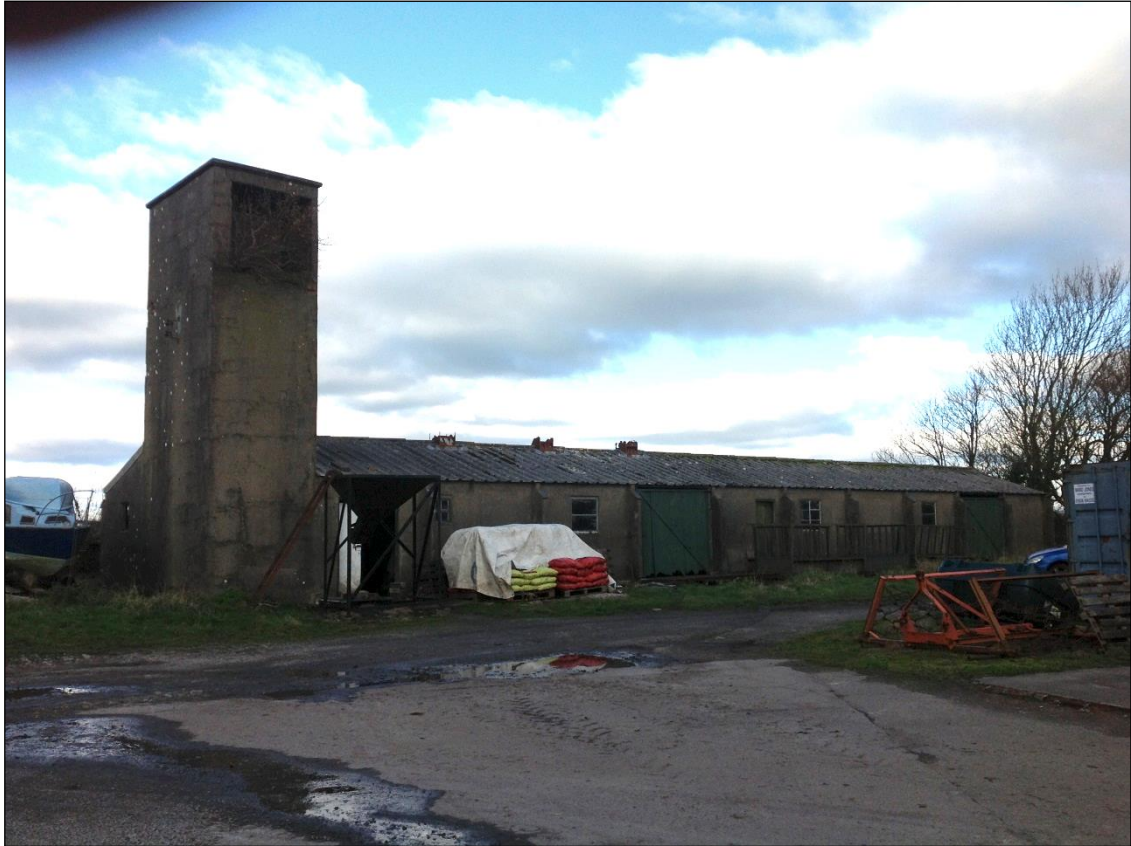
*Plate 93: The Officers bath house. Note the removal of the external walls to make way for additional entrances.*

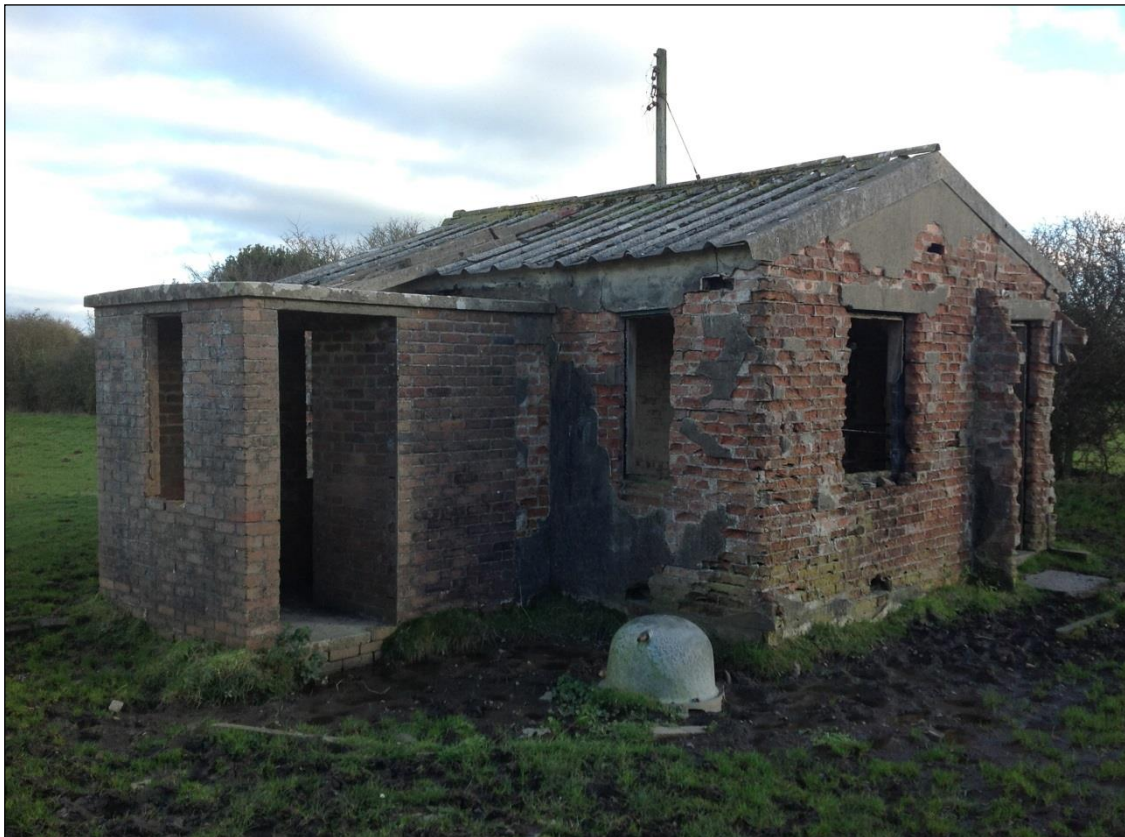
| <b>Description</b> | <p>Picket posts were placed at the entrances to all of the dispersed sites to control traffic entering and leaving the site. This example was an early wartime design.</p> <p>The building is constructed from cement rendered brick with external piers with a single-pitch roof clad with corrugated asbestos cement sheeting. The site is in a poor state of repair, with the greater part of the render having fallen away except in a few select patches, leaving the temporary brick exposed to the elements. All of the windows and doors along with internal walls have been removed. A small single room structure with flat concrete roof extends out from the northeast facing elevation. This extension cannot be accessed from the main Picket Post and has linear windows that look out over Site No.3 and Site No.4.</p> |
| <b>Condition</b> | Near Destroyed |
| <b>Condition rating</b> | Very Poor |

*Plate 94: Picket Post (PRN 04434s). East facing elevation.*

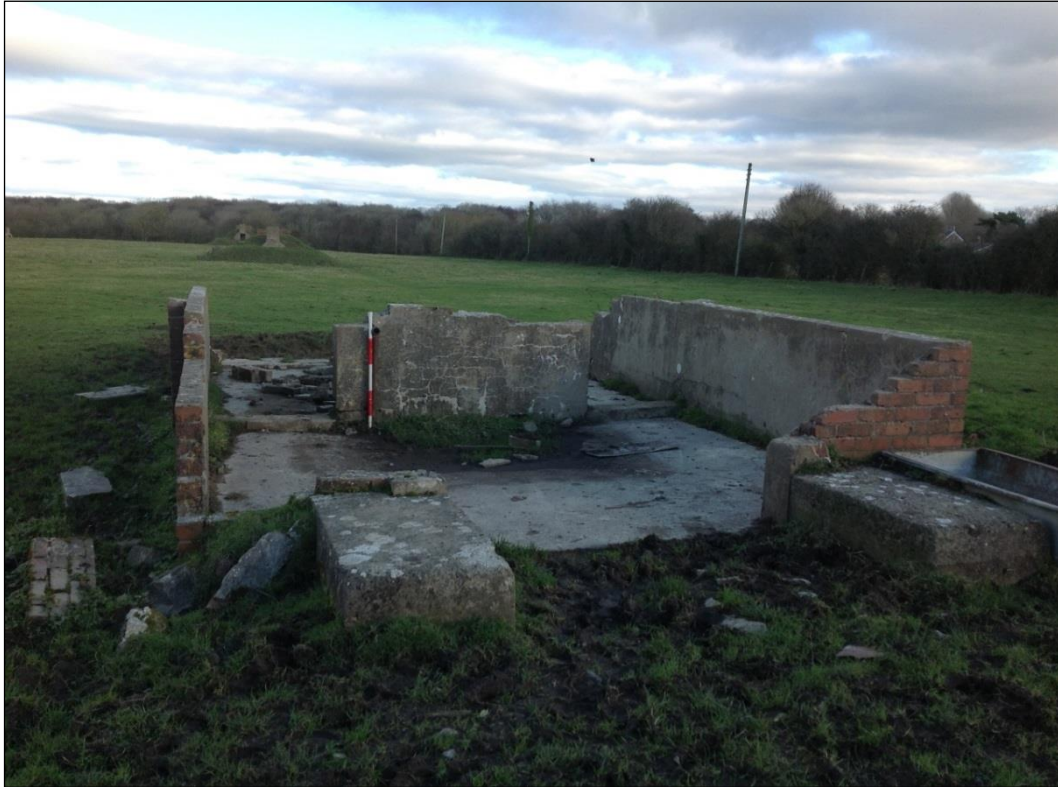
| <b>Condition</b> | Near Destroyed |
| <b>Condition rating</b> | Destroyed |

*Plate 95: The remains of the sites bucket emptying platform.*

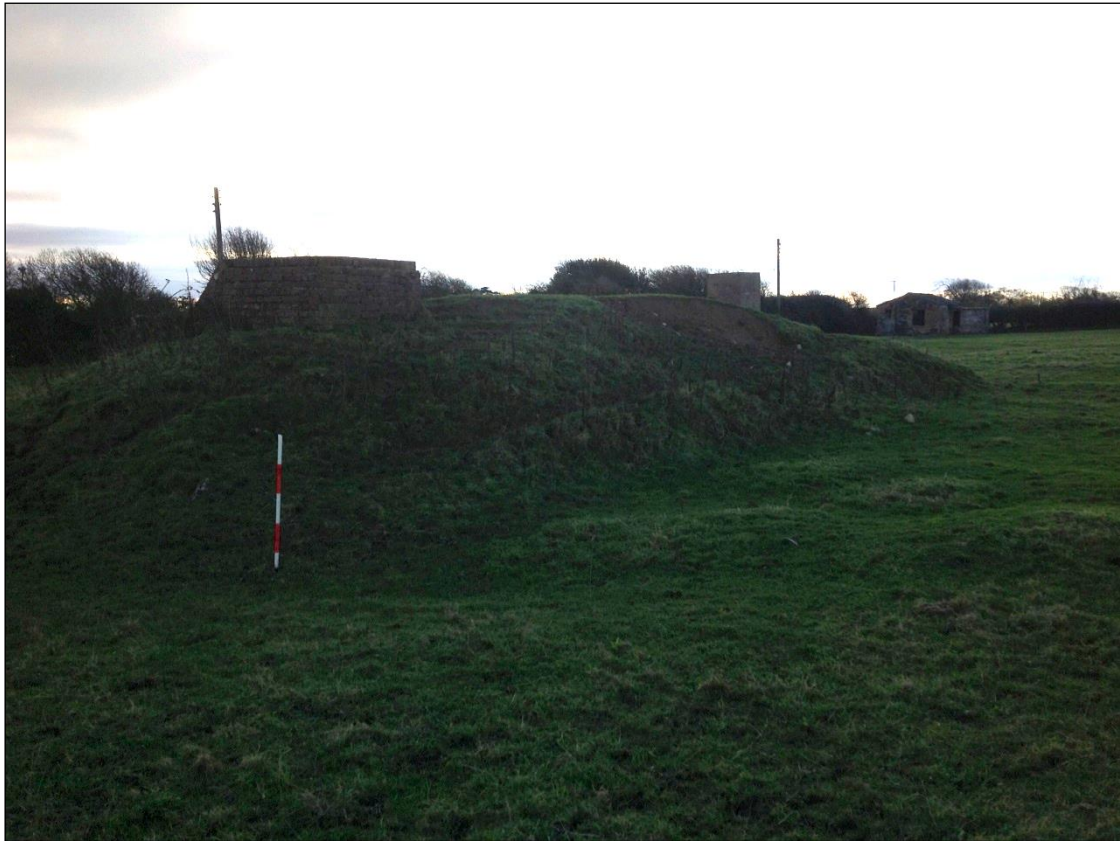
| <b>Condition</b> | Damaged |
| <b>Condition rating</b> | Fair |

*Plate 96: View of the mound surrounding PRN 04435s. Note the Picket Post in the distance.*

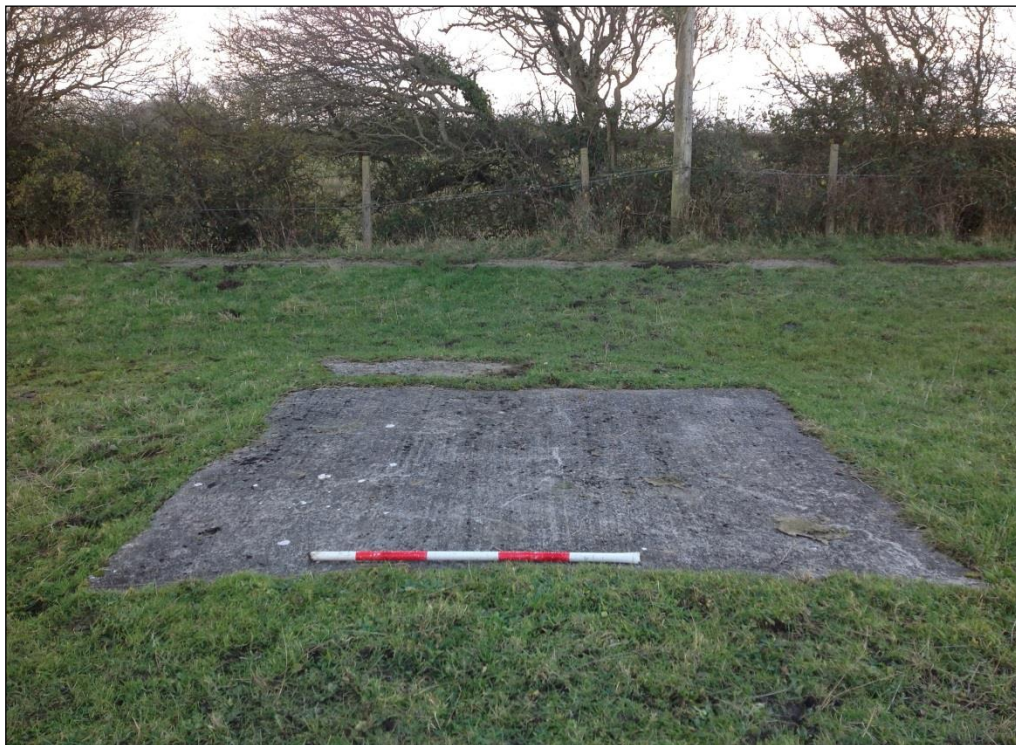
| <b>Condition</b> | Near Destroyed |
| <b>Condition rating</b> | Destroyed |

*Plate 97: A small section of concrete apron is all that survives of building 45.*

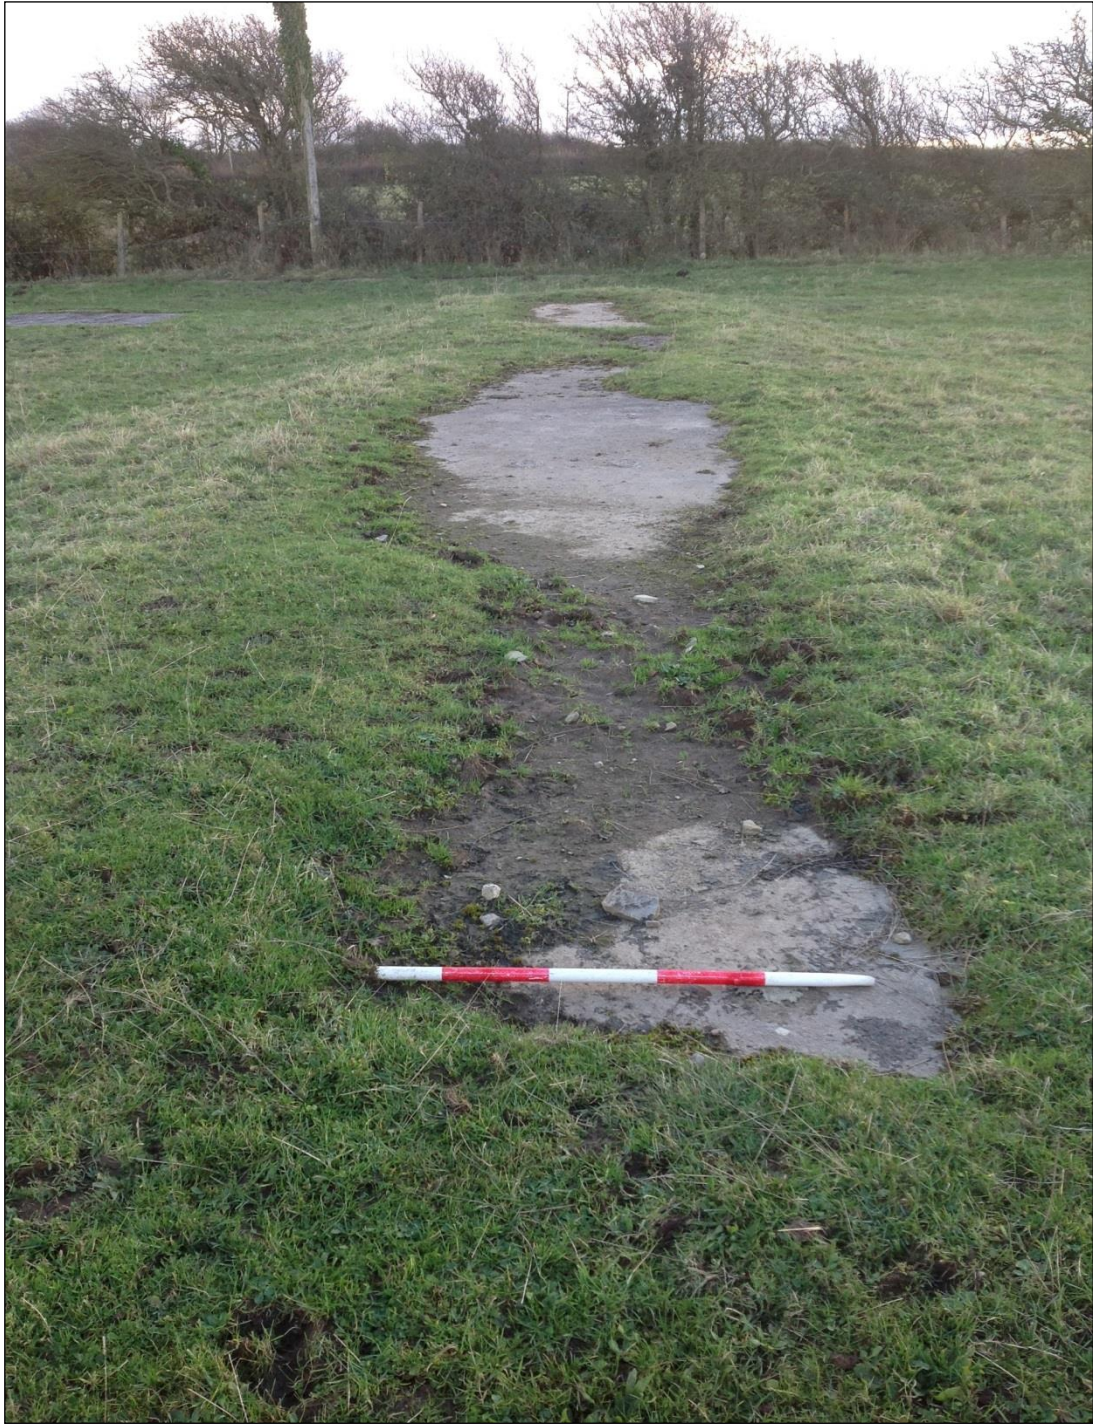
| <b>Condition</b> | Near Destroyed |
| <b>Condition rating</b> | Destroyed |

*Plate 98: View to the southeast along the remains of the airmen's latrine and drying room.*

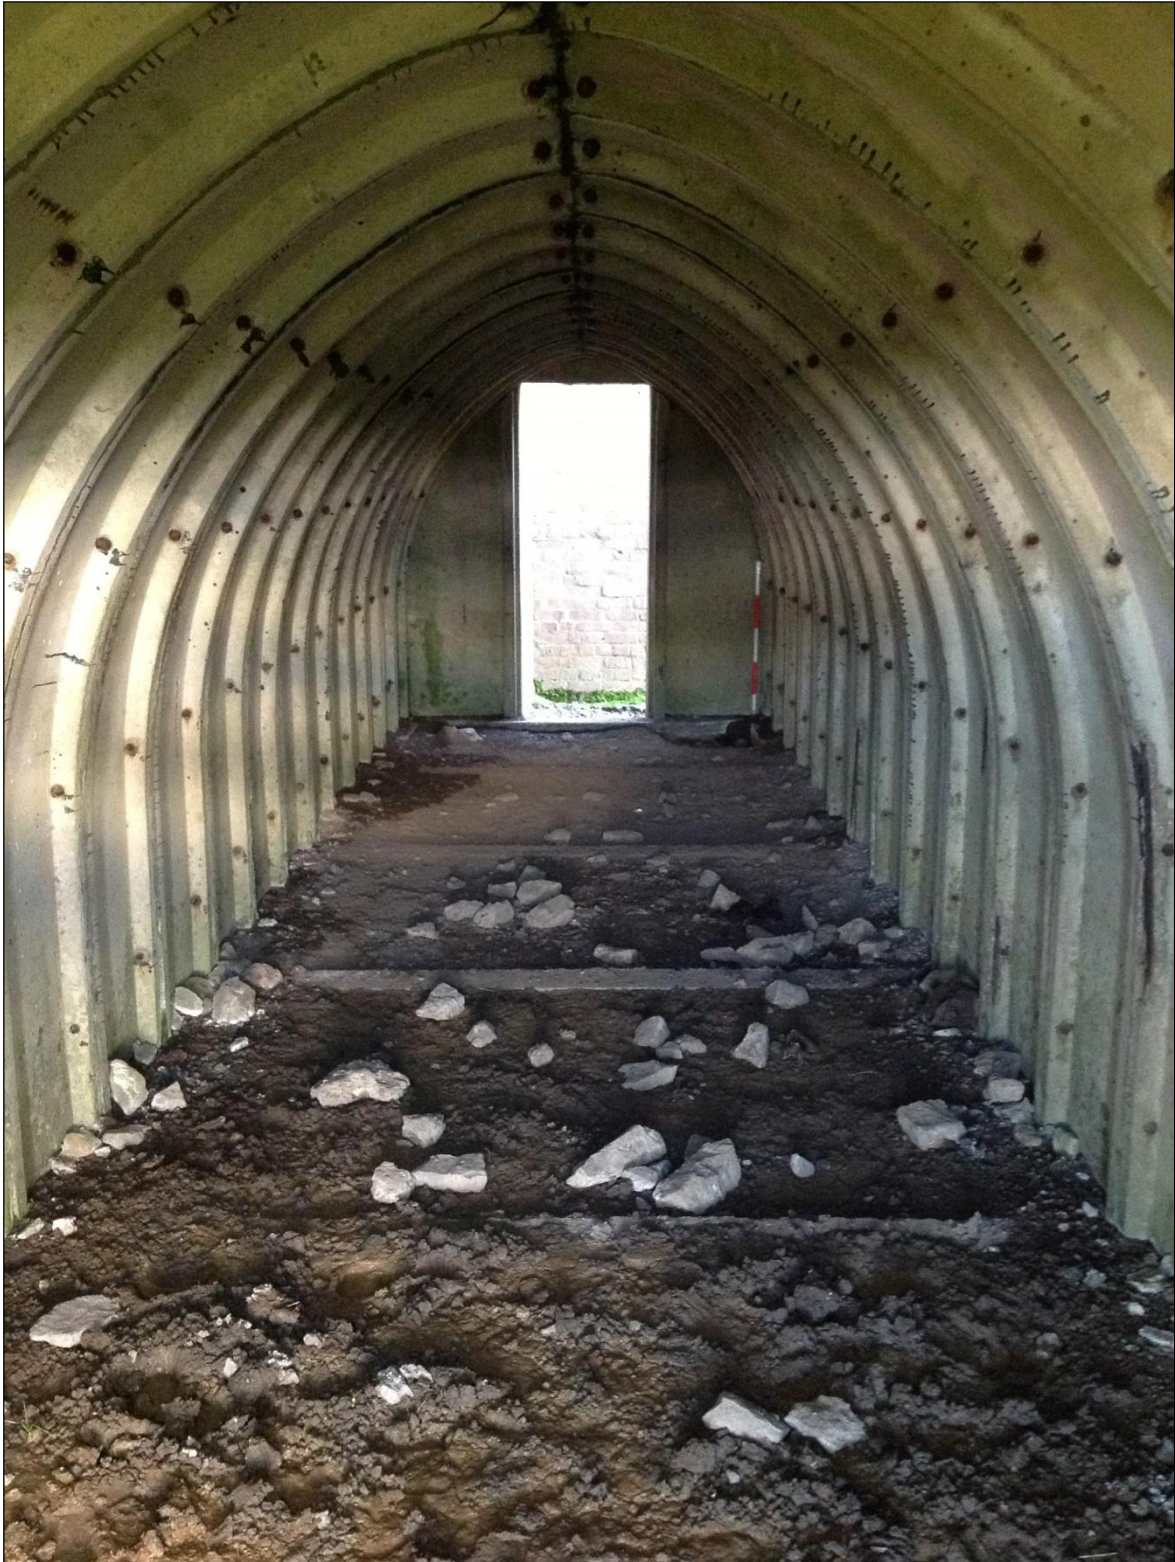
| <b>Condition</b> | Damaged |
| <b>Condition rating</b> | Fair |

*Plate 99: The interior of PRN 04439s. Note the pre-cast concrete sections which bolted together to form a tunnel of the required length.*

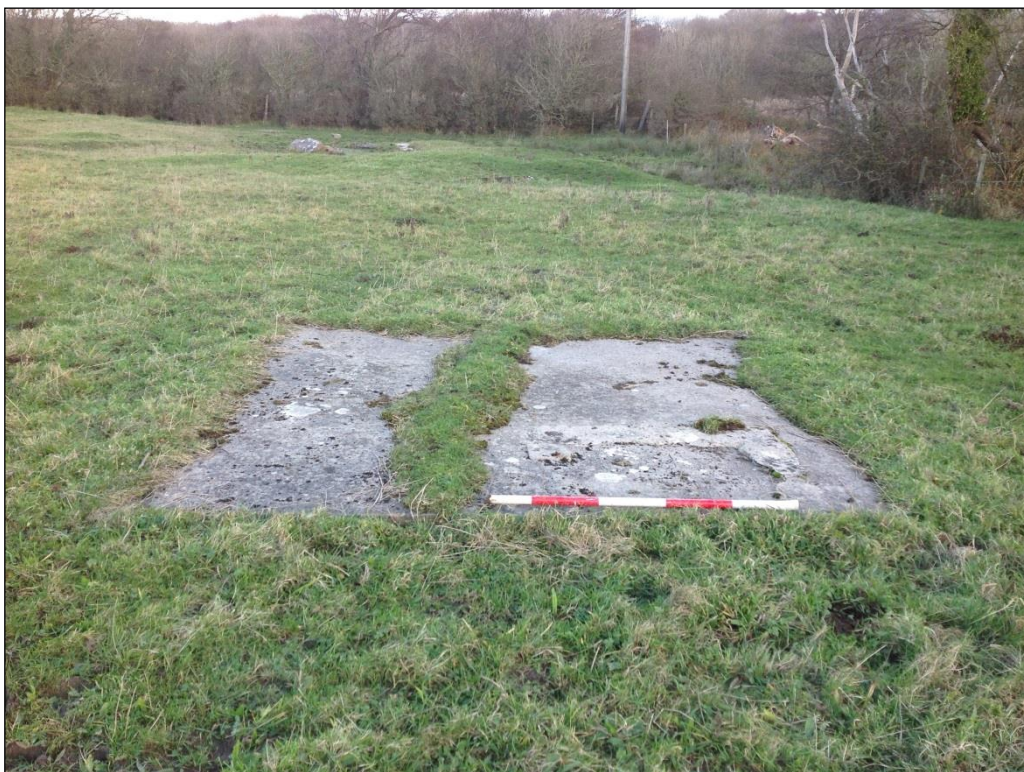
| <b>Condition</b> | Near Destroyed |
| <b>Condition rating</b> | Destroyed |

*Plate 100: A small section of concrete apron is all that survives of building 45.*

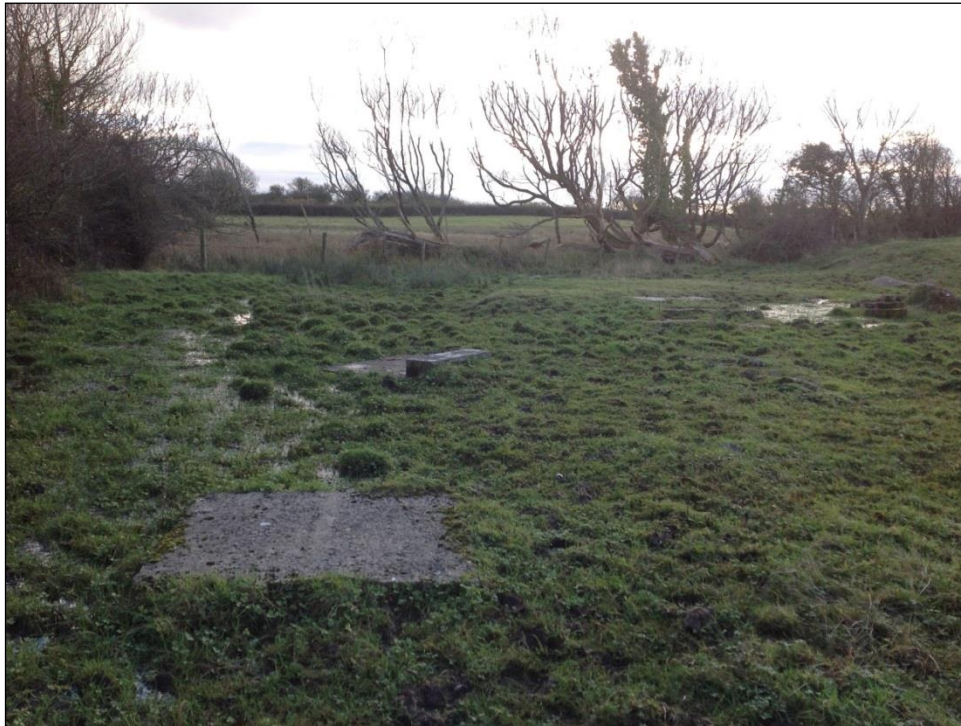
| <b>Condition</b> | Near Destroyed |
| <b>Condition rating</b> | Destroyed |

*Plate 101:Disappearing fast: Very little remains of building 48 as it sinks beneath boggy ground.*

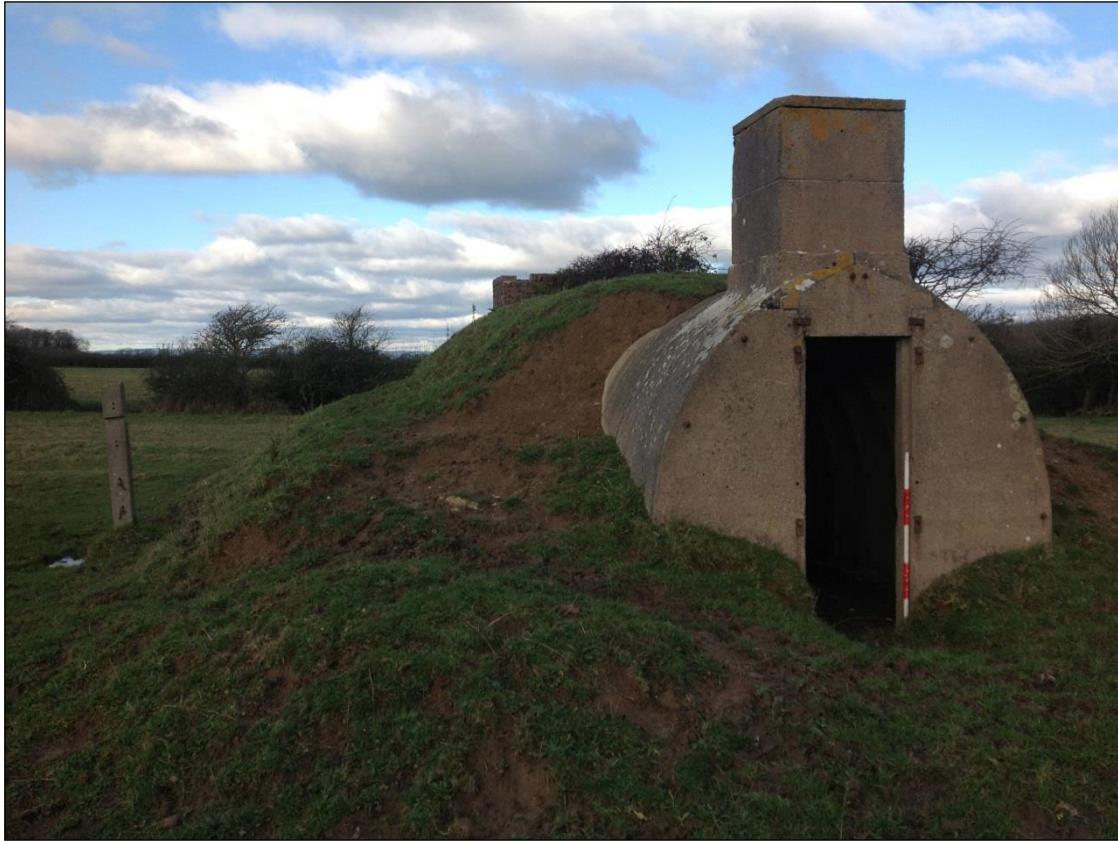
| <b>Condition</b> | Damaged |
| <b>Condition rating</b> | Poor |

*Plate 102: Rear of the air raid shelter PRN 04442s.  
Note the concrete post associated with the structure on the left.*

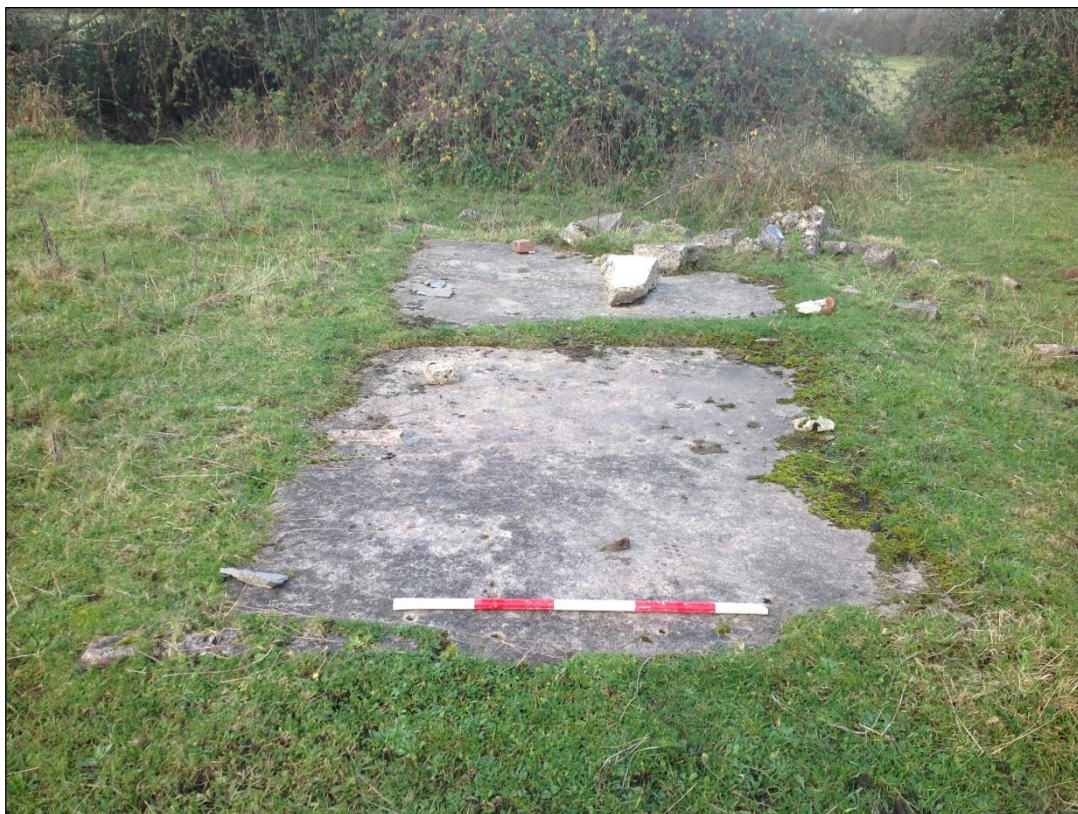
| <b>Condition</b> | Near Destroyed |
| <b>Condition rating</b> | Destroyed |

*Plate 103: Remains of the Sergeants latrine.*

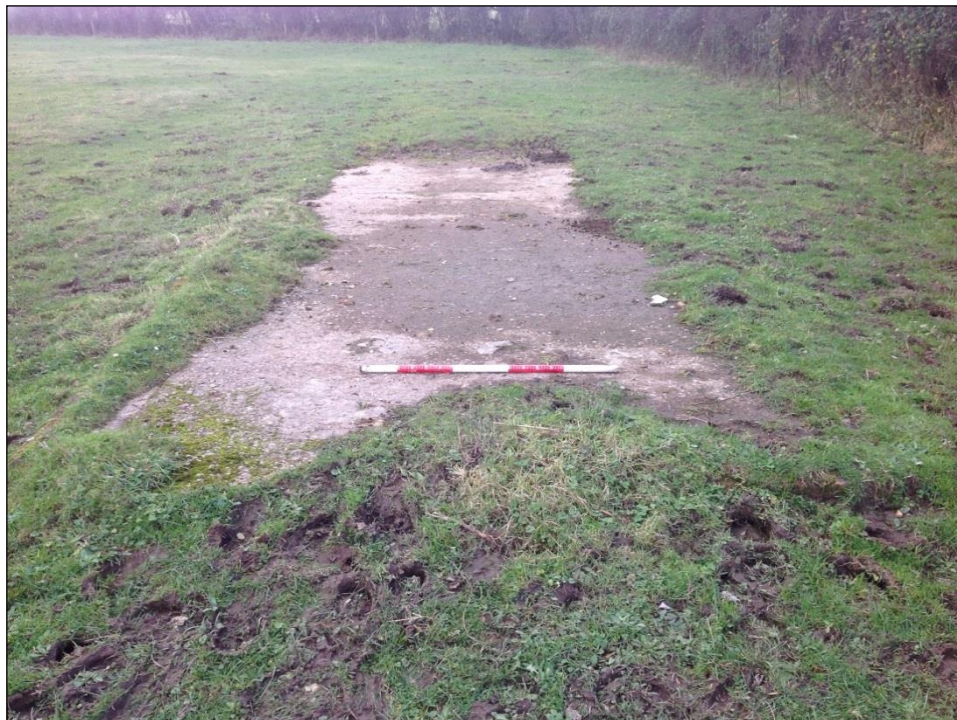
| <b>Condition</b> | Near Destroyed |
| <b>Condition rating</b> | Destroyed |

*Plate 105: The concrete base of building 59.*

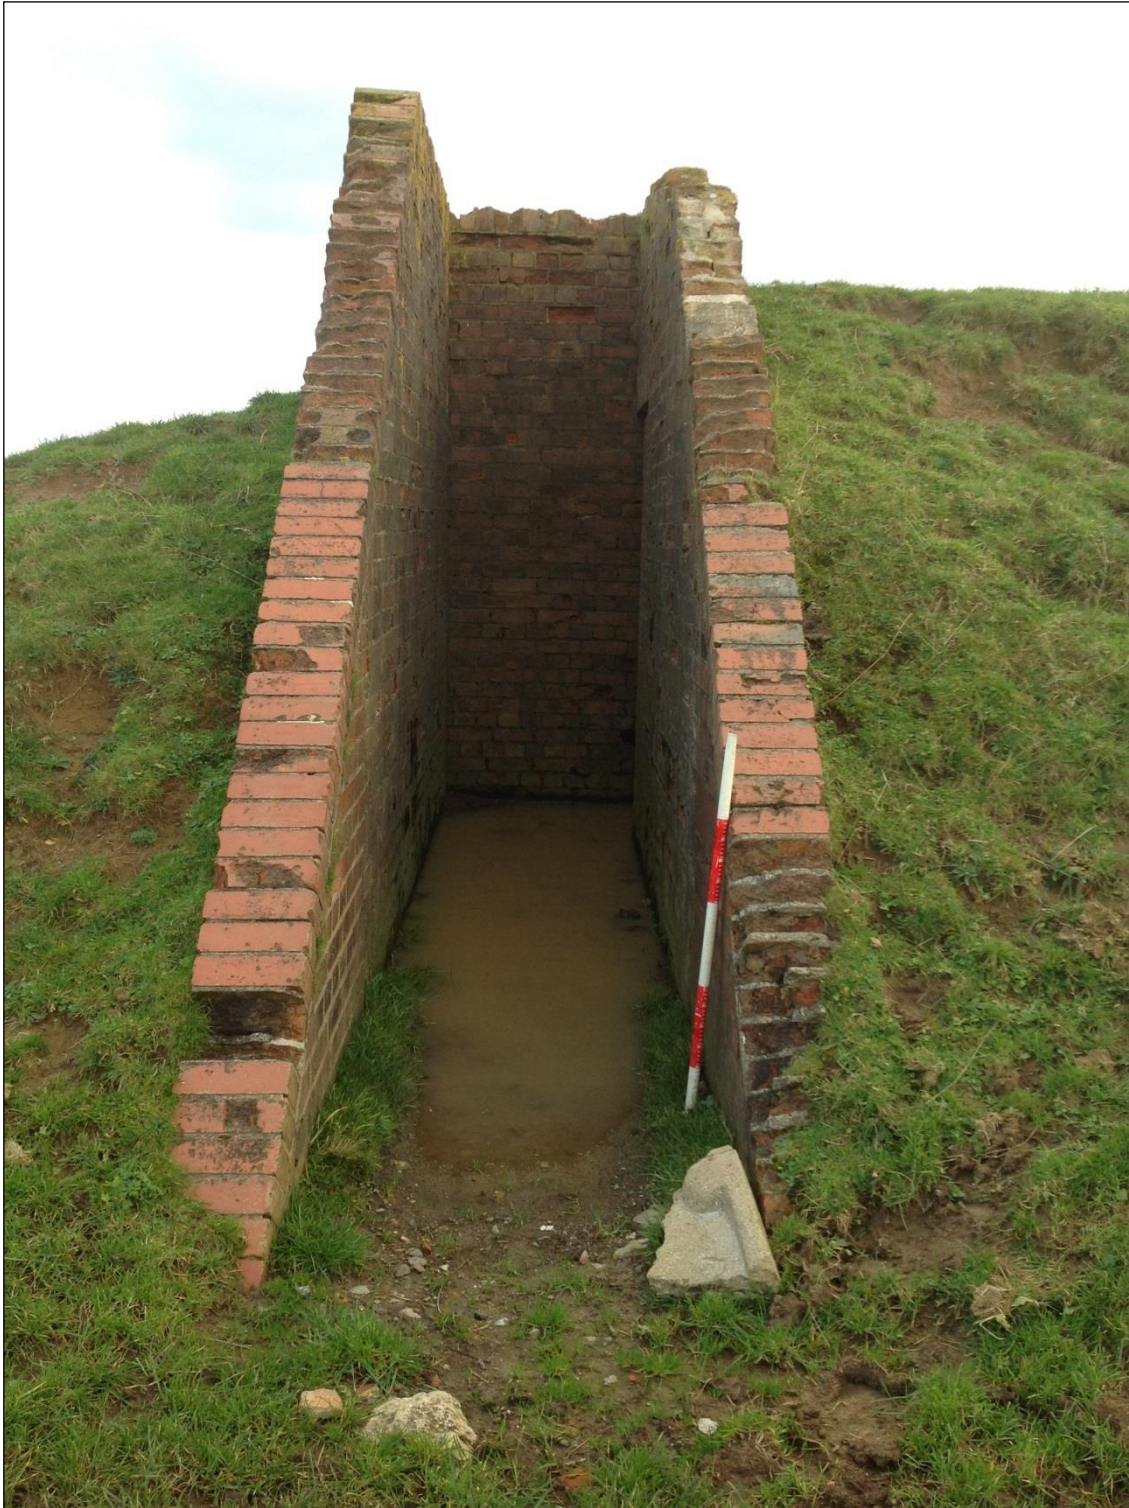
| <b>Condition</b> | Damaged |
| <b>Condition rating</b> | Poor |

*Plate 106: The brick blast walls protecting the air raid shelter entrance.*

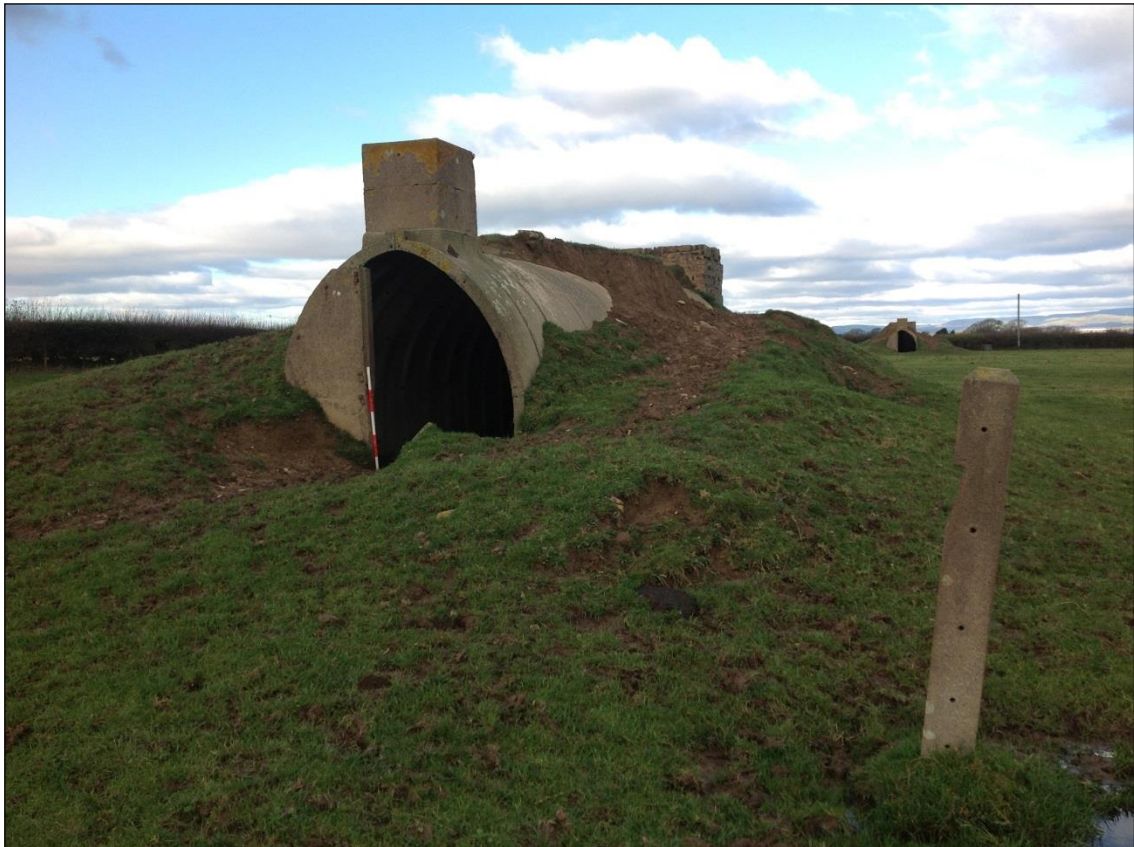
| <b>Condition</b> | Damaged |
| <b>Condition rating</b> | Poor |

*Plate 107: The rear of shelter PRN 04447s, with the unknown concrete post in the foreground.*
