# GGAT 112: Second World War Military Airfields of South Wales

Year 2-Airfield Hinterland

A report for Cadw  
by Paul W Huckfield BA

GGAT report no. 2013/024  
Project no. GGAT 112

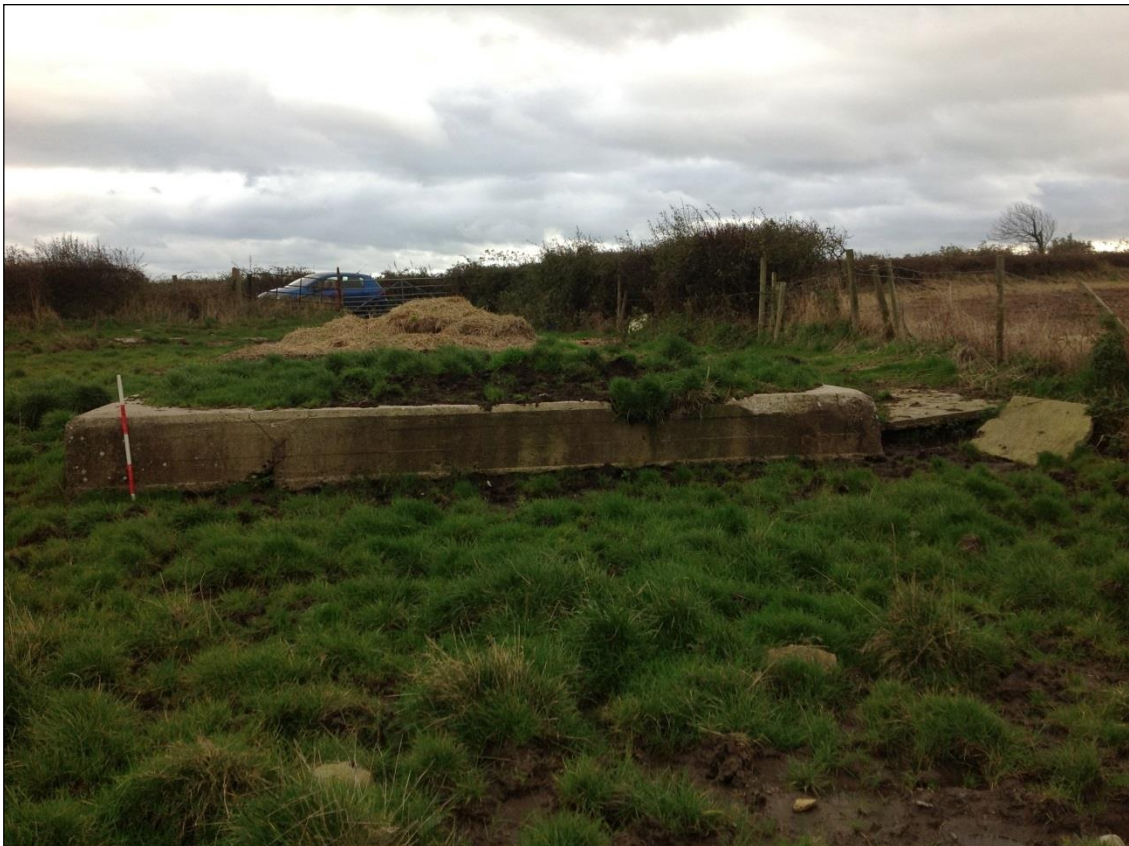
| <b>Condition</b> | Near Destroyed |
| <b>Condition rating</b> | Destroyed |

*Plate 108: The concrete base of the airmen's quarters Laing hut.*

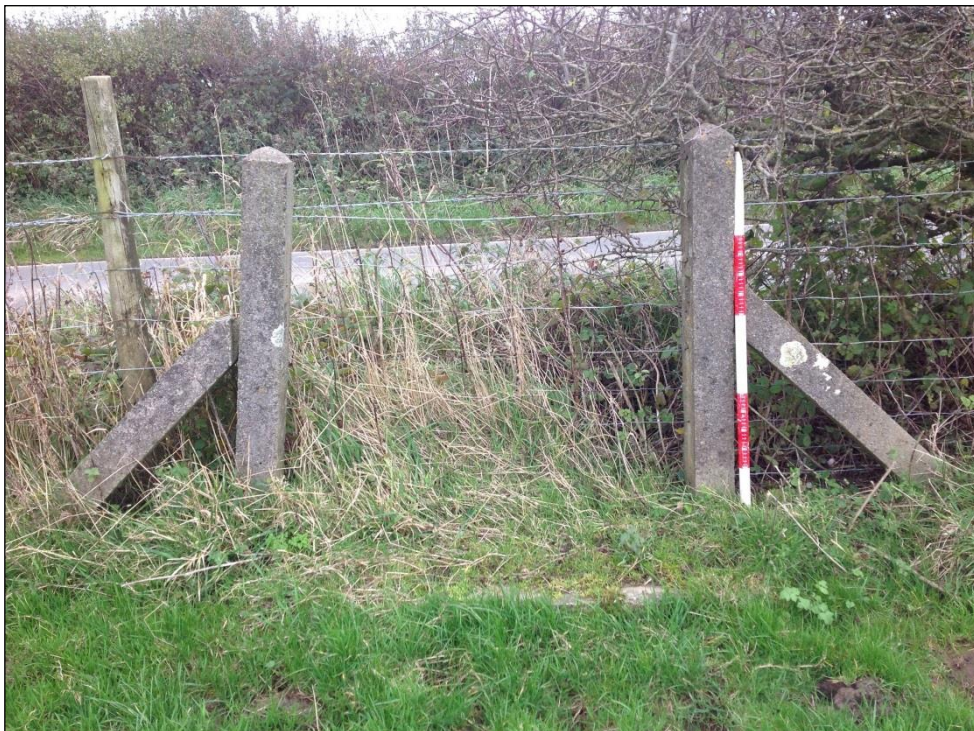
| <b>Condition</b> | Near Destroyed |
| <b>Condition rating</b> | Destroyed |

*Plate 110: One of the original entrances onto Site No.8.*

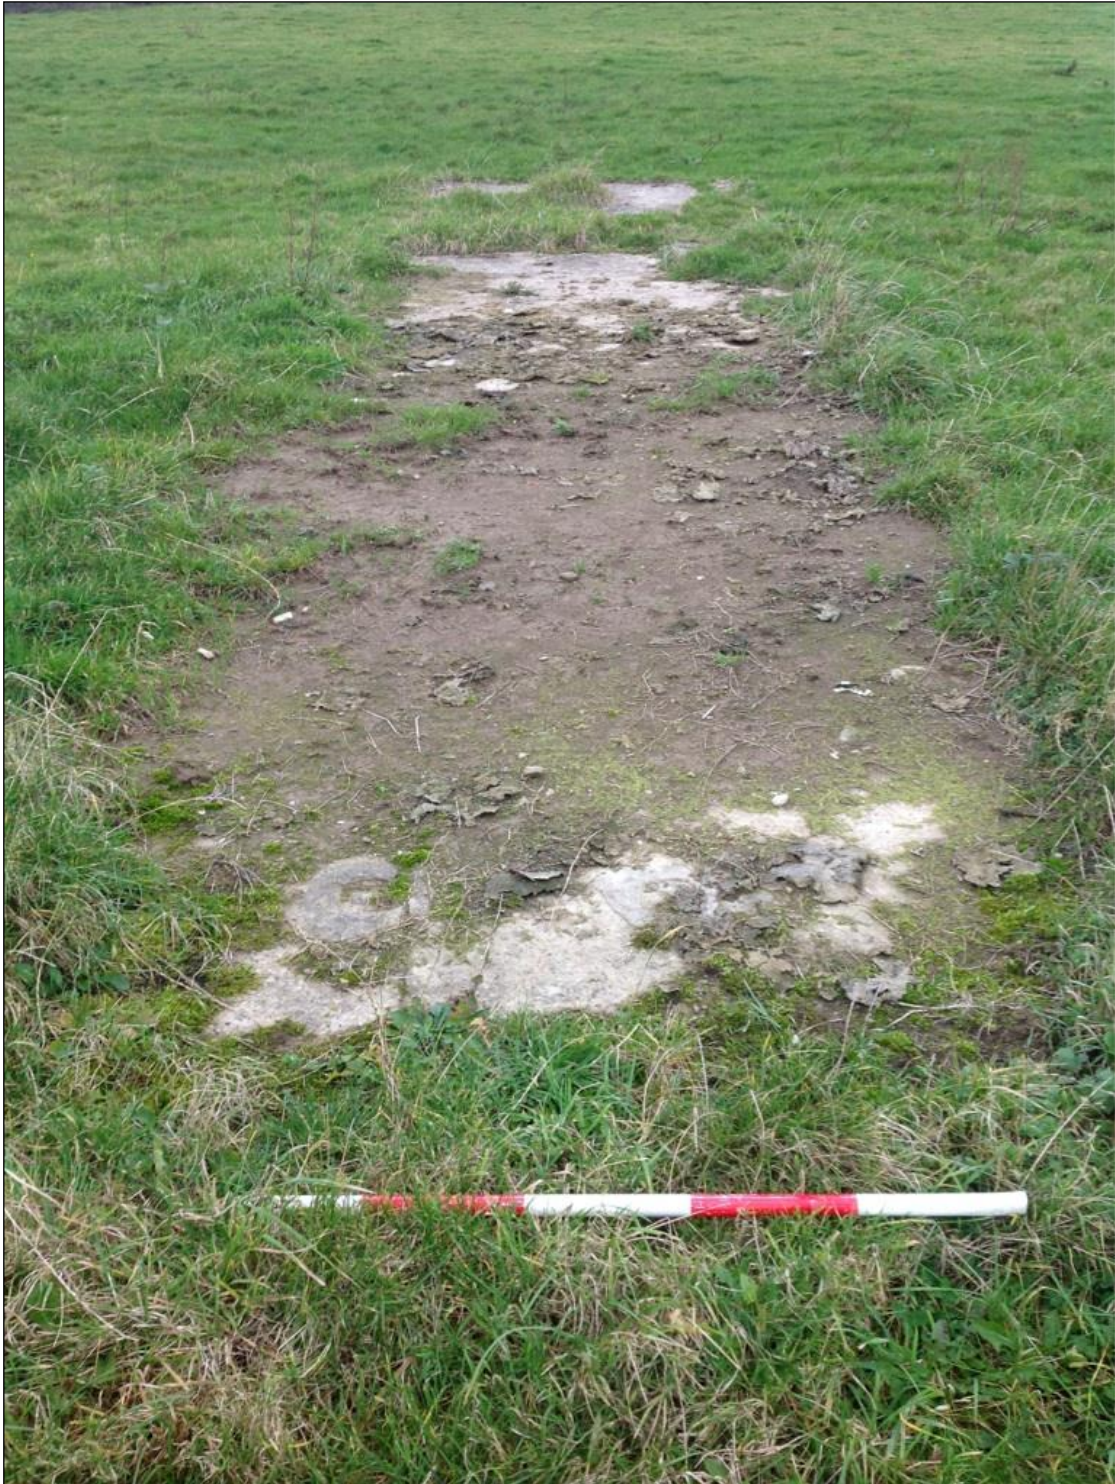
| <b>Condition</b> | Near Destroyed |
| <b>Condition rating</b> | Destroyed |

*Plate 111: Remains of building 106.*

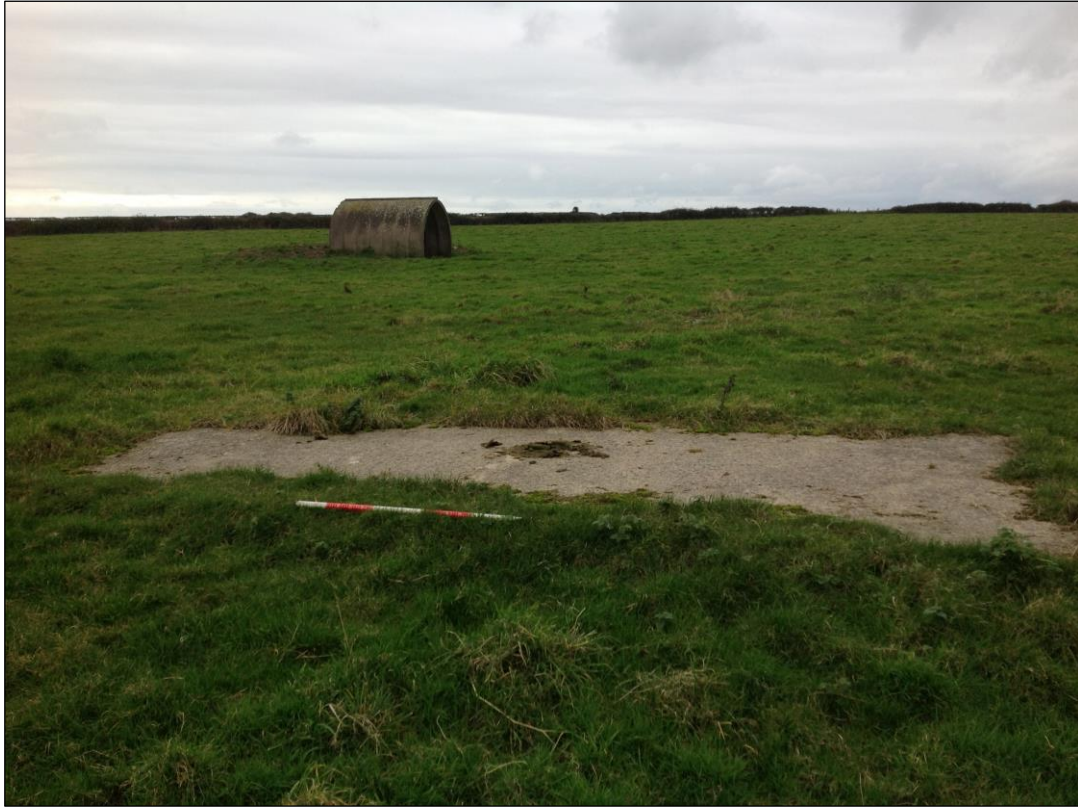
| <b>Condition</b> | Near Destroyed |
| <b>Condition rating</b> | Destroyed |

*Plate 112: Very little remains today of the Airmen's Quarters.*

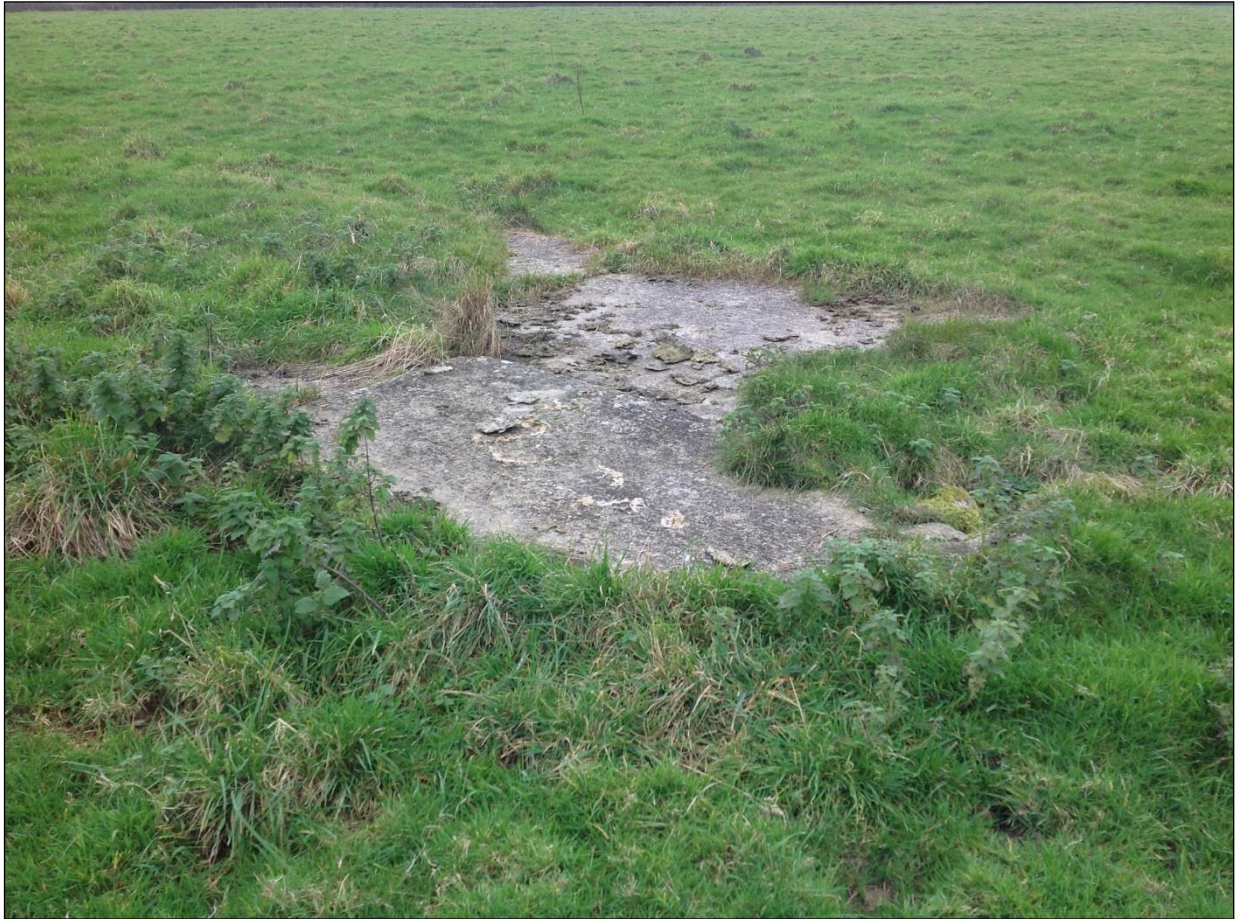
| <b>Condition</b> | Near Destroyed |
| <b>Condition rating</b> | Destroyed |

*Plate 113: The concrete apron of building 103 just visible through the turf.*

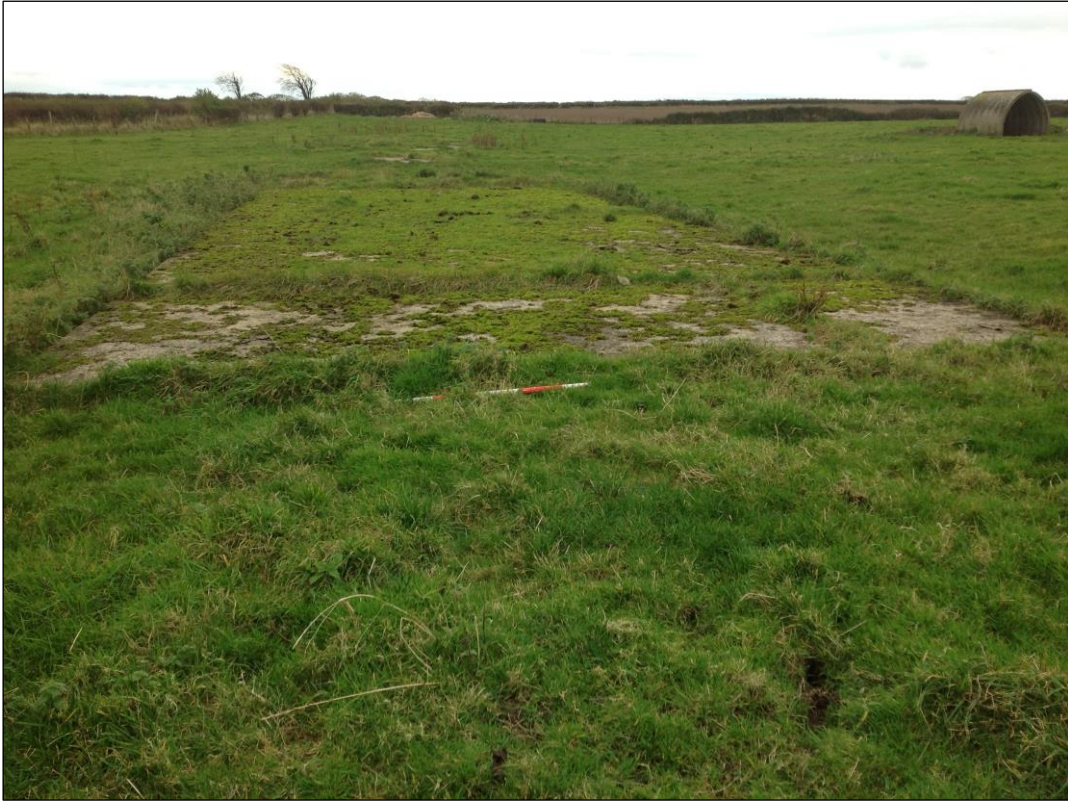
| <b>Condition</b> | Near Destroyed |
| <b>Condition rating</b> | Destroyed |

*Plate 114: The airmen's quarters with Site No.8s air-raid shelter in the background.*

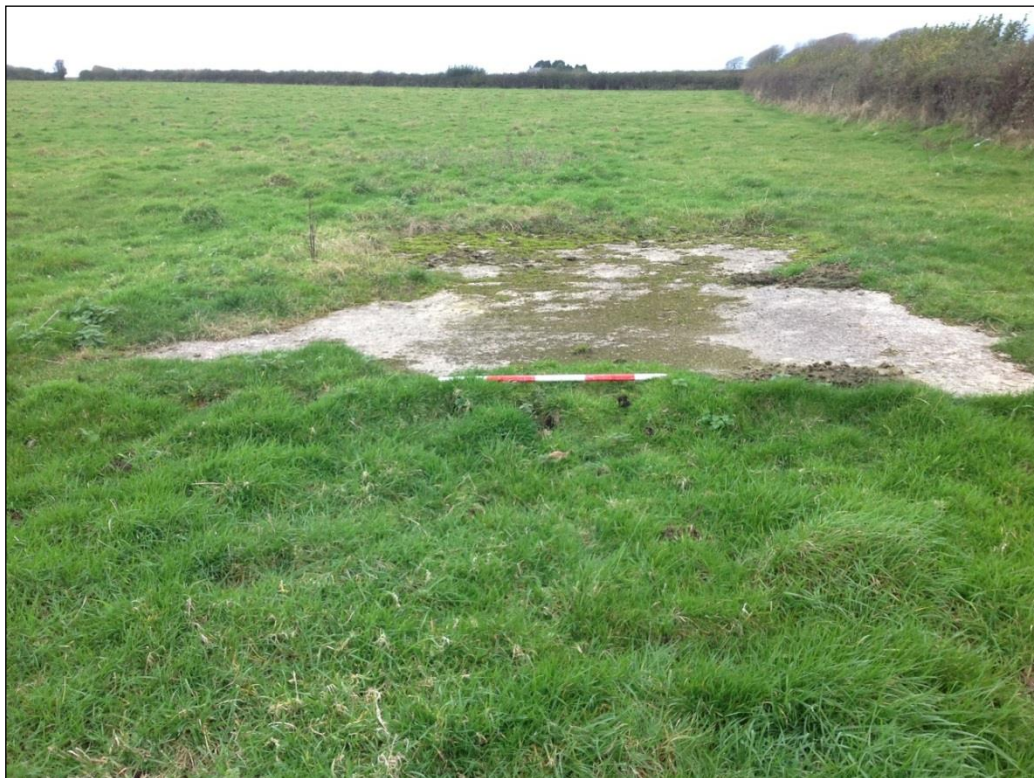
| <b>Condition</b> | Near Destroyed |
| <b>Condition rating</b> | Destroyed |

*Plate 116: All that survives of Site No.8s Picket Post is the concrete base.*

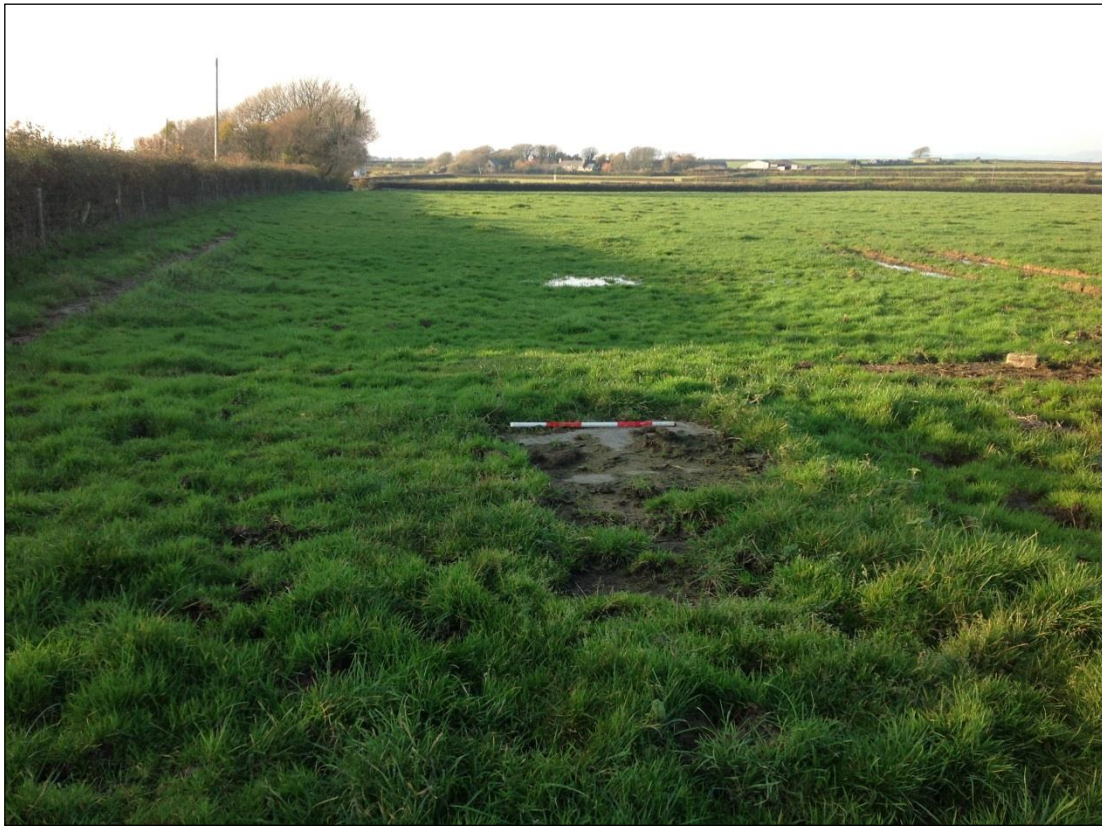
| <b>Condition</b> | Near Destroyed |
| <b>Condition rating</b> | Destroyed |

*Plate 117: The base of the Officers latrine block now overgrown with turf.*

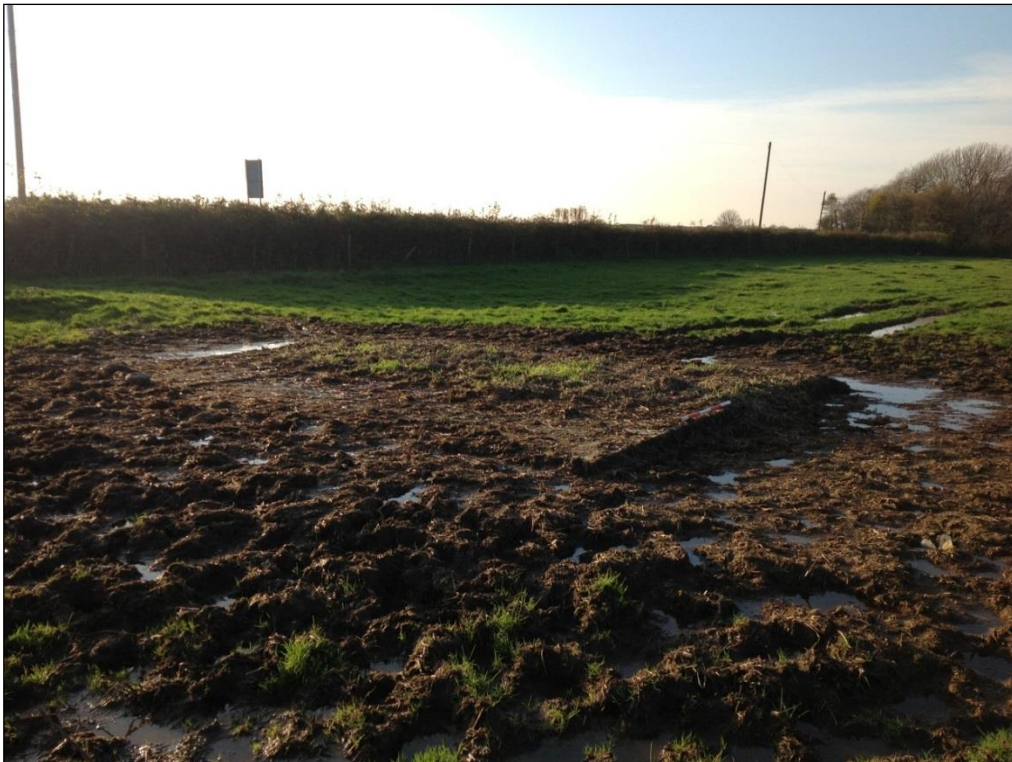
| <b>Condition</b> | Near Destroyed |
| <b>Condition rating</b> | Destroyed |

*Plate 118: The concrete plinth which once housed the Officers Bath House.*

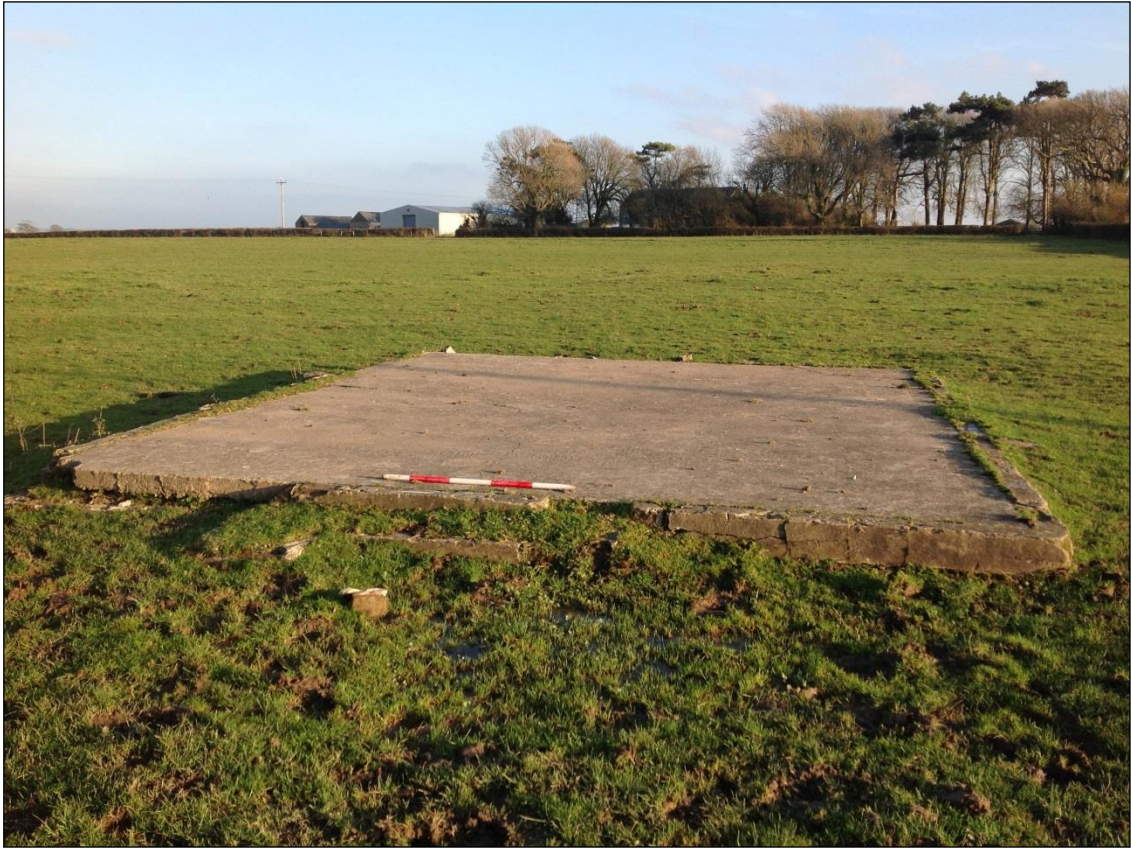
| <b>Condition</b> | Near Destroyed |
| <b>Condition rating</b> | Destroyed |

*Plate 119: The scant remains of Site No.9s Picket Post (PRN 04458s). View to the southeast.*

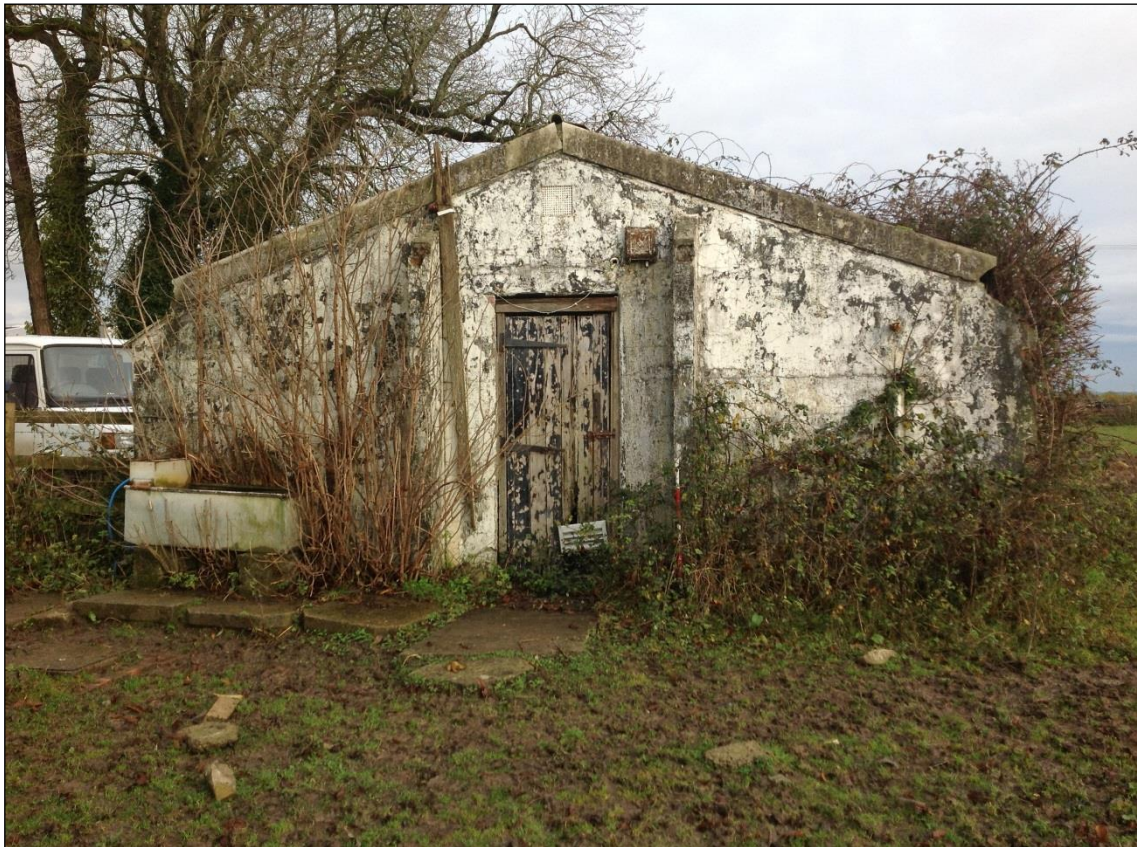
The building overall is in a poor state of repair, being overgrown with scrub vegetation on the southeast facing elevation. A section of the exterior walling on the northwest elevation has been completely removed to improve access to the inside of the building. The internal space is equally as poor, though the timber framework for a dividing stud wall still survives. The site is currently being used as a general storage space.

| <b>Condition</b> | Damaged |
| <b>Condition rating</b> | Poor |

*Plate 120: The southwest facing gable end of the Airwomen's Quarters building. Note the remains of buildings telegraph pole to the left of the doorway.*

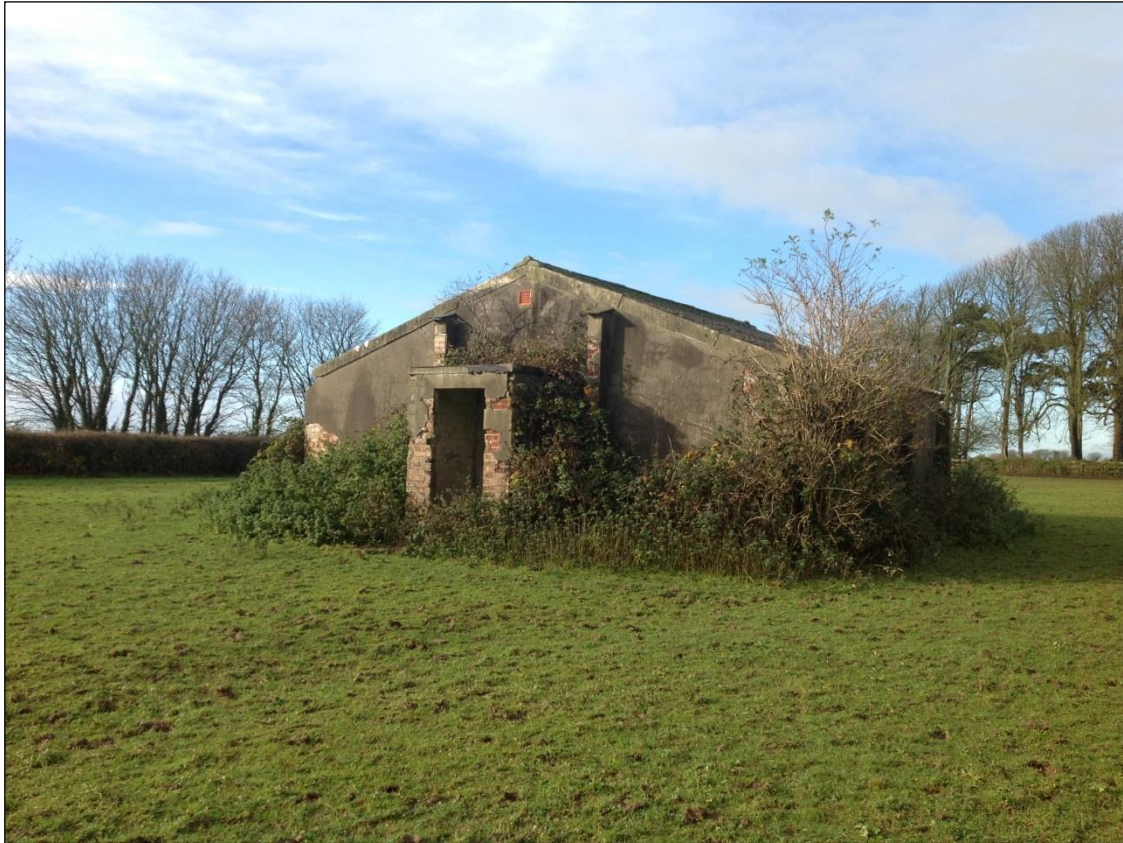
| <b>Description</b> | <p>The recreation hut is similar in construction to the airwomen's quarters, being of cement rendered brick with external piers at 10ft. centres. A flat roofed, brick porch surrounds the front and rear gable end doorways. The external windows have all been in filled and skimmed with similar concrete render to the rest of the building.</p> <p>The building is in a poor state of repair, being heavily overgrown on both sides with vegetation. Large sections of the cement render have come away from the northwest gable end and the brickwork beneath has suffered badly, especially around the porches. The internal space is devoid of features, having been totally stripped bare.</p> |
| <b>Condition</b> | Damaged |

*Plate 121: Southeast facing elevation of the recreation hut.*

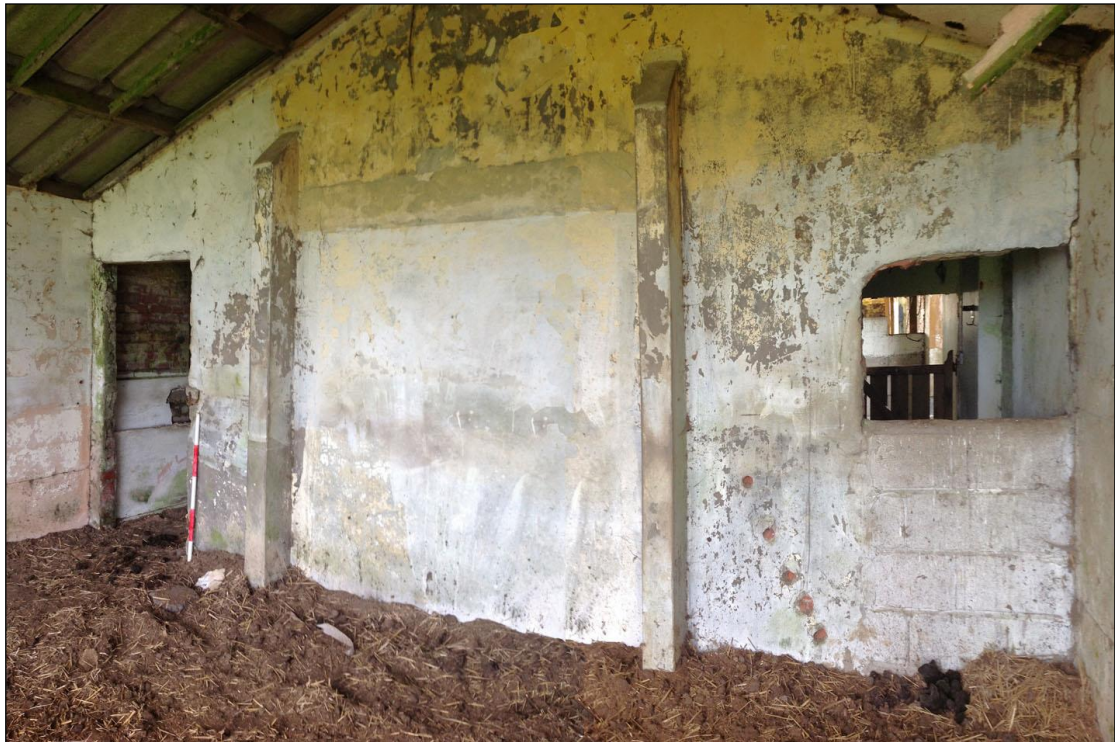
*Plate 123: The interior of the Mess extension. Note the external piers on the interior wall. This wall would have been the original gable end of the building.*

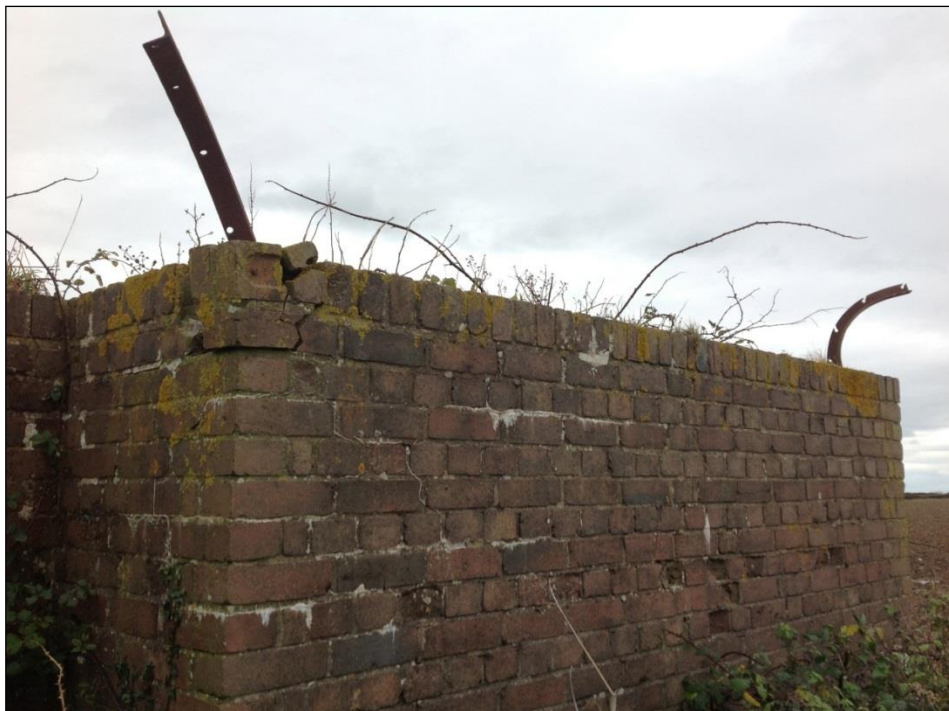
*Plate 125: Cast iron posts extend from the top corners of the wall to act as a deterrent*

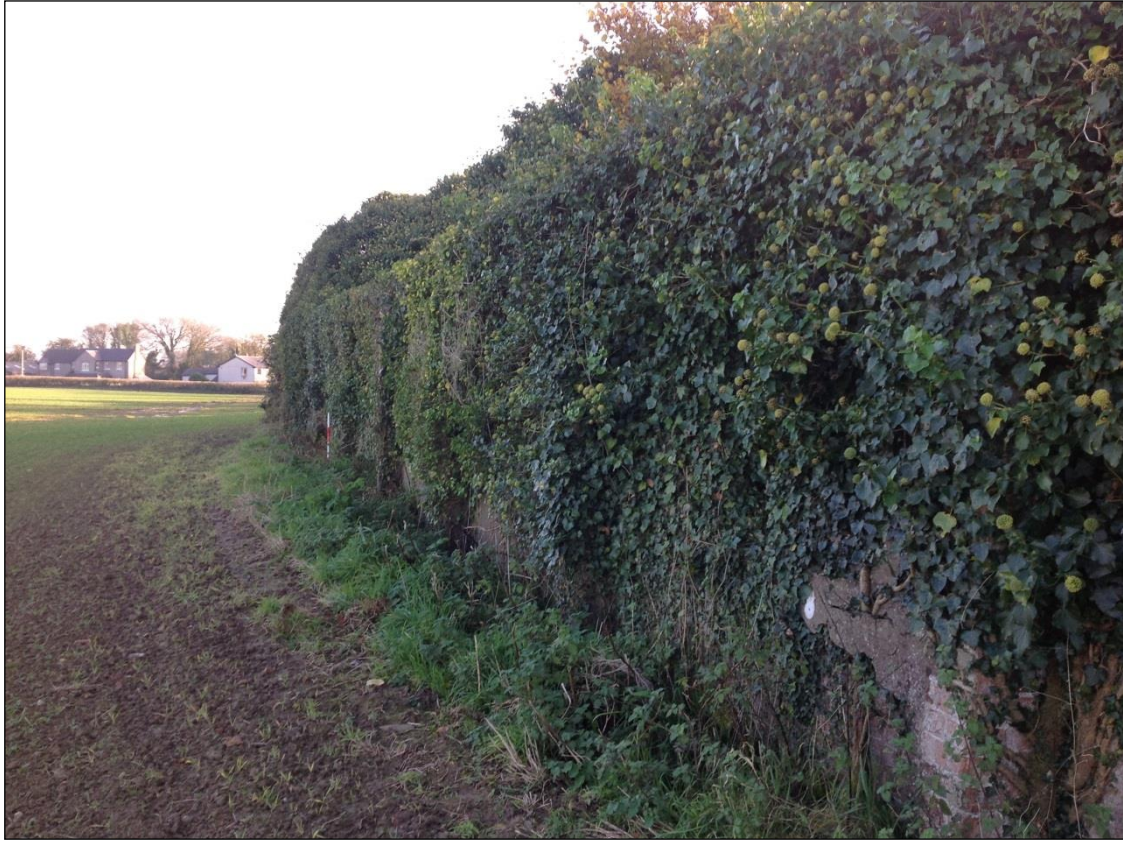
*Plate 126: The heavily camouflaged Defence Hut (PRN 04464s).*

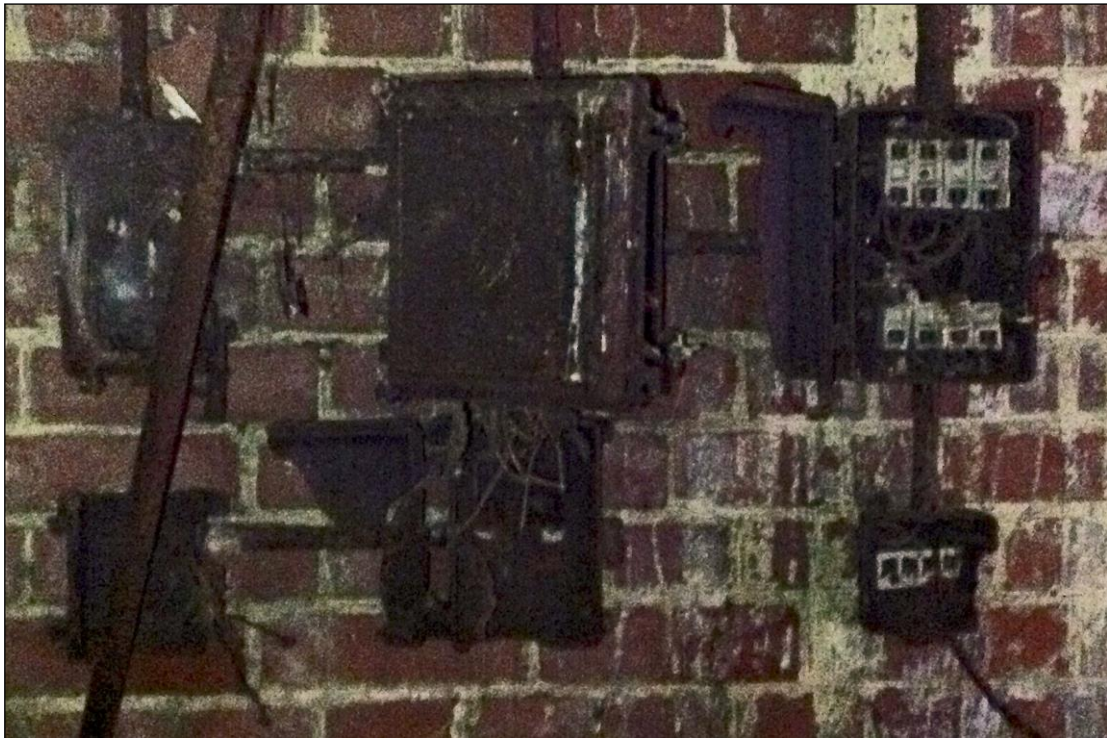
*Plate 129: Remains of the electrical switching gear.*

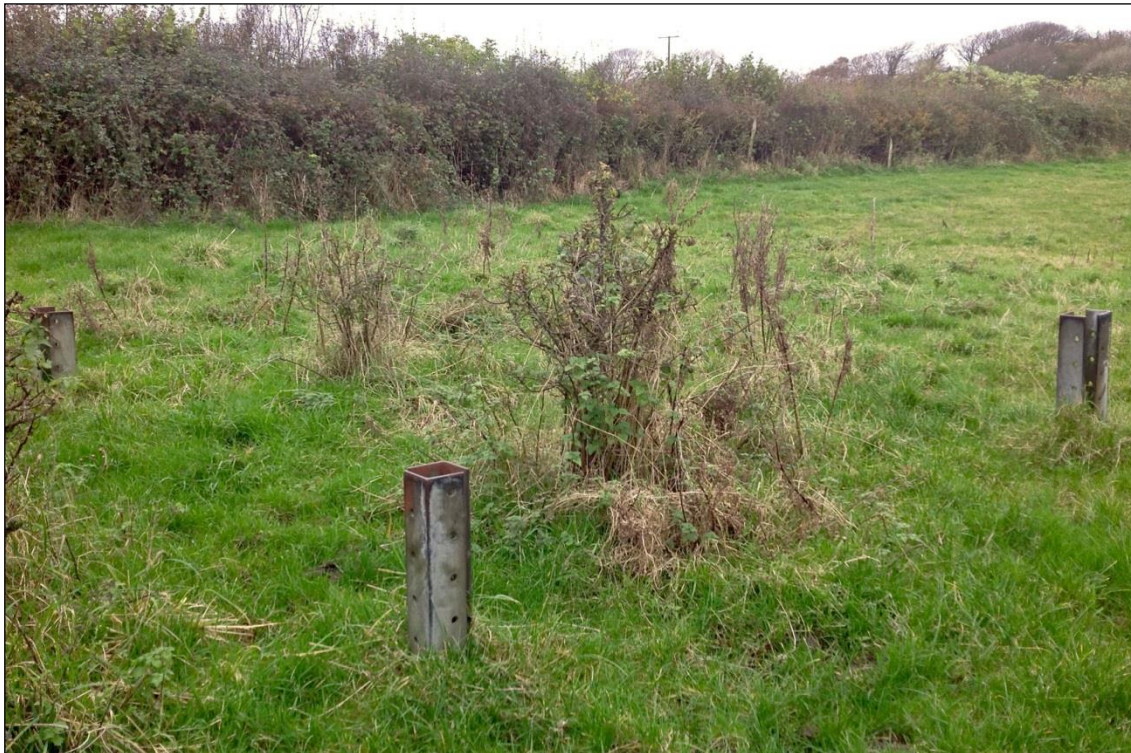
*Plate 130: Remains of the posts that anchored one of the VHF aerials*

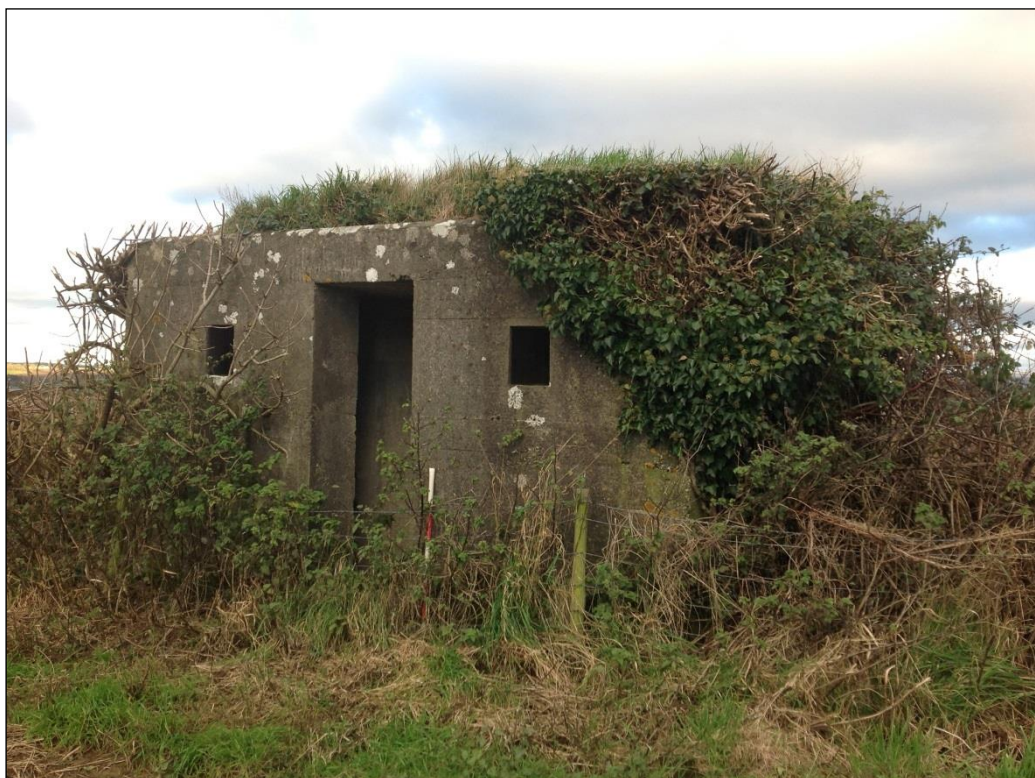
**Condition** Damaged

**Condition rating** Fair

*Plate 131: The south facing elevation of PRN 04467s.*

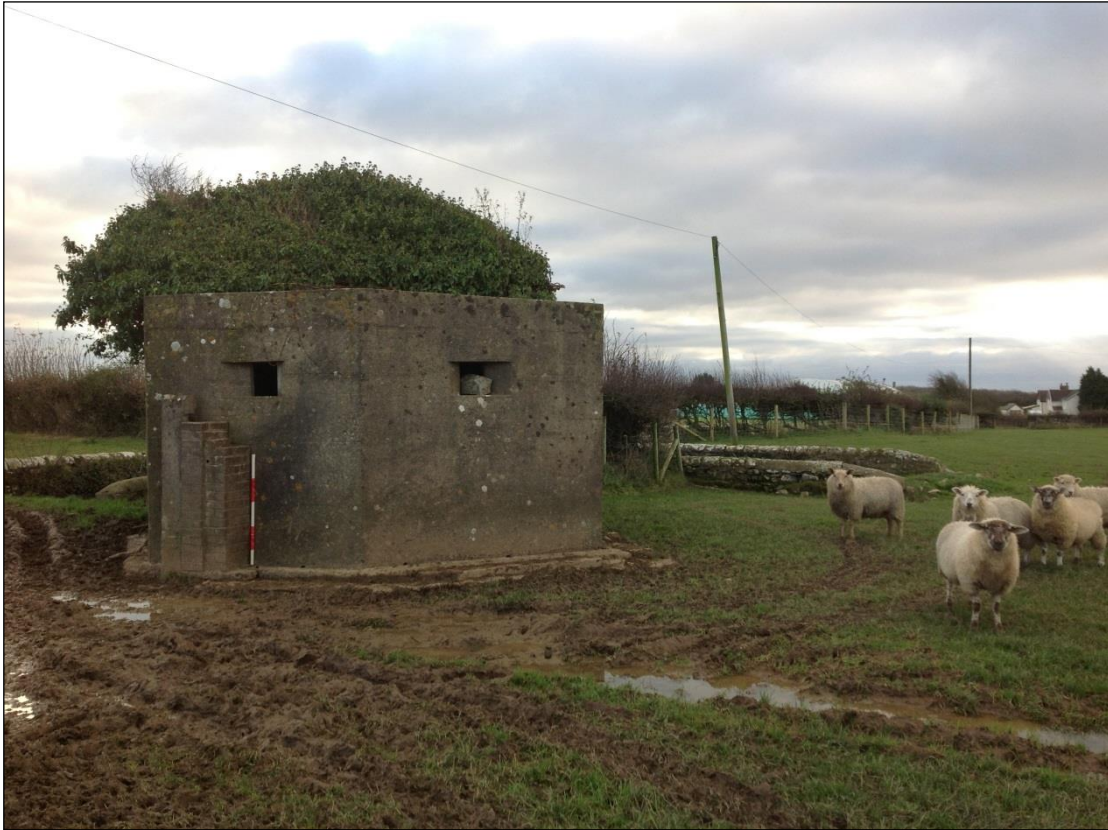
*Plate 132: The north facing elevation of pillbox 04468s.  
Note the concrete and brick dais on which the structure stands.*

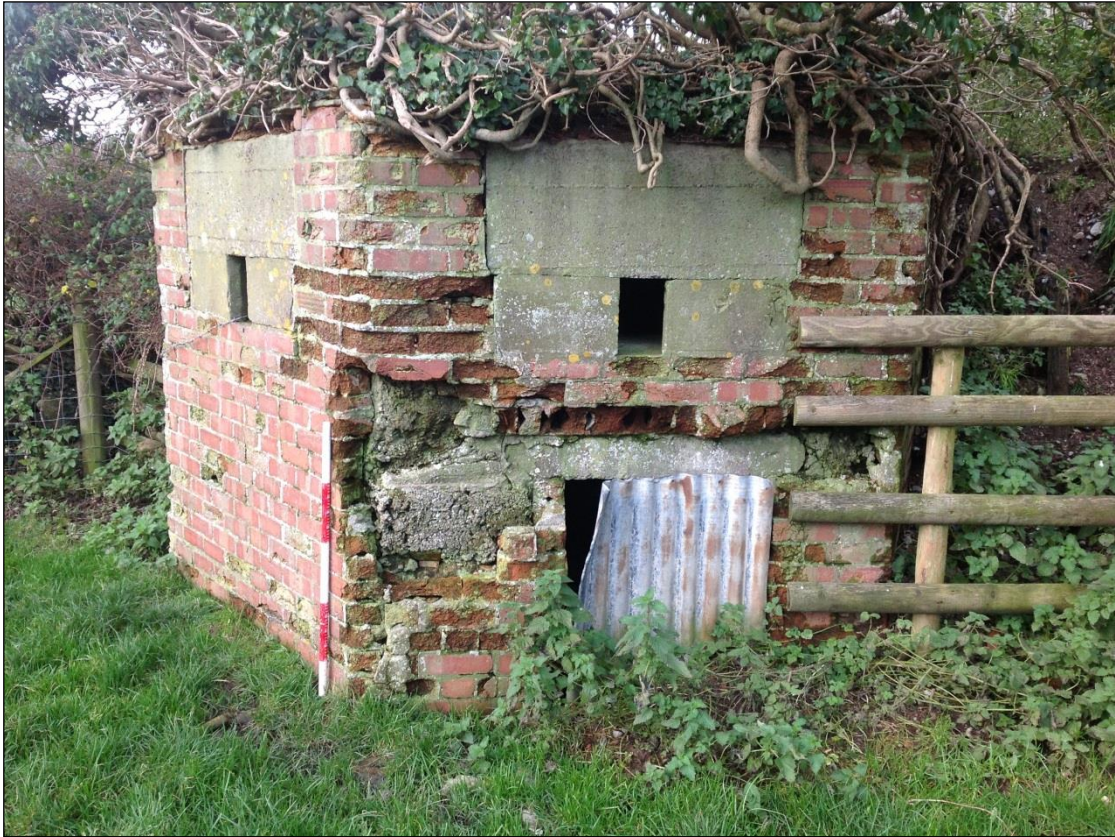
*Plate 133: The east facing elevation of Pillbox 04469s.*

*Note the unusual embrasures with the overlarge concrete lintel.*

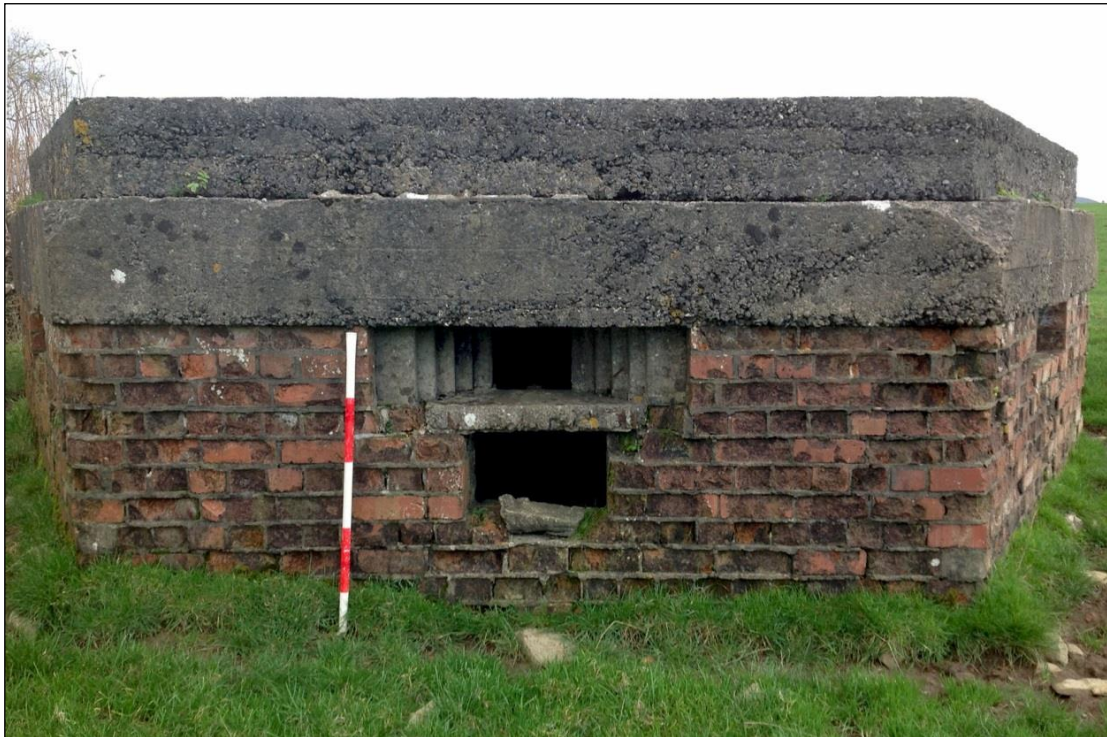
*Plate 135: The west facing loopholes. The top is for fitted with a Turnbull mount for Vickers MG, while the lower is for 'Boys' anti-tank rifle.*

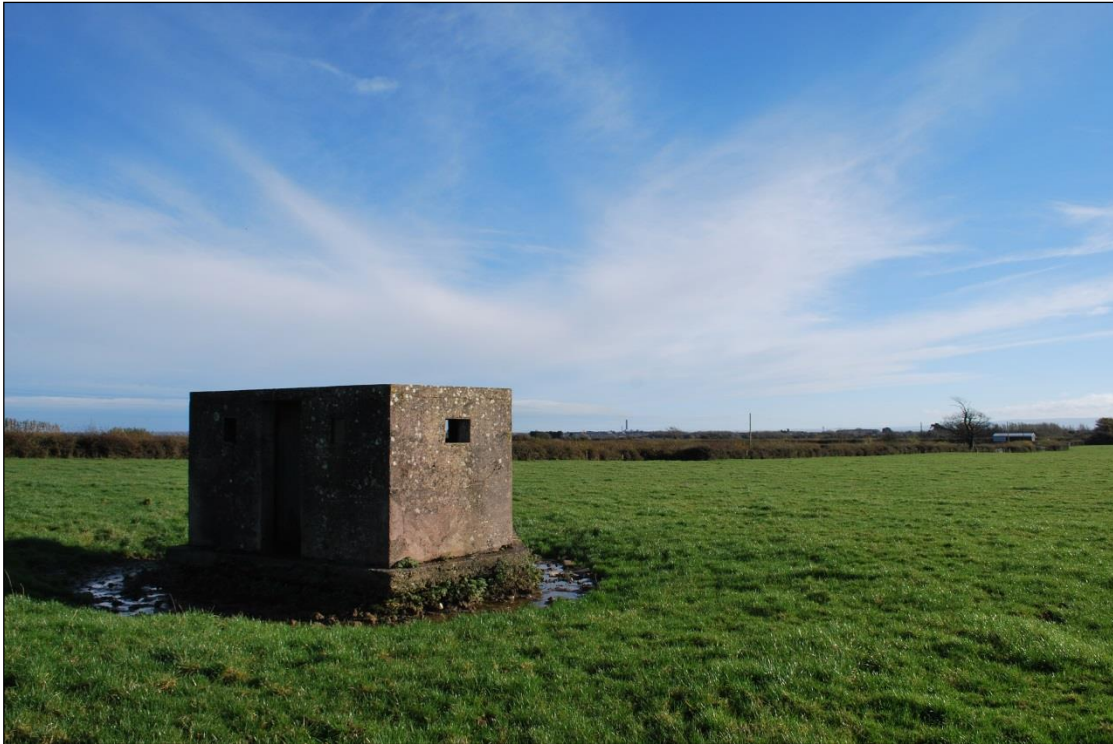
| <b>Condition</b> | Damaged |

**Condition rating** Fair  
**Period** Modern  
**Group Value** Yes  
**Form** Other structure  
**Associated PRN sites** 04467s, 04468s, 04469s, 04470s, 04471s  
**Linked to airfield function?** Yes  
**Of technical/Structural interest?** No  
**Historical association?** No

*Plate 137: The Type 24 pillbox was once hidden within a hedgeline.*

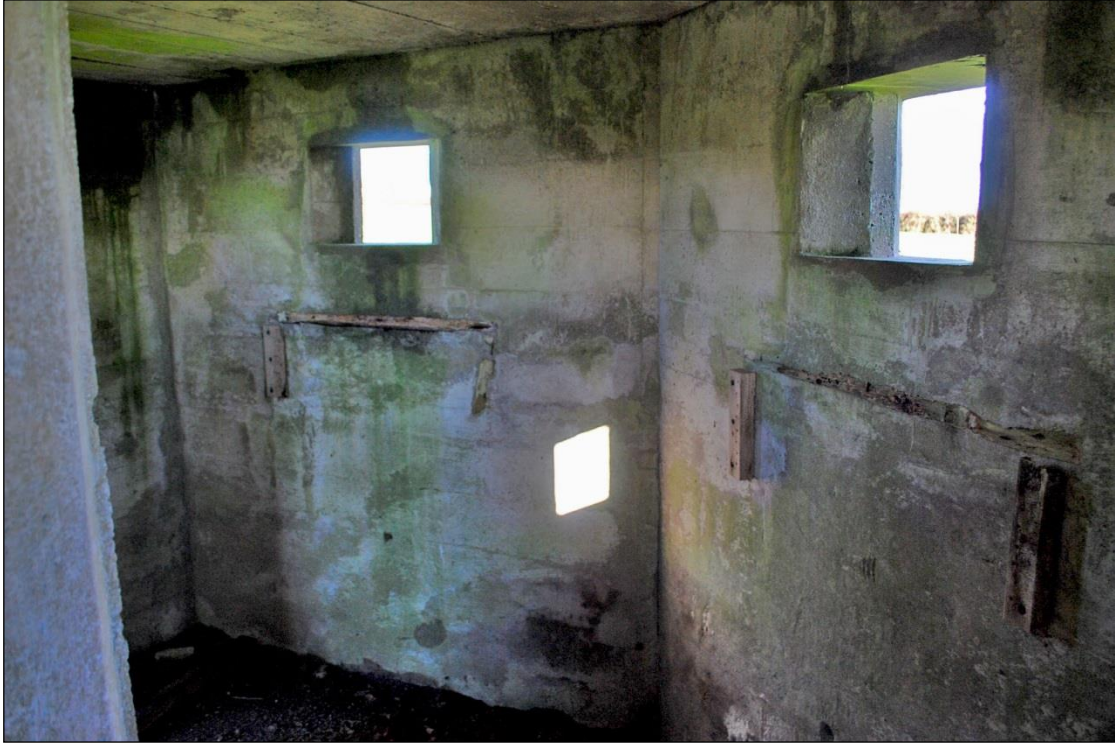
*Plate 138: Remains of the brackets that held the wooden shelves.*

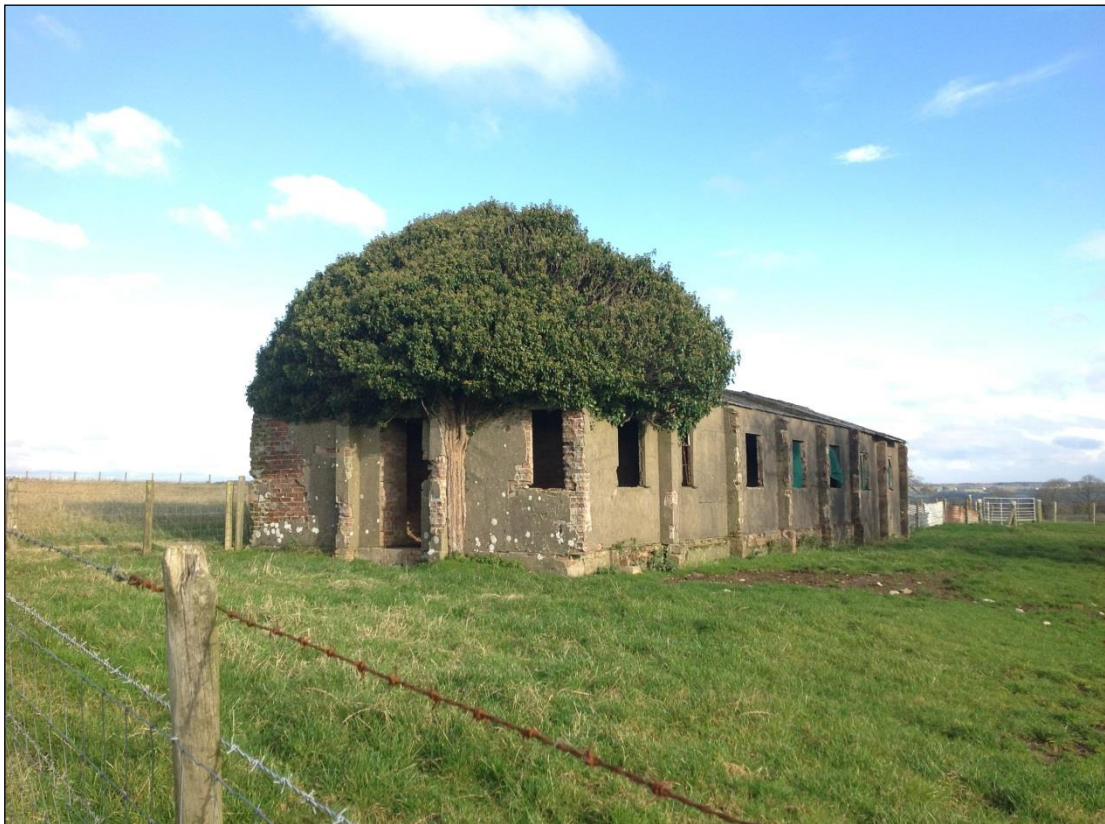
**Condition** Near Destroyed

**Condition rating** Very Poor

*Plate 139: PRN 04418s remains of a possible Defence Hut. View to the northeast*
