# GGAT 112: Second World War Military Airfields of South Wales

Year 2-Airfield Hinterland

A report for Cadw  
by Paul W Huckfield BA

GGAT report no. 2013/024  
Project no. GGAT 112

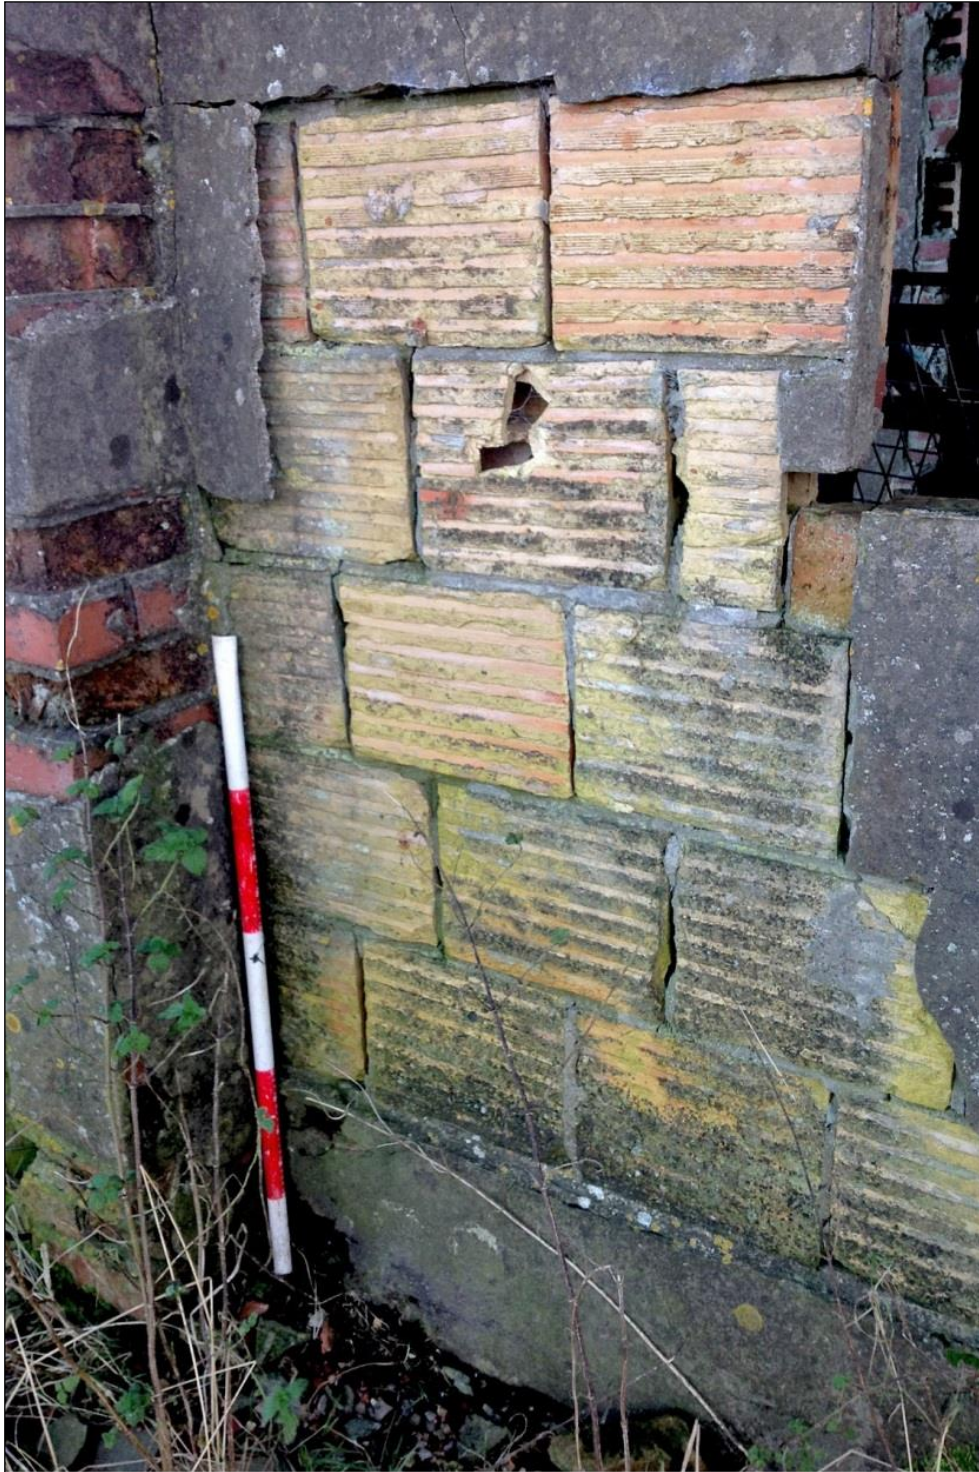
*Plate 140: Detail of the eastern extension, showing the pale yellow hollow terra cotta blocks, usually employed for internal partitions.*

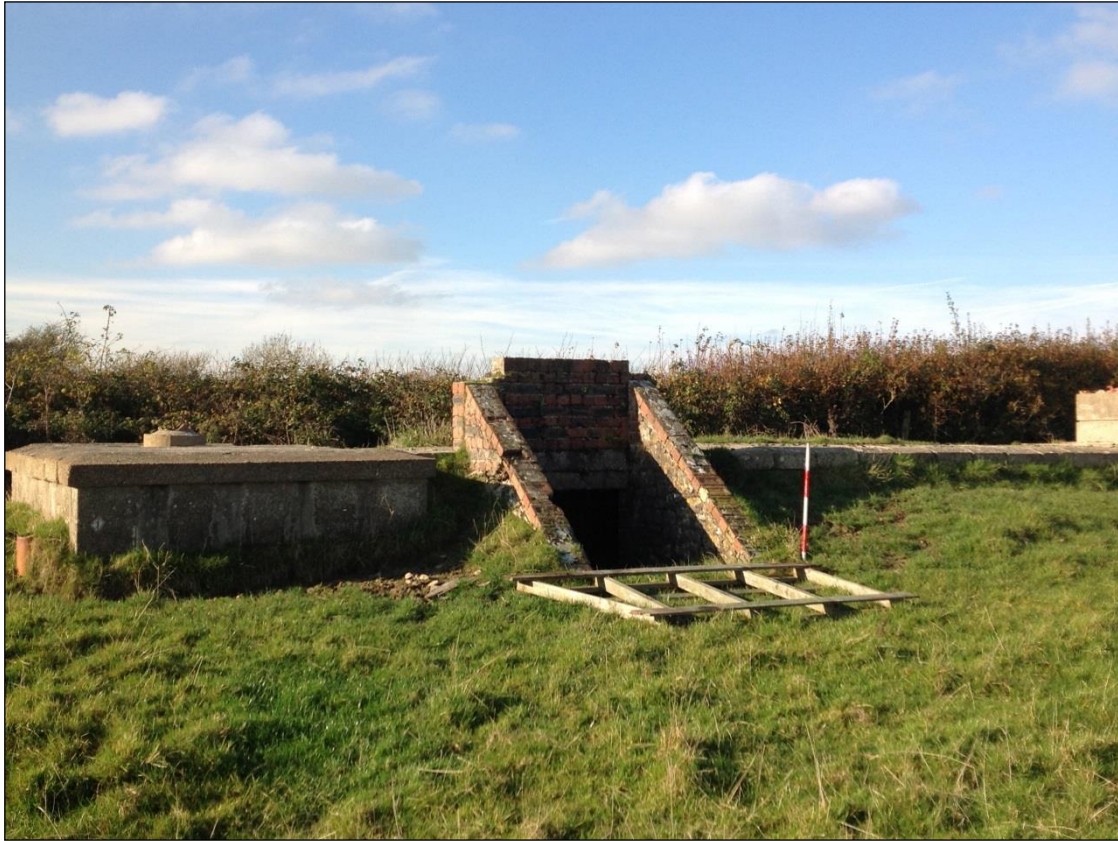
| <b>Condition</b> | Damaged |
| <b>Condition rating</b> | Fair |

*Plate 143: Entrance to the sunken 'Q' site control shelter.*

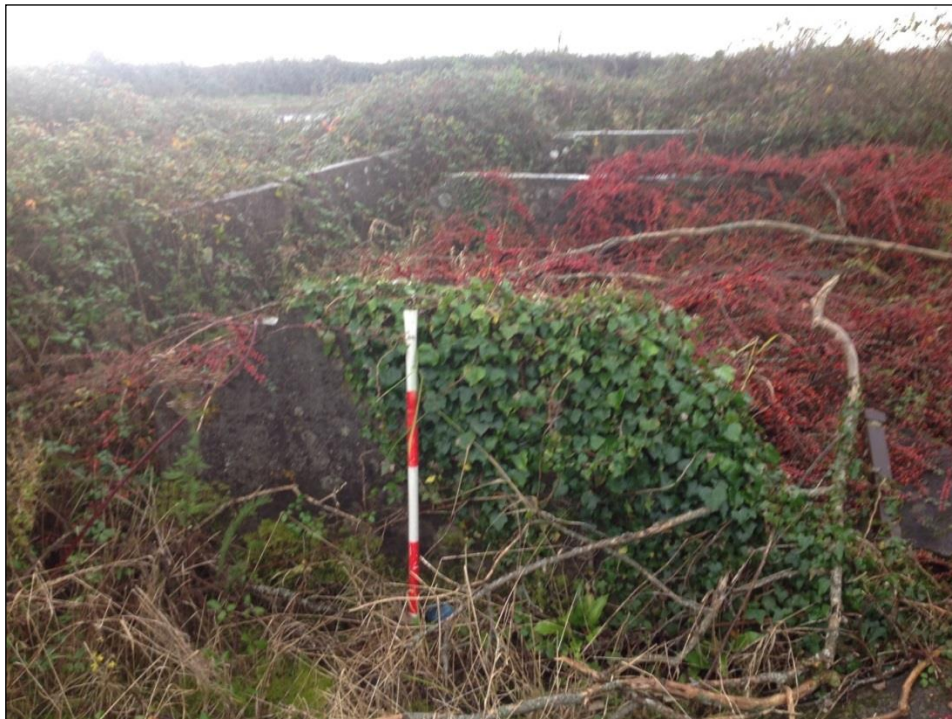
| <b>Condition</b> | Near Destroyed |
| <b>Condition rating</b> | Poor |

*Plate 145: The most visible surviving structure within Site No.4. Note the small compartments.*

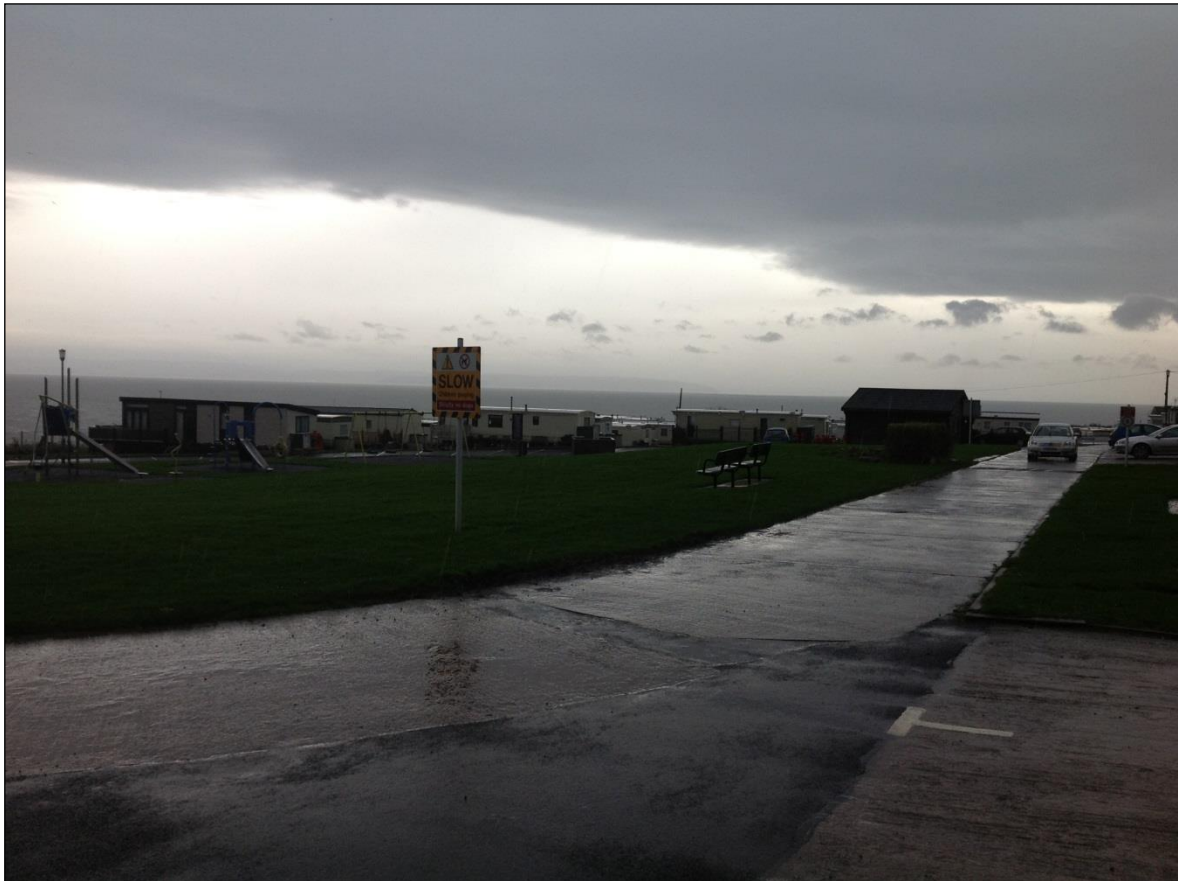
| <b>Condition</b> | Near Destroyed |
| <b>Condition rating</b> | Poor |

*Plate 147: The remains of the perimeter track around the main battery (view to the southwest)*

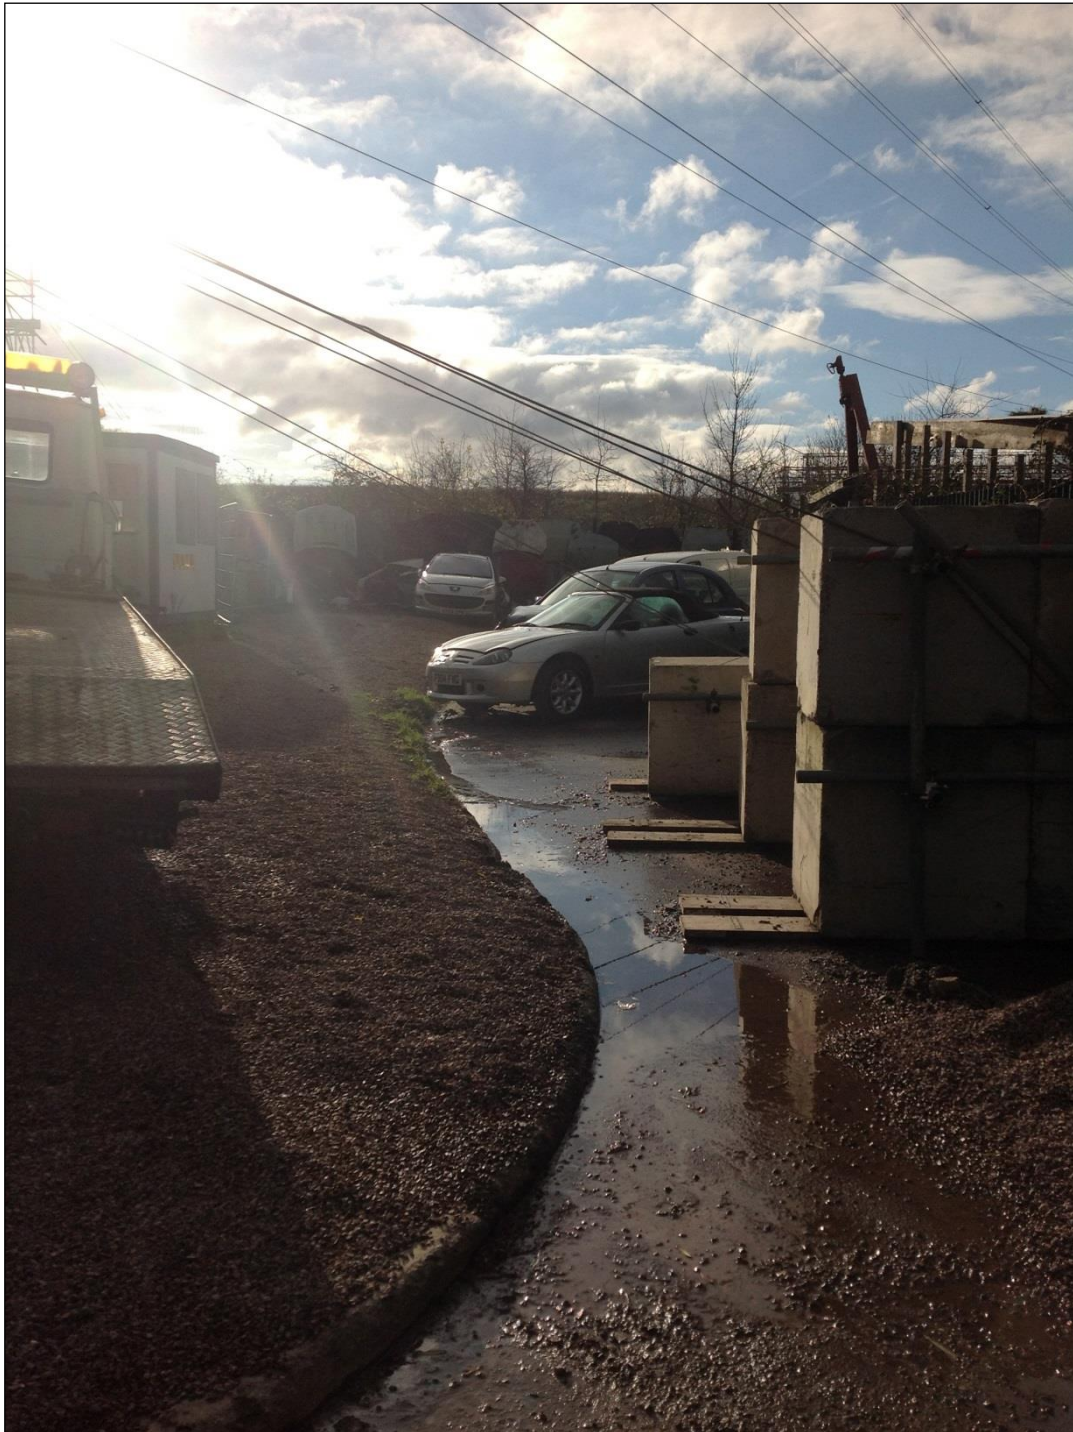
| <b>Condition</b> | Destroyed |
| <b>Condition rating</b> | Very Poor |

*Plate 149: The remains of the perimeter track around the main battery (view to the south west)*

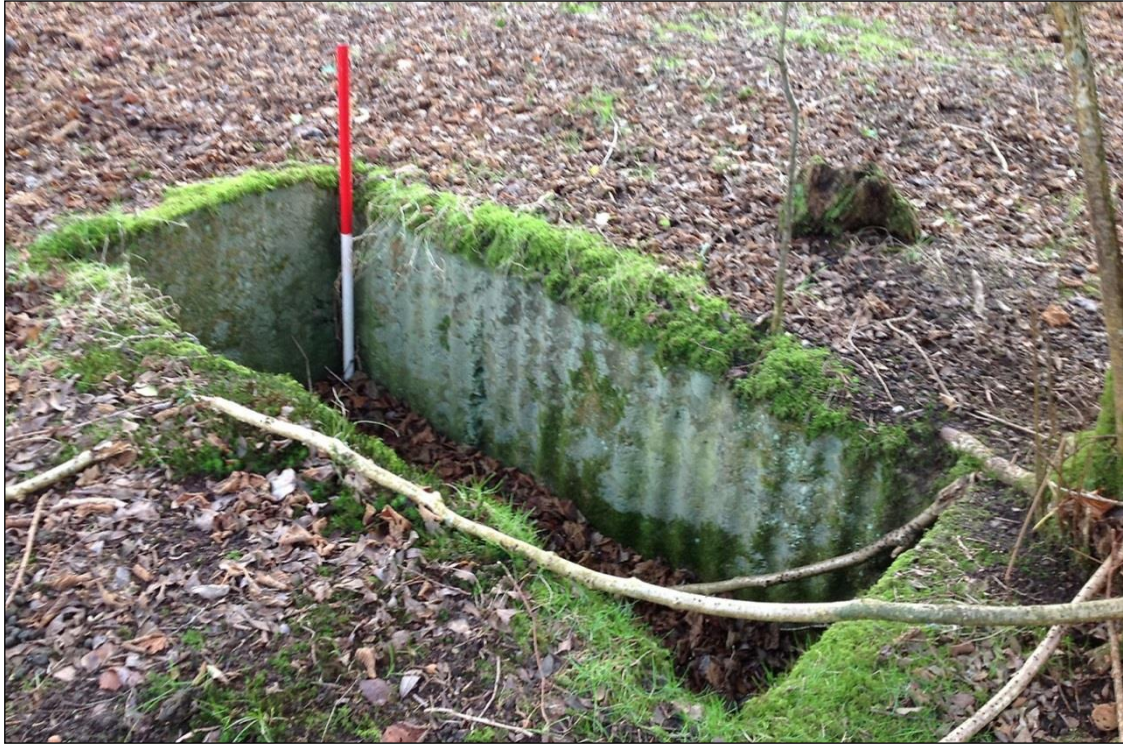
| <b>Condition</b> | Near Destroyed |
| <b>Condition rating</b> | Near Destroyed |

*Plate 150: Remains of a slit trench, protecting the end of runway 29/11.*

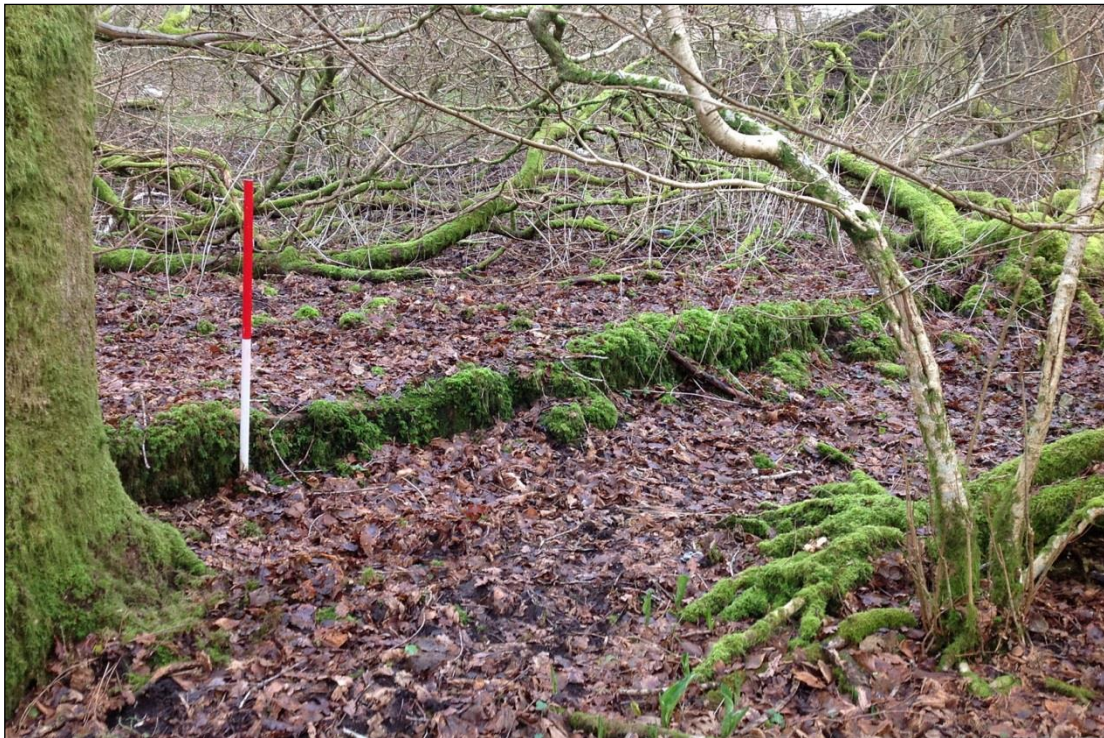
| <b>Condition</b> | Near Destroyed |
| <b>Condition rating</b> | Destroyed |

*Plate 151: Very little now remains to show that this was once one of the airfields workshops.*

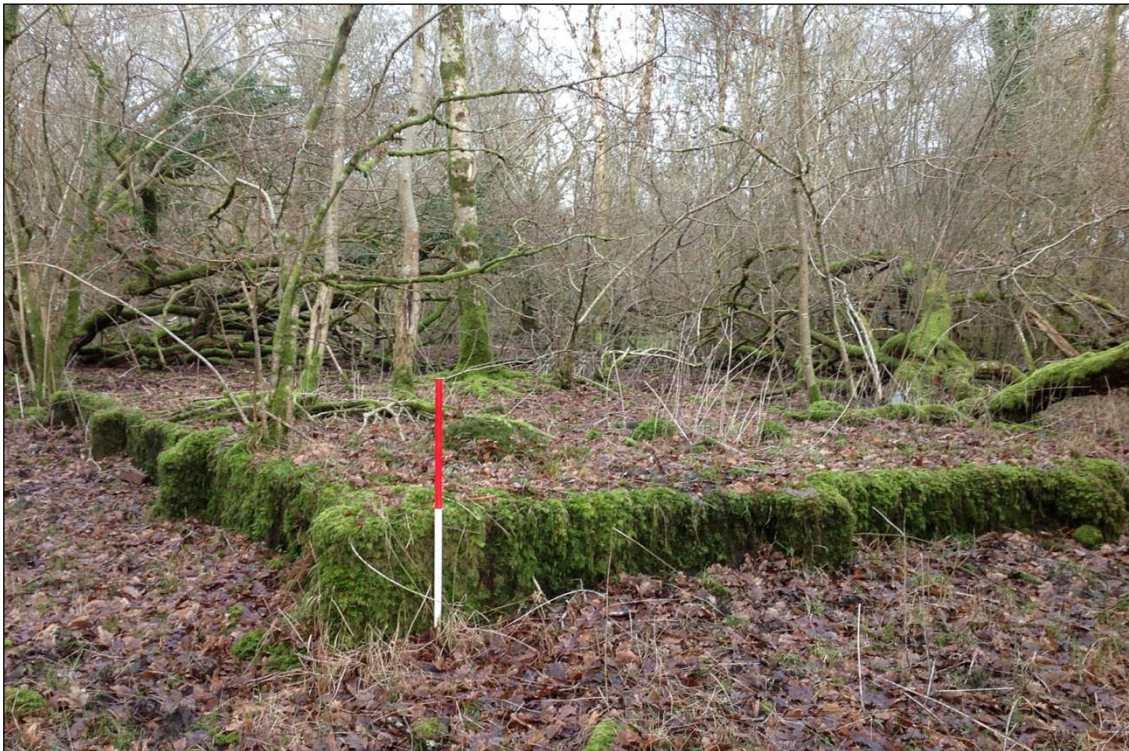
| <b>Condition</b> | Near Destroyed |
| <b>Condition rating</b> | Destroyed |

*Plate 152: Remains of the concrete plinth for the Crew Room. View to the northwest.*

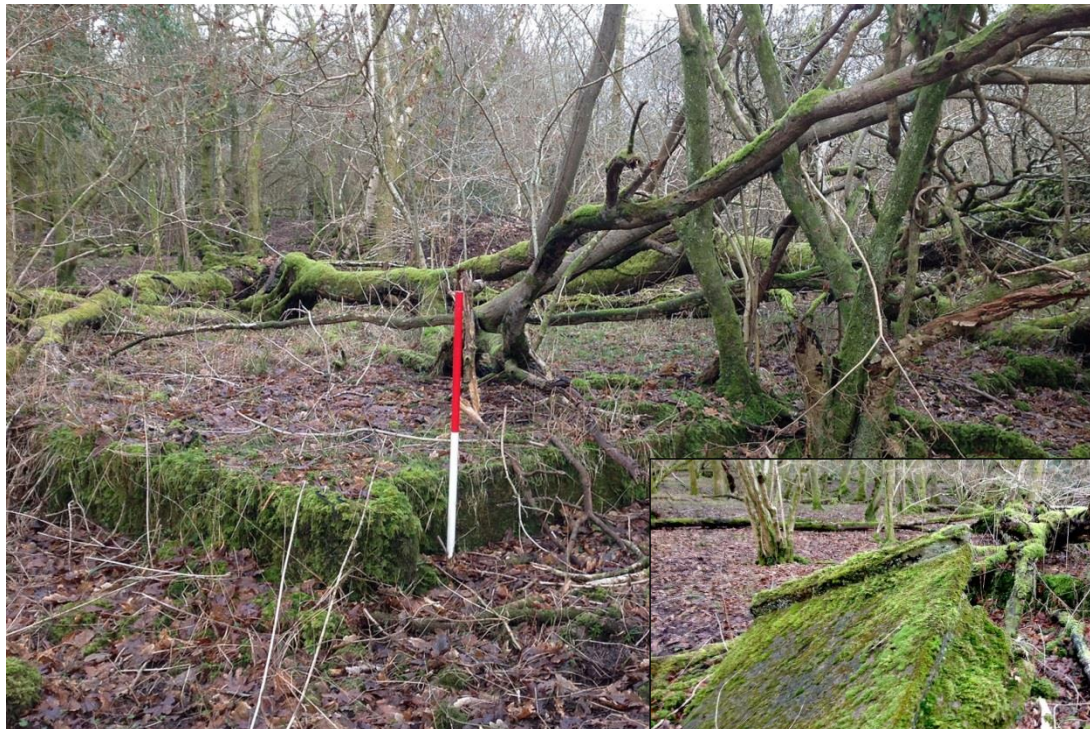
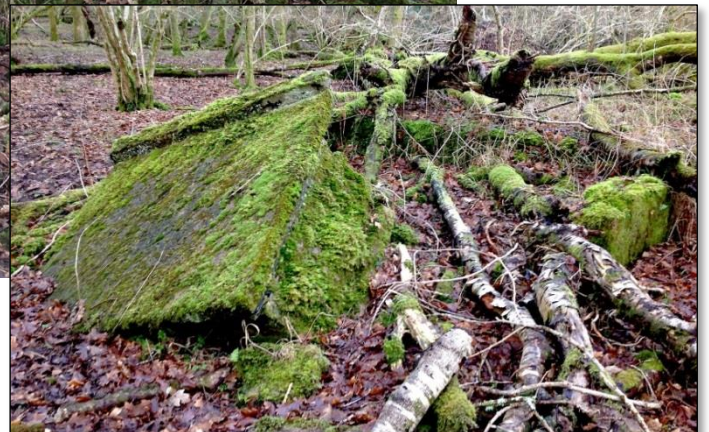
| <b>Condition</b> | Near Destroyed |
| <b>Condition rating</b> | Destroyed |

*Plate 153: (Above) The concrete plinth on which the Drying Room would have stood. (Right) The roof and wall belonging to the external latrine block.*

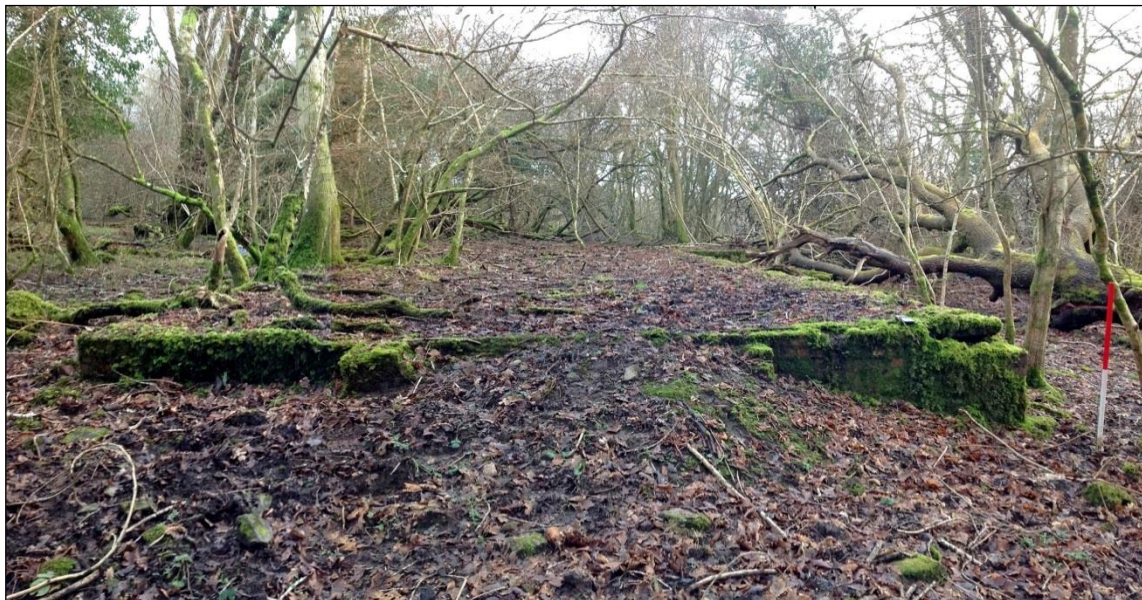
| <b>Condition</b> | Near Destroyed |
| <b>Condition rating</b> | Destroyed |

*Plate 154: Entrance to the Flight Office. View to the northeast.*

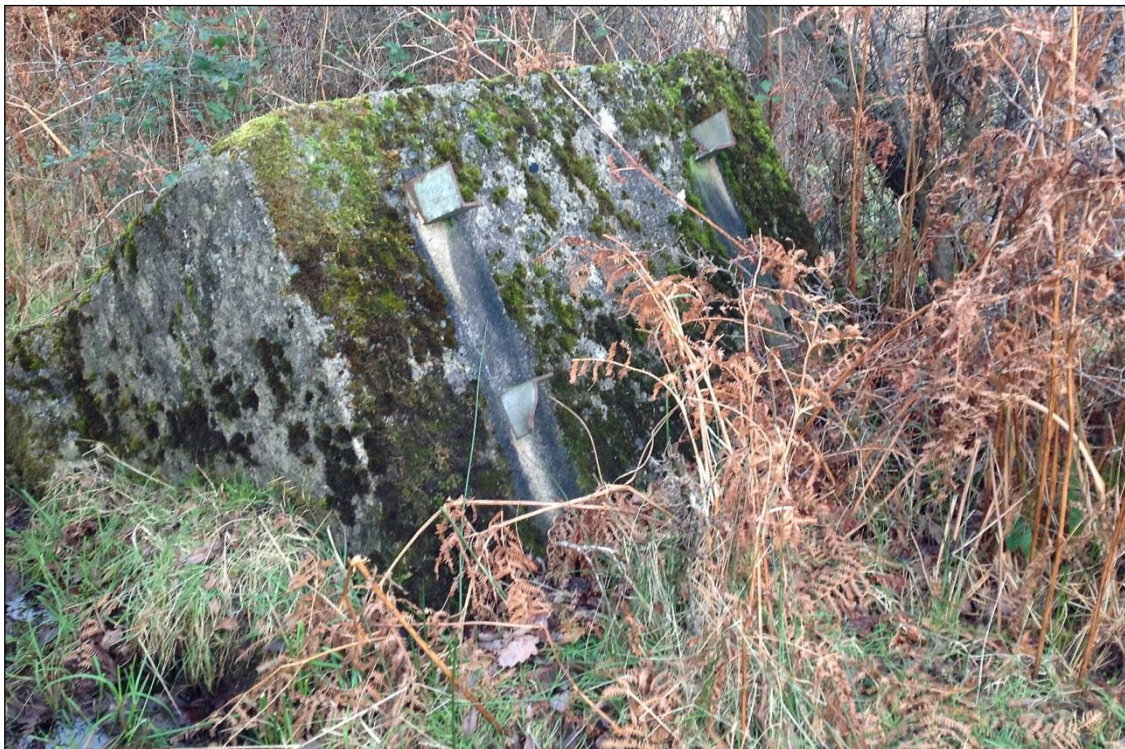
| <b>Condition</b> | Near Destroyed |
| <b>Condition rating</b> | Destroyed |

*Plate 155: Concrete block of unknown use.*

*Note the remains of four 'L' shaped metal fittings extend out from the top.*

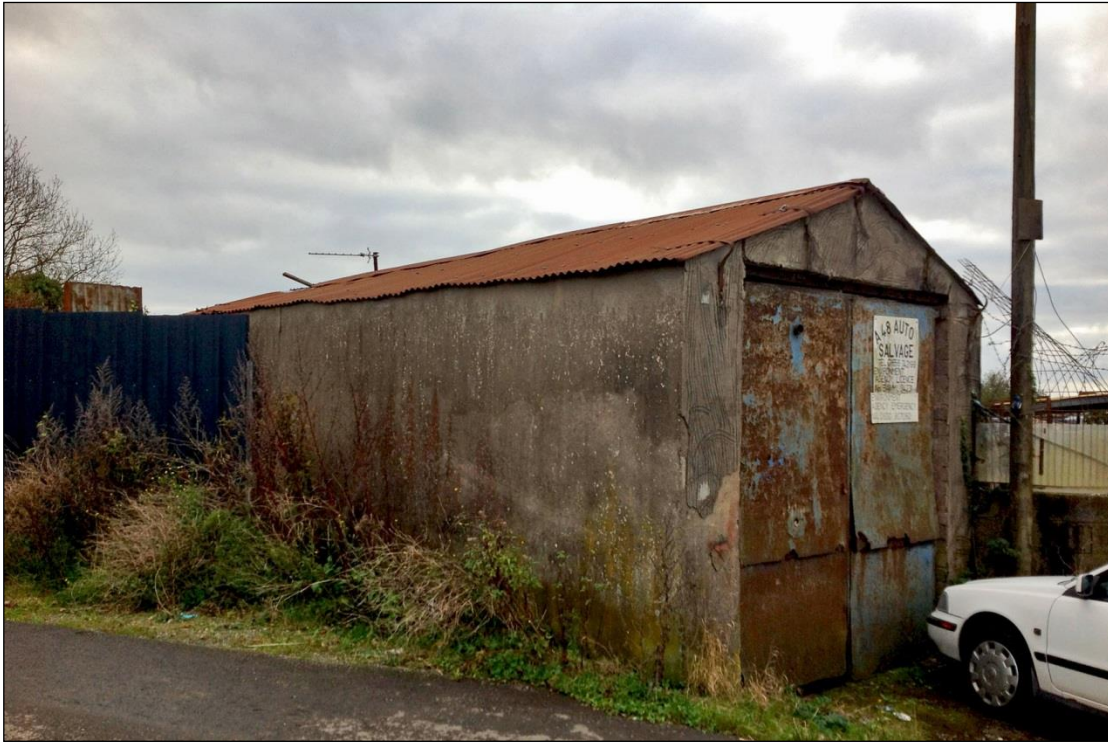
| <b>Condition</b> | Damaged |
| <b>Condition rating</b> | Fair |

*Plate 156: Building of unknown use. View to the west.*

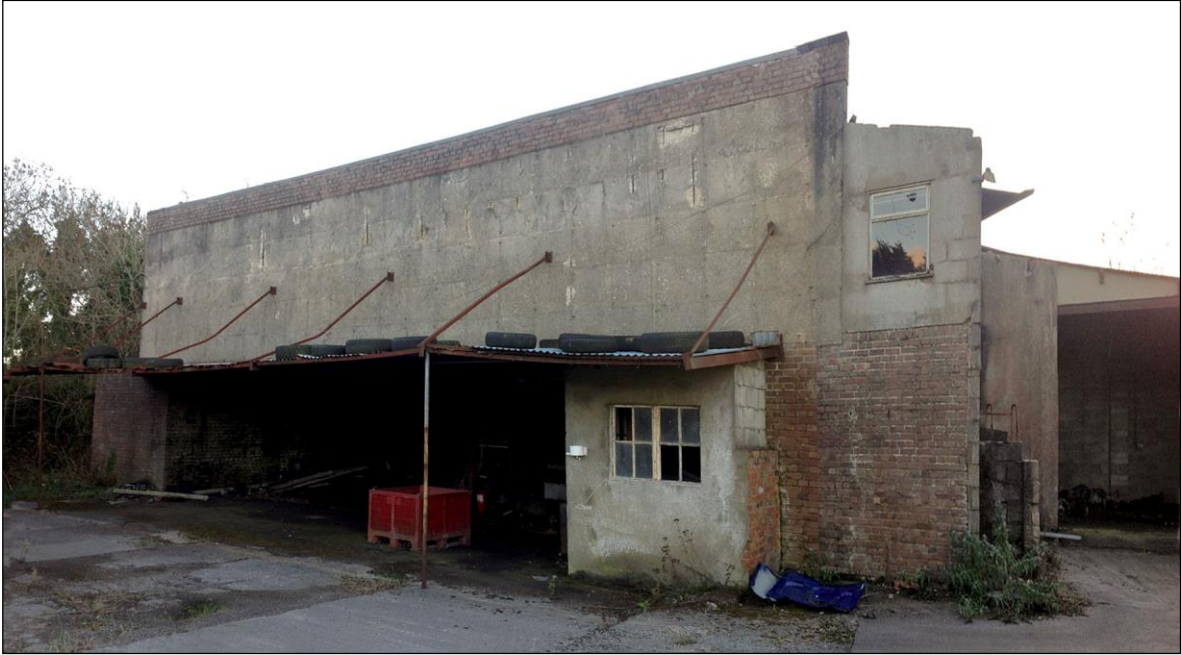
| <b>Condition</b> | Converted |
| <b>Condition rating</b> | Converted |

*Plate 157: Northeast facing elevation of the Aircraft MG Test Butts.*

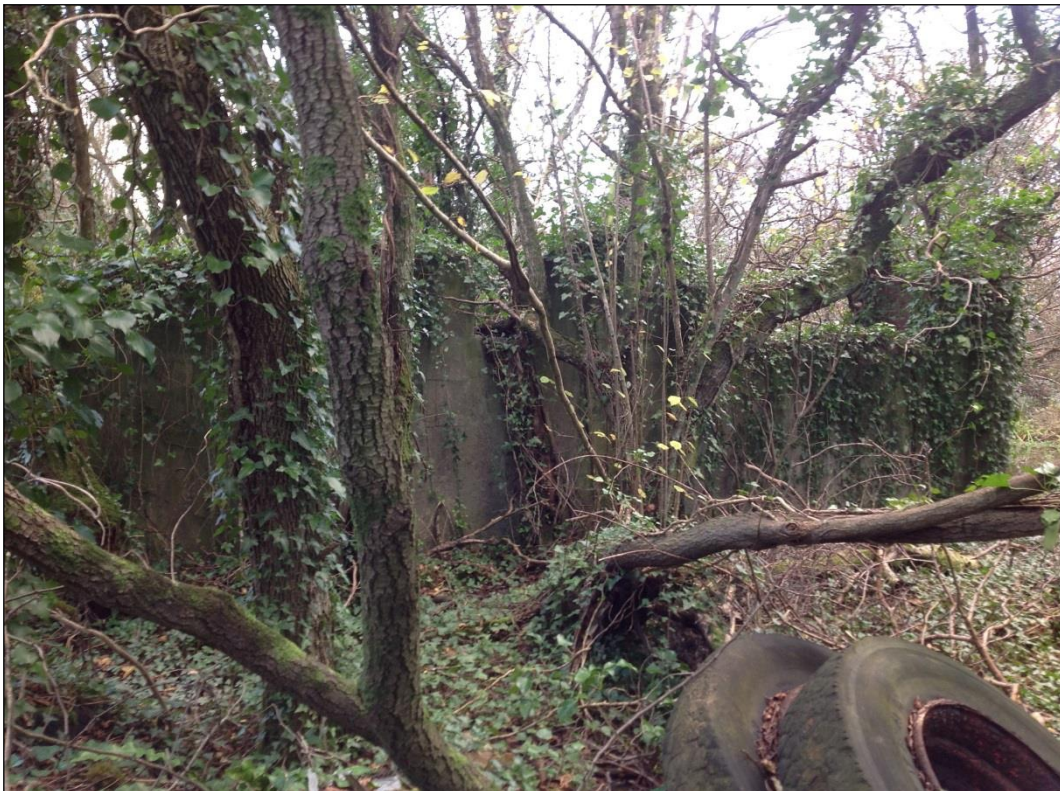
| <b>Condition</b> | Near Destroyed |
| <b>Condition rating</b> | Destroyed |

*Plate 159: All that remains of the latrine block is this east facing wall.*

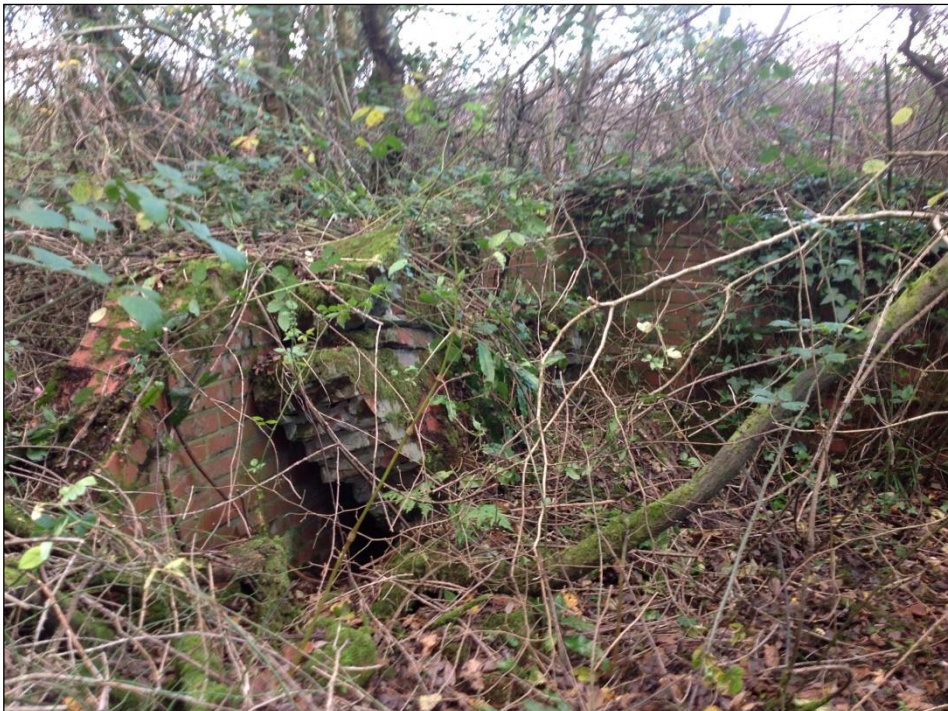
| <b>Condition</b> | Near Destroyed |
| <b>Condition rating</b> | Damaged |

*Plate 160: The northwest facing entrance to the blast shelter.*

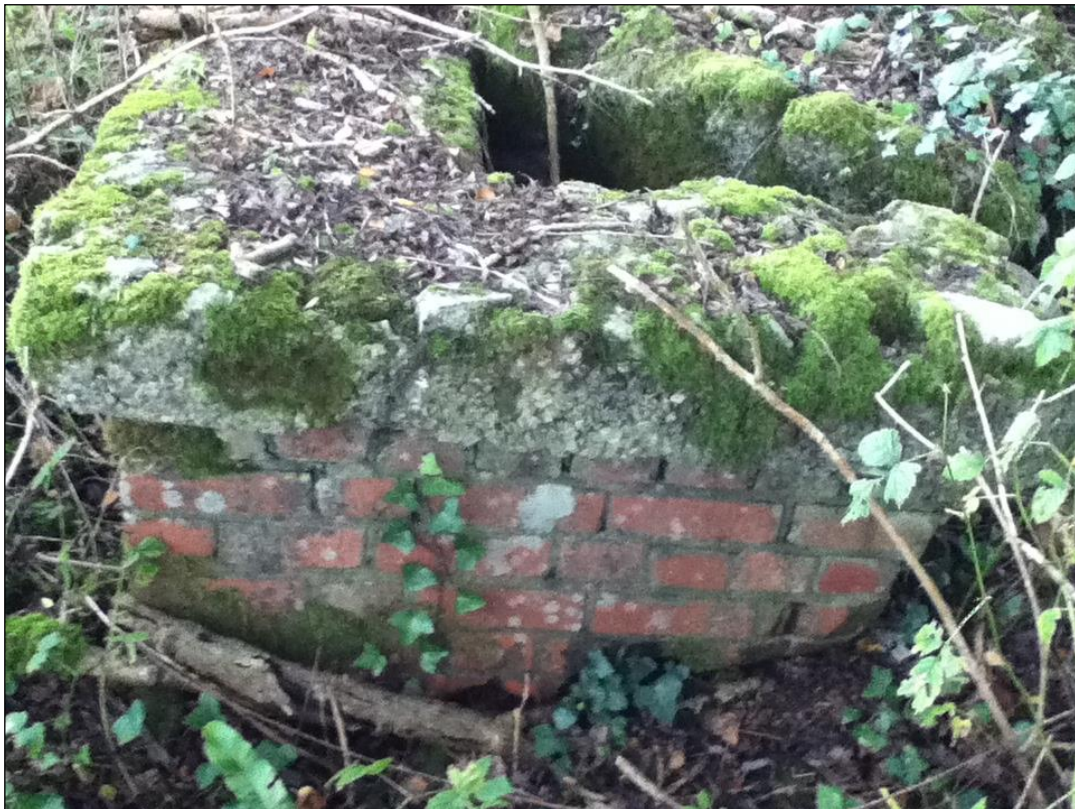
| <b>Condition</b> | Destroyed |
| <b>Condition rating</b> | Destroyed |

*Plate 161: Remains of a corner of a building*
