# **MEDIEVAL AND EARLY POST-MEDIEVAL CHURCHES AND CHAPELS**

**A THREAT-RELATED ASSESSMENT 2010-11**

Prepared by Dyfed Archaeological Trust  
For Cadw

RHIF YR ADRODDIAD / REPORT NO. 100039  
RHIF Y PROSIECT / PROJECT RECORD NO. 2010/47

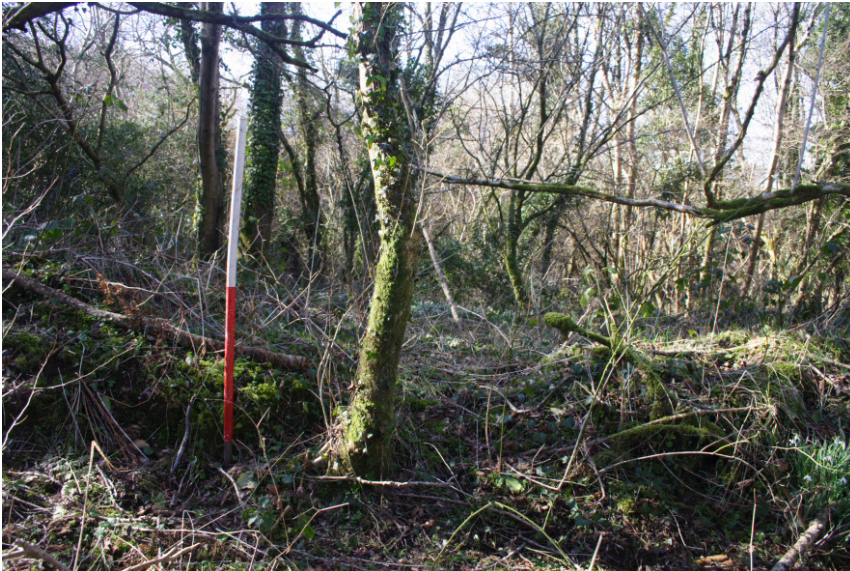
The site of the chapel was visited during the Churches and Chapels project, 2011. It lies within a fenced-off area of woodland that is very overgrown with brambles. Earthworks were recorded on an area of relatively levelled ground above a stream. The full extent and accurate form of the earthworks were difficult to determine, partially due to the indistinct and incomplete nature of the site itself and also because of the ground-covering vegetation. The best preserved earthwork runs north-south, alongside a possible trackway to the east. This stands some 0.40 metres high and stone courses are revealed within its length of some 12 metres. There appears to be a possible entranceway within this earthwork and it may be part of an enclosure around the chapel to the west, where. very slight earthworks were recorded as comprising a square some 6x6 metres, sat on a levelled platform. The farmer informed me that an excavation of the site, some 30 years or so ago, by Aberystwyth University revealed nothing.

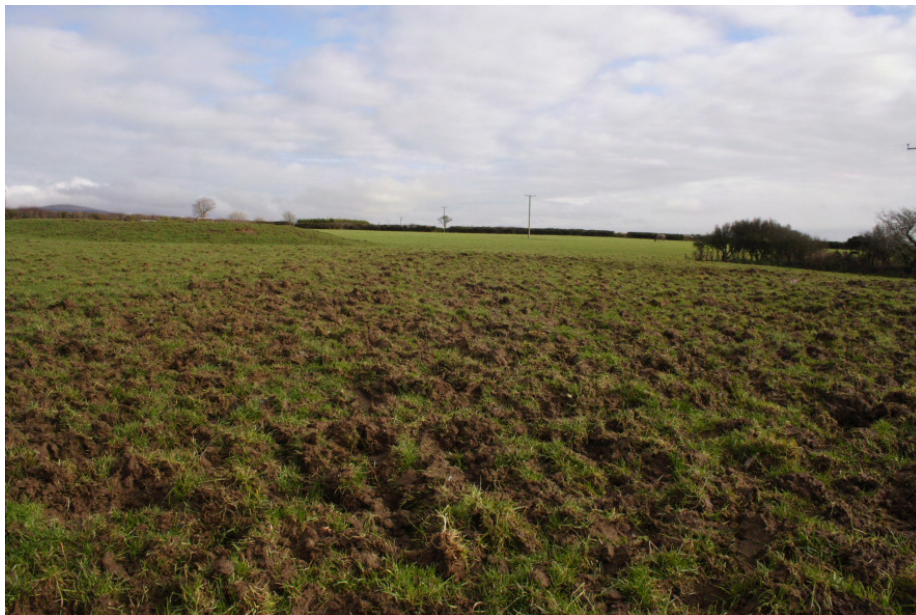
The site comprises a rectilinear enclosure delineated by low earthwork banks that are clearly discernible on the ground. The enclosed area has a high frequency of stones and slate fragments. The site lies within a pasture field and there are no surviving upstanding remains of the former chapel.

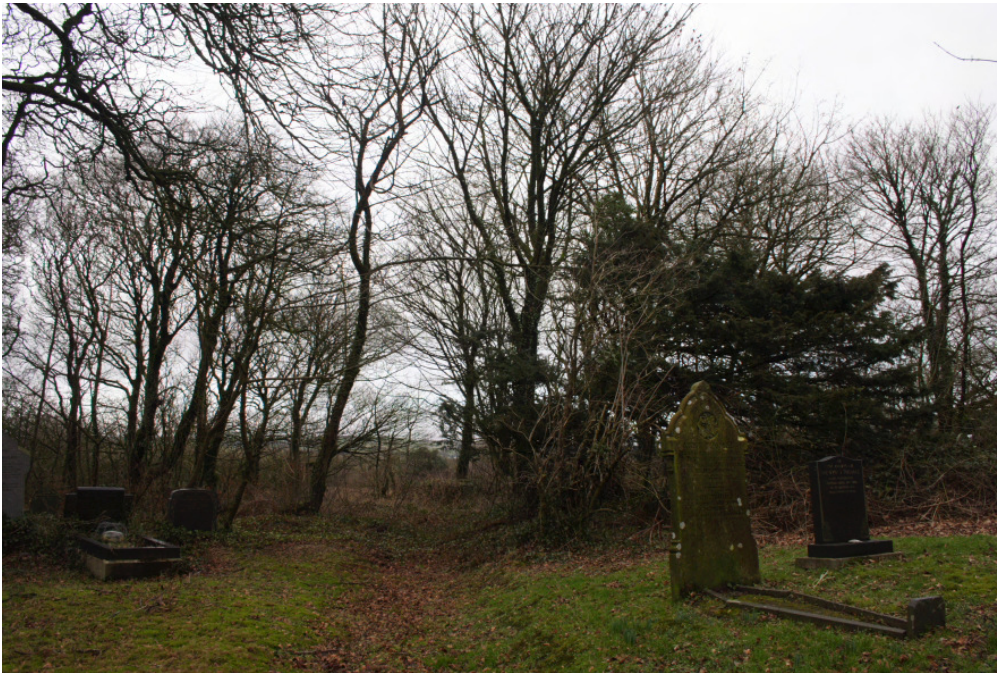
The church is a roofless shell with all the walls standing to a height of just over a metre. There is no evidence for stone tumble or any roofing material, indicating that the walls were reduced for the site to be managed as a ruin. The wall tops are capped with concrete. The chancel arch is now only marked by an internal buttress. Within the chancel there is a stone cross carved in relief on the east wall, a window recess on the southern wall and a small stone shelf in the northeast corner. At the western end of the church is the stone base of the former tower. The church sits within a graveyard, with early 20th century graves to the north of the building and 19<sup>th</sup> century graves to the west. The area just within the churchyard gate appears to still be tended and there are more recent headstones, the latest dated 1979.

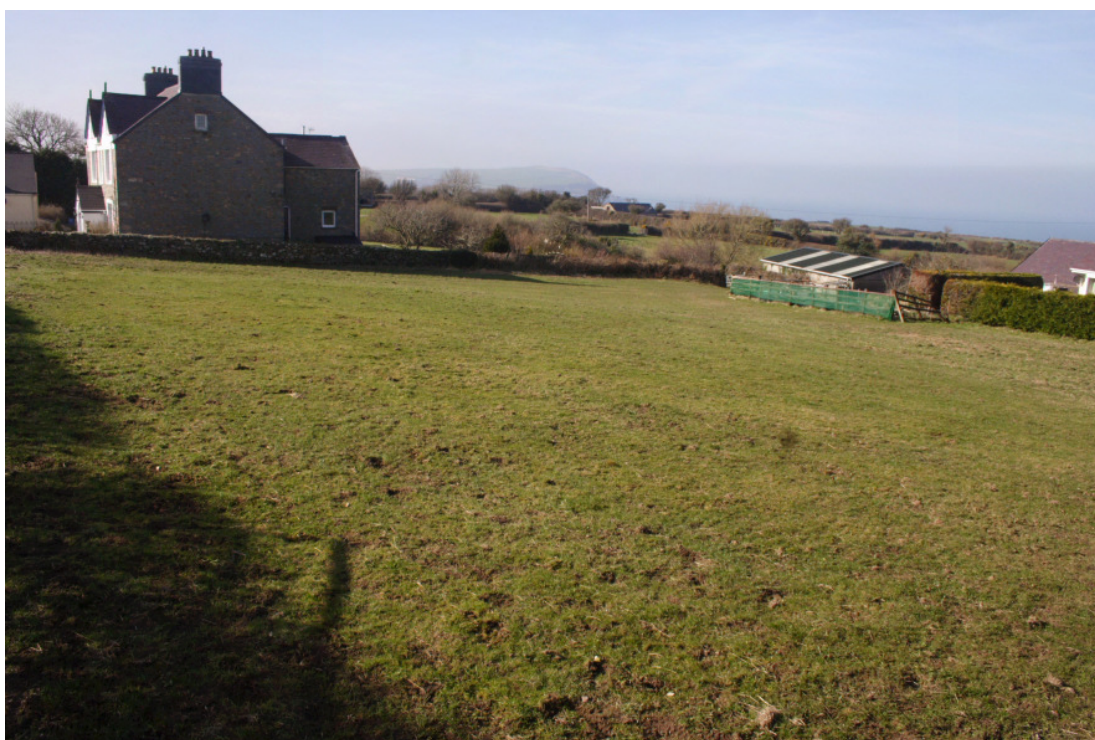
In 2011 no sign of earthworks were seen at the recorded location within a field currently under pasture. The field slopes gently up towards the southeast. Apart from a few small fragments of slate, no building material was apparent within the field.

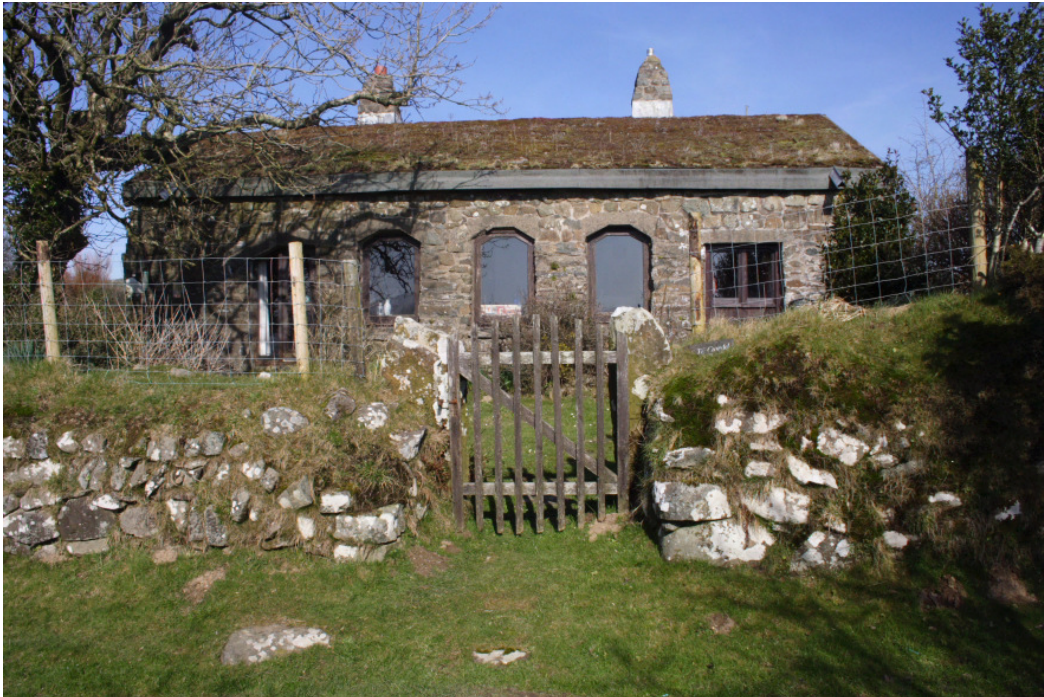
A domestic building is now on the site, on the same footprint as the chapel. It wasn't apparent whether any of the chapel survived within the fabric of the new building and the owners were absent. The substantial stone wall that now comprises the boundary to the front garden may possibly survive from the former churchyard and further remnants of wall were noted to the southwest and northeast of the current building.

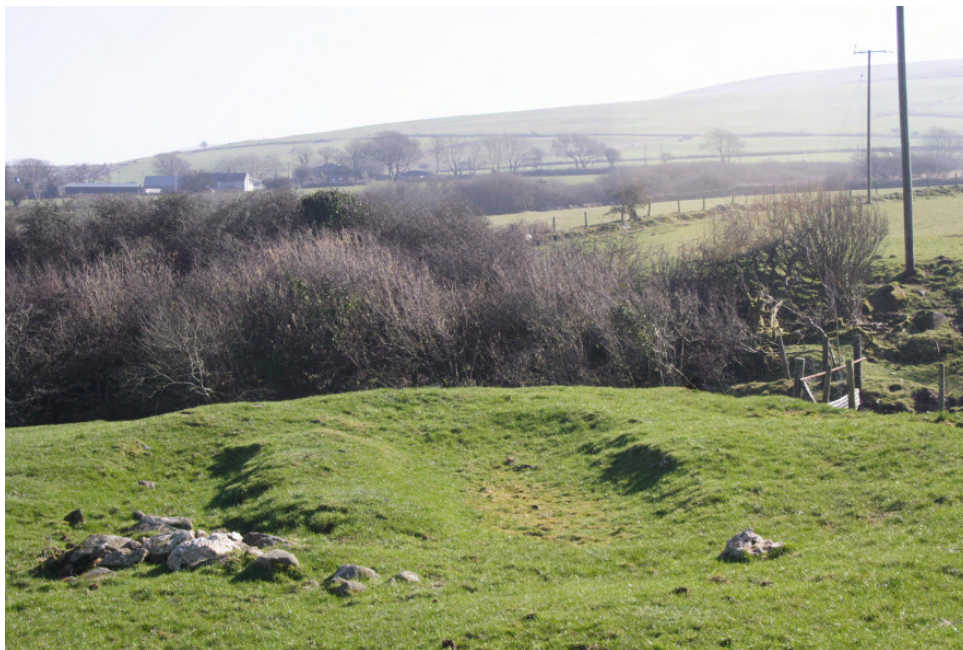
The site now comprises a rectilinear area of earthworks aligned east-west and measuring approximately 16 x 10 metres. Mainly covered with grass, there are also numerous exposed stones particularly at the northwest corner. A stream runs north-south close to the eastern edge of the site

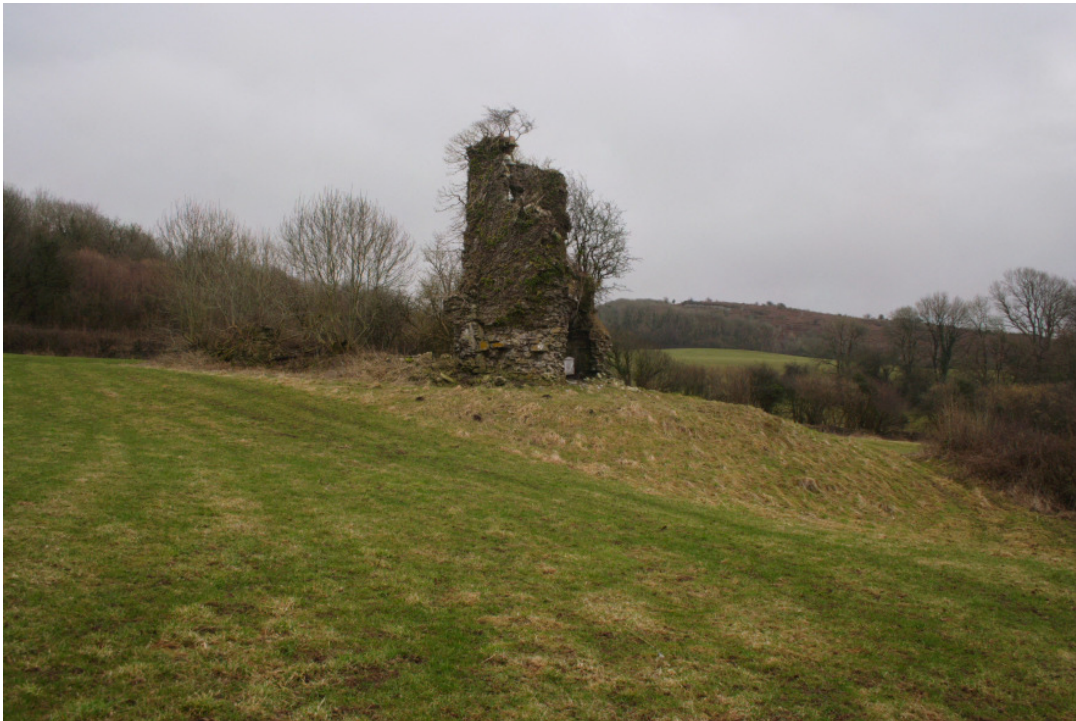
It now (2011) consists of substantial standing remains of a medieval chapelry to Llandyfaelog parish (now in Llangendeirne parish), comprising a chancel, nave and tower, situated on a raised platform and orientated E to W. The condition of the church as ruinous was recorded by R. E. Kay (DRF) in his notebooks at the end of the 19th century. The tower still stands to around 4m, but is covered in ivy and scrub and has clearly deteriorated since Kay's recordings. The walls of the nave and chancel are around 1m high, but are also covered in vegetation. The interior of the church has been used to dump old farm equipment.

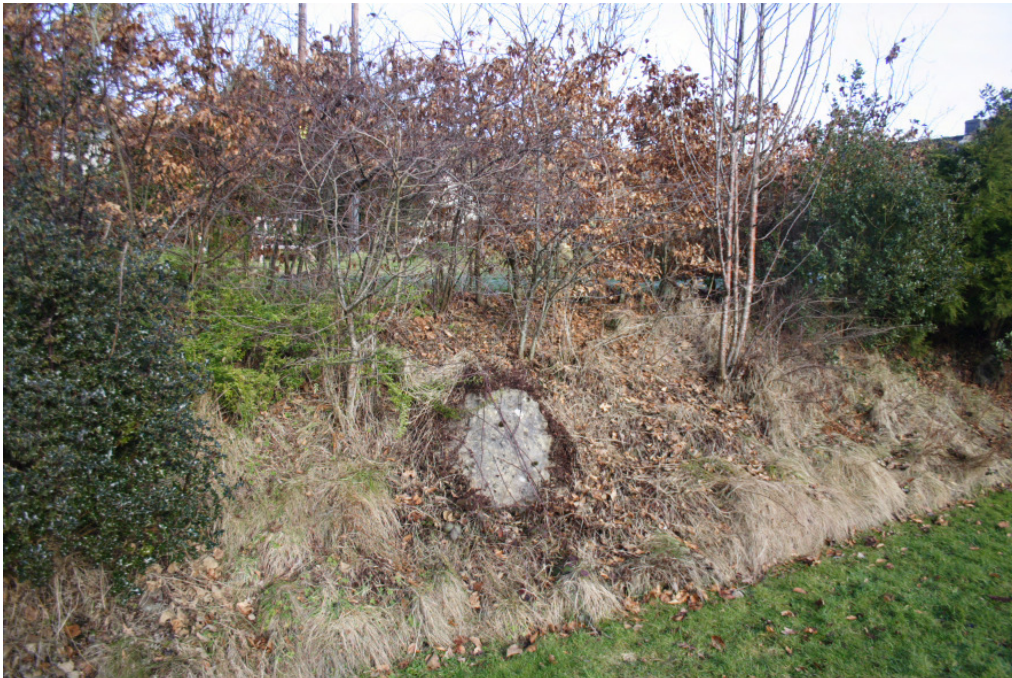
Site visit in 2011 revealed no upstanding remains visible - the area marked on the OS 1st ed is now a house and garden.

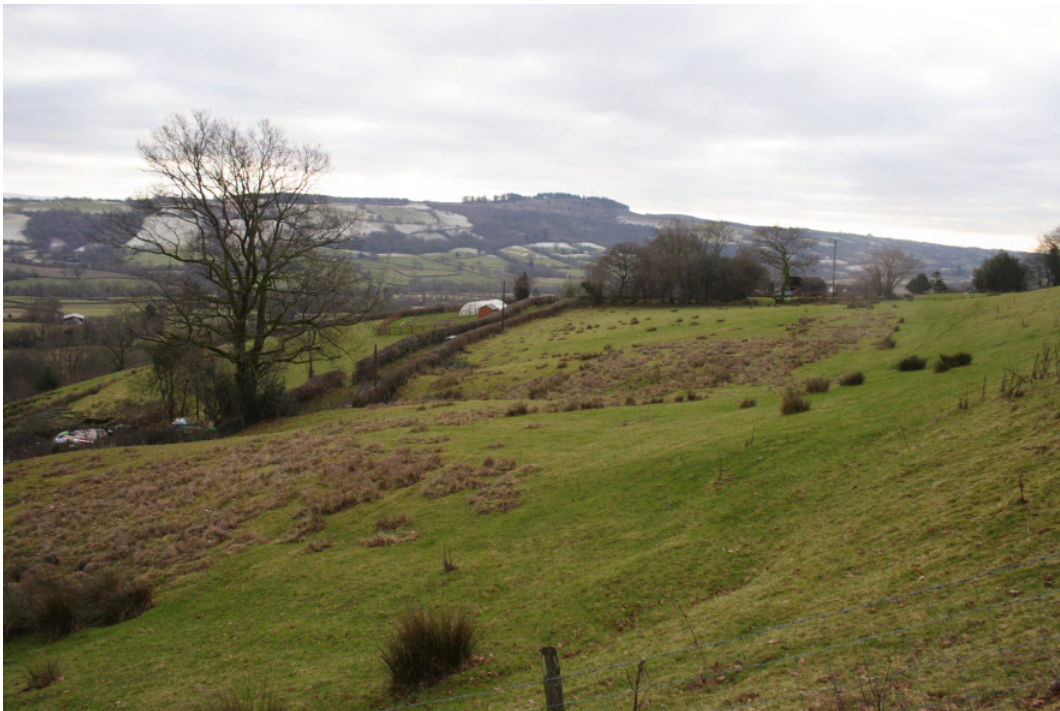
The field-name 'Mynwent Capel Llanfihangel' represents the site of the medieval Capel Mihangel, which was a grange-chapel to Talley Abbey, belonging to Cefn-blaidd Grange (Richards 1974, 113), and was mentioned in a mid 18th century list when it was 'ruinated' (Price 1879, 165). It stood near Ty Hewell Farm (RCAHM 1917, 264) on the slopes of Mynydd Cynros, from which it received its alternative name 'Llanfihangel Cynros' (Richards 1974, 113). Site visit in 2011 showed that no trace of this chapel survives above ground, although a few small 'shaped' stones may be the remains of the masonry. Presumably the cottage Ty-Hywel is constructed from the stonework of the chapel. The chapel is located in a steep sided valley, but there are 3 places where the slope levels out and one of these were probably the location of the building and graveyard.

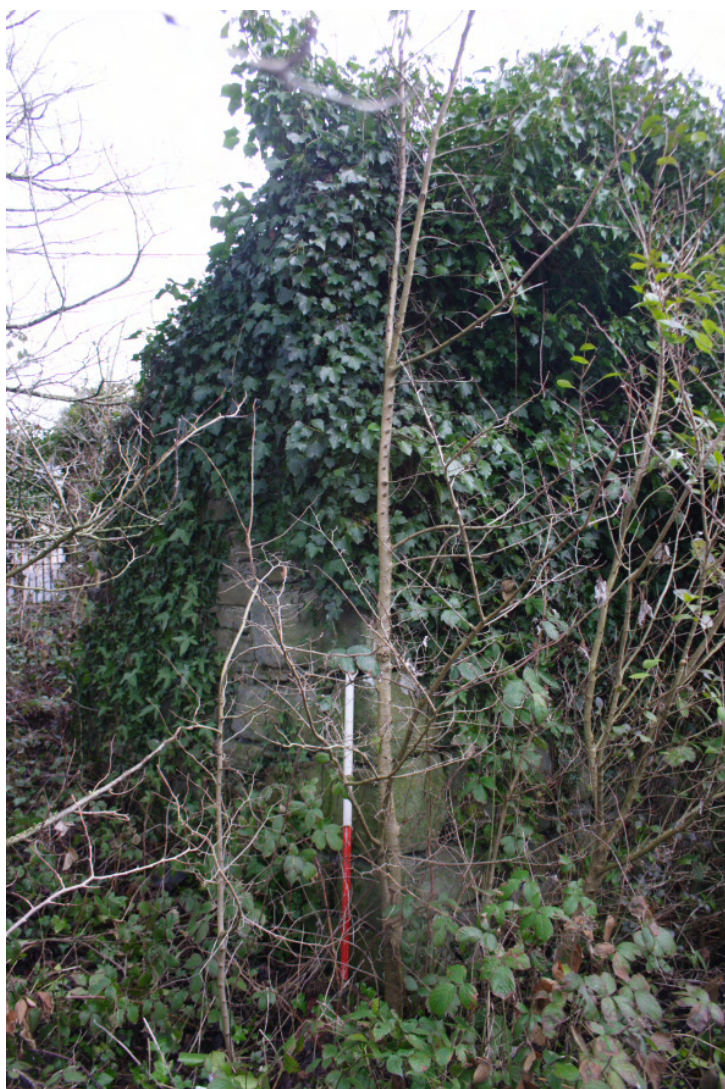
A medieval chapel-of-ease to Llanelli parish, ruinous by 1833 (Lewis 1833), whose remains still survive in Llwynhendy, on the opposite side of the B4297 to the de novo St Davids Church (PRN 7276) by which it was superseded it in the mid 19th century (RCAHM 1917, 119 no.347). Part of the west and south walls of the nave survive and are believed to date from the 12th or 13th century, the rest of the structure is believed to survive under the road. The chapel had burial rights and was associated with a cemetery A local resident stated that a churchyard was located next to the chapel and that school children dug up bones from the site. A gravestone was also dug up from a neighbouring garden. It was dedicated to the 'Celtic' St David, but was probably a late medieval foundation (Yates 1973, 57-8) there is no current evidence for an early medieval date. The remains of the chapel, and the area between it and Llwynhendy Road, are a scheduled ancient monument.

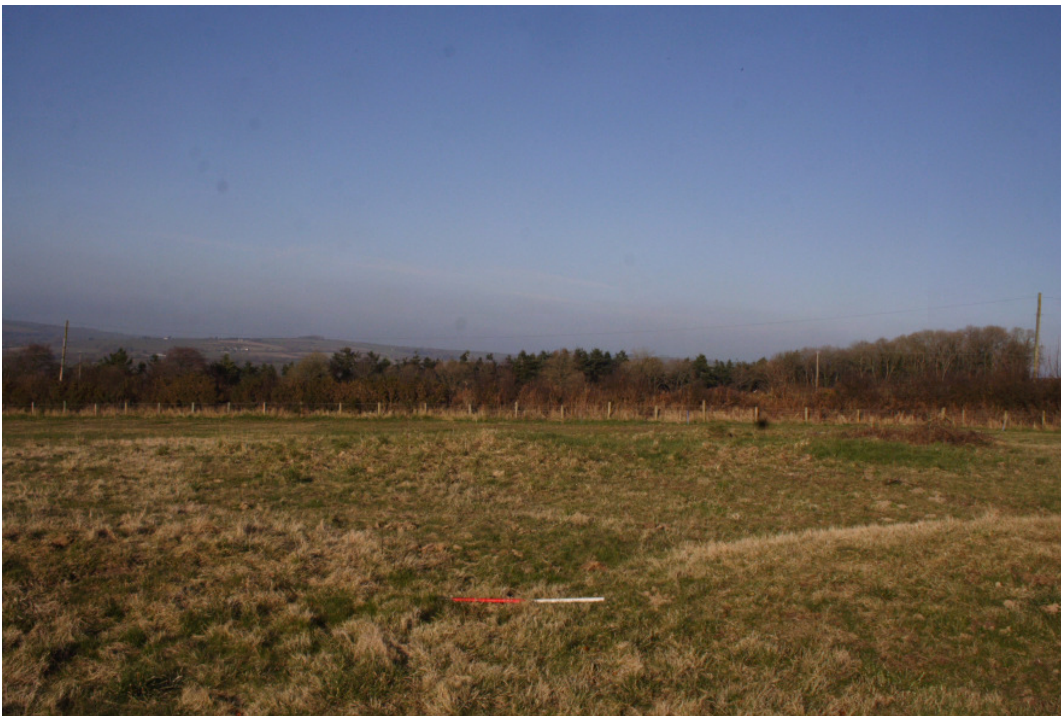
The owners informed me that there is a well in the field on the other side of the lane, associated with the subterranean watercourse that runs north-south just to the east of the site.

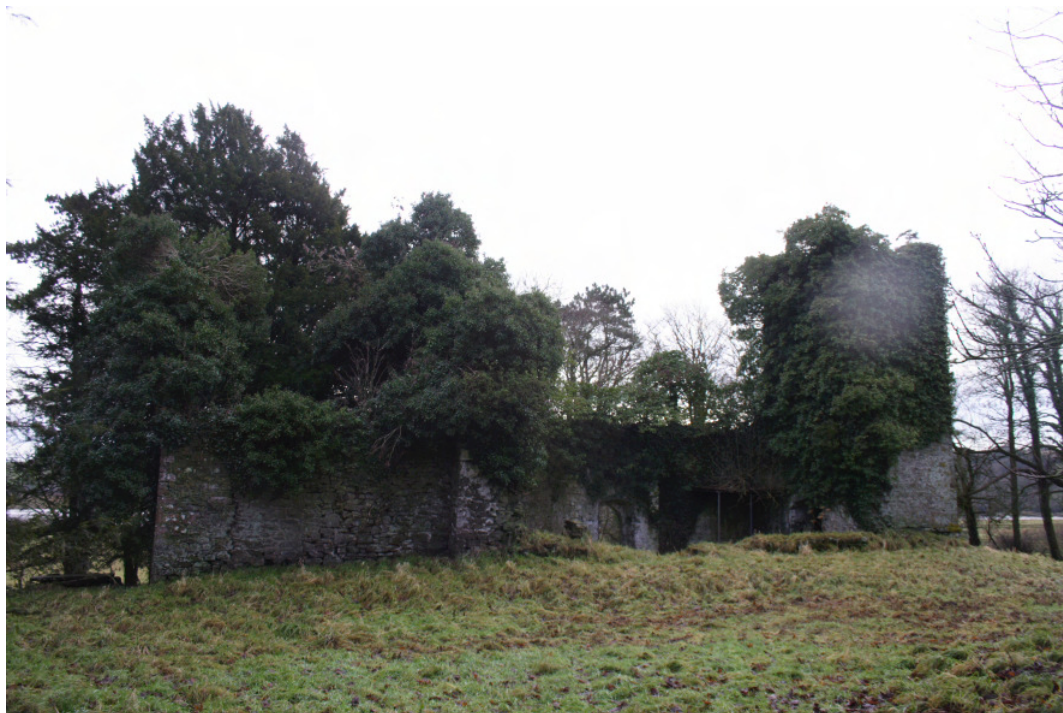
Small medieval parish church comprising chancel, nave and west tower, standing in a large rectangular earthwork enclosure. There is an entrance in the south wall and west wall (into the tower). The south and east walls still exist to roof height, but the north wall is only around 1m high. A modern concrete structure exists in the SW corner of the nave and may be where current services take place. The church appears terraced into the slope. A mound of material abutts the north wall, presumably the collapse from that wall.

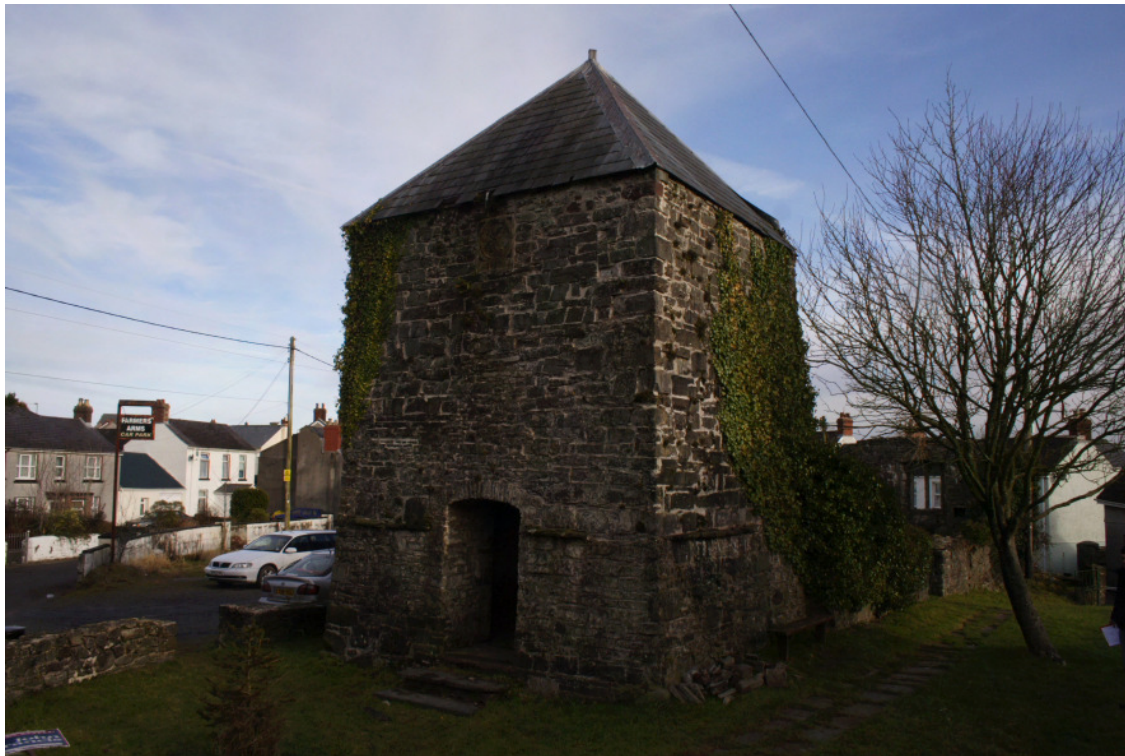
Former chapel-of-ease to Llanstephan parish which became disused in the mid 20th century and is now ruinous. The remains are scheduled. Site visit in 2011 showed that it comprises a chancel and nave with a roofed tower at the western end. The N and S walls stand to about 1m, but the E gable end is much more substantial, surviving to roof height.

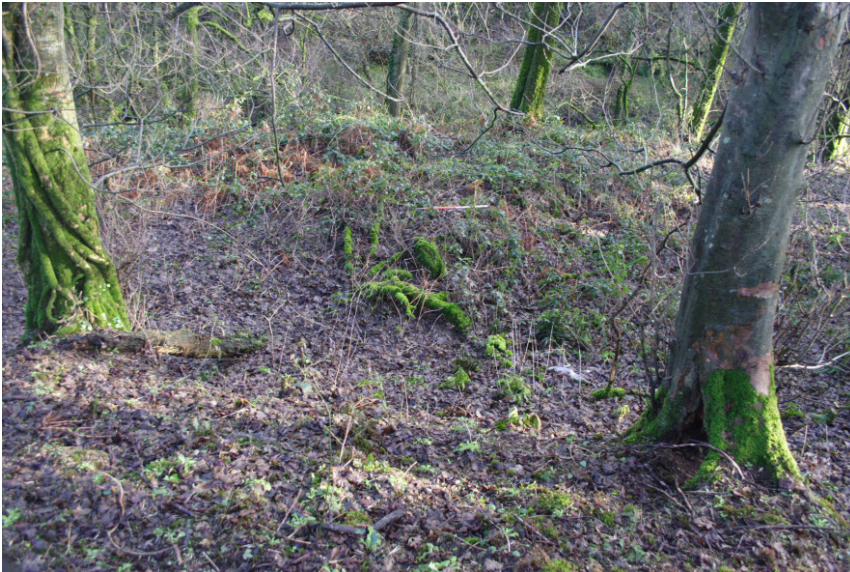
Site of undated (medieval?) chapel, represented by rectangular platform and place-name 'Old Chapel'. The site comprises a relatively level, rectangular platform cut into a steep, north-facing, wooded slope, accessed by a pathway to the northwest. No remnant of the chapel building was evident, although two substantial stones were noted in the centre of the platform

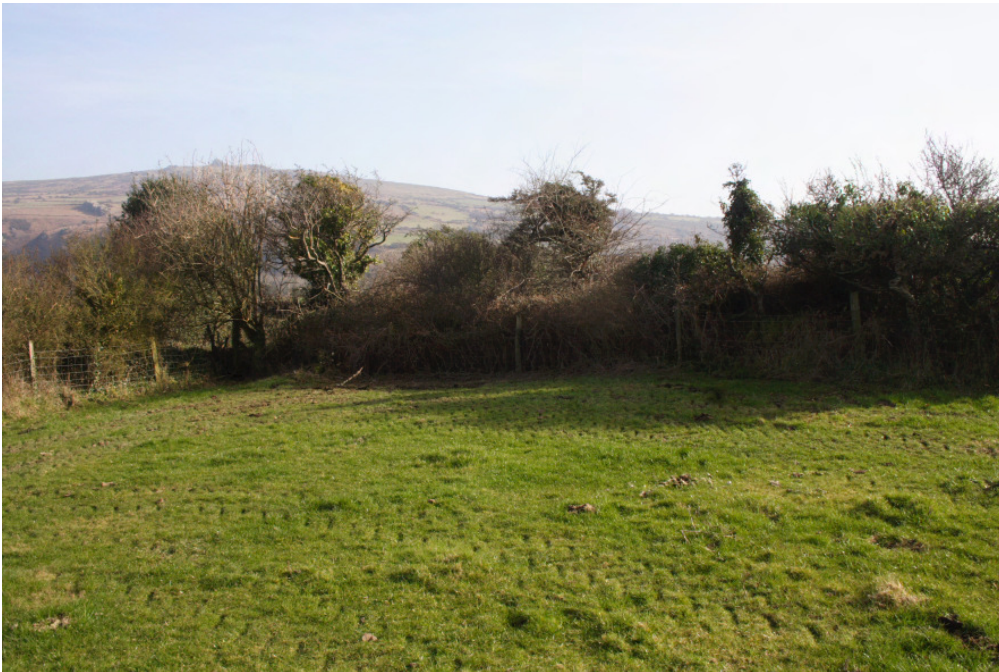
In 2011, no evidence was found for earthworks or building materials at the recorded location of the chapel. The field is under pasture and slopes down towards the east. The owner of Garn Farm believes that the actual location of the chapel was just to the north, on the other side of the adjacent lane, from where stone is thought to have been taken to build the farmstead (now ruined) opposite.

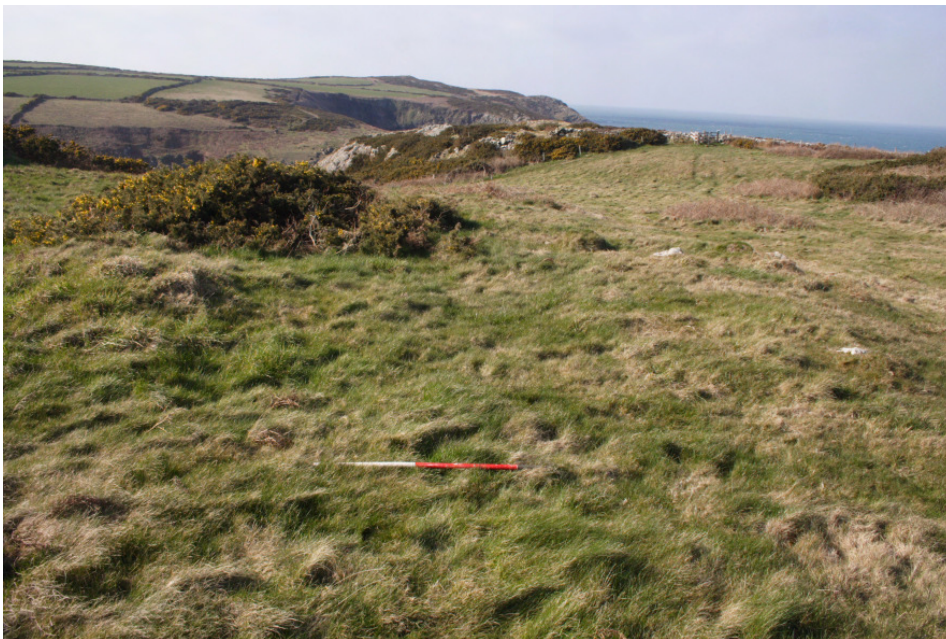
A site visit in 2011 revealed no structural remains, but possible earthworks were recorded, although they were indistinct and partially obscured by extensive gorse. A local resident believes that stone from the site was taken to build one of the nearby cottages.

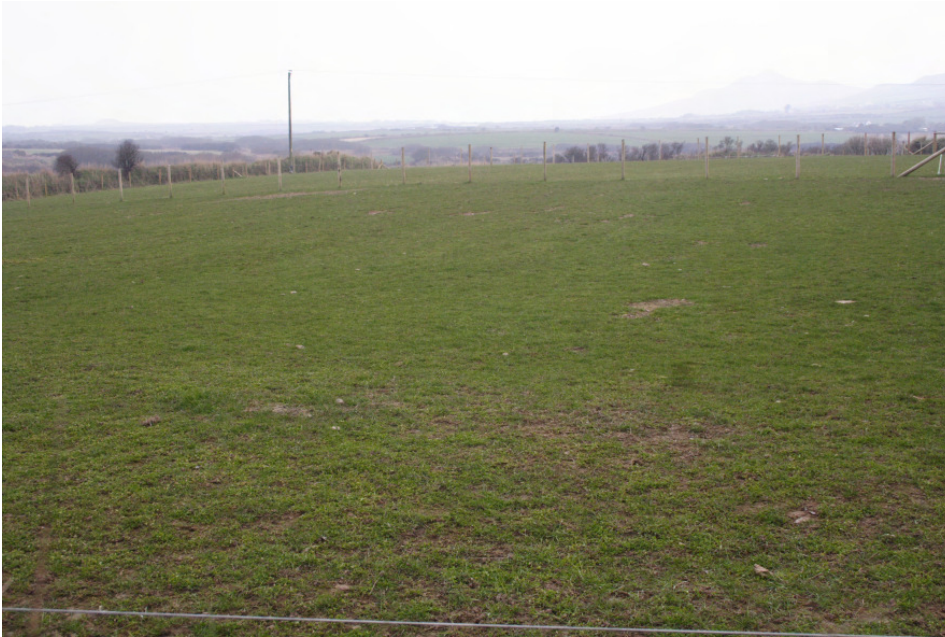
The site is now (20110) a generally flat field under short grass and there are no structural remains. Earthworks could be discerned, although they were very slight, forming a possible rectilinear enclosure. Local residents informed me that the stone font from the site had been removed to St Non's.

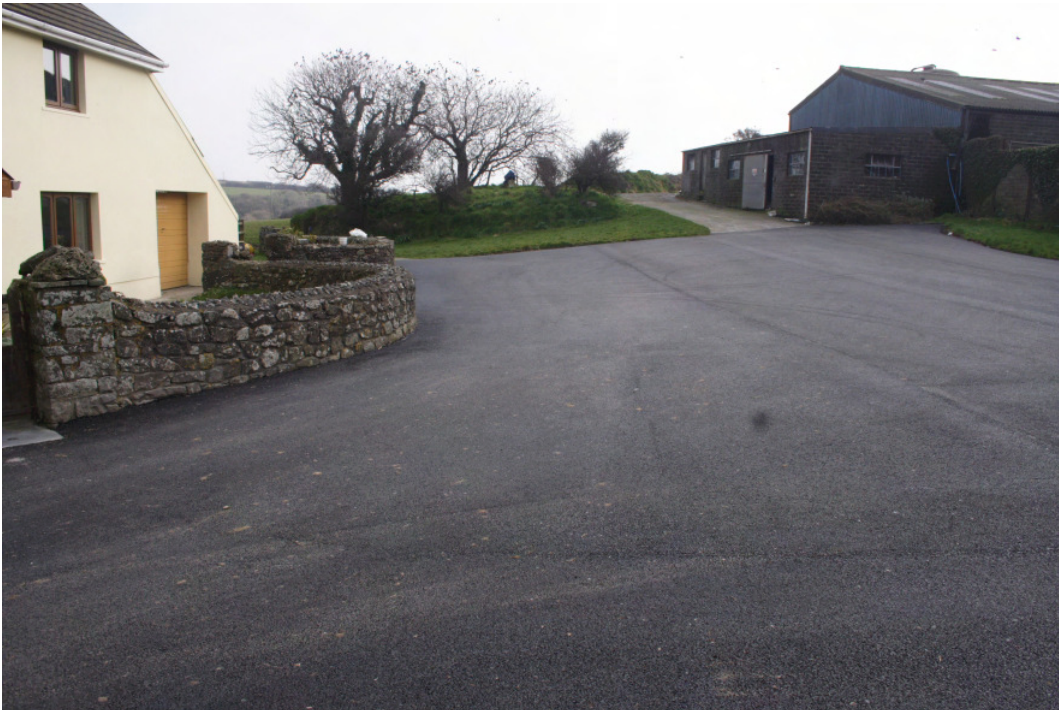
The recorded site of this chapel is based on its location on historic Ordnance Survey maps where it is shown located immediately south of the farmhouse and to the east of an L-shaped complex of farm buildings. These buildings all still stand (2011) but the area of the chapel is now a tarmacked driveway / courtyard.

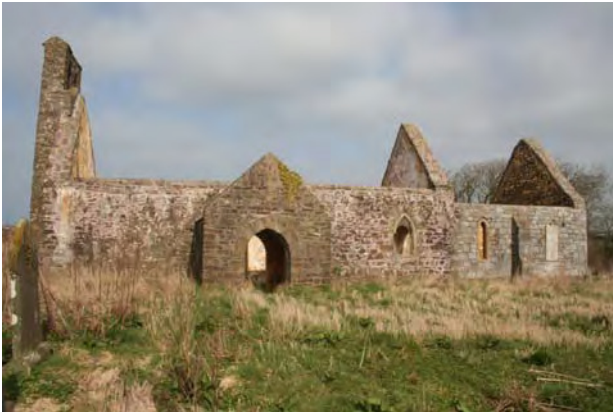
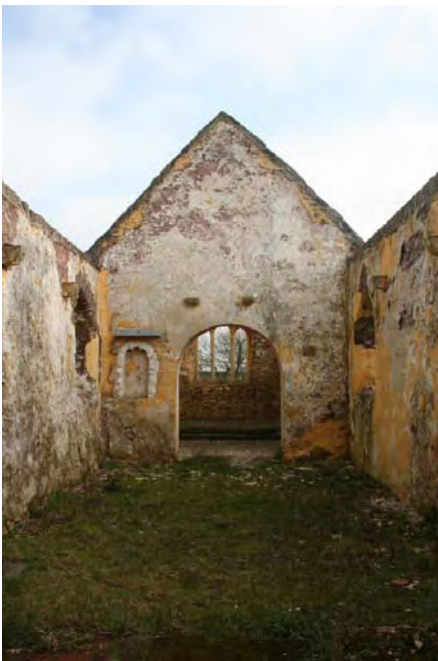
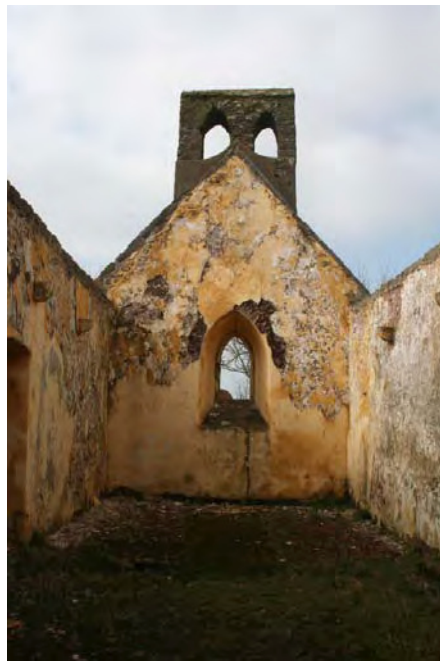
Medieval parish church listed in Taxatio of 1291. It is located in a small, square churchyard next to a farm. It consists of a nave, chancel and south porch with a west bellcote. It is roofless and conserved as a ruin. The nave and chancel arch are late medieval, but the chancel dates from the restoration of 1874.

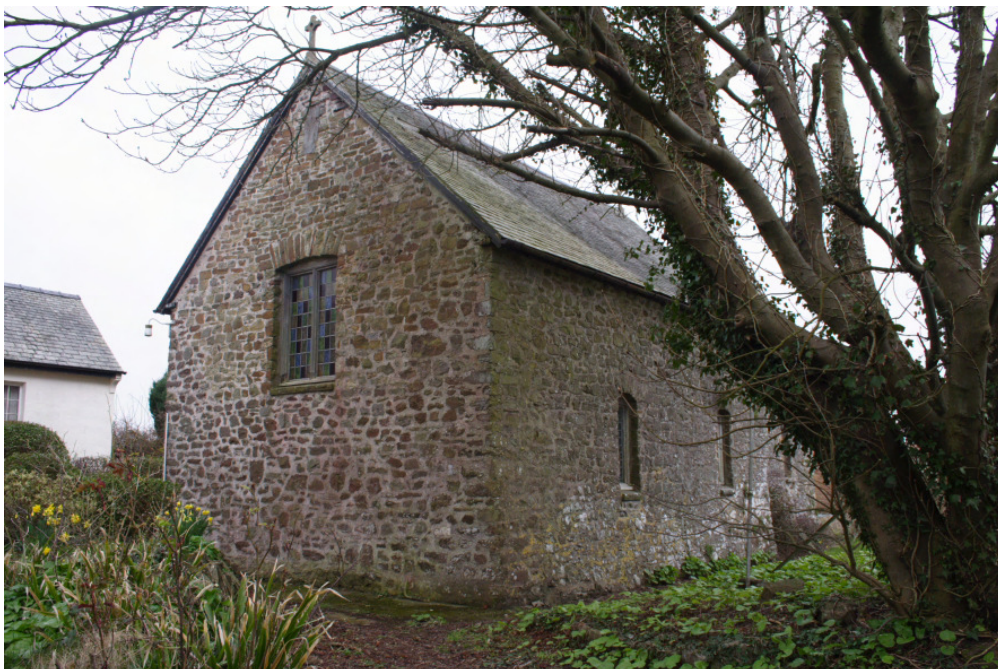
A medieval chapel in Steynton parish (now in Milford Haven parish). It was founded in the 13th century as a chapel to Pill Priory. It was disused by the early 19th century and ruinous. It had burial rites and the boundary of the ancient cemetery was visible in the early 19th century. It was restored in 1930-01, but much of the fabric is medieval. It consists of a small nave and chancel, both vaulted. In 2011, it was recorded as being well maintained and located in the garden of a house. The dedication of this chapel is a little confused, some authorities having it as St Catherine, others as St Thomas a Becket.

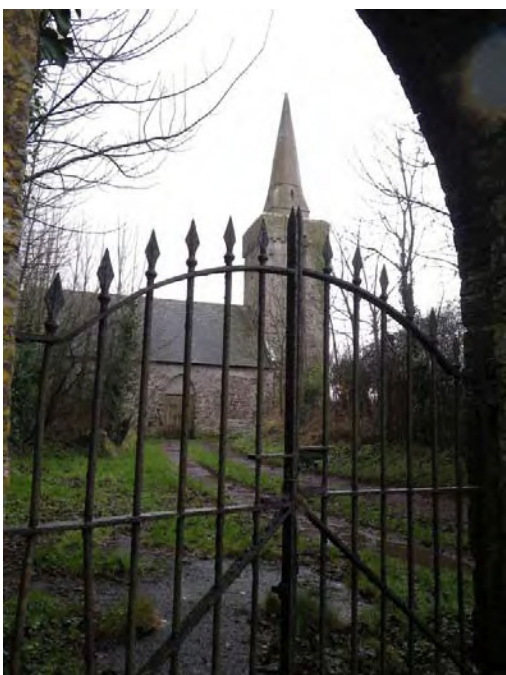
Its fabric is mostly medieval, and comprises a chancel, nave and west tower. It has vaulted roofs. The windows are now covered with zinc sheets, guttering is missing, ivy is growing up the walls and the over part of the lightning conductor has been removed.

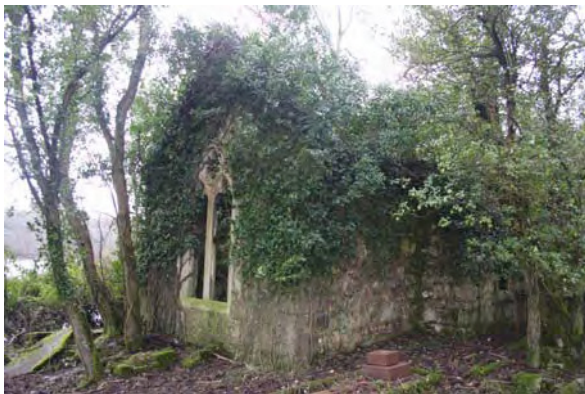
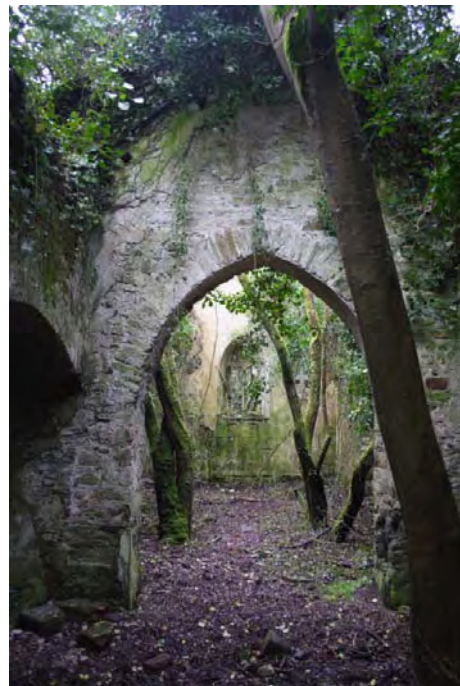
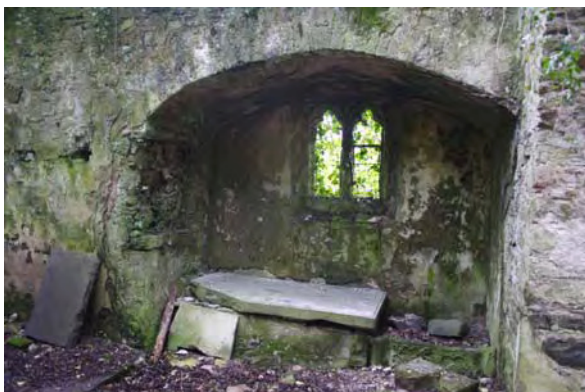
A field visit to the site during the Churches and Chapels project (2011) observed the building to be within a wooded churchyard fenced off from the pasture field to the north and located on a large, raised rectilinear platform above the Hook Reach. There are two, opposite arched doorways in the north and south walls of the nave and window apertures in the north, south and west walls. Stone steps in the southeast corner of the nave indicate the position of the pulpit. Through the chancel arch, there are further windows in the north and south walls of the chancel, set within wide, arched recesses. The recess within the south wall has a stone box tomb in it and remnant of similar is apparent within the opposite wall. A further, smaller arched recess is located in the southeast corner of the chancel, with a remnant of carved stone column. A large twin-arched window dominates the southern gable, above a slightly raised area where the altar would have stood. The floor of the church is obscured by vegetation growth. Some stone slabs and loose masonry were apparent within the nave.

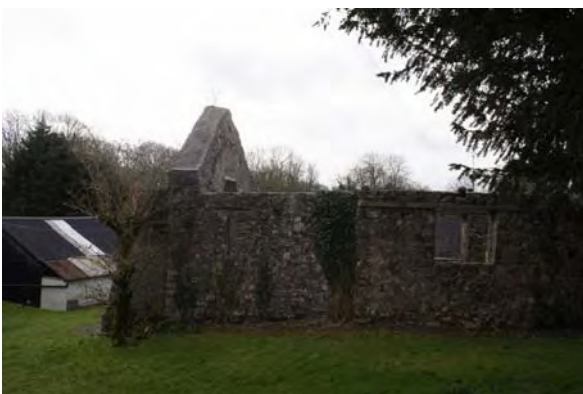
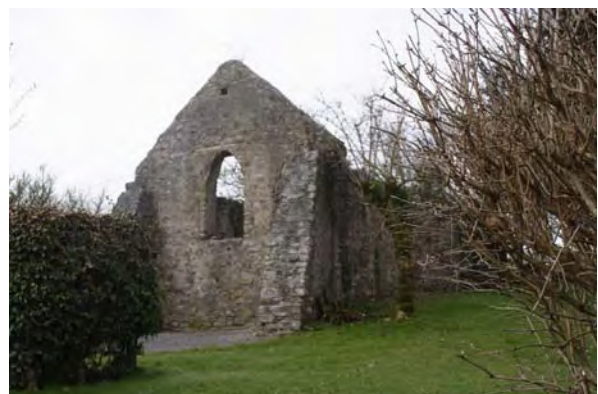
In 2011 a site visit showed it to be a simple rectangular building with a bell tower at the west end, and walls standing to their full height, but roofless. The masonry seems to be in good condition, and it stands within a private garden surrounded by lawns. Some gravestones are visible.

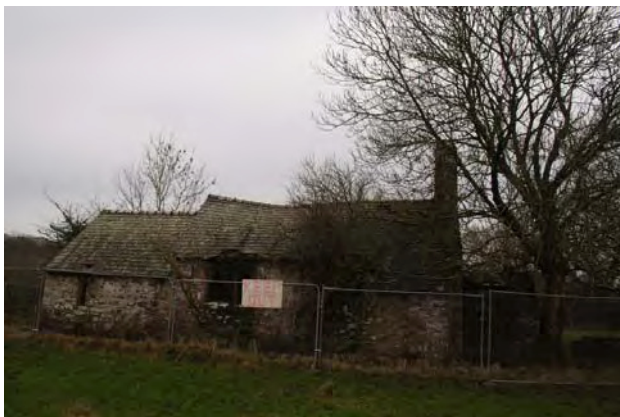
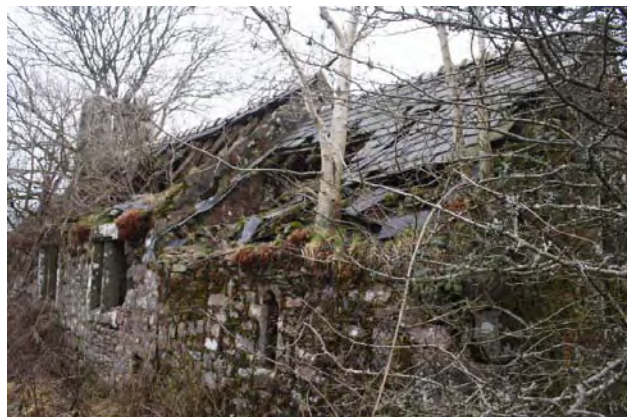
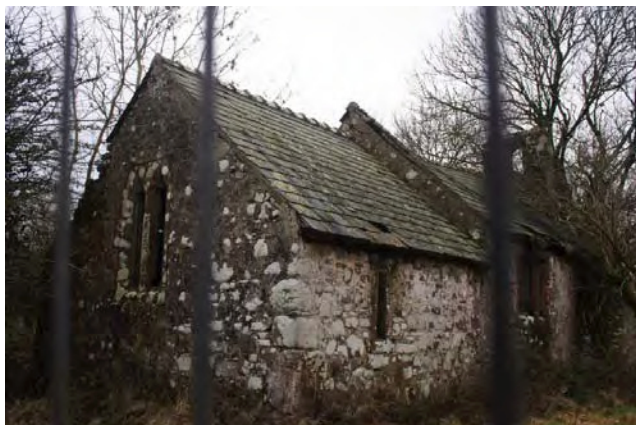
The church was visited during the Churches and Chapels project of 2011. It was encircled with high wire fencing, with notices to 'keep out' so the interior was inaccessible. The building stands within a circular pasture field on the edge of Canaston Wood. There is no attendant graveyard. It is a 2-cell building aligned east-west, comprising entrance porch, with bellcote, to the west and the chancel lower in height to the nave. A later extension has been added to the northwest corner of the nave but, without seeing it from inside, its purpose is unknown. A substantial stone plinth stands beyond the western entrance, presumably the base of a cross. The roof timbers on the southern side of the church have rotted through and collapsed, although the ridge and ridge tiles survive. The roof on the northern pitch is still intact, although bowing inward at the centre, with some slate displacement. The porch roof has collapsed and the masonry on the southwest corner has been damaged. Elsewhere, the masonry stands to full height and is generally free of vegetation. However, the exposed wall tops on the southern side have plants, including young trees, growing from them. More mature trees and a thorn bush grow close to the church, particularly to the northwest, where their branches are causing damage to the fabric of the building.

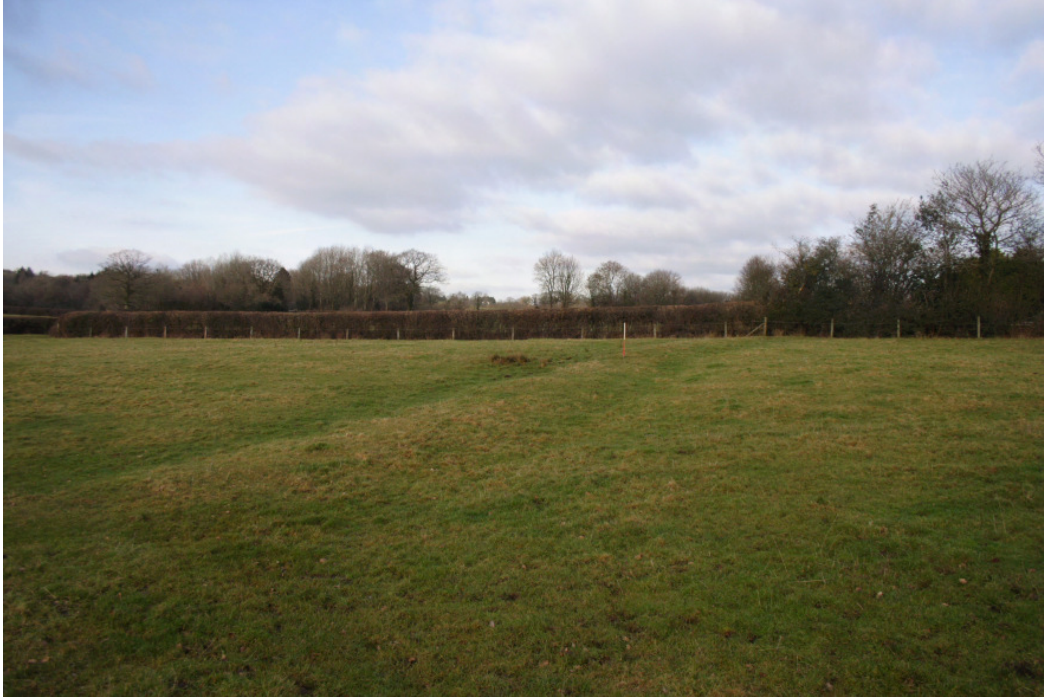
OS 1st ed. shows site of chapel in field to NW of Arfryn cottage. A site visit (2011) confirmed that no trace survives above ground. A linear earthwork, probably an old field boundary, runs SW to NE across the field. The exact location of the chapel was not clear, and there were no earthworks or masonry remains.

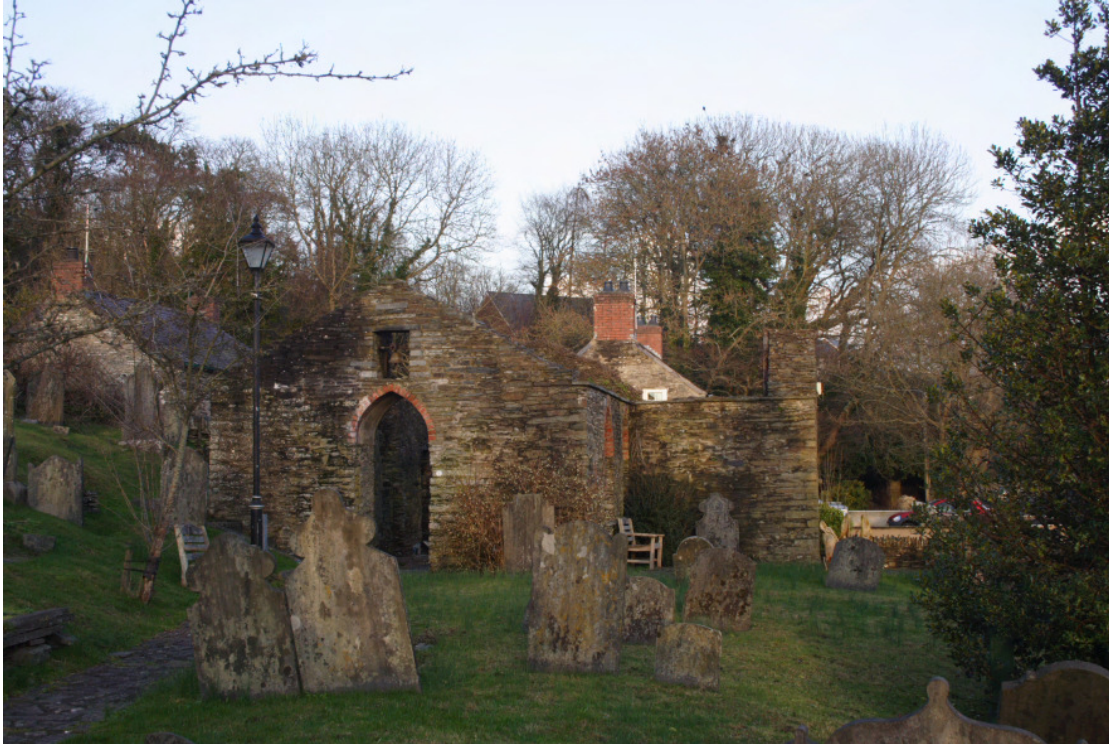
The now roofless church is aligned east-west and is built of slatestone rubble. There is a high, arched doorway, below a bell-tower, at the western end leading to a single space comprising the nave, chancel and a later south chapel. A doorway within the northern wall leads through to a vestry containing a fireplace. All internal furniture - pews and pulpit - have now gone and the floor is now of stone slabs and gravel. There is a stone slab altar on the raised platform of the chancel and a wooden cross stands on the window sill of the south chapel. Two floodlights have been placed on the floor, under the northern wall. The church sits within a rectilinear churchyard containing numerous graves.

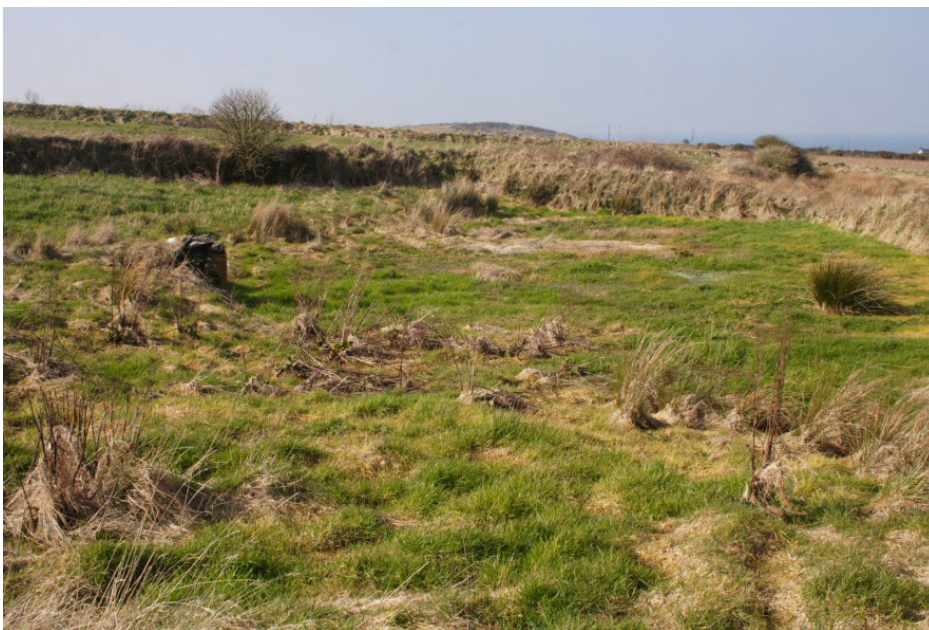
Recorded site of a well-chapel to St David's. It was ruinous by the 17th century but the associated well house (PRN 7571) survived. The site was represented by an earthwork by around 1900 and this had gone by 1925. The site is also recorded as PRN 2842. It is marked on the 1907 2nd edition Ordnance Survey map as the 'Supposed site of chapel'. The site was visited during the Churches and Chapels project of 2011 but no surface evidence for the chapel were noted. The area is under relatively long grass and slopes down towards the north, becoming increasingly waterlogged. The well survives at the edge of the marshiest area, with a stone and brick surround.
