# **MEDIEVAL AND EARLY POST-MEDIEVAL CHURCHES AND CHAPELS**

**A THREAT-RELATED ASSESSMENT 2010-11**

Prepared by Dyfed Archaeological Trust  
For Cadw

RHIF YR ADRODDIAD / REPORT NO. 100039  
RHIF Y PROSIECT / PROJECT RECORD NO. 2010/47

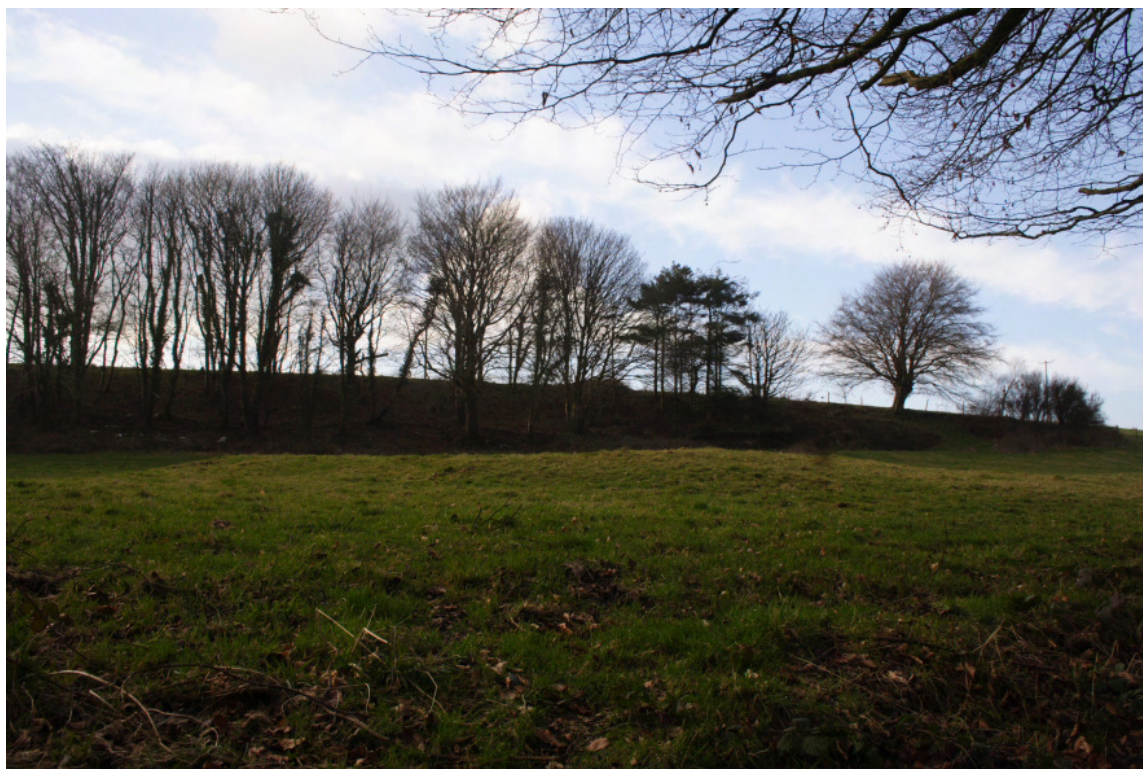
The site comprises a subrectangular earthwork platform some 16m x 14m, aligned east-west within a pasture field above a stream, which runs to the east of the site. The slopes of the platform are well defined and stand some 0.50m high and the relatively level top measures approximately 12 m x 8m. No vestige of the former chapel building was evident. A possible further platform was evident to the south of the main earthwork and it has been suggested (in 1975) that this may represent a burial enclosure. A local resident told me that the chapel was linked to the nearby Noyadd Trefawr mansion by carriageway that ran alongside the stream. Remnant of stone walling was recorded adjacent to the stream where it was believed the carriageway reached the entrance to the chapel site - marked on the modern OS10k map as a rectilinear interruption within the boundary.

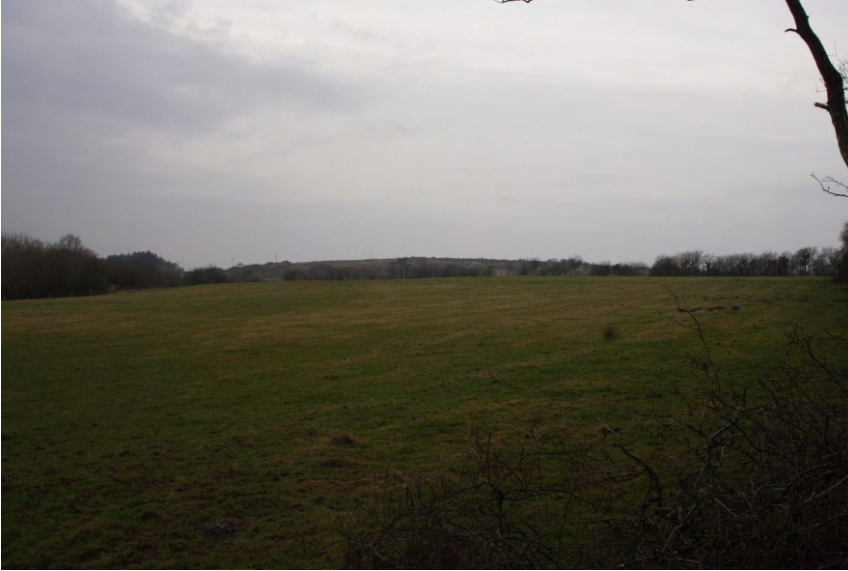
Situated near the farm with the name of 'Capel Sylen'. Only stones remain on this site. The farmer in 1983 from Pantyceln nr Capel Sylen farmhouse remembers a service held here in the ruins. The exact location of this former chapel was not clear on the ground. No stones could be located at the given coordinates.

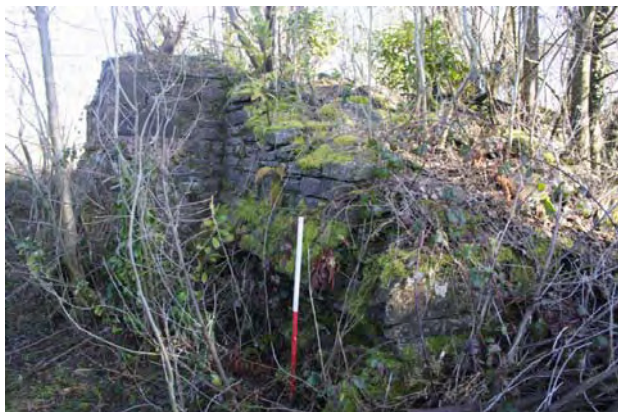
Site of a now ruined church built in 1853, and depicted on the 19th century Ordnance Survey map, to replace the medieval church (PRN 1107) on the same site. The church walls now stand to a minimum height of about a metre and the interior has been infilled with the stone demolition. This destruction has occurred since 1984, when the RCAHMW recorded the site to be complete, roofed and with interior fittings. The shaft of a medieval cross (PRN 1110) stands within the extensive, walled churchyard, which is now (2011) heavily overgrown.

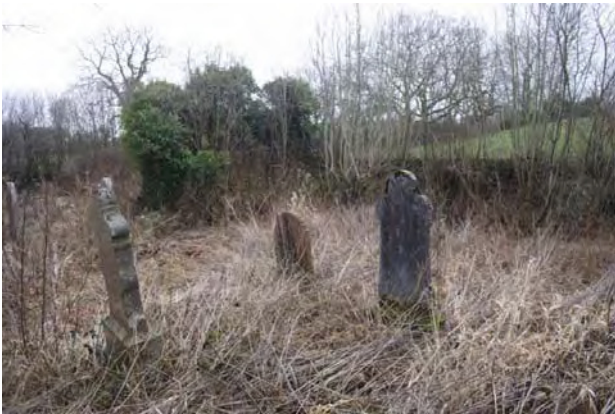
The remnant of a chapel building is located within a rectilinear churchyard that contains several in situ graves. The churchyard is bordered by a stone wall to the east and north, a stream to the south and hedgerows to the northwest and west.. Only the western end wall of the chapel survives, although this is obscured by heavy vegetation. Further masonry stands at the southwest corner and there is a wall remnant, aligned north-south, amongst piles of stone tumble that represents either part of the eastern end wall or an internal dividing wall. Piles of tumbled stones are heaped around the building remains and the churchyard is heavily overgrown.

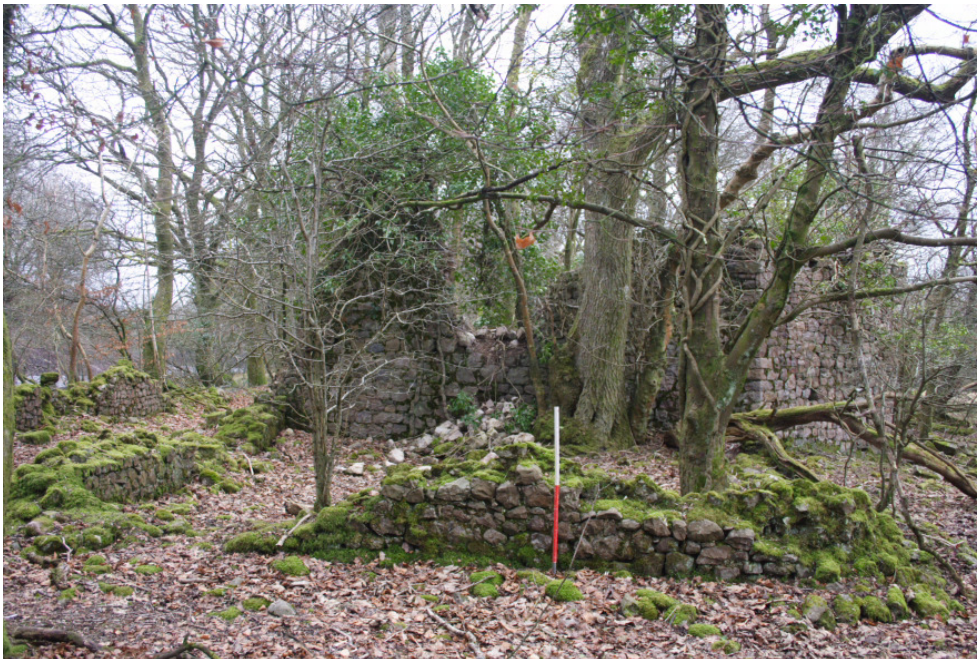
A structure, apparently known locally as a chapel, in a bad state of repair. Site visit in 2011 showed that the structure is an octagonal building around 10m in diameter. A small rectangular annexe is fixed to its north side, but there is no entrance passage between the two structures. The building is set within a rectangular stone built enclosure and sits along the line of an old droveway. The entrance to the structure is presumably on the SE side, but this is not clear due to masonry collapse. There is considerable fallen masonry within the structure and vegetation has colonised the area and is damaging the building. The owner is certain that the structure is not a chapel. It is not marked on the OS 1st or 2nd ed maps as a chapel and its shape is contrary to other chapels in the region. It is likely to be a folly or an elaborate cattle shelter - for a comparable octagonal structure see Wiliam, E. 'Hist farm buildings of Wales' (1986, fig 90). Its shape suggests it could be a large dovecote, although there are no apparent nesting holes within the interior.

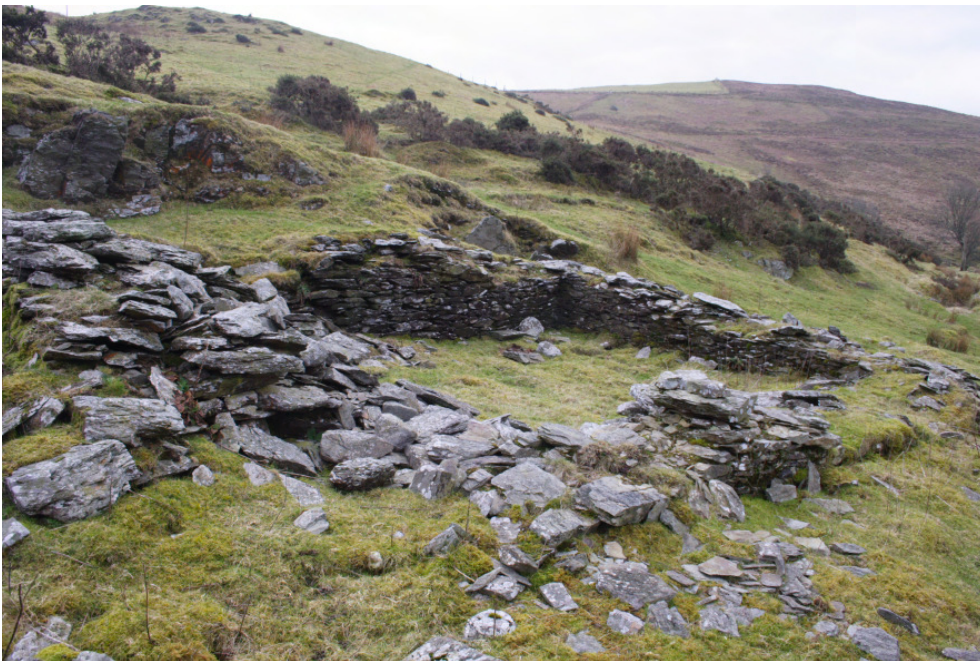
The remains of this building comprise a small rectangular (approximately 5x6 metres) structure of drystone walling set on a levelled platform into a west-facing slope. Largely destroyed, the eastern (rear) wall of the structure survives to some 15 courses, set into the bank. The footprint of the building is discernible but there is much tumble/stone piling against the northern wall. No sign of roofing material and the remaining wall heights are insufficient to ascertain window placements. There are also no obvious doorways - entrance was possibly through the, now obscured, northern end wall. Nothing in the physical remains mark them out as a chapel site and it is not labelled as such on the historic OS map. However, it is recorded by Protheroe-Jones (1993) as Sir Hugh Myddeton's Chapel - "built to serve miners in the 16<sup>th</sup> century".
