Clwyd Powys Archaeological Trust Historic Settlement Survey - Montgomeryshire

Hirnant

Introduction

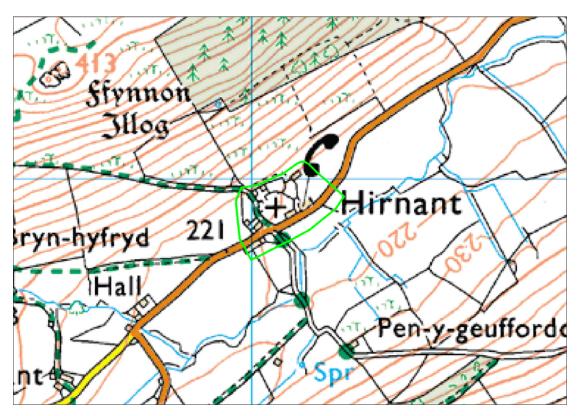
The accompanying map is offered only as an indicative guide to the historic settlement. The continuous line defining the historic core provides a visual interpretation of the area within which the settlement developed, based on our interpretation of the evidence currently to hand. It is not an immutable boundary line, and may need to be modified as new discoveries are made. The map does not show those areas or buildings that are statutorily designated, nor does it pick out those sites or features that are specifically mentioned in the text.
