BOULSTON MANOR, PEMBROKESHIRE: BUILDING RECORDING

Prepared by Dyfed Archaeological Trust
For CADW

RHIF YR ADRODDIAD / REPORT NO. 2012/27
RHIF Y PROSIECT / PROJECT RECORD NO. 102767

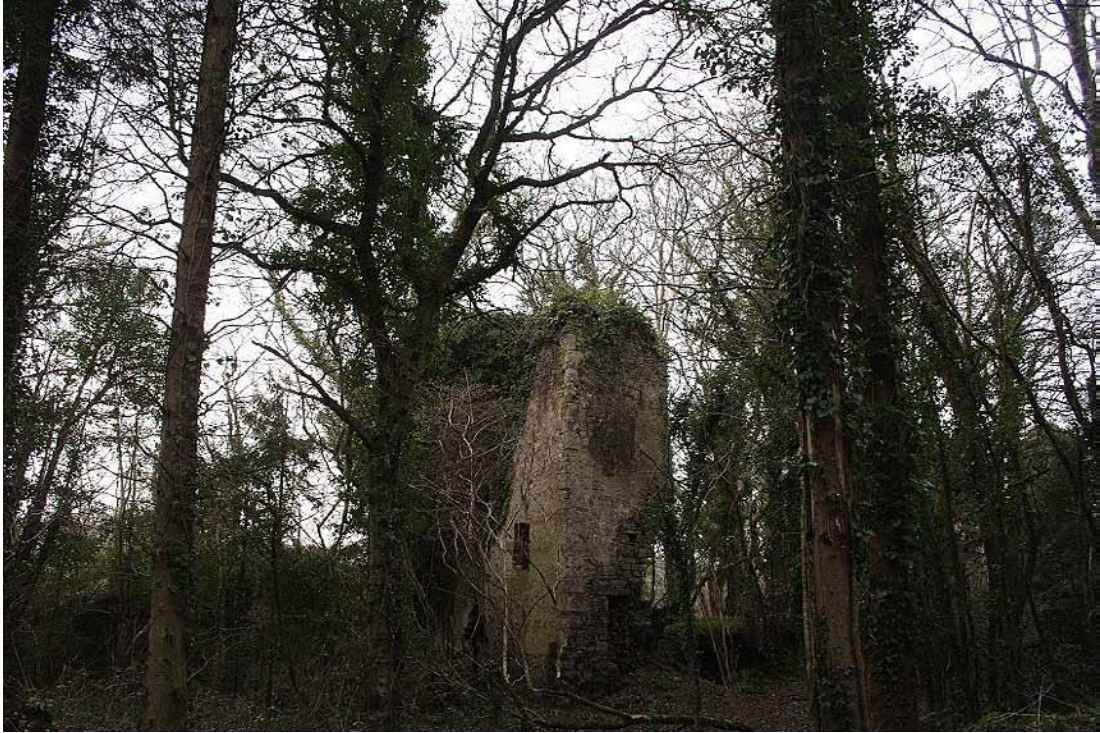
Photo 5: General view of Eastern Tower looking southwest.

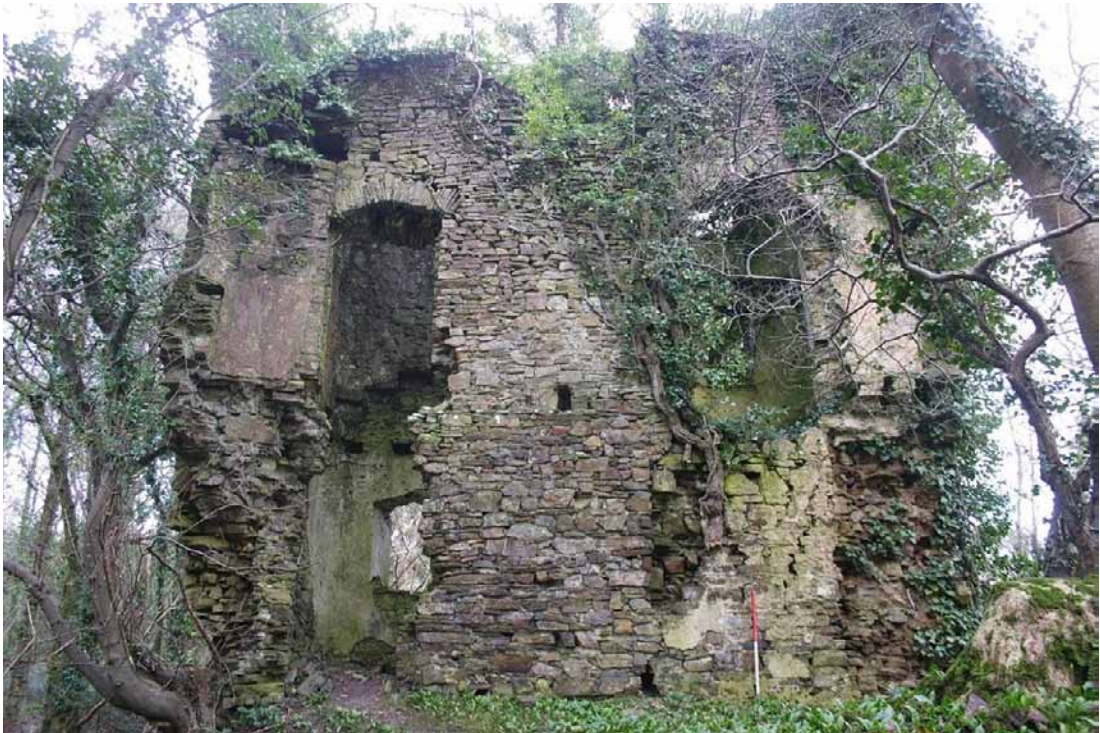
Photo 6: The western face of the Eastern Tower. 1m scale.

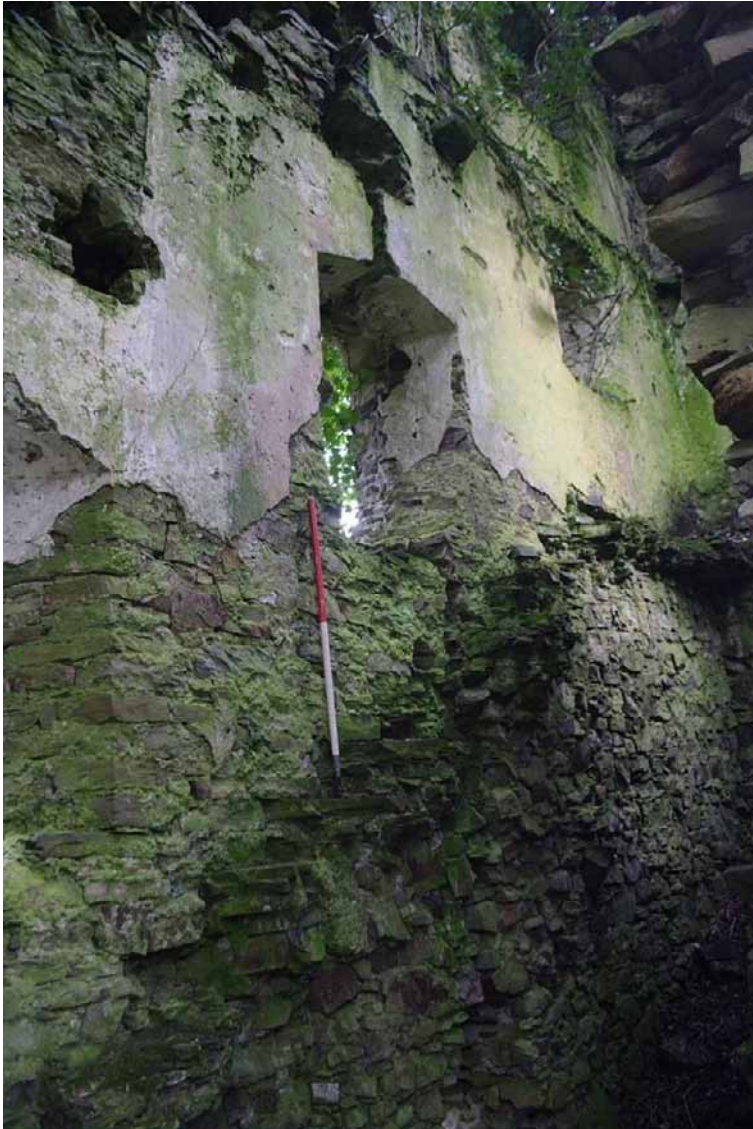
The eastern tower was a stair tower, impressions and some footings for the stairs remain (photo 11). The tower is 8.7m by 3.2m in area and four storeys high. The north and south tower walls have been built around and over (incorporating) the earlier undercroft walls (photo 10), the southern of these earlier wall segments being thicker and higher, almost to second floor level. The internal (west) tower wall has been built directly on top of the east wall of the undercroft. The stonework of the earlier walls generally consisted of smaller lime mortared rubble. The remainder of the tower is built of mortared random rubble and is still largely rendered.

The interior of the staircase tower is rendered in smooth white plaster on all but the western side (photos 11 & 12). At second floor level this appears to have been painted pink/red (photo 13). The internal northeast corner is rounded the full height of the tower.

Photo 11: Interior of Eastern Tower showing staircase remains and internal render. 1m scale

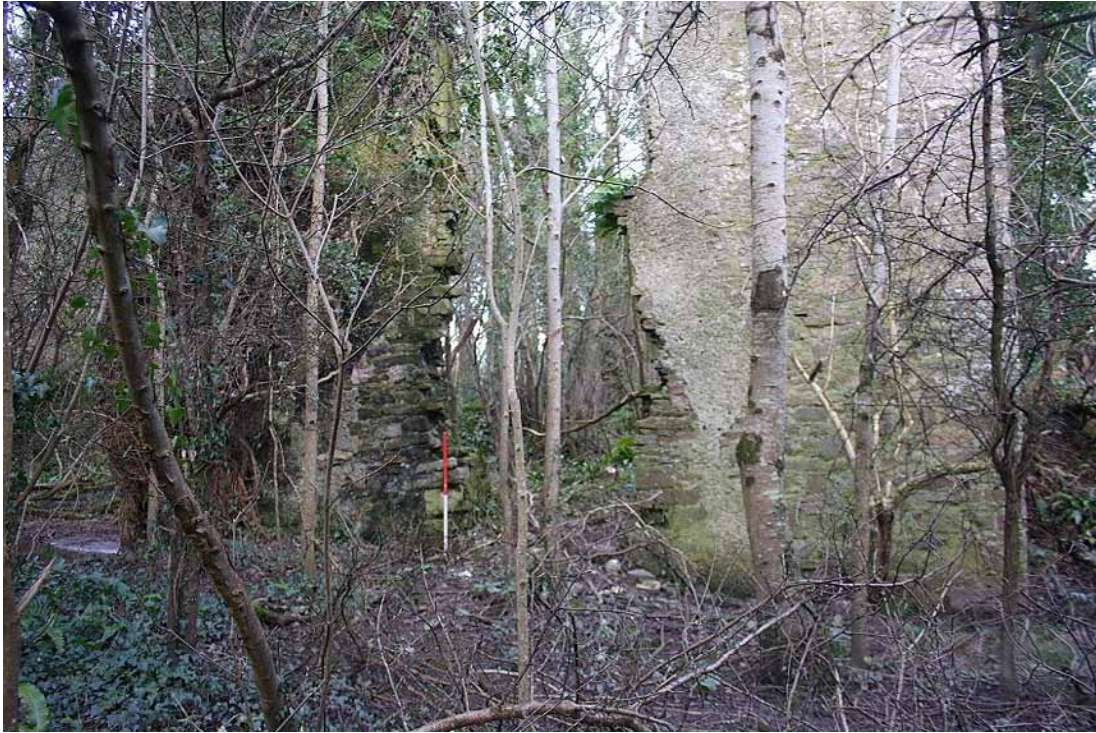
At the west end of the main hall the corners and most of the gable wall of a tower survives, with a large opening in the gable wall running the full height of the tower (photos 14 & 15). It is built in a similar style of lime-mortared random rubble and partially rendered externally, plastered internally. This tower survives to a similar 4-storey height, 7.3m north - south and c.6.2m east - west.

floors (photos 15 & 16). The collapse of the lintels and sills has caused the wide gap the full height of the west gable wall.

Photo 15: Western face of Western Tower. 1m scale.

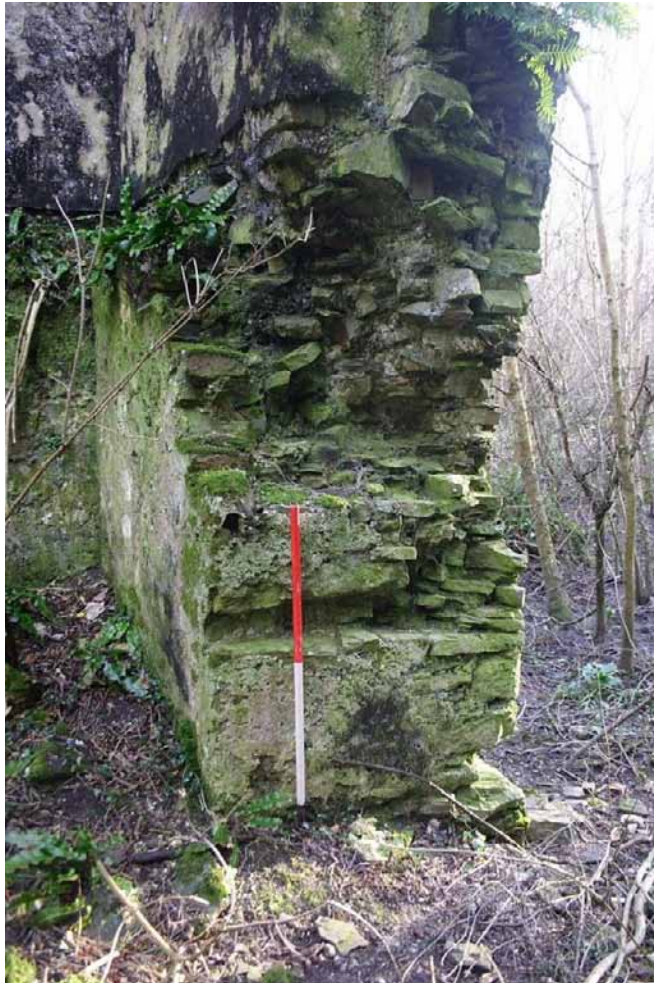
Photo 16: Section of the wall exposed in the main entrance through the western wall of the Western Tower. 1m scale.

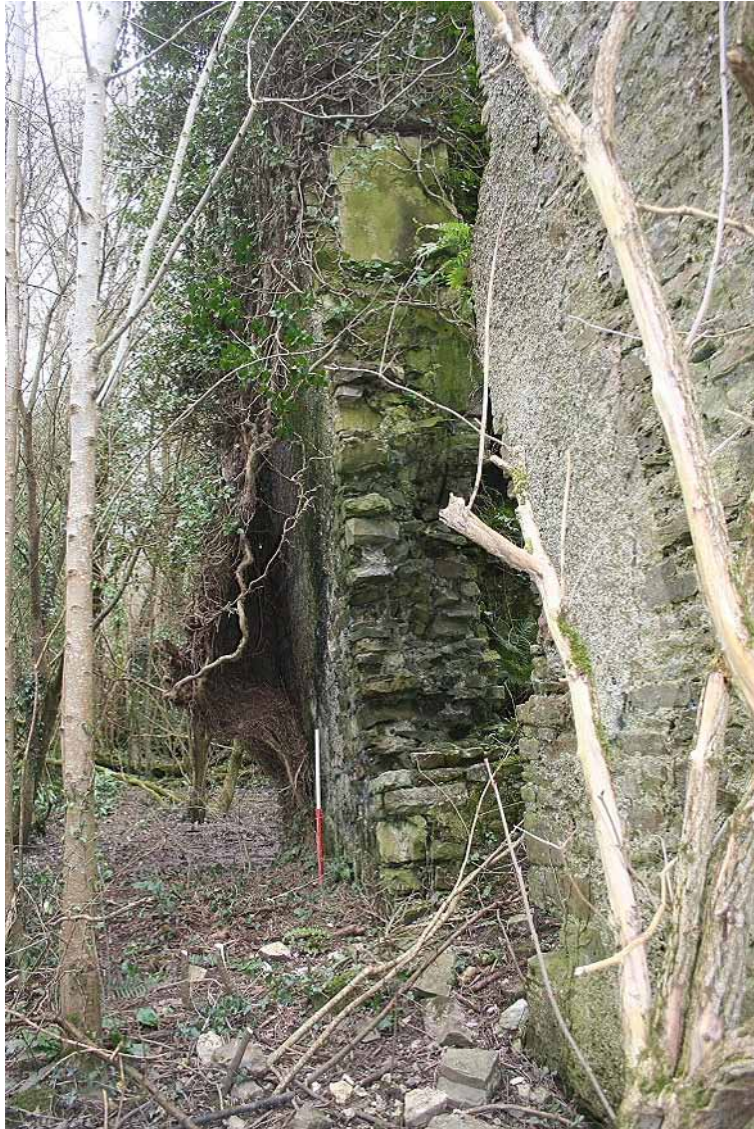
Photo 17: Looking north along the western wall of the Western Tower, showing the outward lean. 1m scale.

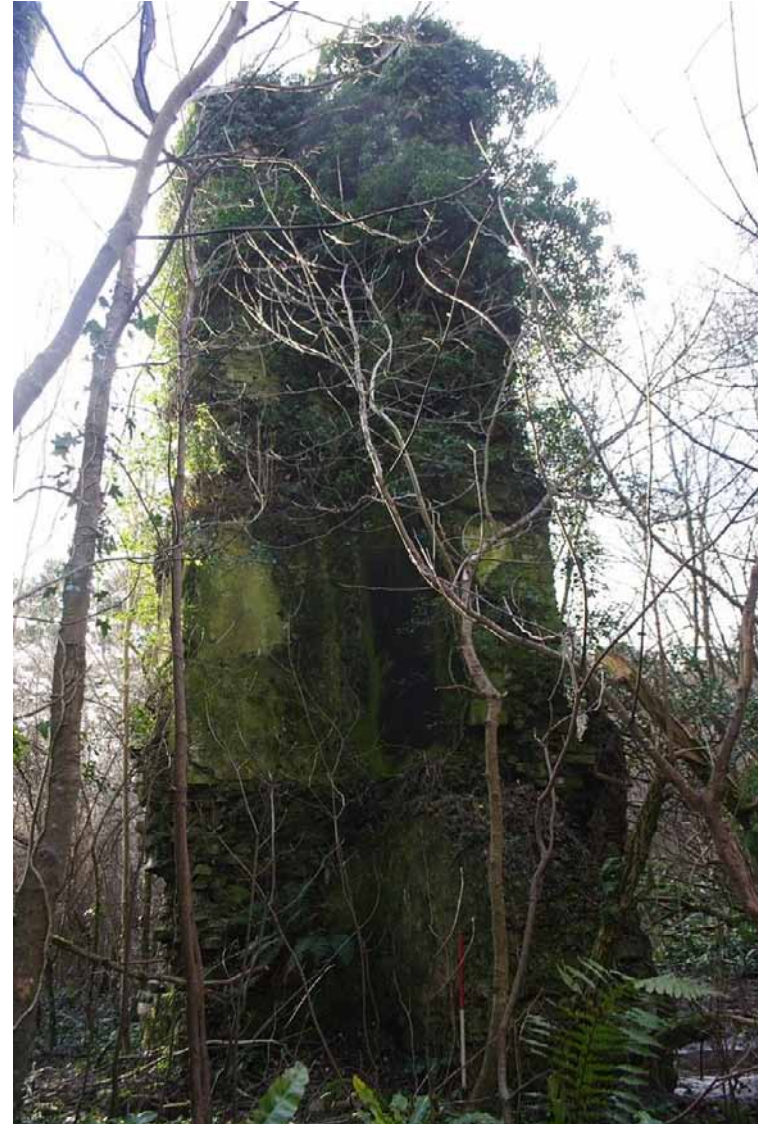
The north wall ends abruptly after 3.4m, presumably at a ground floor doorway (photo 20). There is evidence of further windows above this doorway in the floors above. A very thick growth of ivy now covers the northern face of this wall. A stream is culverted under this wall (photo 21), exiting under the southern wall (photo 22), presumably to flush internal garderobes. This has clearly become partially blocked and pools around the base of the tower (photos 21 & 23). There is evidence of a former lean-to on the external face of the tower above the point where the culvert exits (photo 24).

Photo 20: Interior of the northern part of the Western Tower, also showing the rendered side of a window in the western wall at 1st floor level. 1m scale.

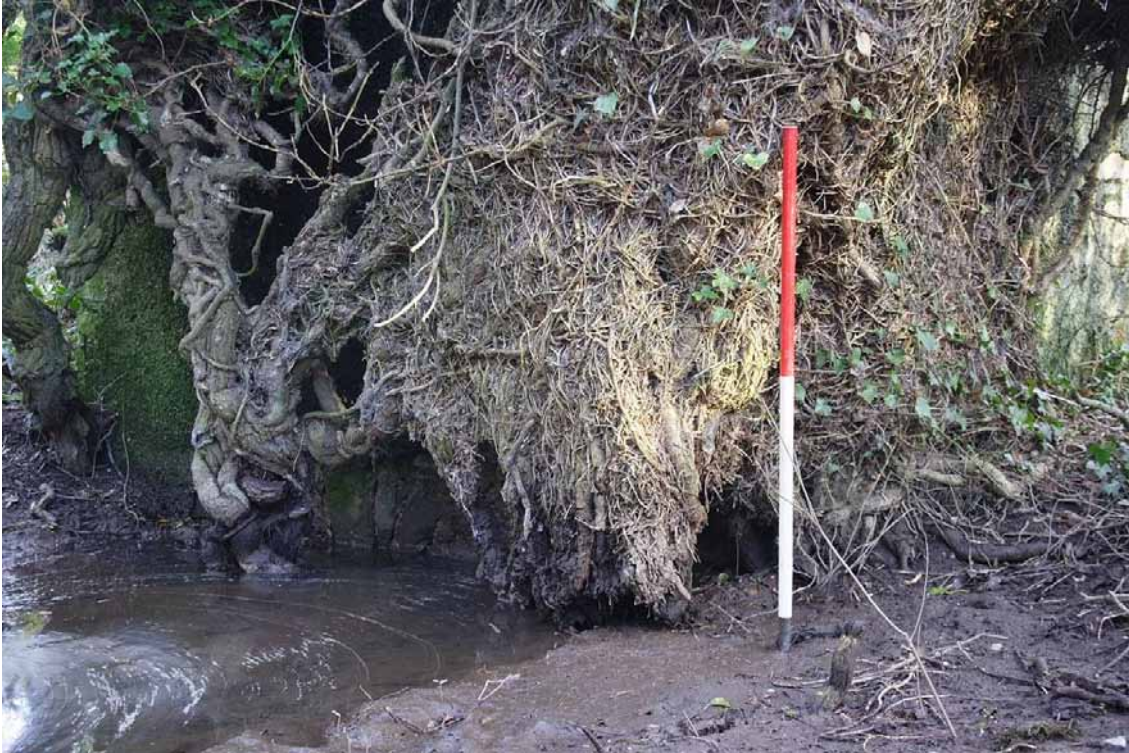
Photo 21: Stream pooling around the northern side of the Western Tower, also showing thick growth of ivy. 1m scale.

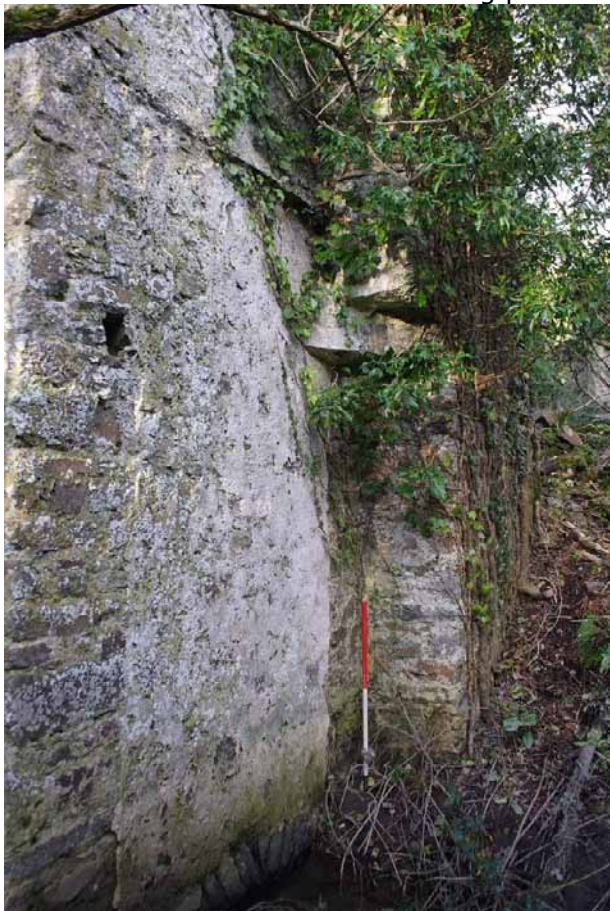
Photo 24: Southern face of the Western Tower, showing the top of the stream culvert, evidence of the former lean-to structure and protruding chimney stack. 1m scale.

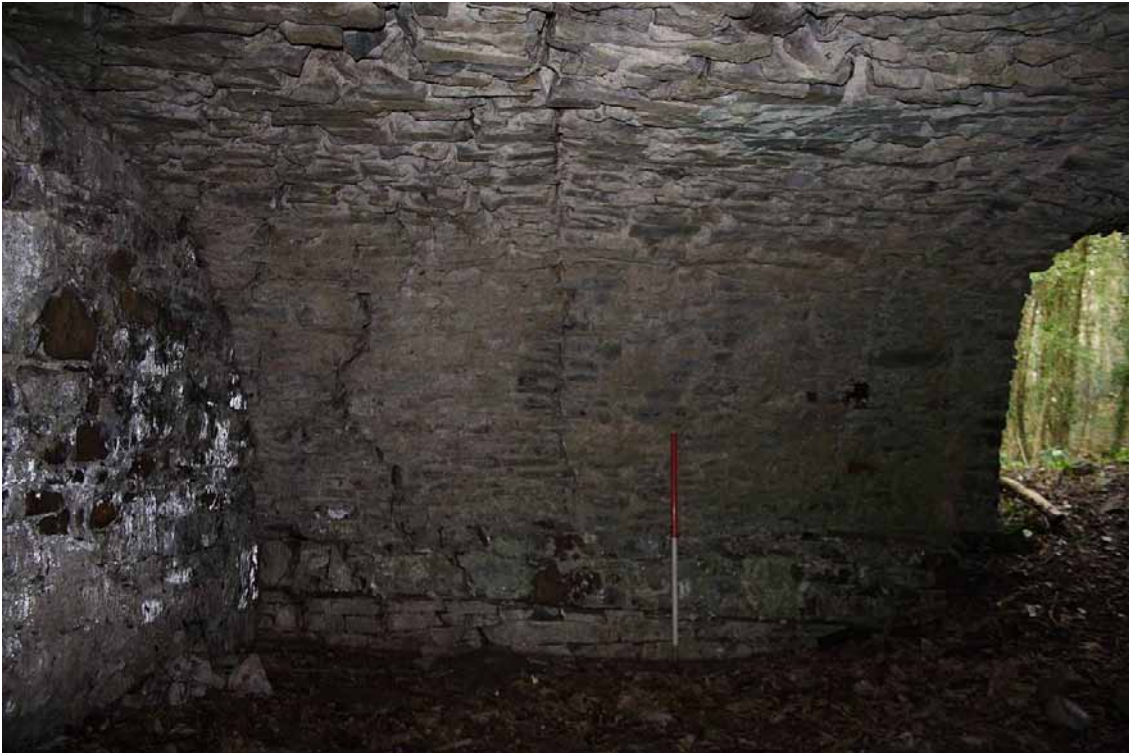
Photo 33: Join in the ceiling of the undercroft. View looking north. 1m scale.

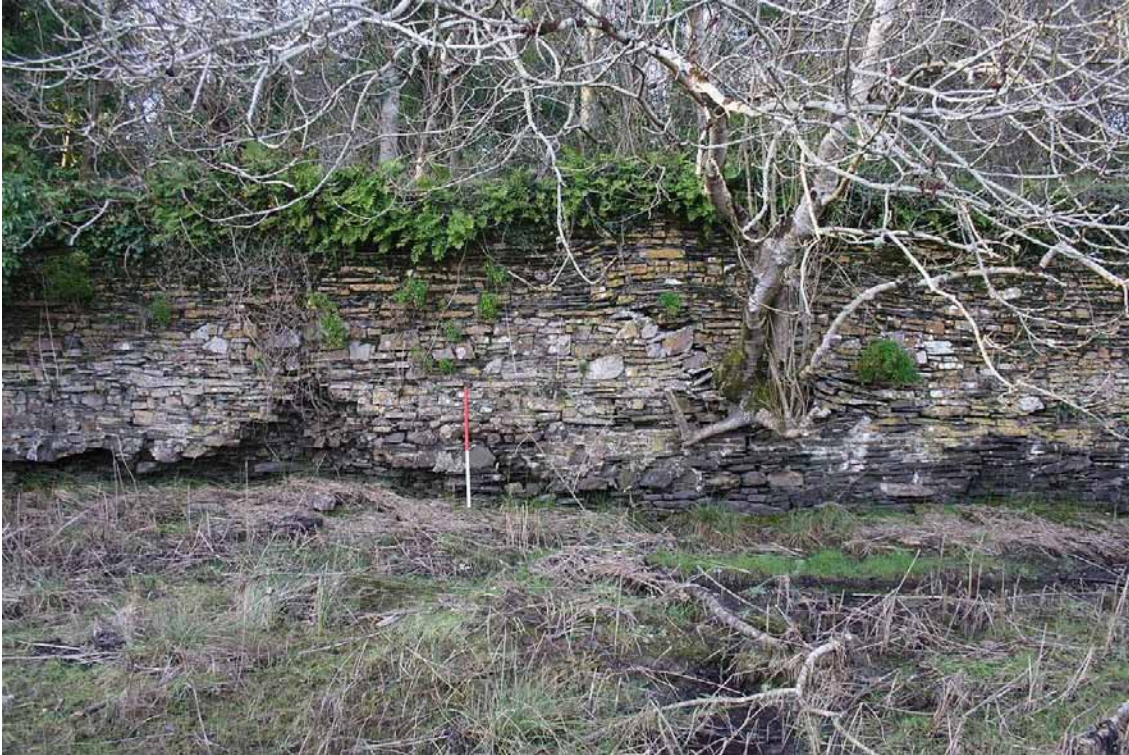
The remains all lie at the edge of the Western Cleddau, which is already undermining the long southern wall of the garden enclosure. The mortar has been washed out of much of the lower courses, and many of the facing stones have been removed exposing the rubble core behind. Erosion from tidal action will increase with rising sea levels. Climate change is recognised by the Welsh Assembly Government as one of the biggest threats facing the planet. Loss of landscape and heritage caused by it will have a negative impact on the quality of life in Wales and that 'without intervention our distinctive historic environment will degrade' (Environment Strategy for Wales, Welsh Assembly Government 2006). It is estimated that during this century temperatures will rise by 1 – 2 degrees centigrade, that there will be a 2% - 9% rise in precipitation and that sea level will rise by 180mm – 790mm (Wales: Changing Climate Challenging Choices, National Assembly for Wales 2007). Climate change and rising sea levels will: increase coastal erosion; inundate currently dry sites; create more extreme weather conditions promoting erosion of upstanding remains, particularly on areas such as sand dunes. Human responses to climate change will also impact on the historic environment, as new sea defences will be required whilst others will be abandoned under 'managed change'.

Photo 35: Closer view of the southern wall of the garden enclosure, viewed from the south. 1m scale.

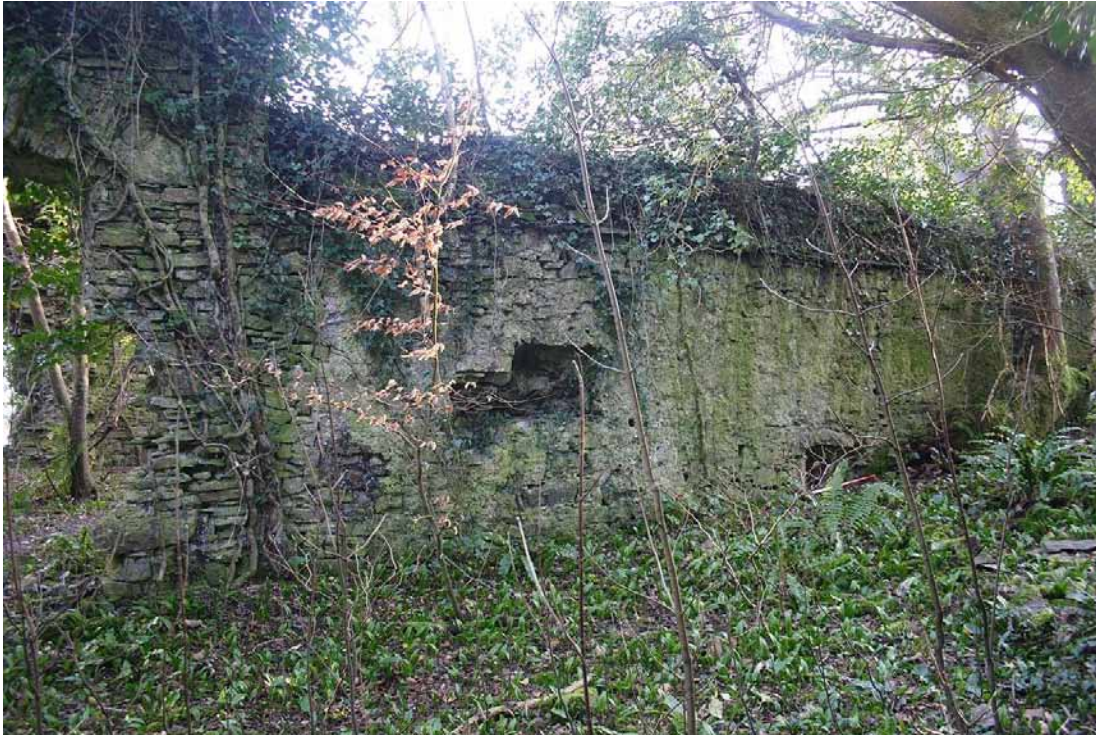
The northern wall is c.4.5m tall on its northern side, c.3.5m on its southern side (photos 39 & 40). The top of the wall tapers, as does the western wall, although this may be a later addition. The western wall, which divides the garden terrace from the Southwest Enclosure, butts against the northern wall (photo 46), and therefore may be a later division. The northeast corner includes some large quoin stones, but has also fallen northwards slightly, leaving a large crack at the join with the eastern wall (photo 43). A lean in this northeastern corner is clearly a longstanding problem, as 4m from the corner a stone buttress has been built against the northern face of the wall (photo 40). The crack has also been partially infilled internally.

On the north side of the northern wall, to the west of the main gateway there is small recess 0.5m wide, partially buried (photo 39). This is described by Davis (1989) as an 'aumbry'. There is a second recess to the east of this and higher in the wall, although this may have been caused by tumbled facing stones.

Photo 39: Northern wall of the Garden Enclosure, viewed from the north. 1m scale laid in front of the 'aumbry'.

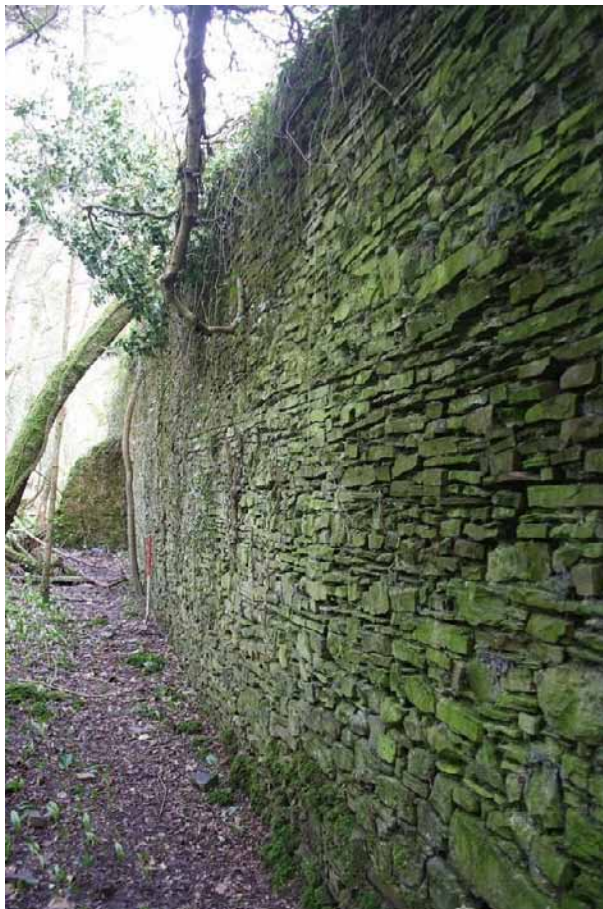
Photo 40: Northern wall of the Garden Enclosure looking southeast. Buttress visible to the left. 1m scale.

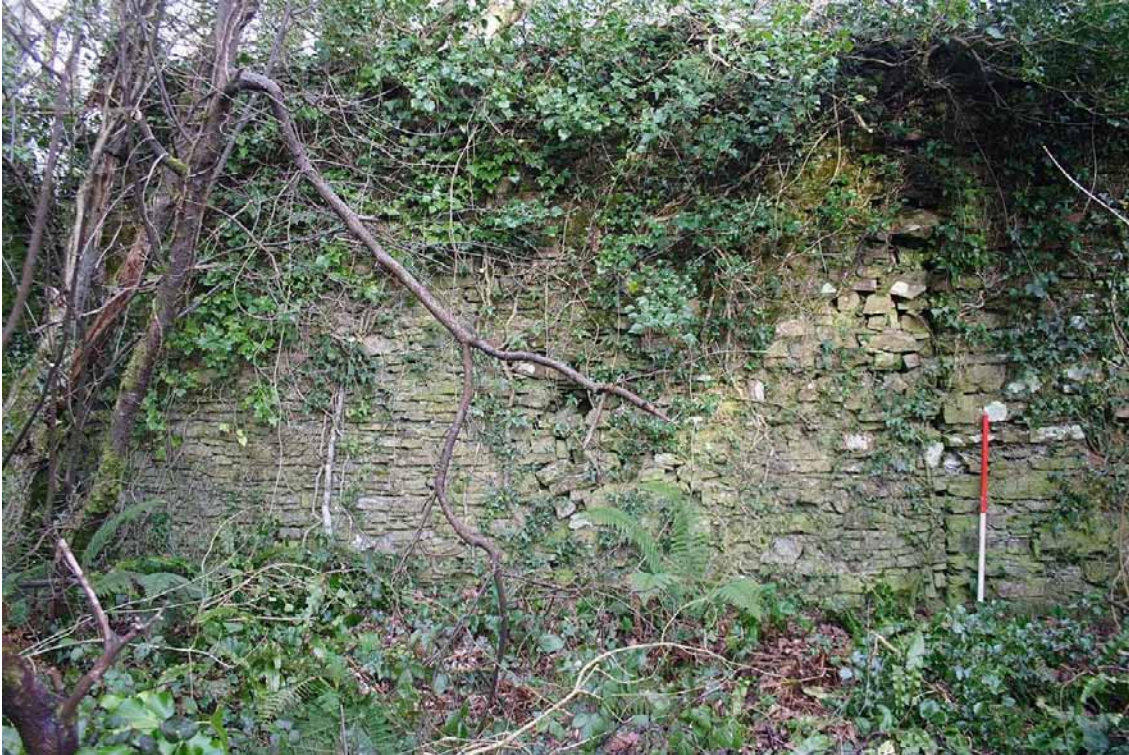
Photo 41: Interior of the eastern wall of the Garden Enclosure, showing the vertical joint of a possible entranceway. 1m scale.

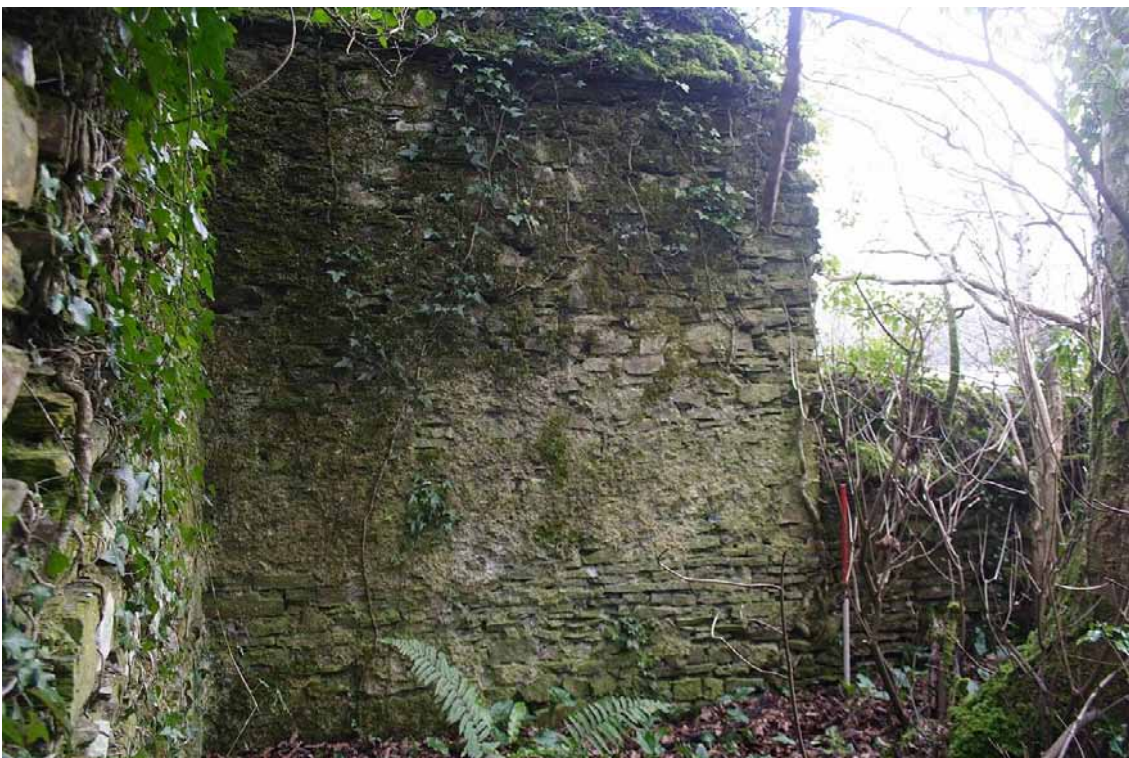
Internally a straight joint is visible between the lower parapet wall and the high wall at the southeast corner (photo 42). This straight joint only extends c.1m down from the top of the parapet wall, possibly indicating a later heightening of the parapet wall, although this is not as apparent externally.

Photo 42: Interior of the southern wall at the southeast corner of the Garden Enclosure. Straight vertical joint visible to the left of the 1m scale.

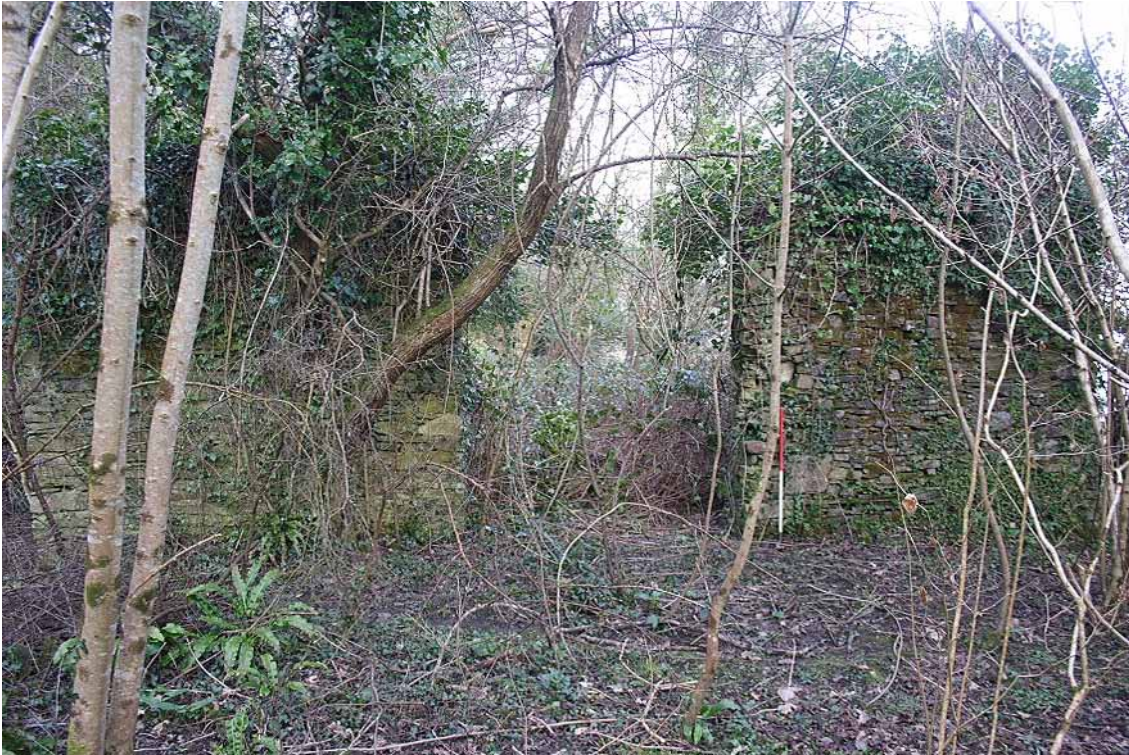
Photo 45: Entranceway through the western wall of the Southwest Enclosure. 1m scale.

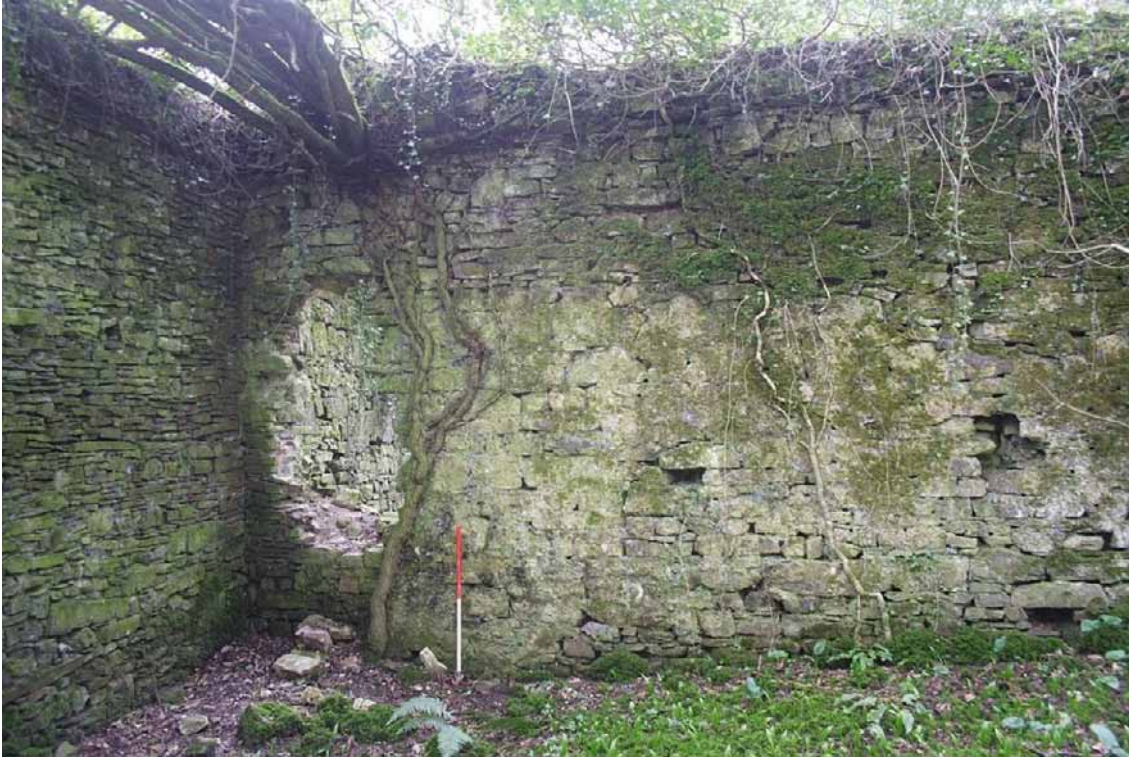
Photo 47: Looking west at the eastern wall of the Northeast Enclosure. 1m scale.

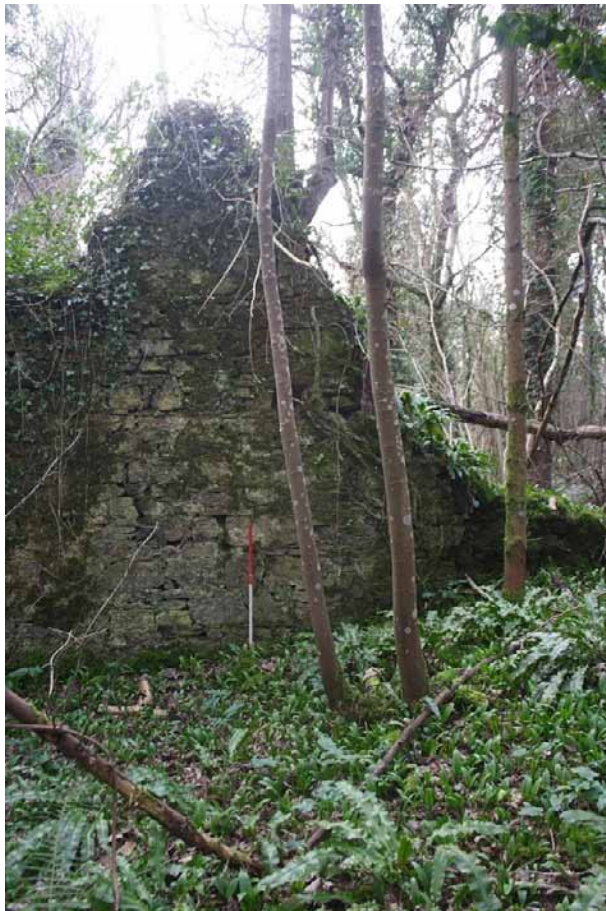
Photo 48: Northern end of the eastern wall of the Northeast Enclosure. Blocked loophole visible to the left of the 1m scale.

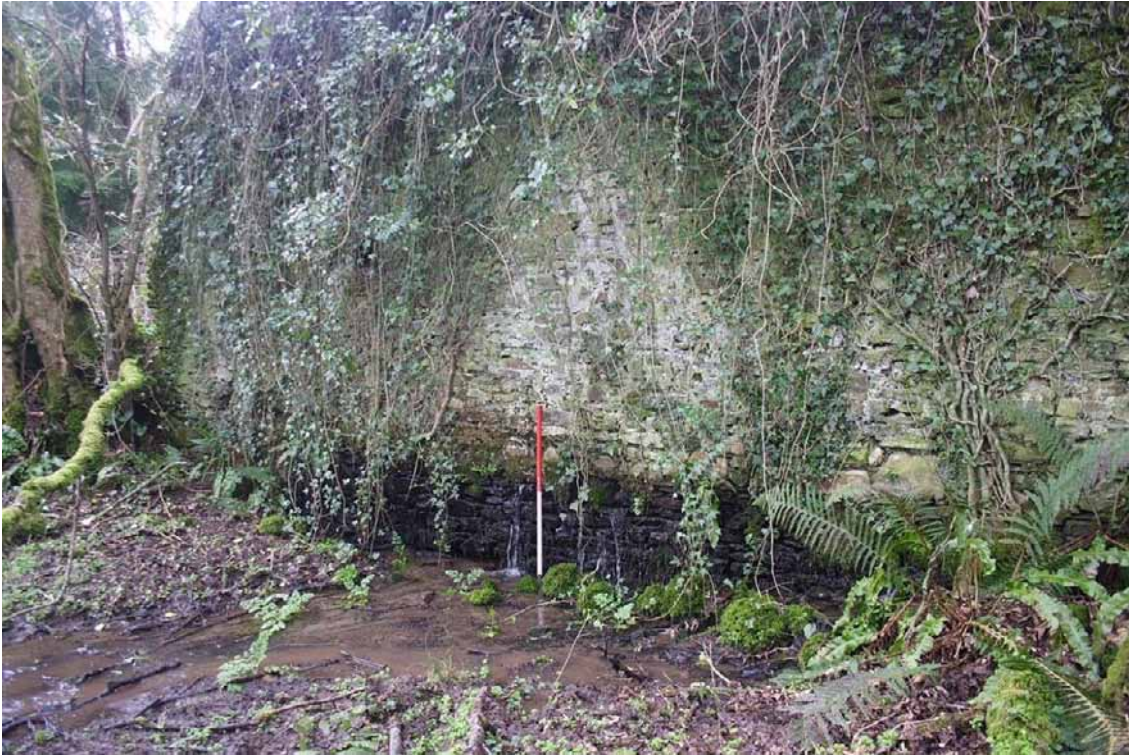
Photo 51: Water seeping through the northern wall of the Northwest Enclosure. 1m scale.

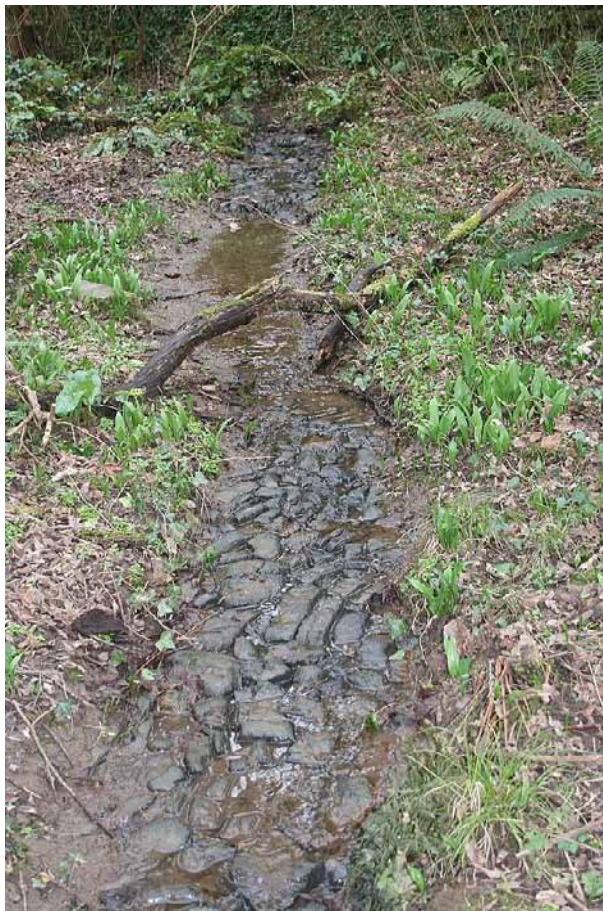
Photo 52: Cobbled surface uncovered in the Northwest Enclosure.

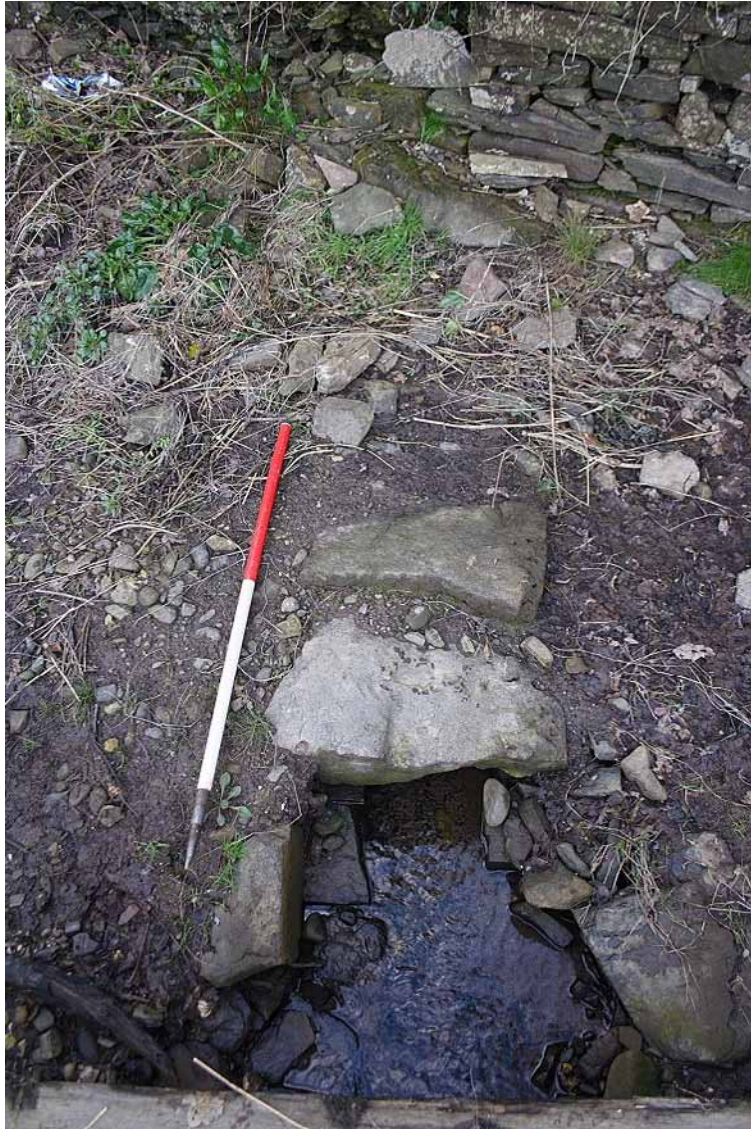
Photo 53: Culverted stream running out from underneath the Southwest Enclosure, looking north. 1m scale.

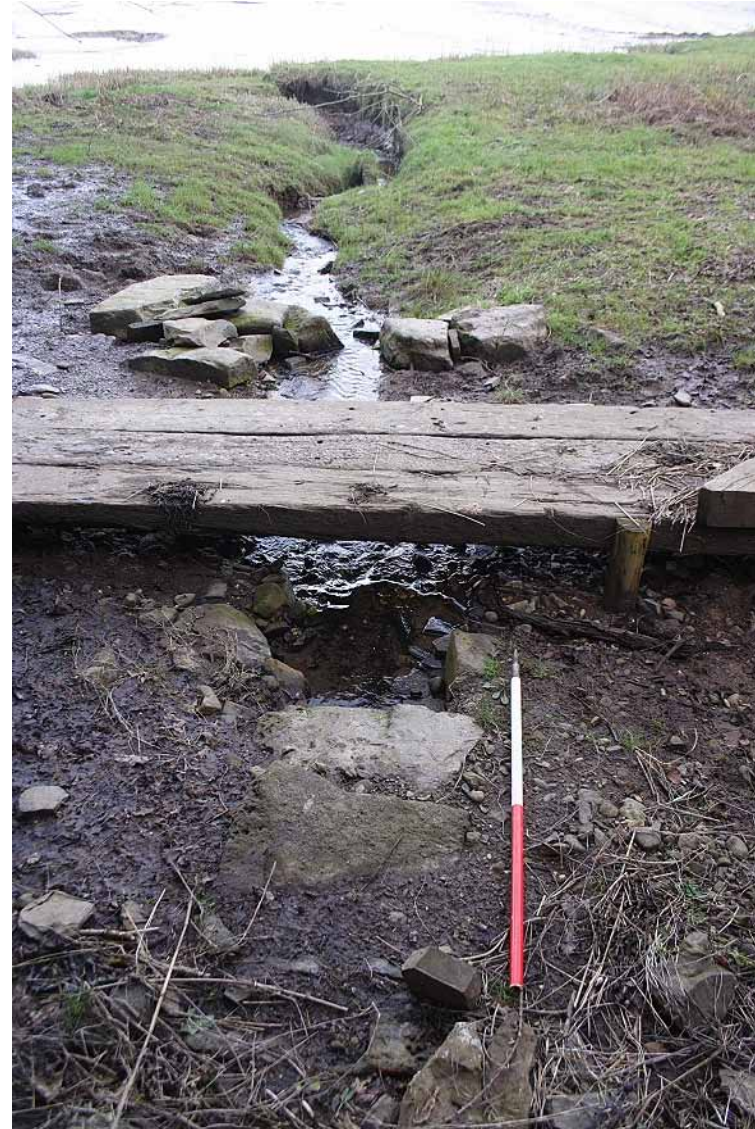
Photo 54: Stream running out into the river. 1m scale.

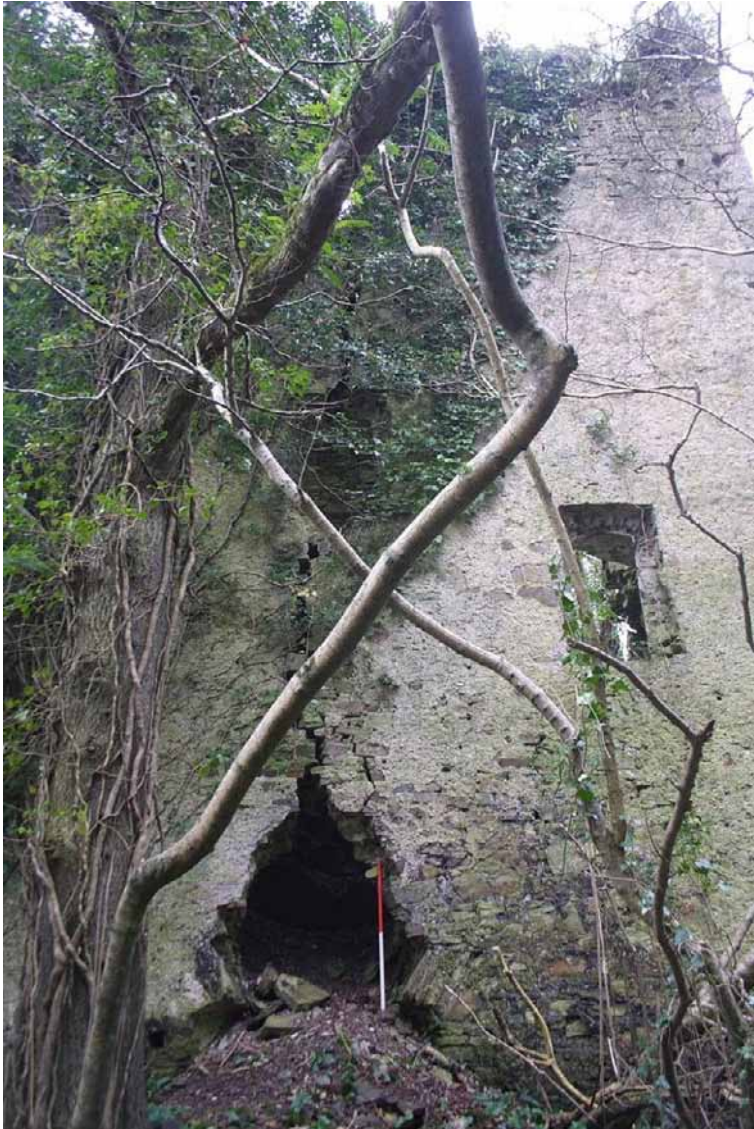
Photo 9: Closer view of the collapsed archway and vertical crack above. 1m scale.

There is a ground floor arch, presumably for an entranceway, in the centre of the east gable tower wall, just visible above the build-up of rubble and soil (photo 9). The top of the arch has collapsed, which has caused stonework immediately above to fall in, and a large crack has opened the full height of the tower. This entrance opens into a narrow space 0.8m wide, and opposite a blocked narrow splayed opening in the undercroft wall.

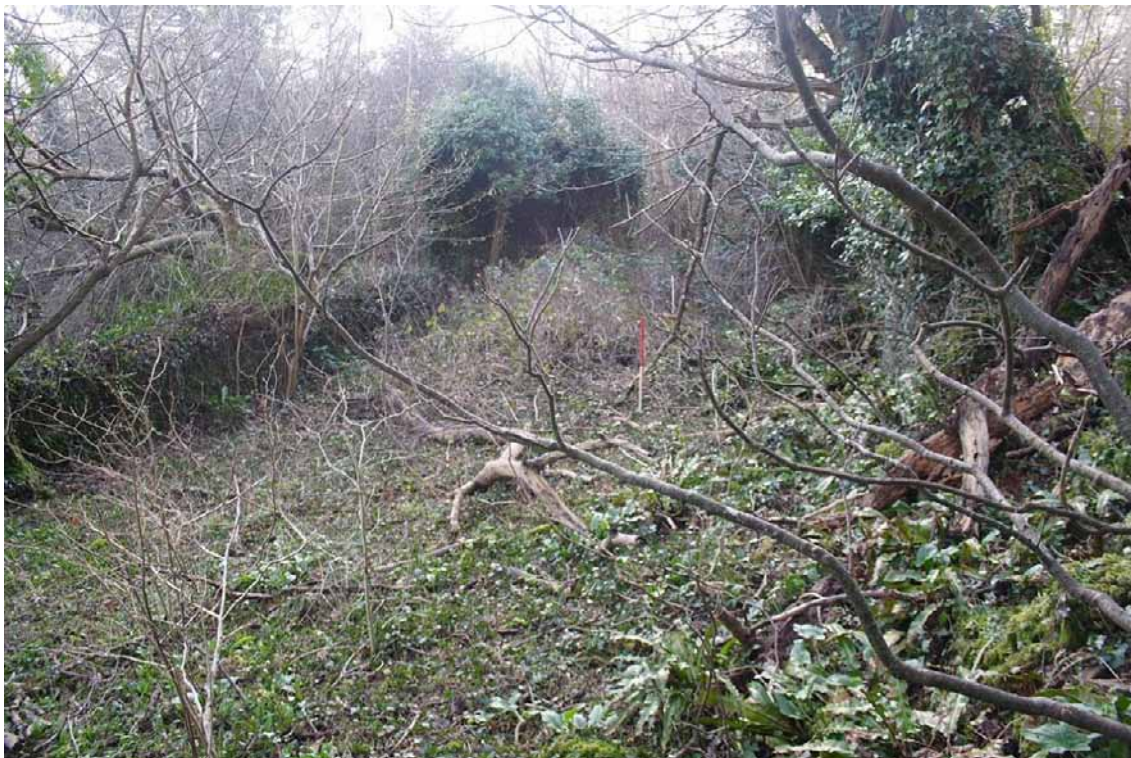
Photo 44: Interior of the Southwest Enclosure, looking southwest. 1m scale.

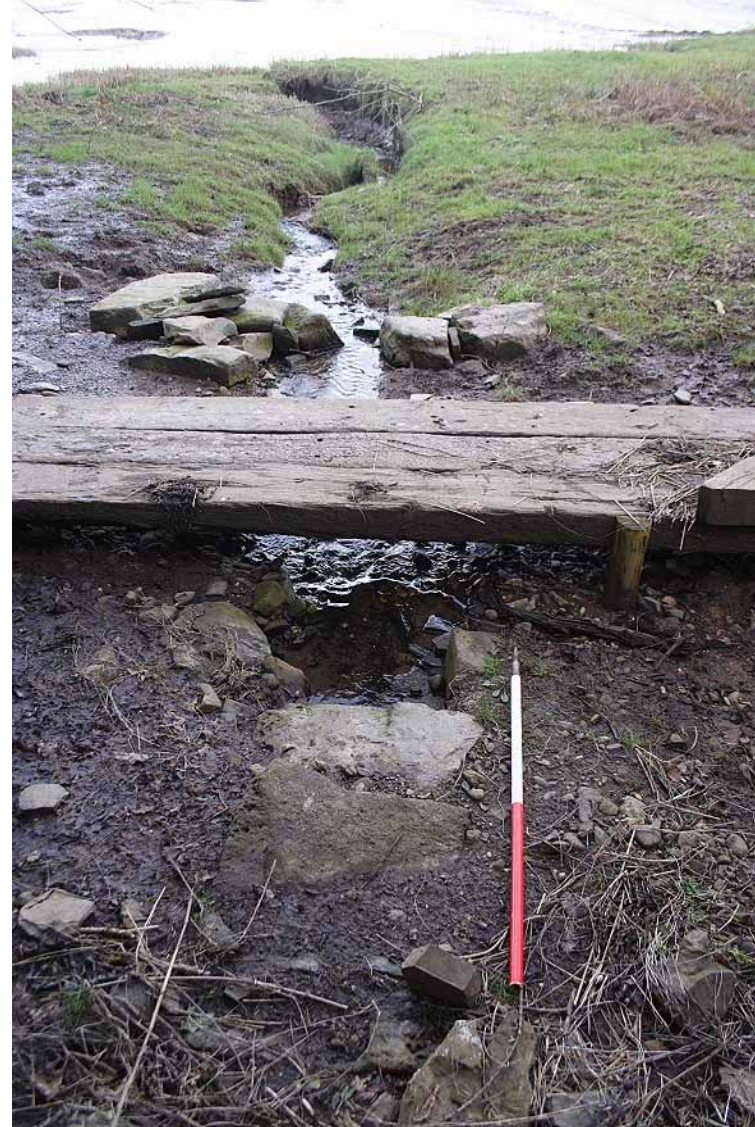
Photo 54: Stream running out into the river. 1m scale.
